Robert Dulin A 2 Storm water BMP work 12-11-17

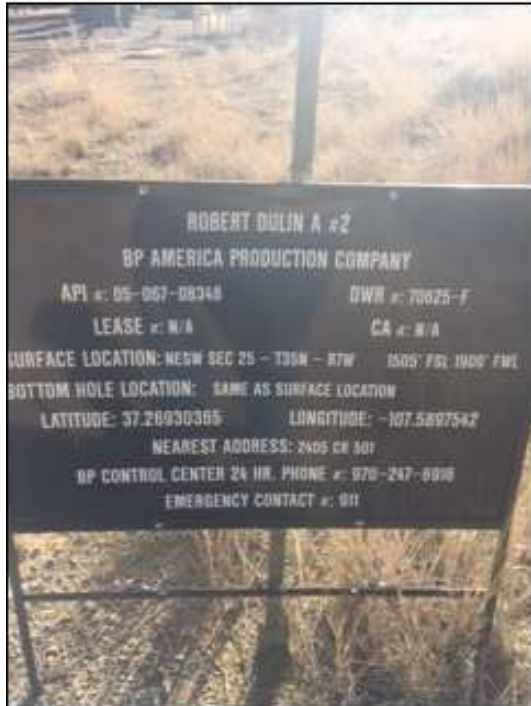
Location sign is a new sign no actions taken
