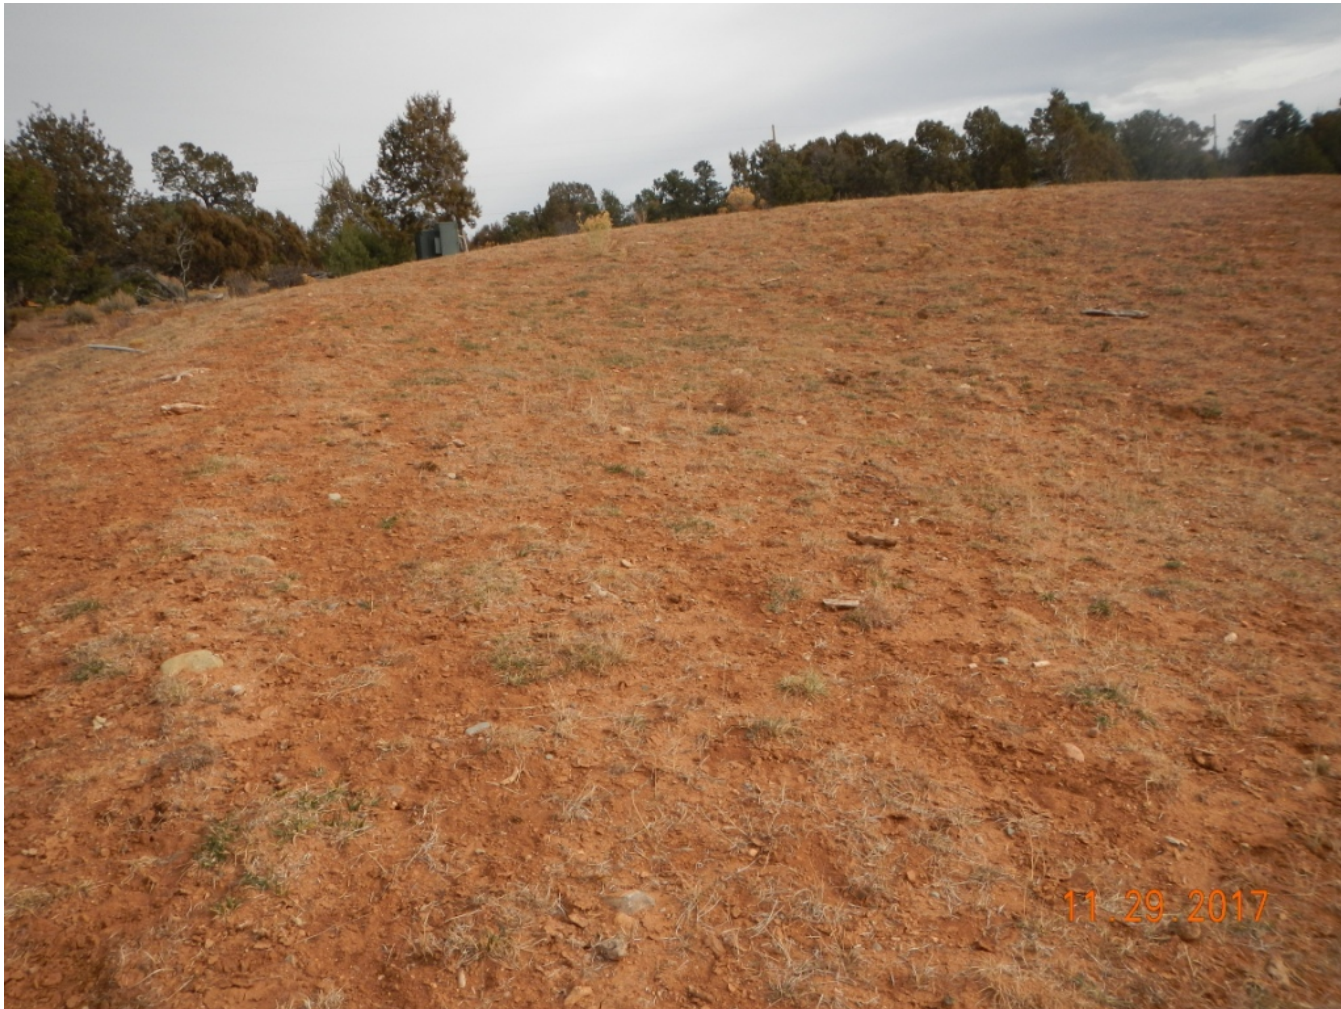
Photo 1. View of area in the northeastern portion of the project area where it appears Russian knapweeds have been treated.

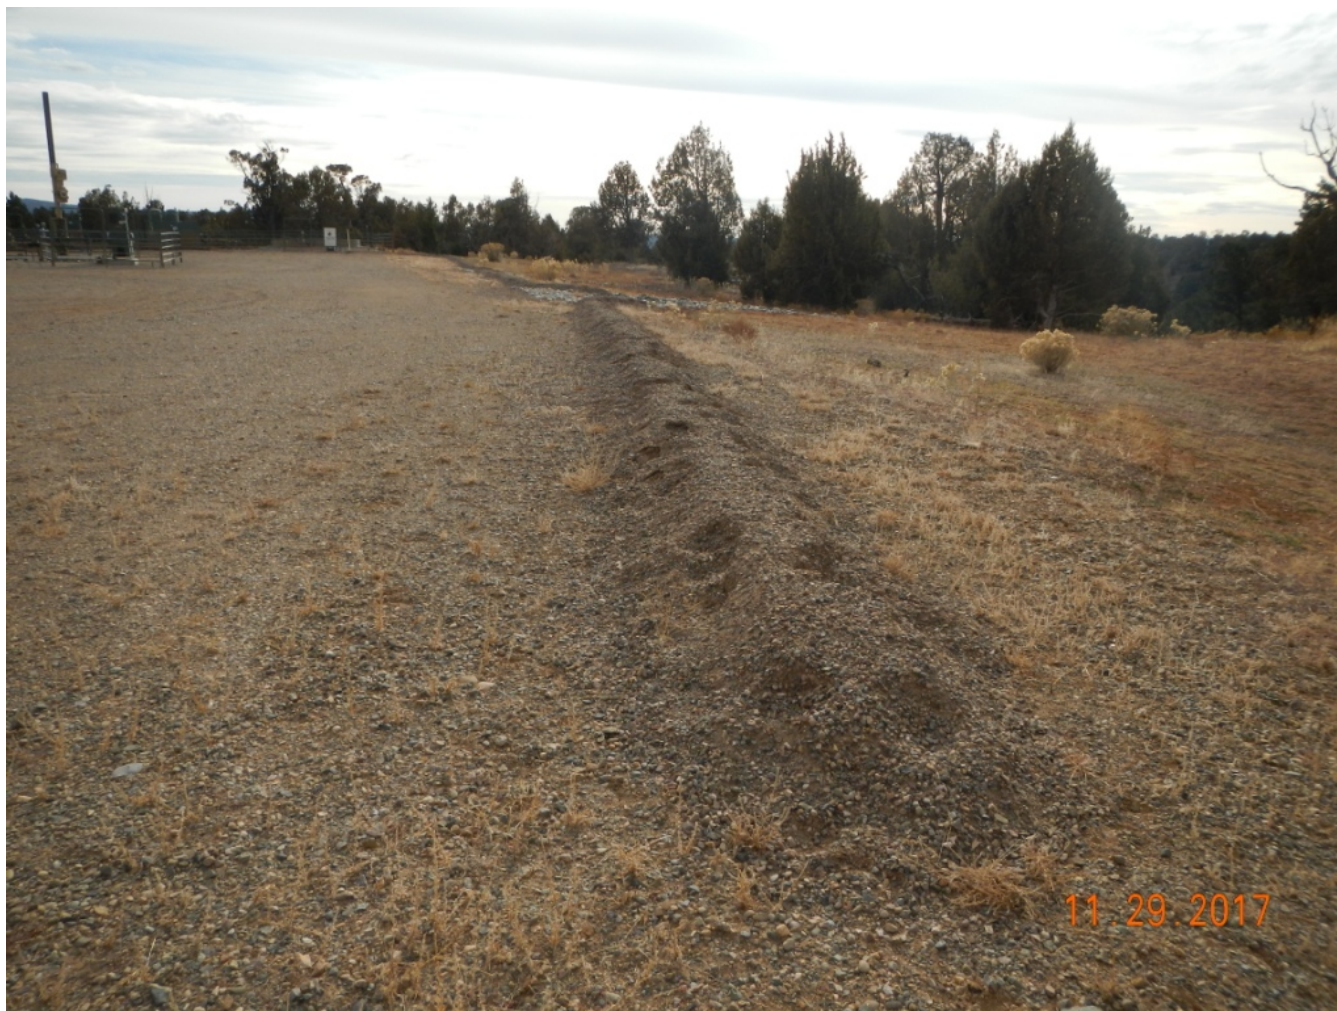
Photo 2. View of berm in the western portion of the project area.

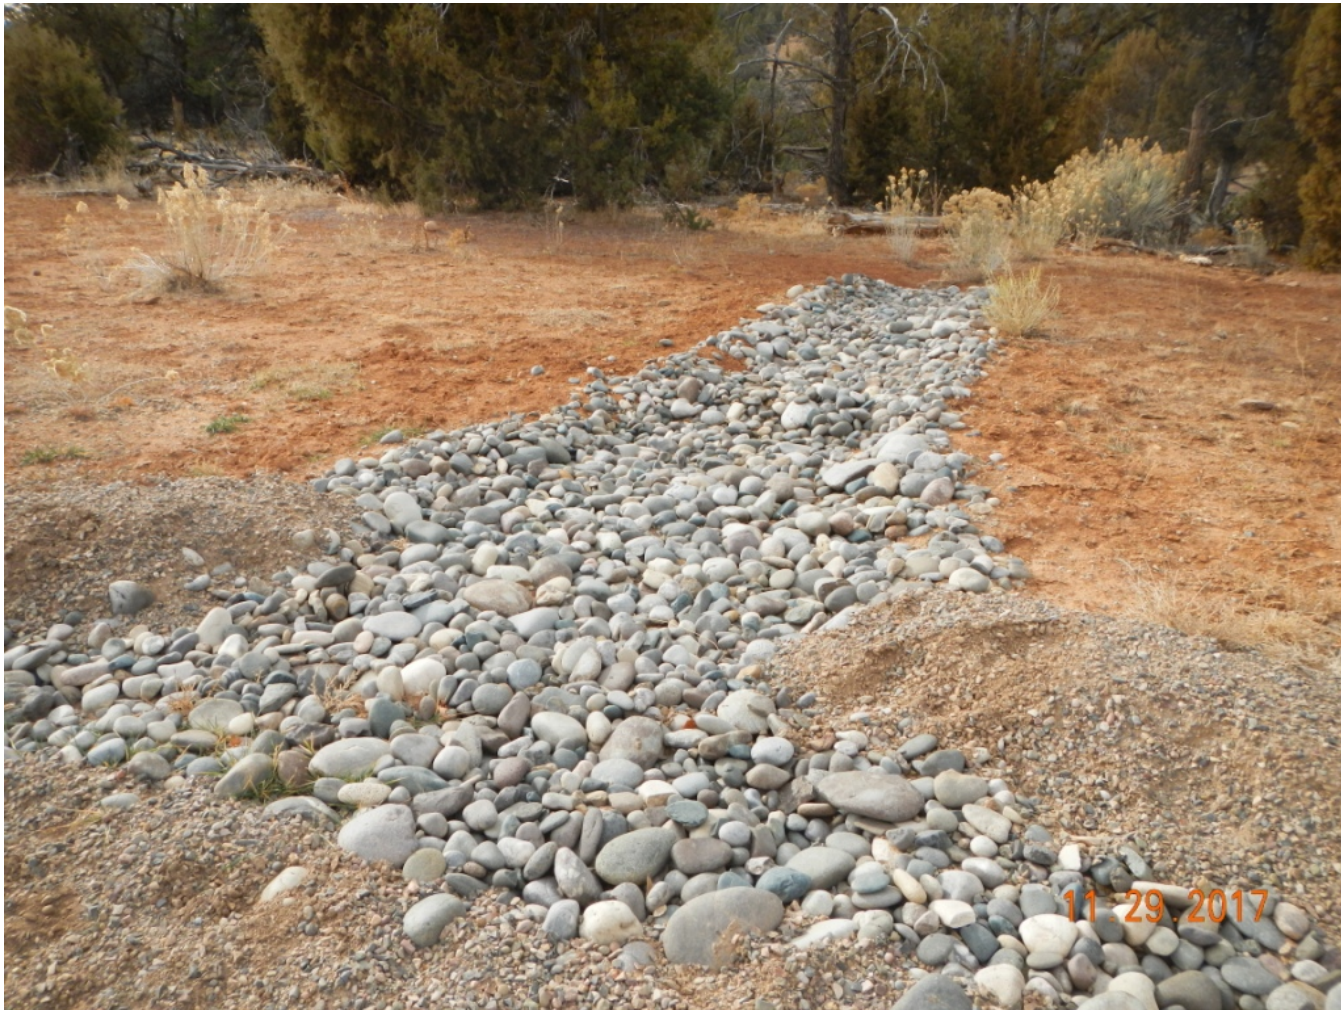
Photo 3. View of cobble run-down in the western portion of the project area.
