Inspection Photos
Location Name: Semler #1
API: 05-067-07909

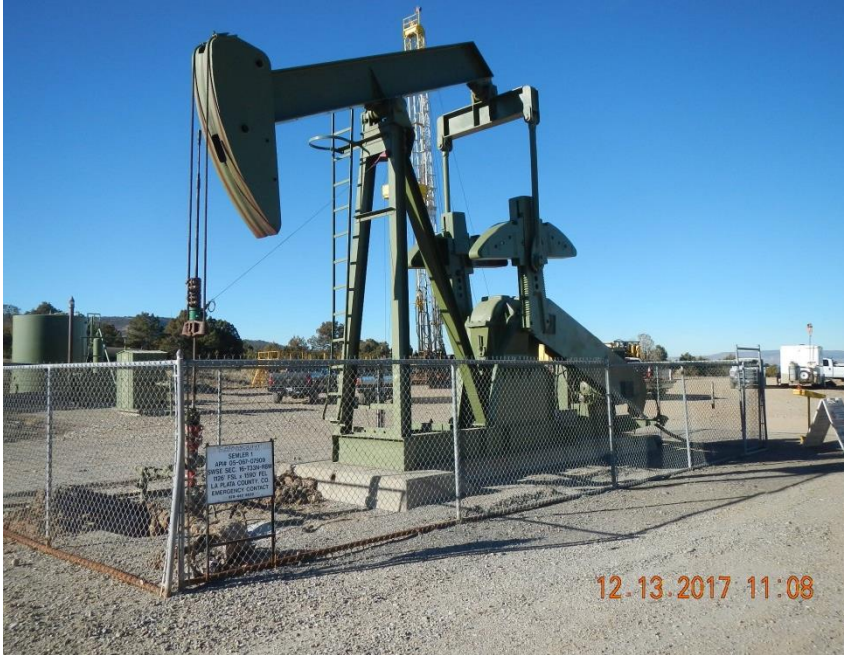
Semler #1 well head and pump jack.

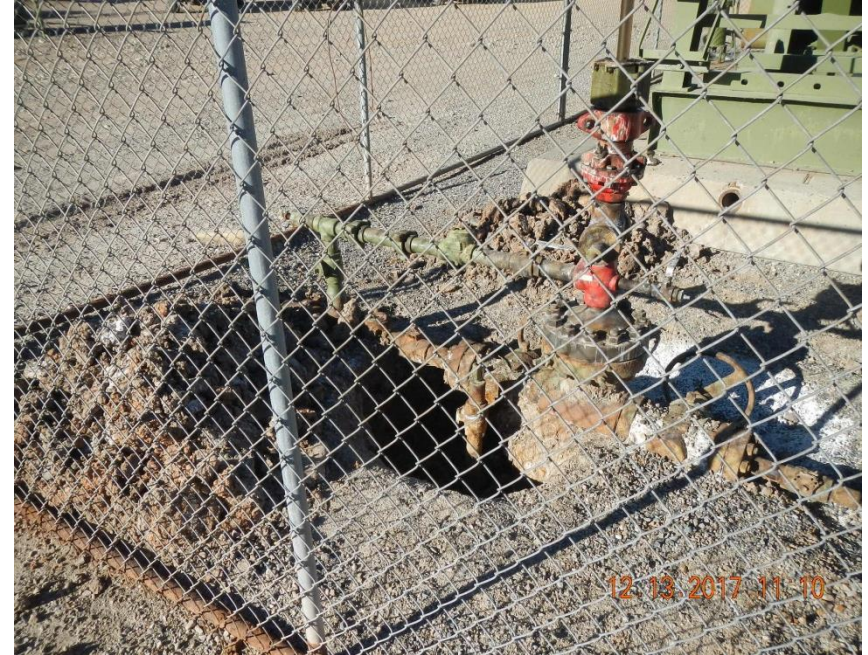
Stained soil and excavation around well head.

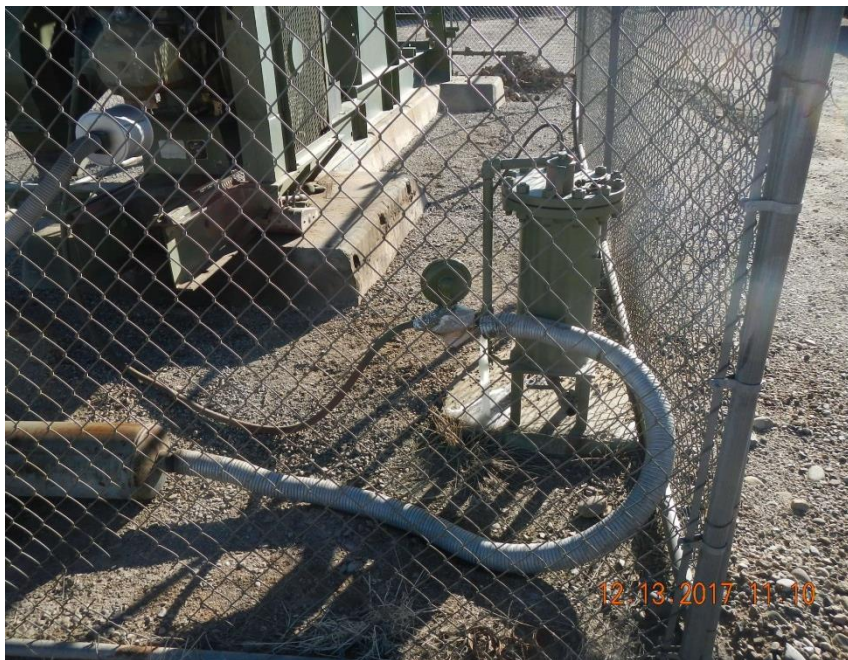
Stained soil noted on inspection document #674901962 has been removed.

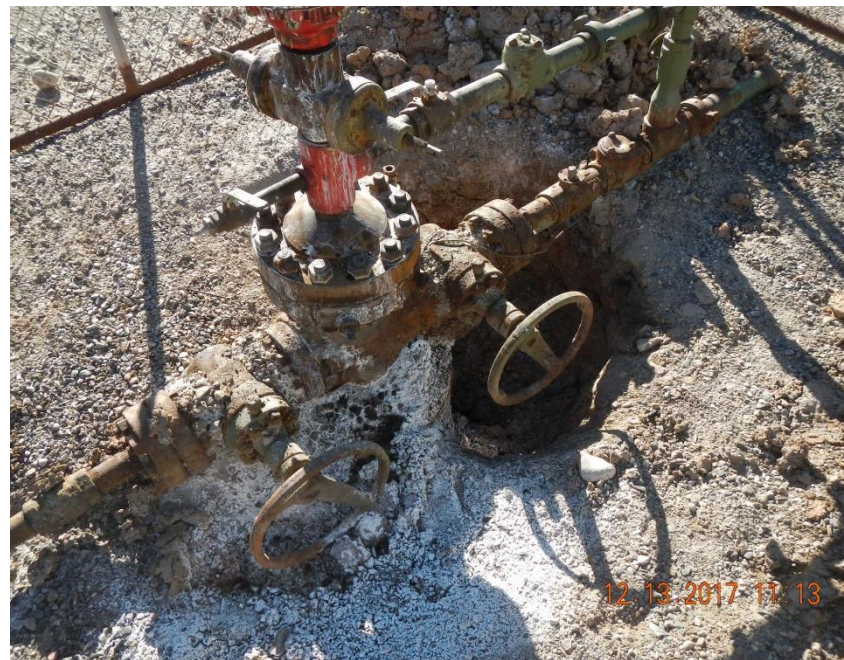
Stained soil and open excavation at well head.

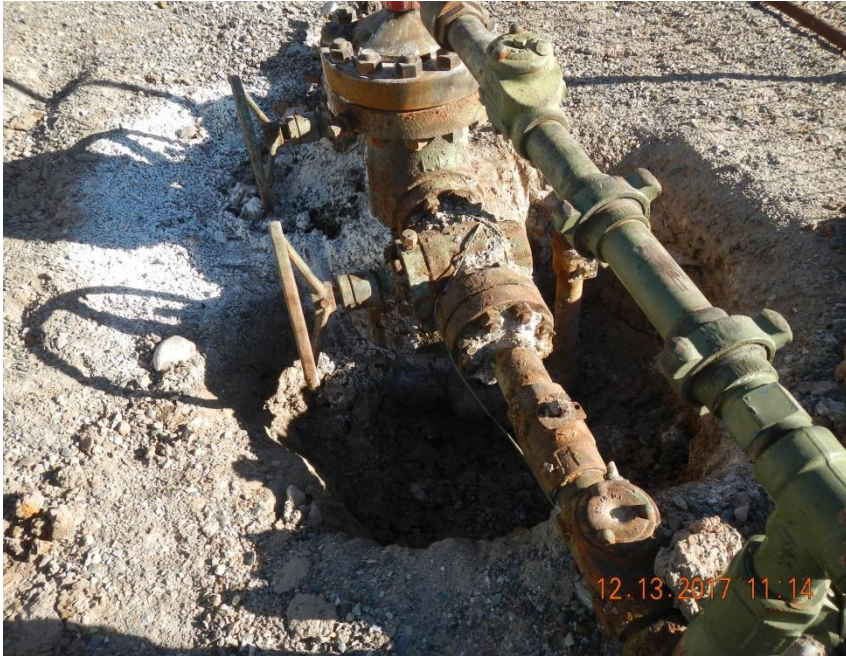
Alternate view of excavation near well head.

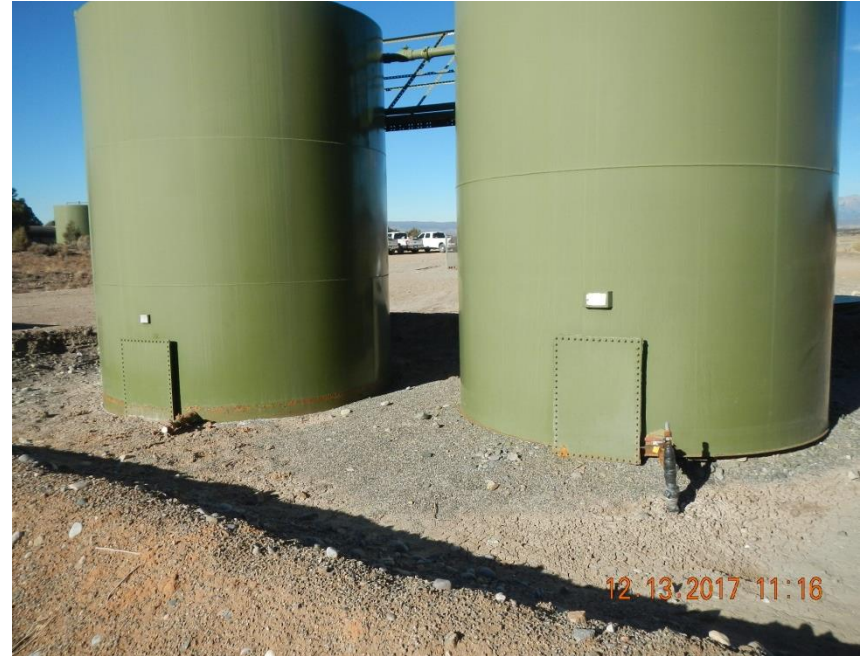
Secondary containment berm for tank battery has been repaired.
