Inspection Photos
Location Name: Herrera MV #1
API: 05-067-05410

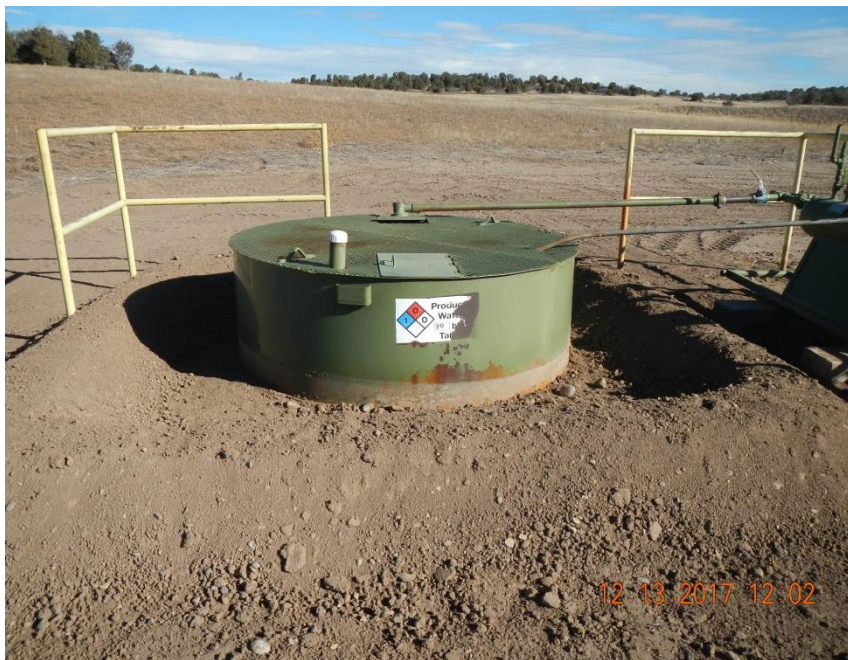
Open topped PW vessel.

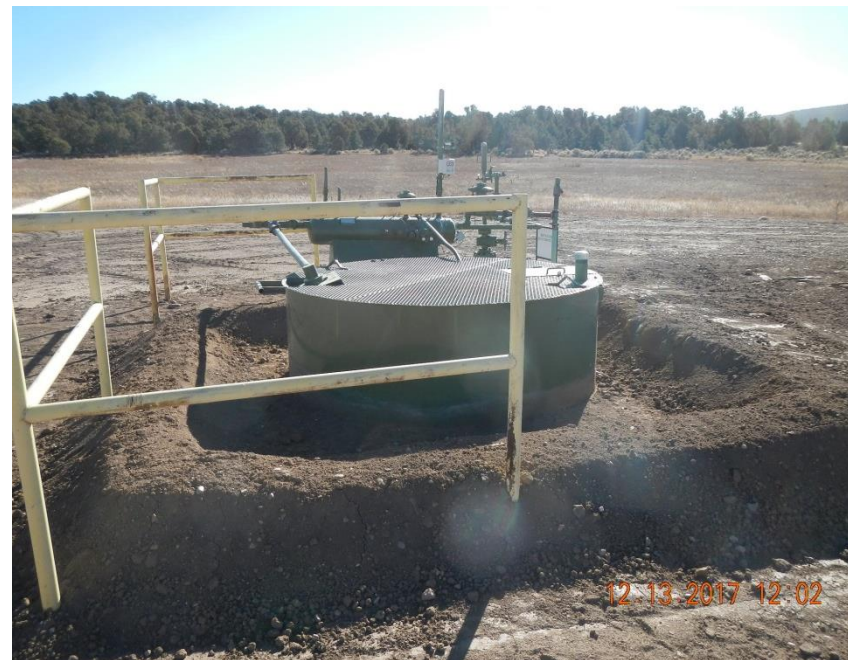
Secondary containment berm has been repaired.

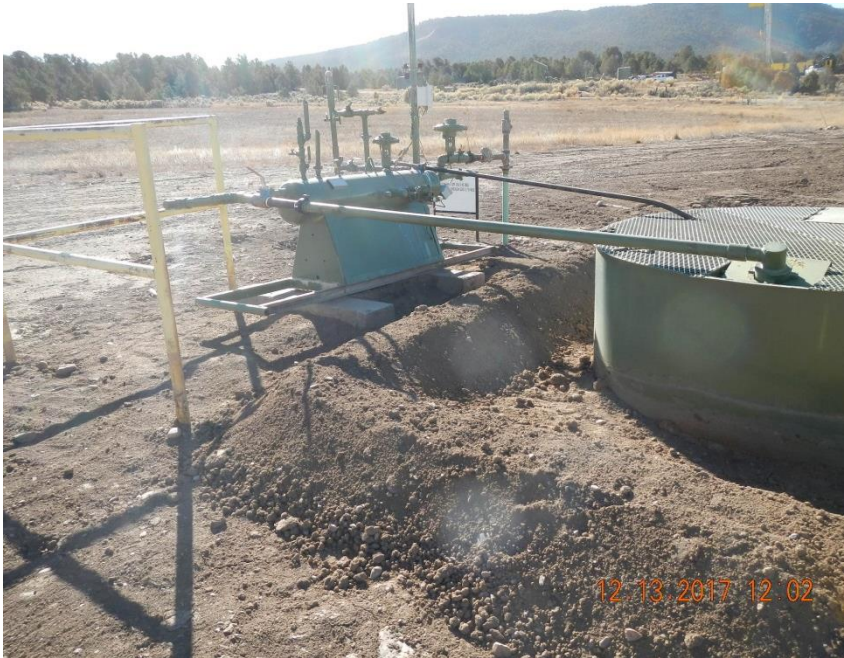
Secondary containment berm maintained to provide adequate capacity.

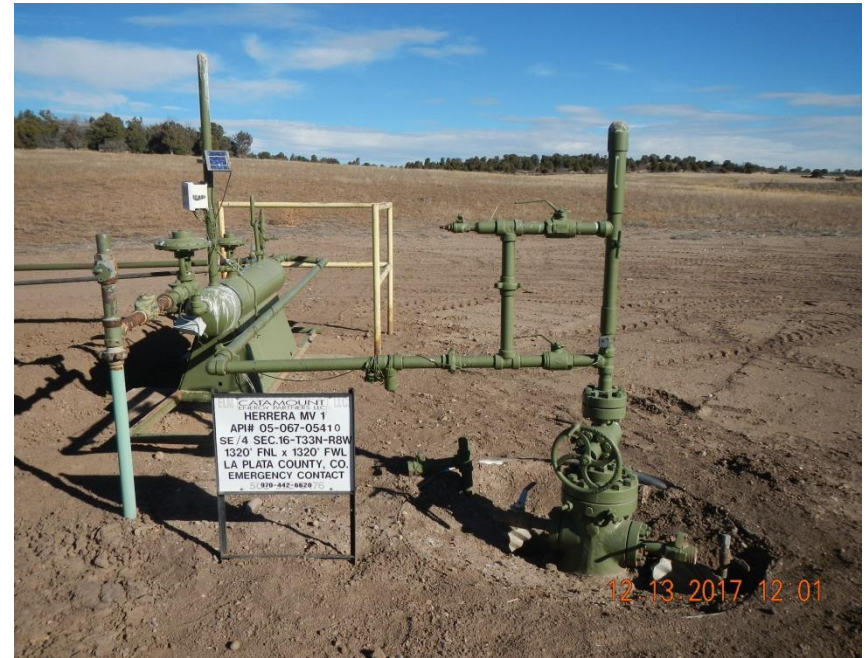
Herrera MV #1 well head and dehy unit.
