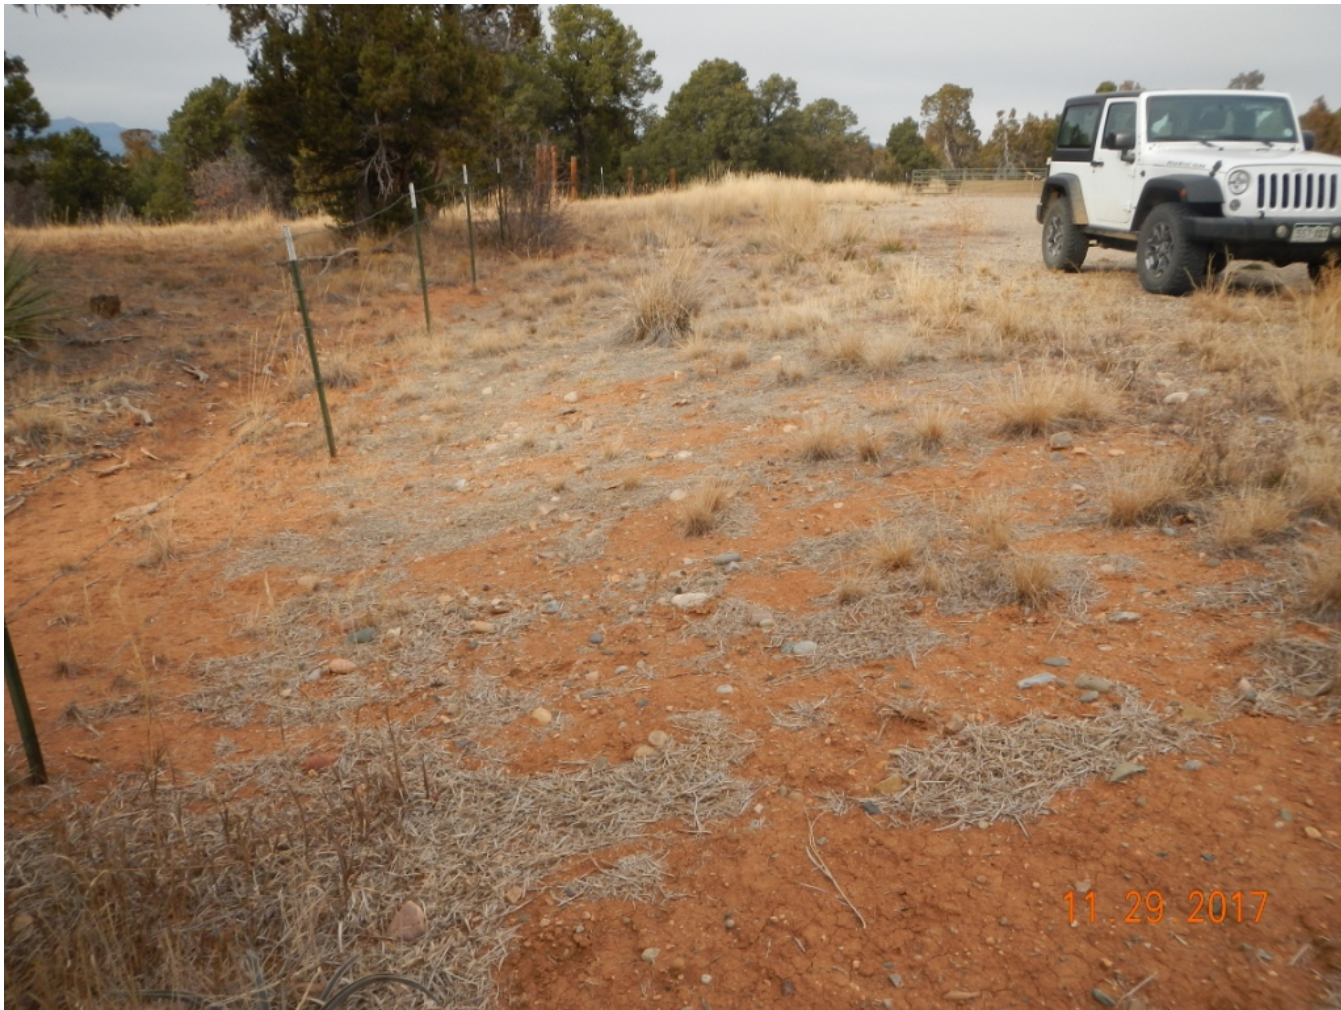
Photo 1. View of straw and area with documented erosion, appears to be functioning, but controls may not be sufficient. No clear whether the area was seeded.

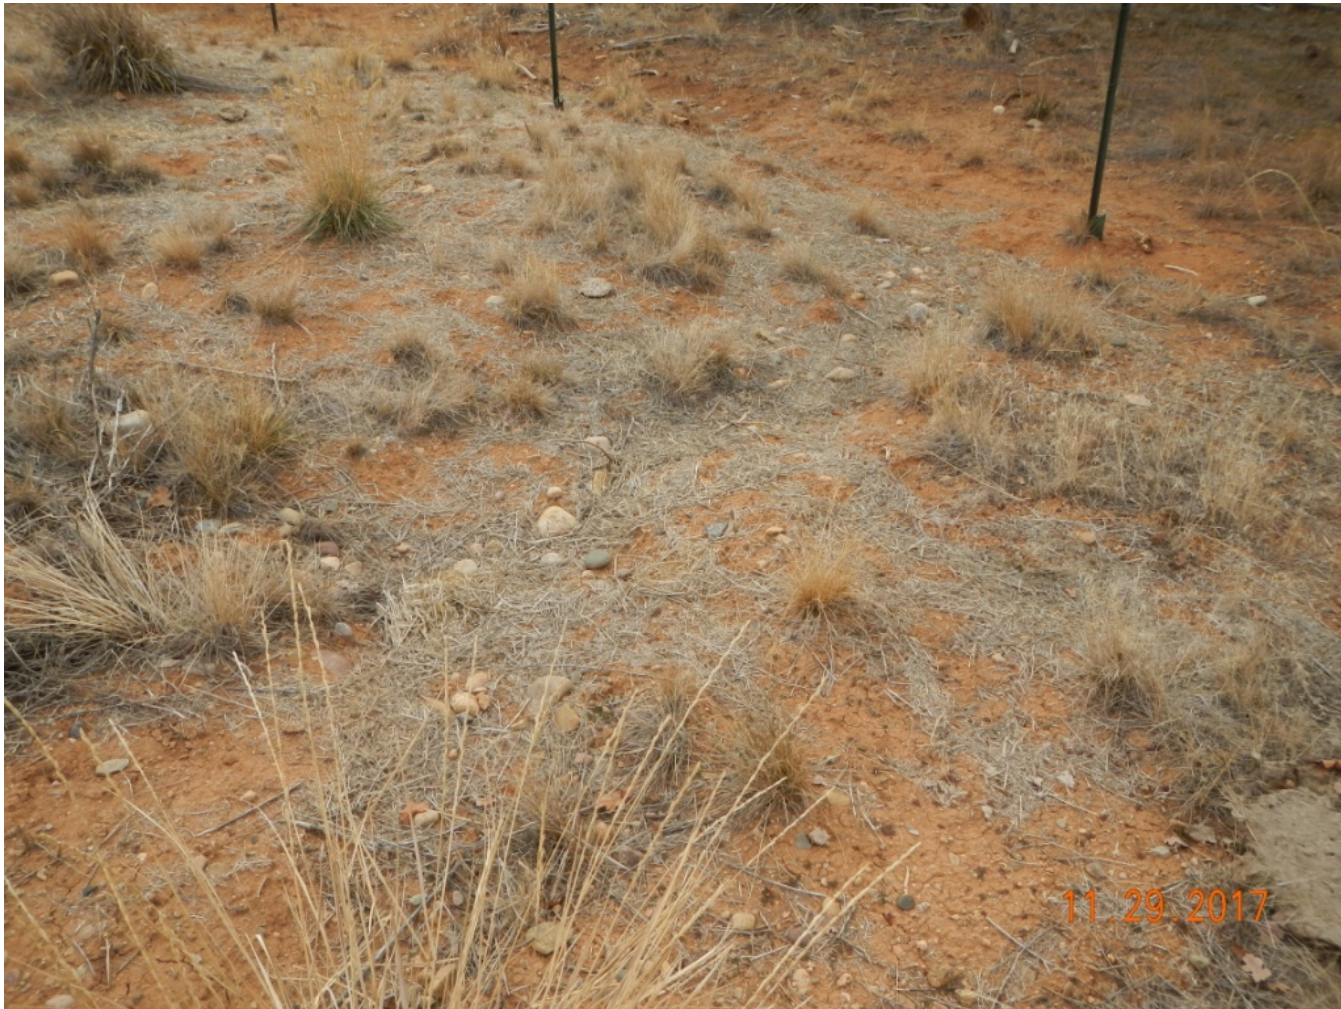
Photo 2. View of area where erosional channel has been filled and straw applied. Not clear whether it's been seeded.

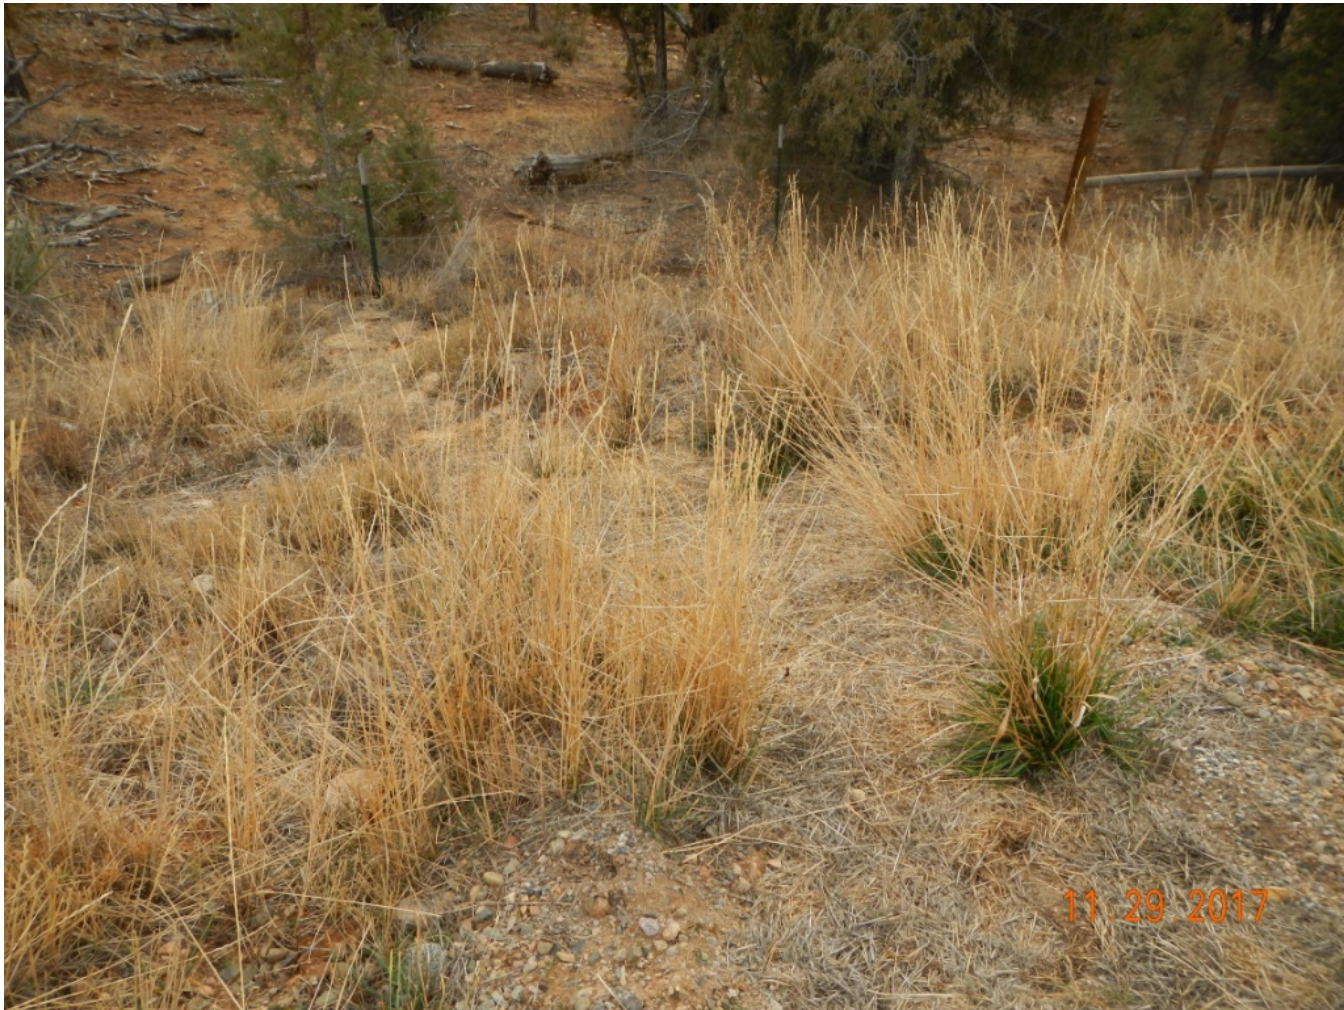
Photo 3. View of another area where erosional channel has been filled and straw applied. Not clear whether it's been seeded.
