- Southern Ute 33 – 10; 15 - 3
- 05-067-08833

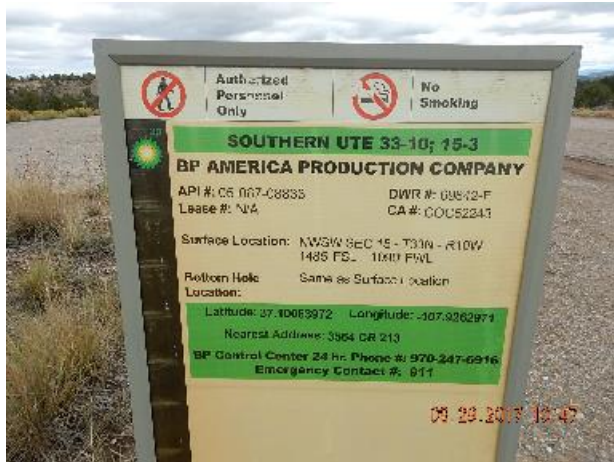
Photo 1: Wellhead sign. Previous inspection.

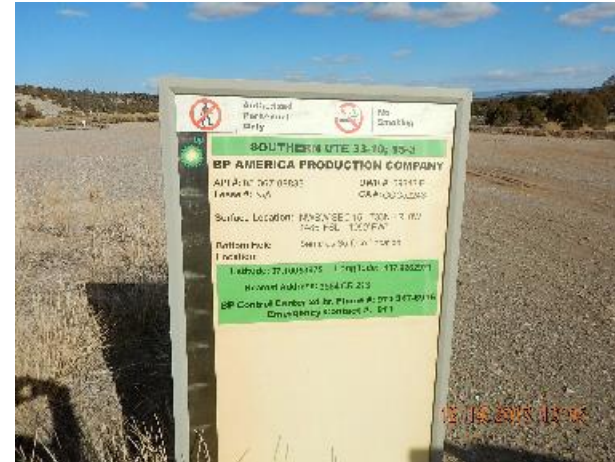
Photo 2: Wellhead sign.

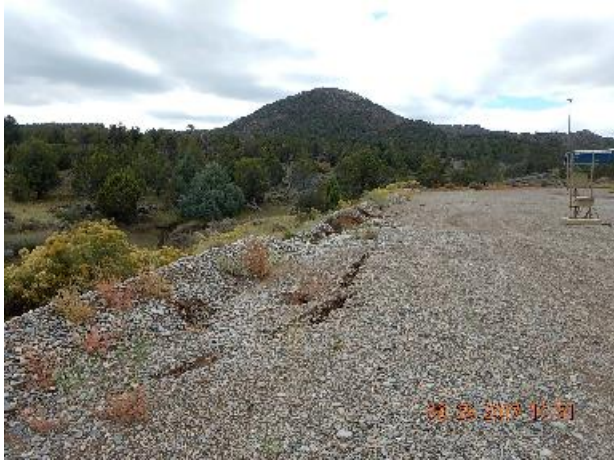
Photo 3: Separation in E fill slope. Previous inspection.

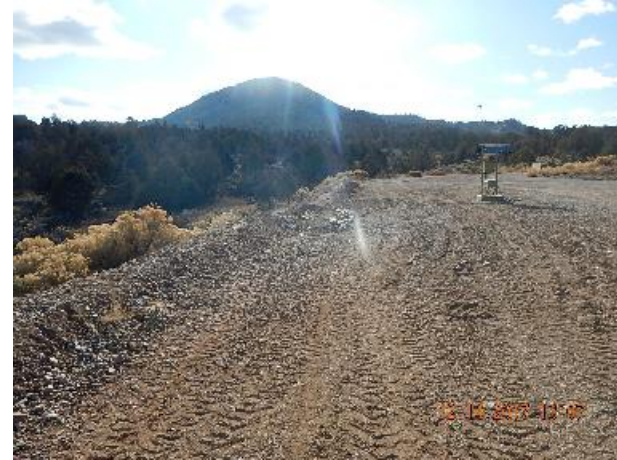
Photo 4: Repair made to the separation in E fill slope.

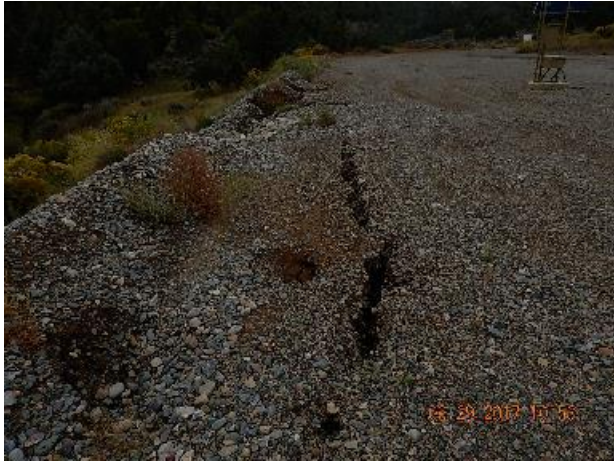
Photo 5: Closer view of separation. Previous inspection.

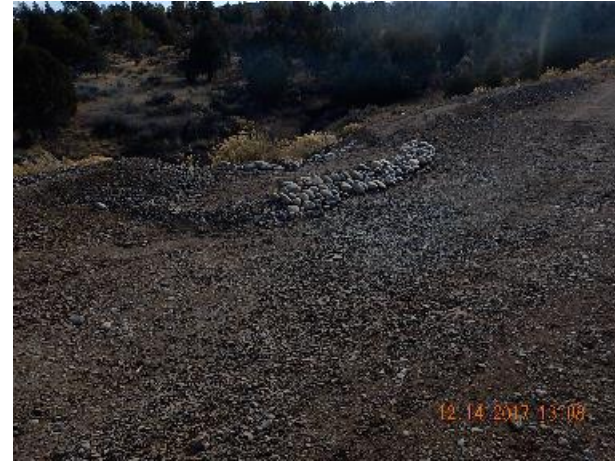
Photo 6: Closer view of repair made to the separation.

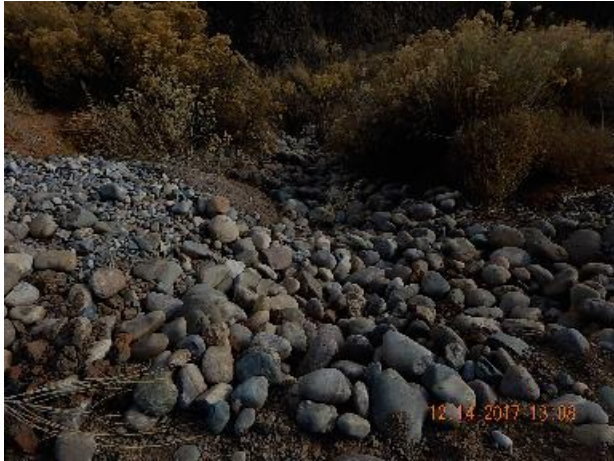
Photo 7: Rock in the repair to the erosion channel on fill slope.

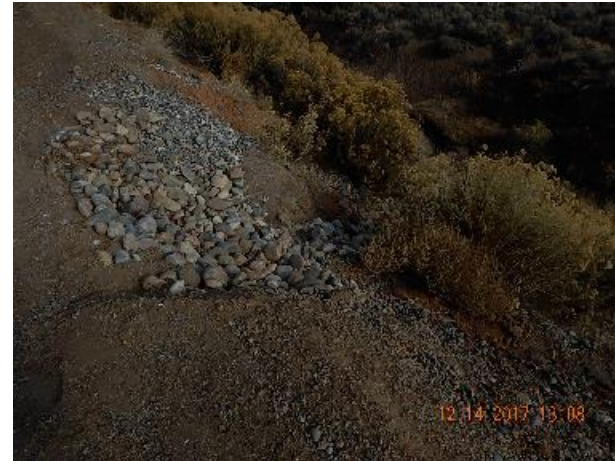
Photo 8: Additional view of repair in the fill slope..

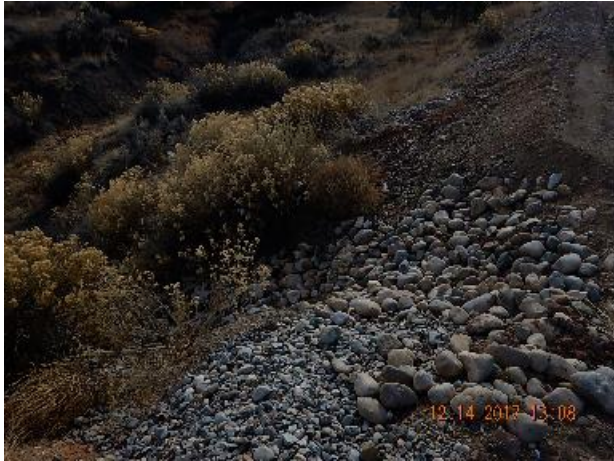
Photo 9: Rock on rill slope.

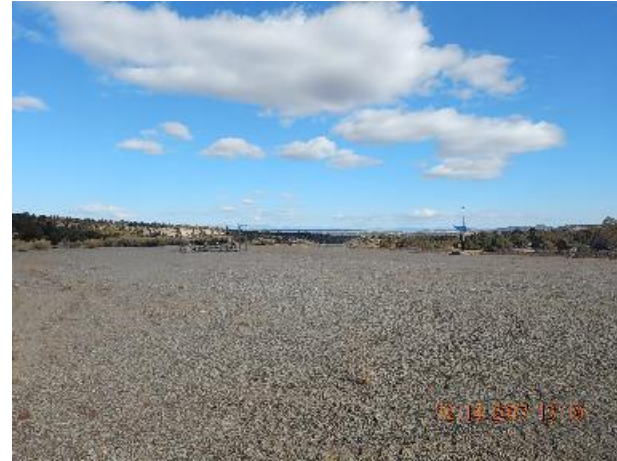
Photo 10: Location overview.
