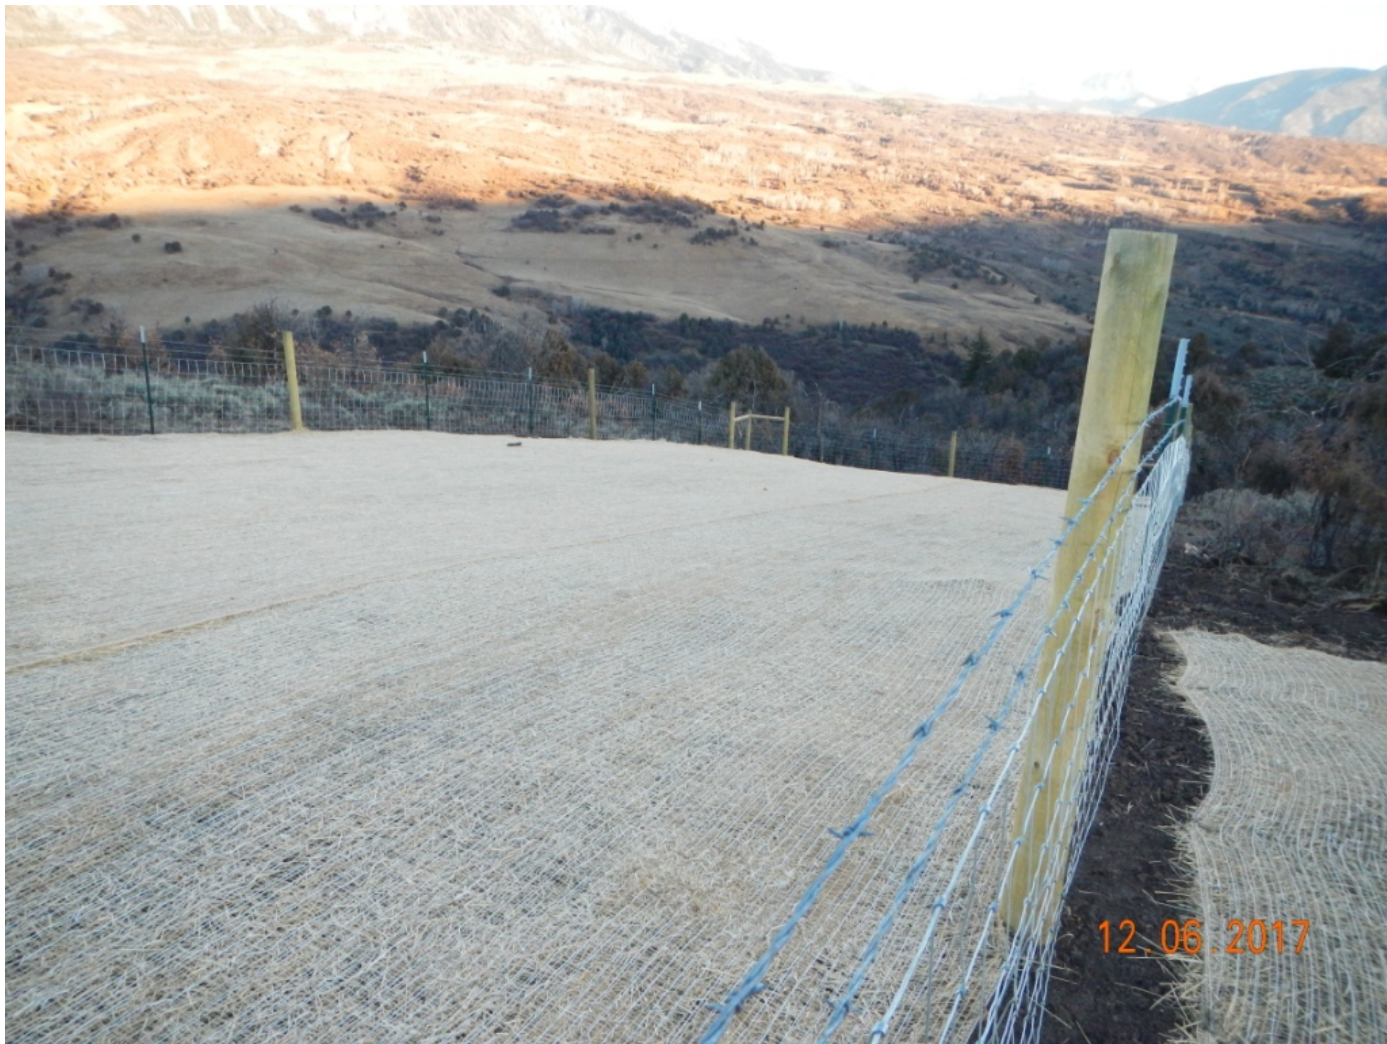
Photo 1. View of area recently reclaimed. From the southwester edge facing eastward. Showing erosion control blanket and fencing.

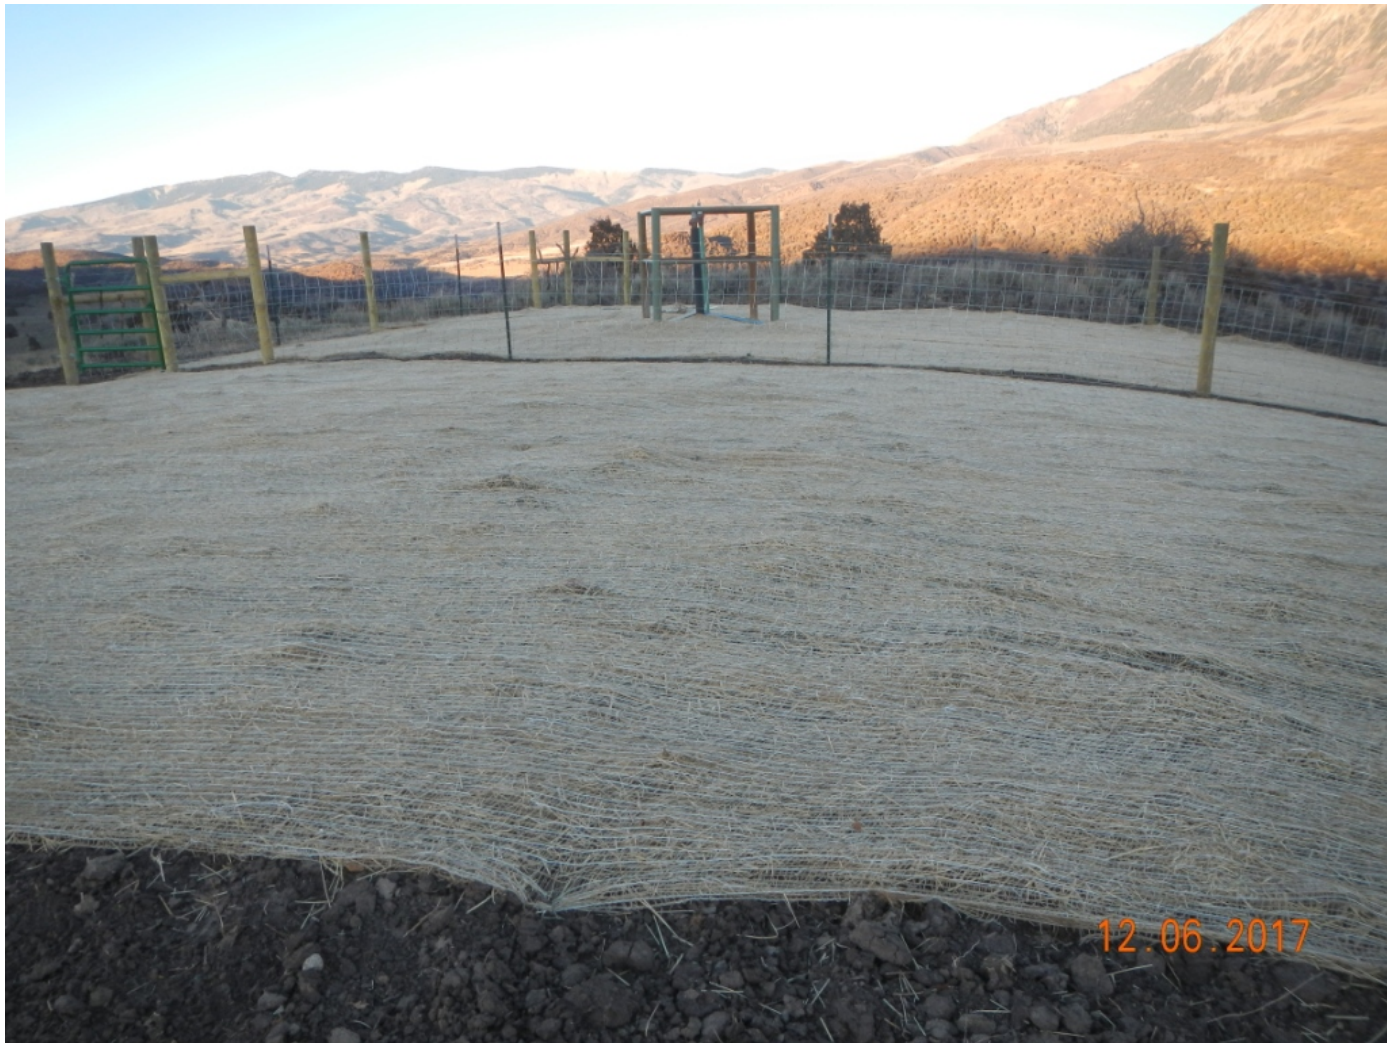
Photo 2. View of reclaimed area from the southern portion facing northward toward riser.

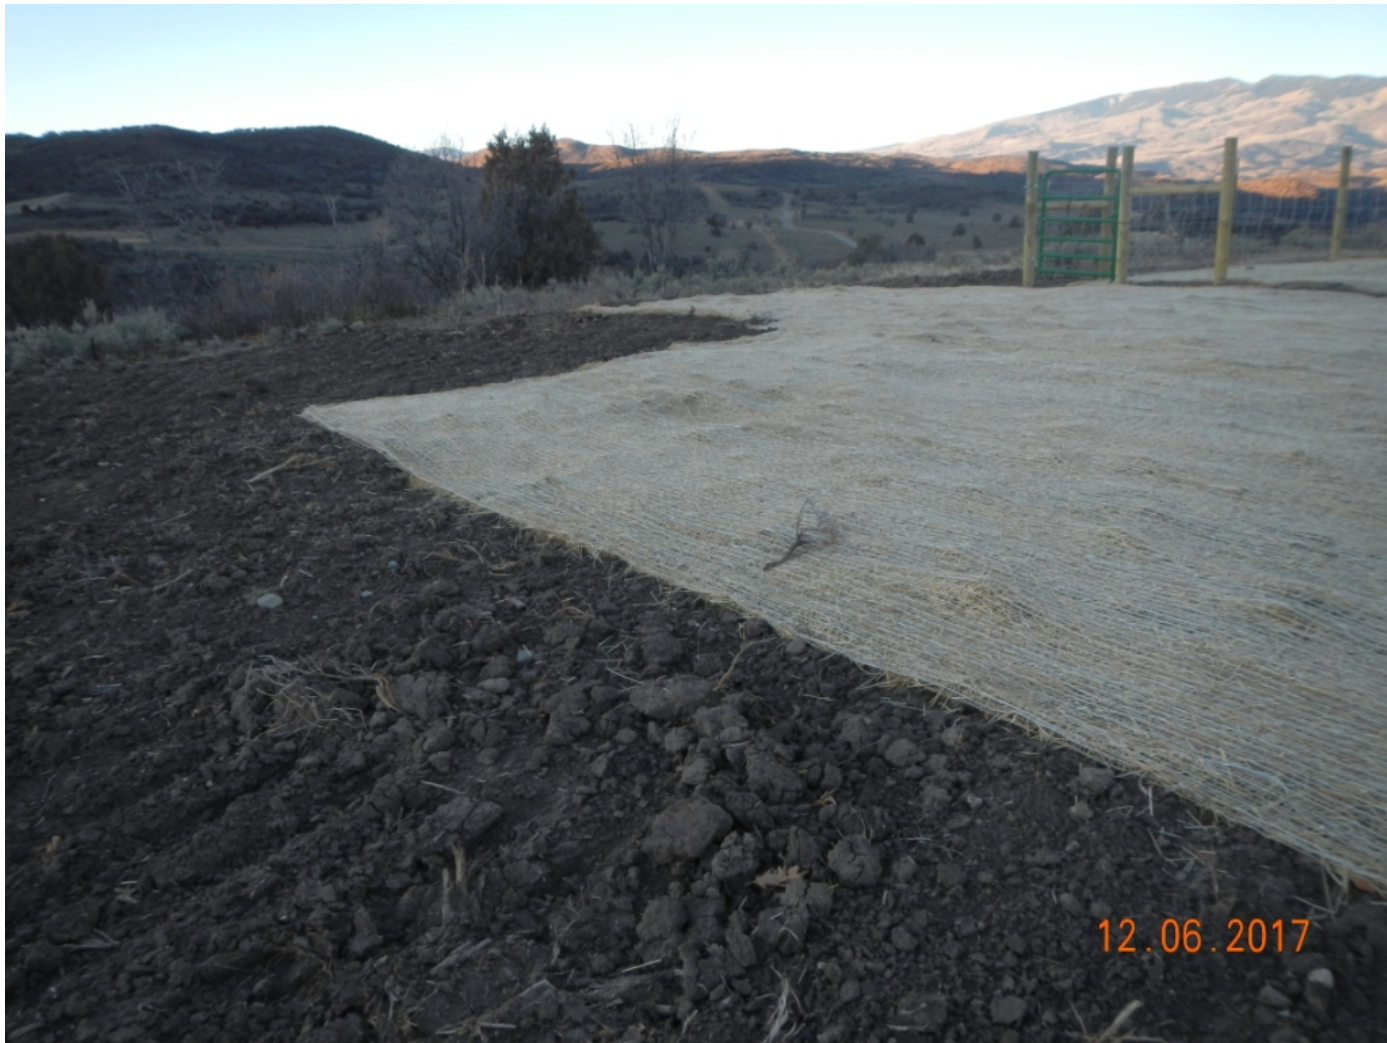
Photo 3. View of reclaimed area from the southern portion facing northwestward.

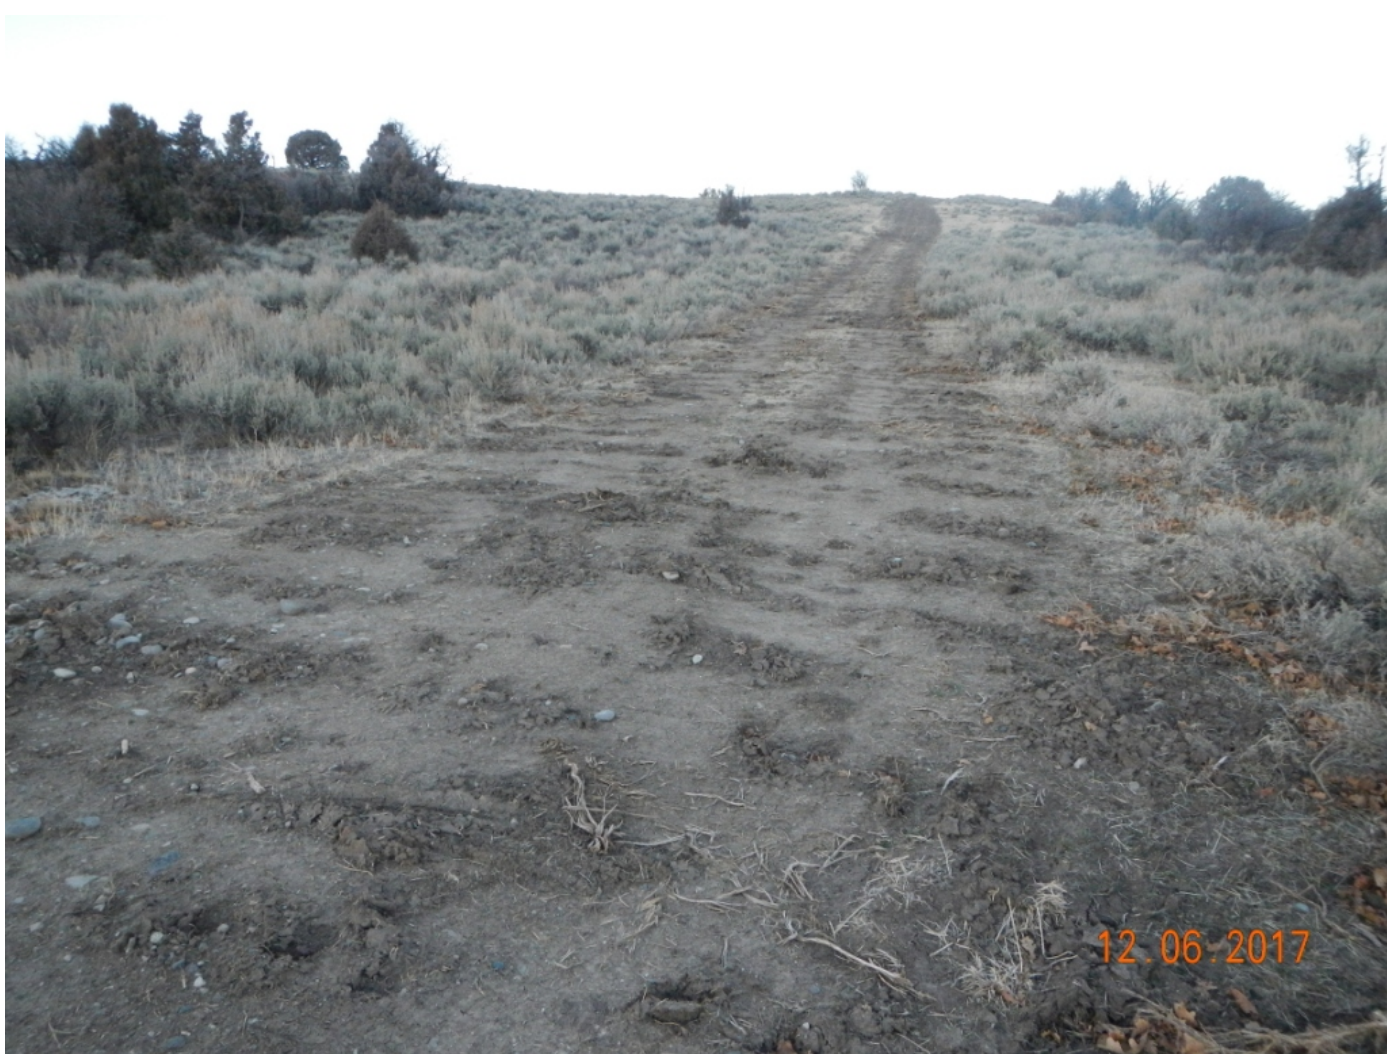
Photo 4. View of area of exposed soils from the access road facing upslope along the pipeline alignment toward the riser at the top of the hill. This area should be seeded and carefully monitored until stabilized.
