Inspection Photos

12/18/2017

Operator: PETRO-CANADA RESOURCES (USA)

Location ID: 311664

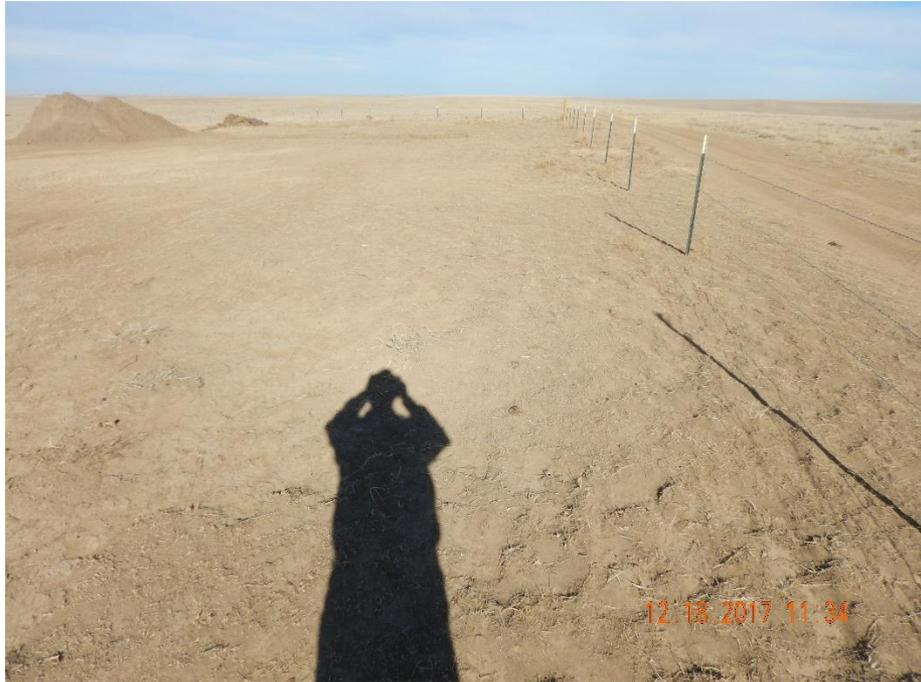
Photo 1: Photo taken from within the fenced area of the northern spill area, facing north. Photo shows areas that appear to have been regraded/recontoured and additional topsoil brought in. Areas do not appear to have been seeded and stabilized; reclamation activities do not appear to be complete in accordance to the corrective action. Corrective action and date will remain applicable until corrective action has been addressed.

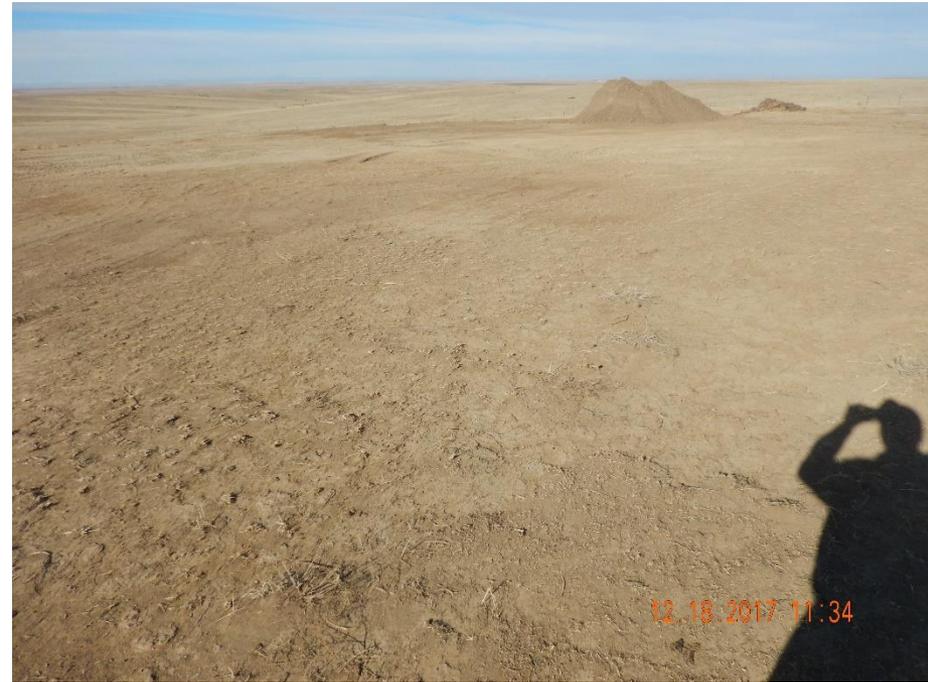
Photo 2: Photo taken from within the fenced area of the northern spill area, facing northwest. See comments under photo 1

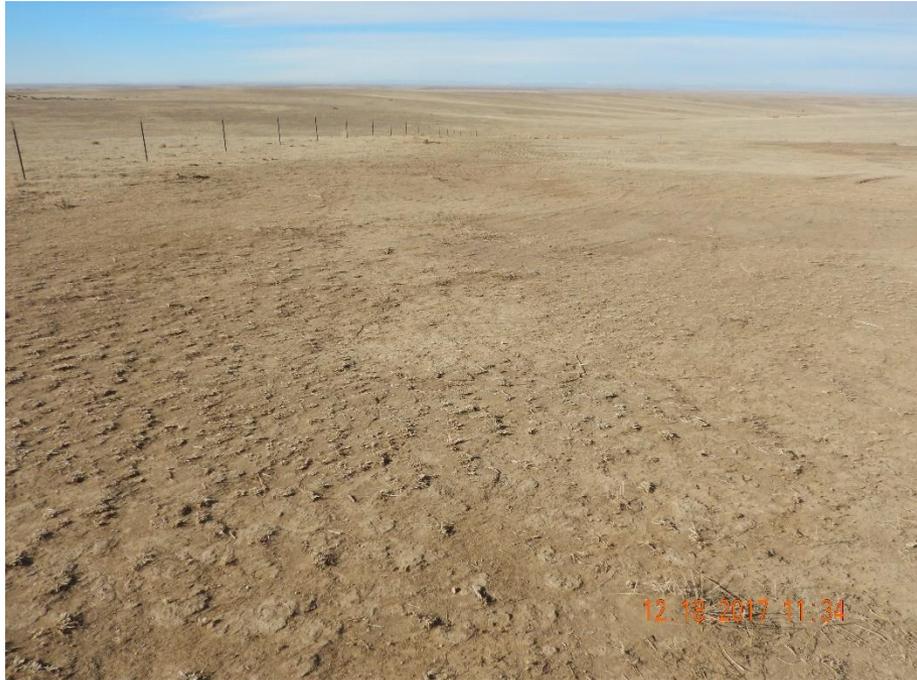
Photo 3: Photo taken from within the fenced area of the northern spill area, facing west. See comments under photo 1

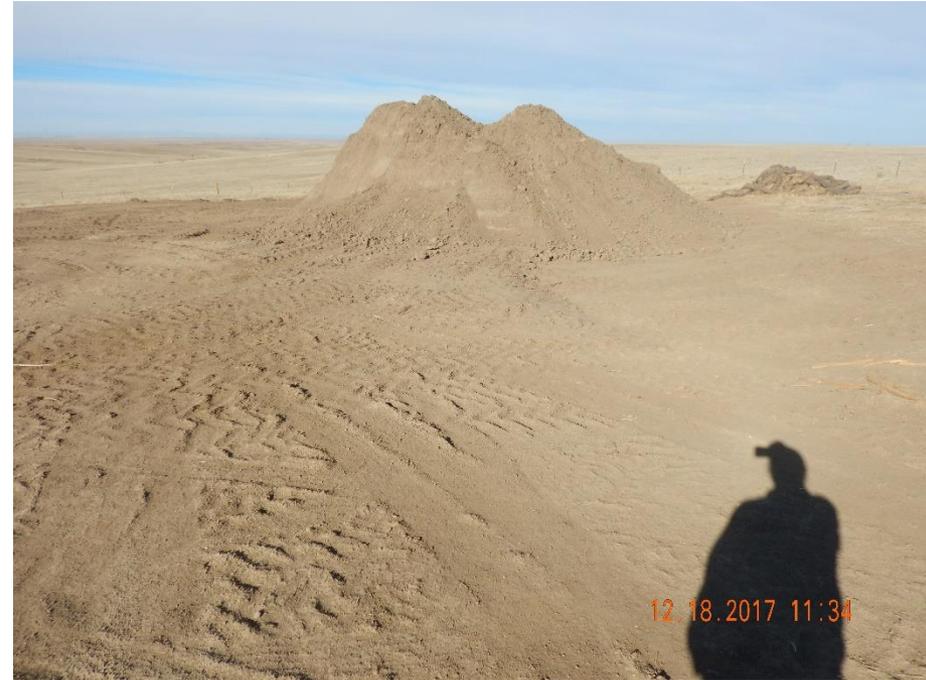
Photo 4: Photo taken from within the fenced area of the northern spill area, facing northwest. Photo shows what appears to be a pile of topsoil likely being used for reclamation activities.

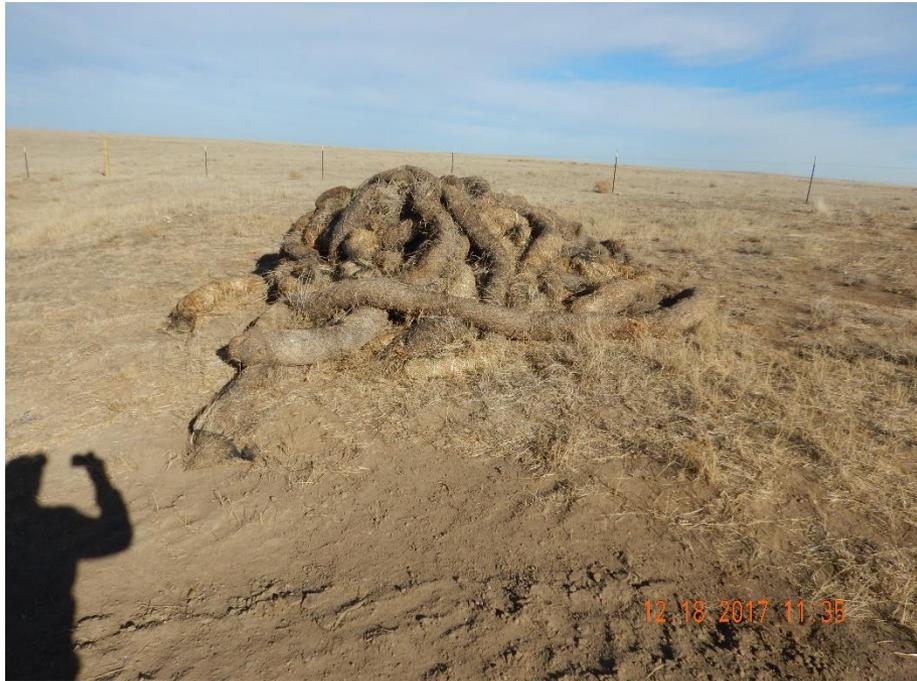
Photo 5: Photo taken from the north end fenced area of the northern spill area, facing north. Previous inspections documented straw wattles that were considered debris and was required to be removed. Corrective action and date will remain applicable until corrective action has been addressed.

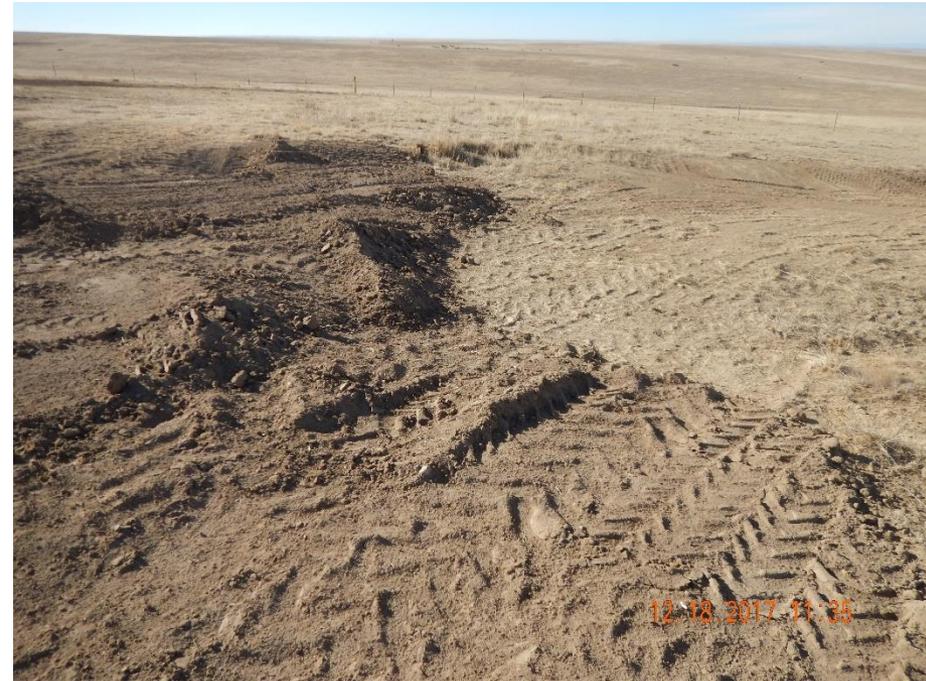
Photo 6: Photo taken from the fenced area of the northern spill area, facing west. Photo shows areas that appear to have been recontoured/regraded and additional topsoil brought in. Areas do not appear to have been seeded and stabilized; reclamation activities do not appear to be complete in accordance to the corrective action. Corrective action and date will remain applicable until corrective action has been addressed.

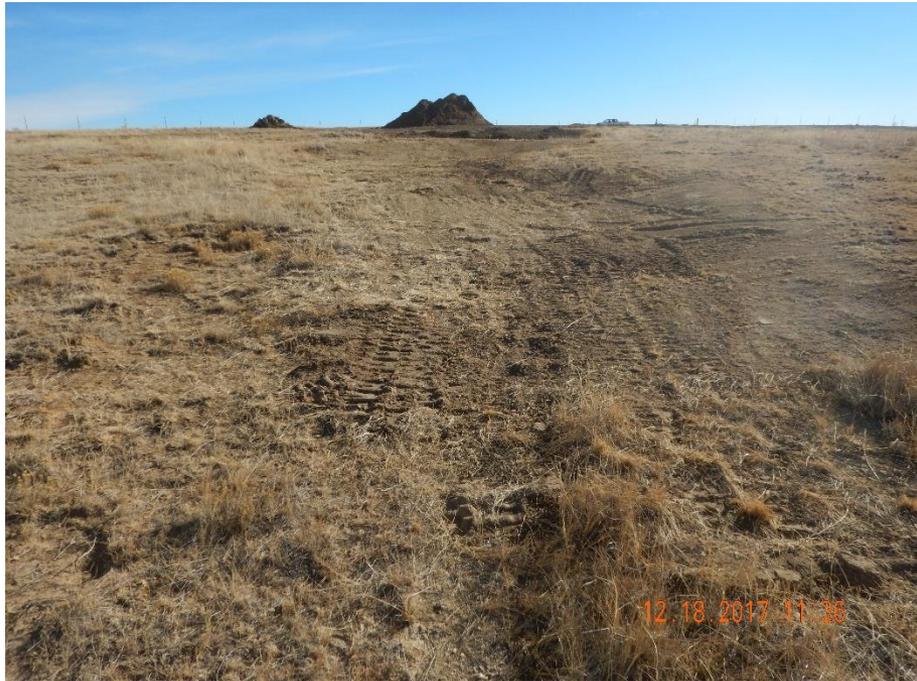
Photo 7: Photo taken from the northwest end of the northern spill area, facing east. See comments under photo 6.

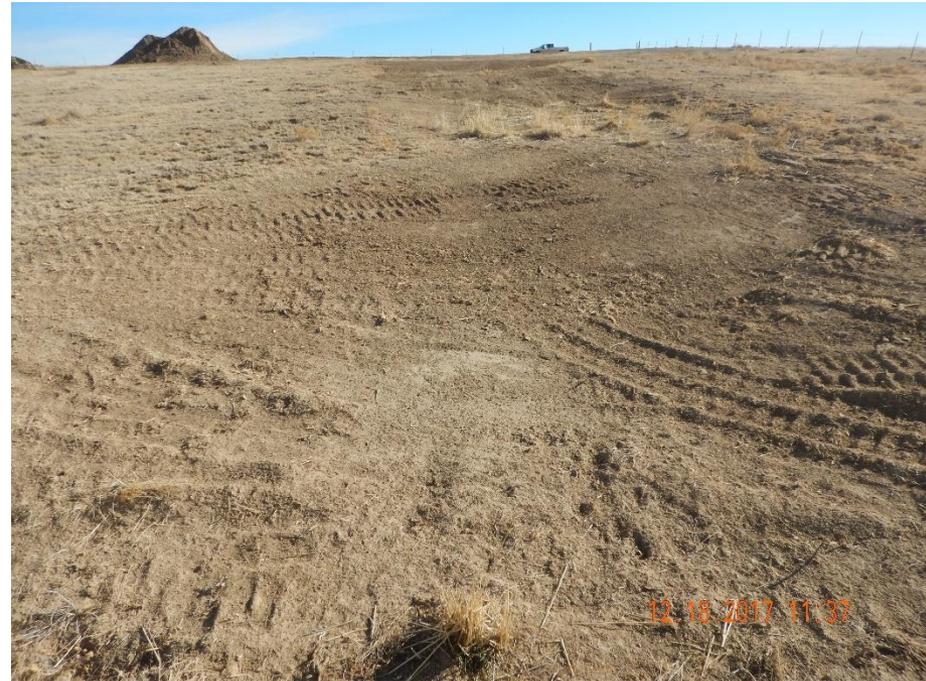
Photo 8: Photo taken from the southwest end of the northern spill area, facing east. See comments under photo 6.

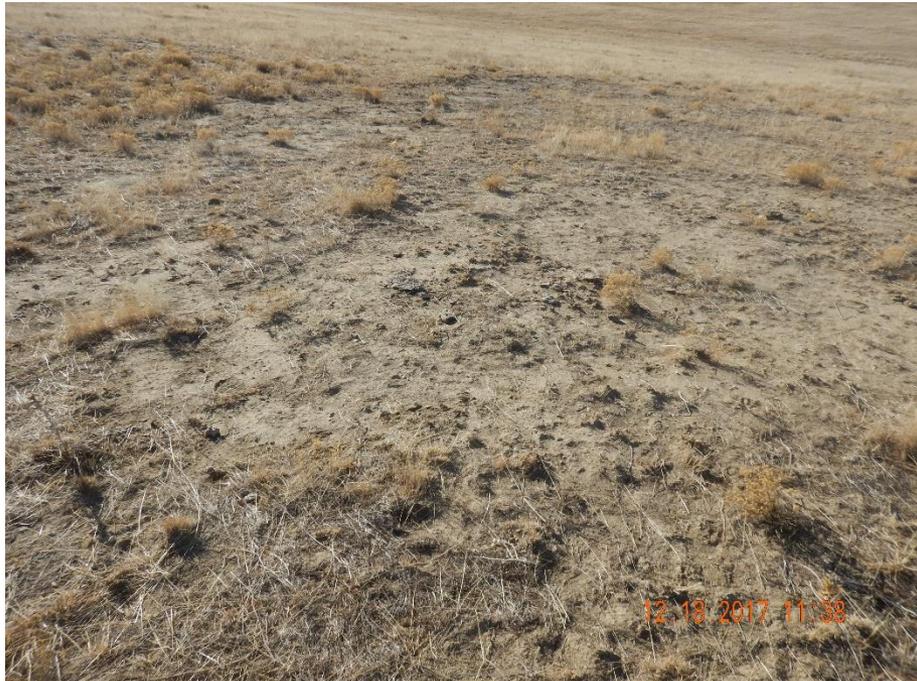
Photo 9: Photo taken from the areas downgrade of the fenced southern spill area, facing southwest. Previous inspections required reclamation to be performed on unvegetated areas downgrade of the fenced remediation area. These areas were also noted during an on-site meeting with operator. Reclamation activities do not appear to be complete in accordance to the corrective action. Corrective action and date will remain applicable until corrective action has been addressed.

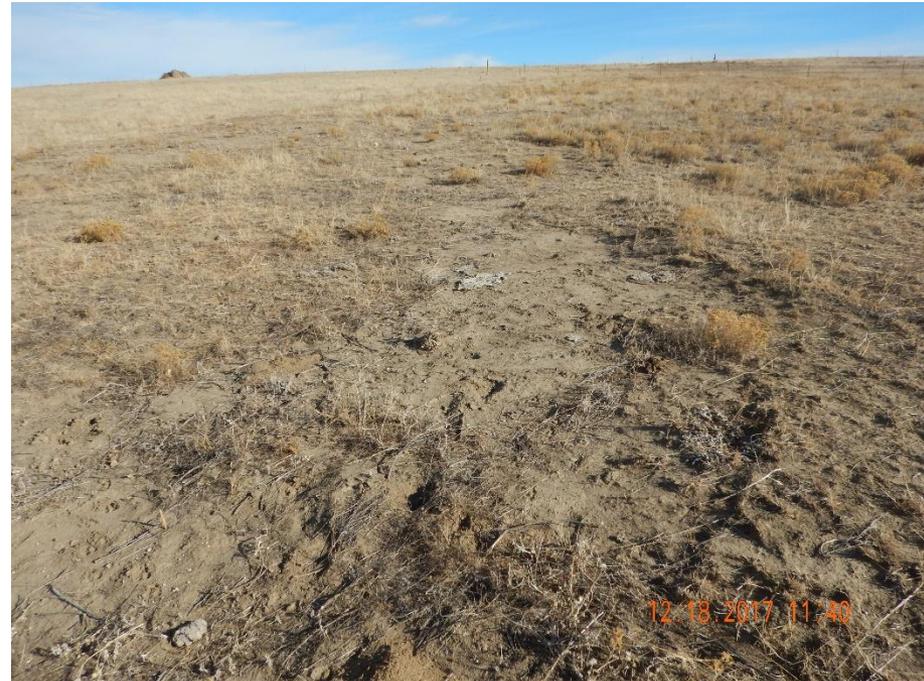
Photo 10: Photo taken from the areas downgrade of the fenced southern spill area, facing east. Previous inspections required reclamation to be performed on unvegetated areas downgrade of the fenced remediation area. These areas were also noted during an on-site meeting with operator. Reclamation activities do not appear to be complete in accordance to the corrective action. Corrective action and date will remain applicable until corrective action has been addressed.

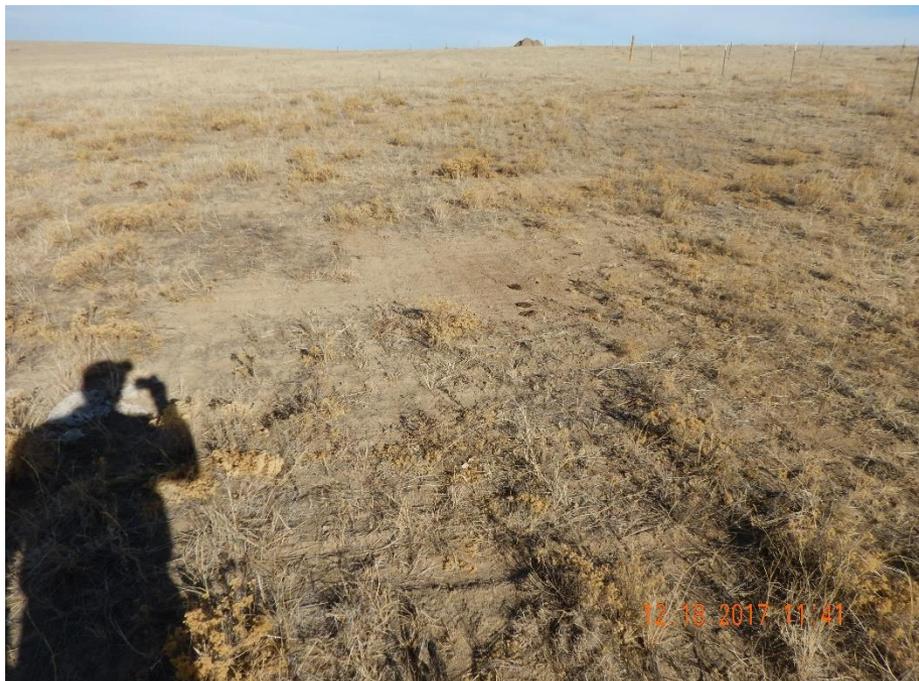
Photo 11: Photo taken to the west, of the fenced southern spill area, facing north. Photo shows areas where striations were observed in the soil, suggesting some areas downgrade of the fenced area may have been seeded.

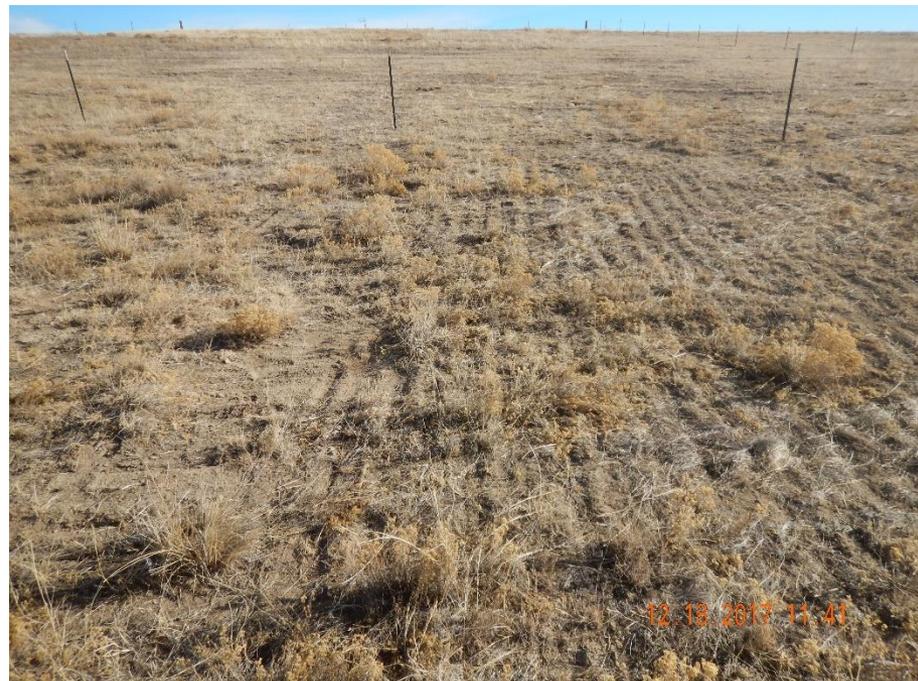
Photo 10: Photo taken to the west, of the fenced southern spill area, facing east. Photo shows areas where striations were observed in the soil, suggesting some areas downgrade of the fenced area may have been seeded.
