Inspection Photos

12/18/2017

Operator: PETRO-CANADA RESOURCES (USA)
INC - 72085

Inspection Doc. Number: 682502978
Adams County, CO

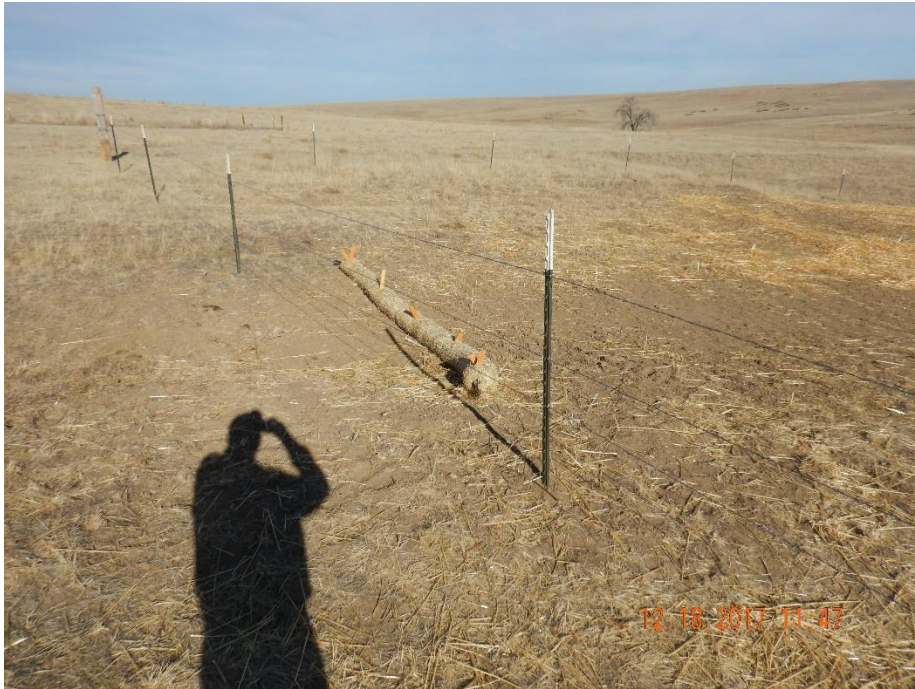
Photo 1: Photo taken from the west end of the well pad location, facing north. Photo shows well pad appears to have been recontoured/regraded, reseeded and crimped with straw for stabilization.

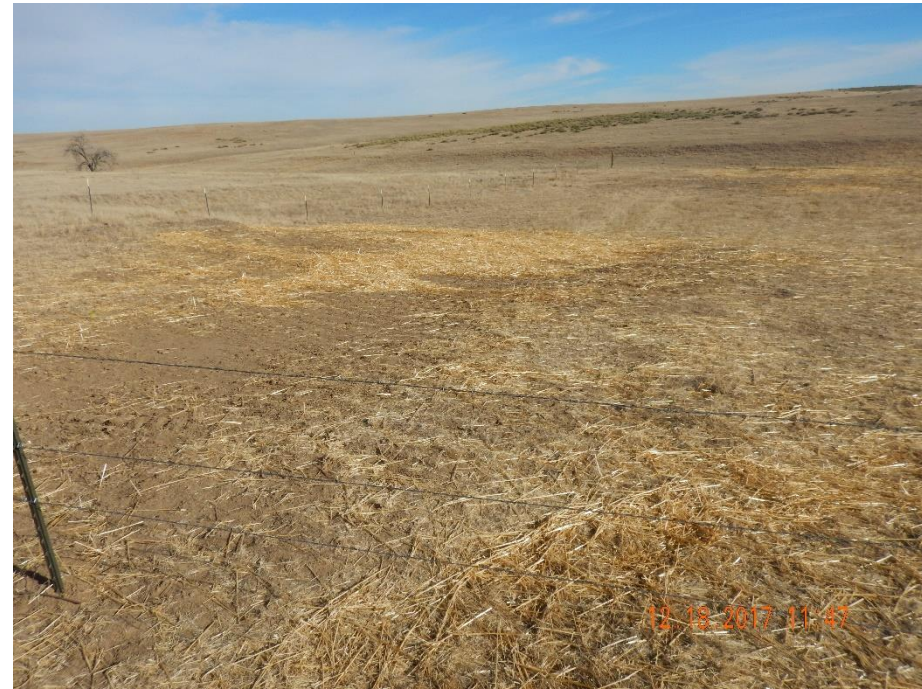
Photo 2: Photo taken from the west end of the well pad location, facing east. Photo shows well pad appears to have been recontoured/regraded, reseeded and crimped with straw for stabilization.

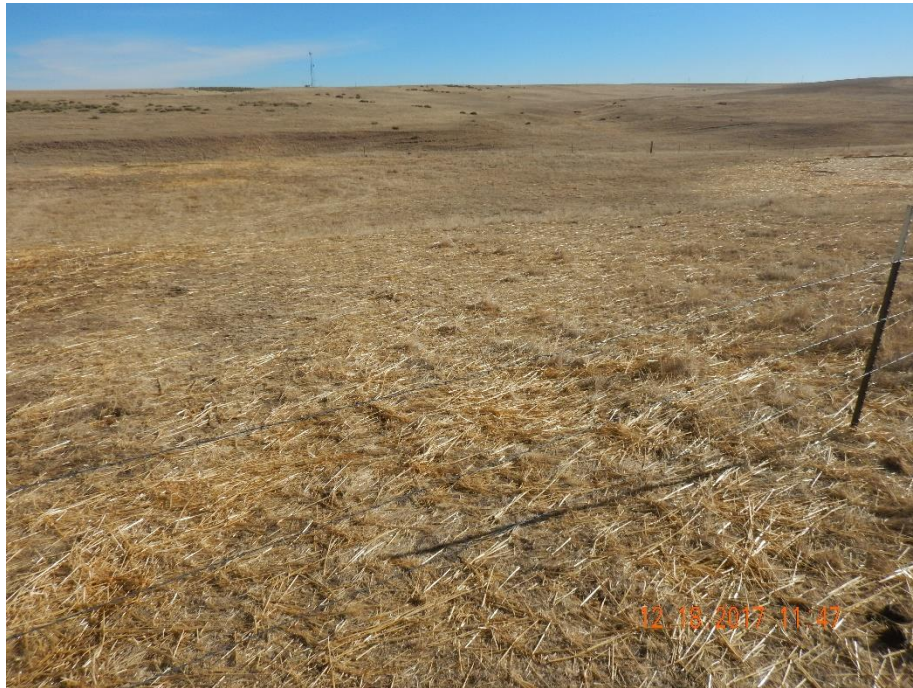
Photo 3: Photo taken from the west end of the well pad location, facing southeast. Photo shows well pad appears to have been recontoured/regraded, reseeded and crimped with straw for stabilization.

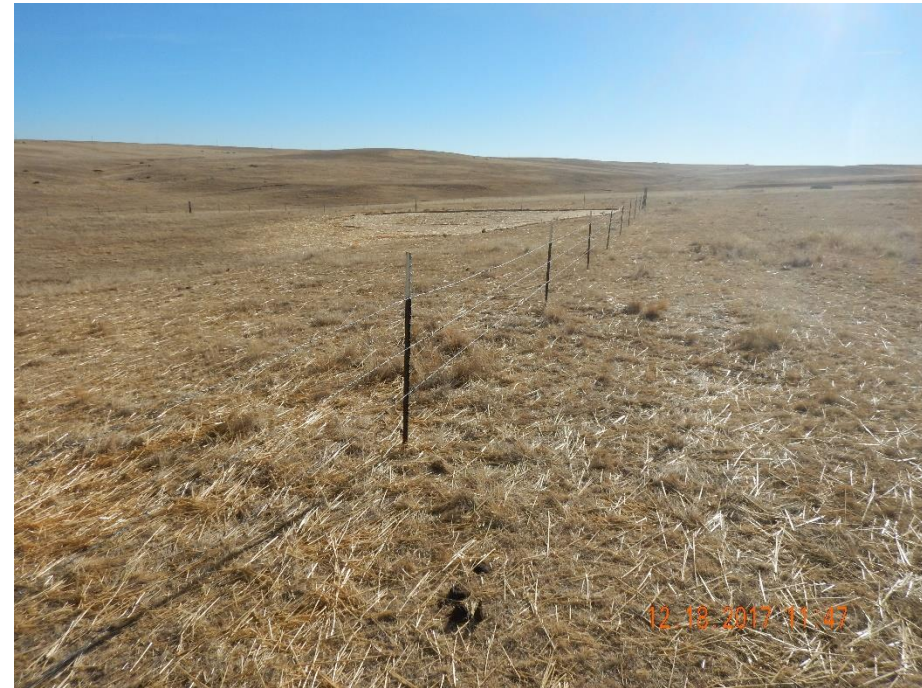
Photo 4: Photo taken from the west end of the well pad location, facing south. Photo shows well pad appears to have been recontoured/regraded, reseeded and crimped with straw for stabilization.

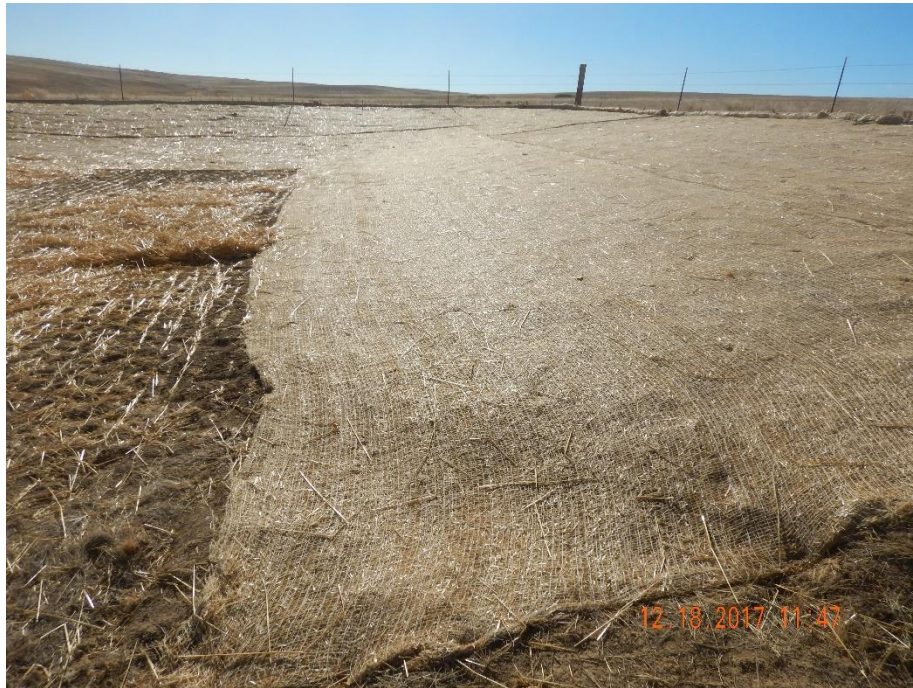
Photo 5: Photo taken southwest corner of the well location, facing south. Photo shows well pad appears to have been recontoured/regraded, seeded and stabilized w/ matting.

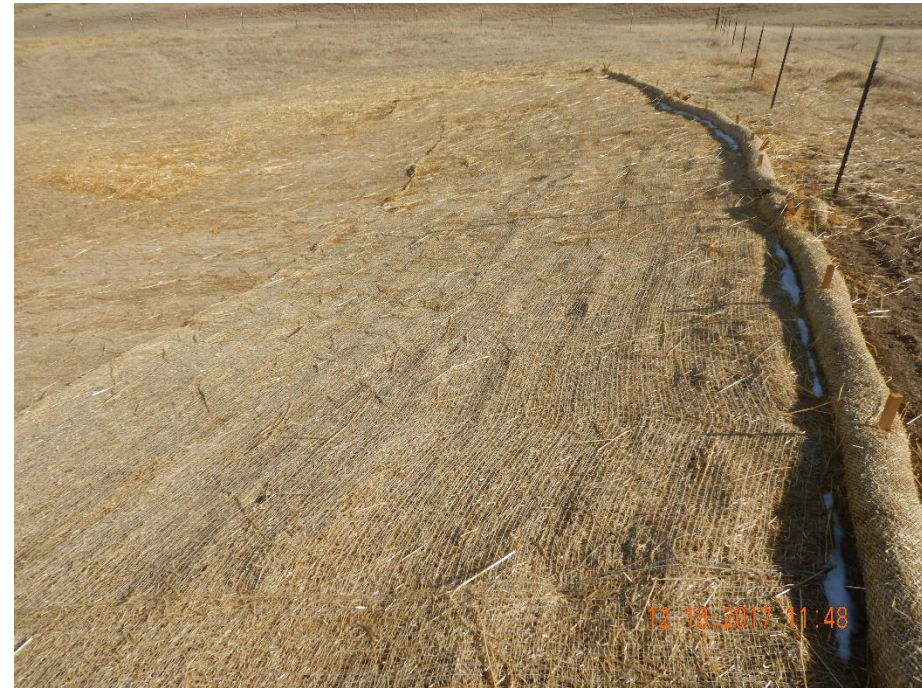
Photo 6: Photo taken southwest corner of the well location, facing east. Photo shows well pad appears to have been recontoured/regraded, seeded and stabilized w/ matting.

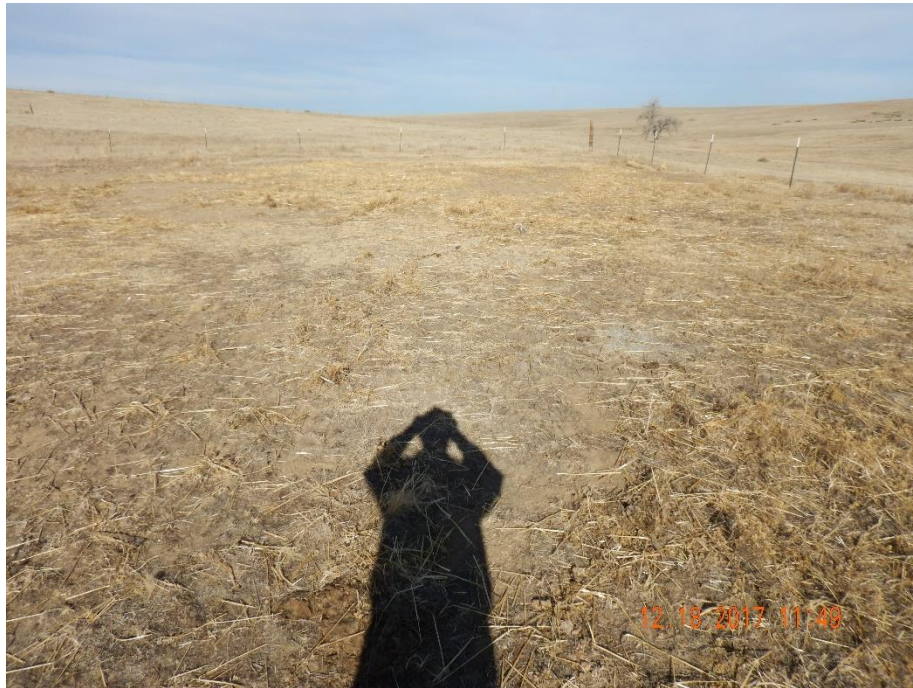
Photo 7: Photo taken from well location, facing north. Photo shows gravel has been removed from well location and area appears to have been reseeded and crimped with straw for stabilization.

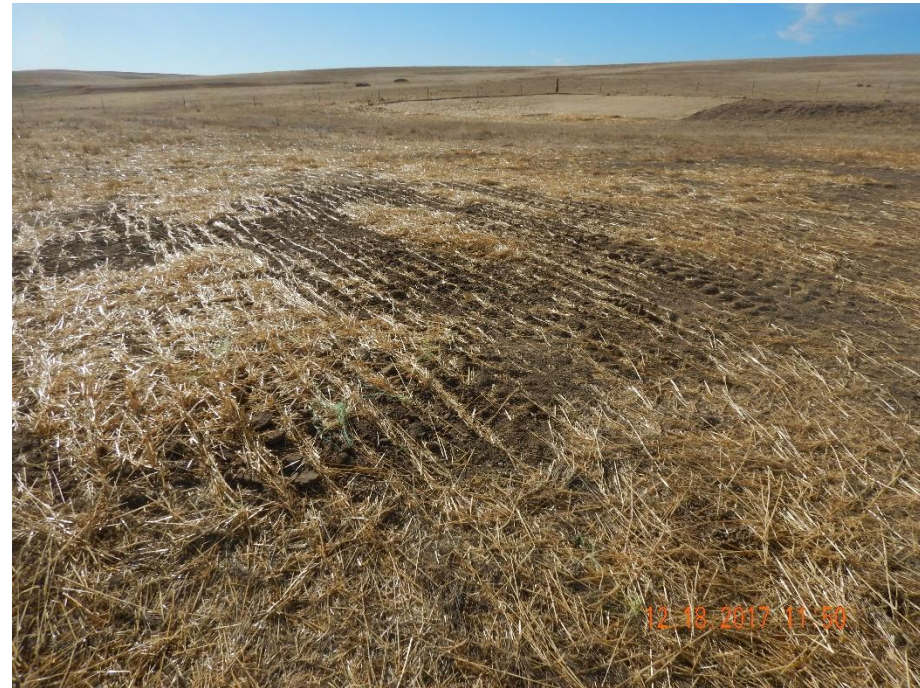
Photo 8: Photo taken from well location, facing southwest. Photo shows gravel has been removed from well location and area appears to have been reseeded and crimped with straw for stabilization.

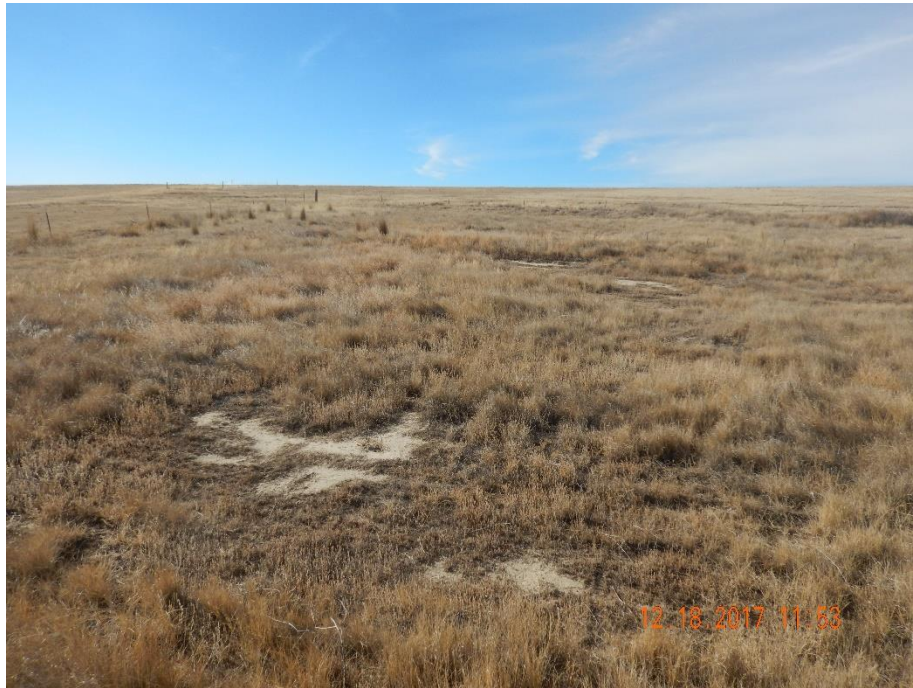
Photo 9: Photo taken from within the fenced remediation area, facing west. Previous inspections identified areas within the remediation area that remain bare and unvegetated, or predominantly undesirable weedy plant species and required additional reclamation to be performed. Photo shows bare and exposed areas. Unable to find evidence that additional reclamation activities have been conducted on these areas per the corrective action.

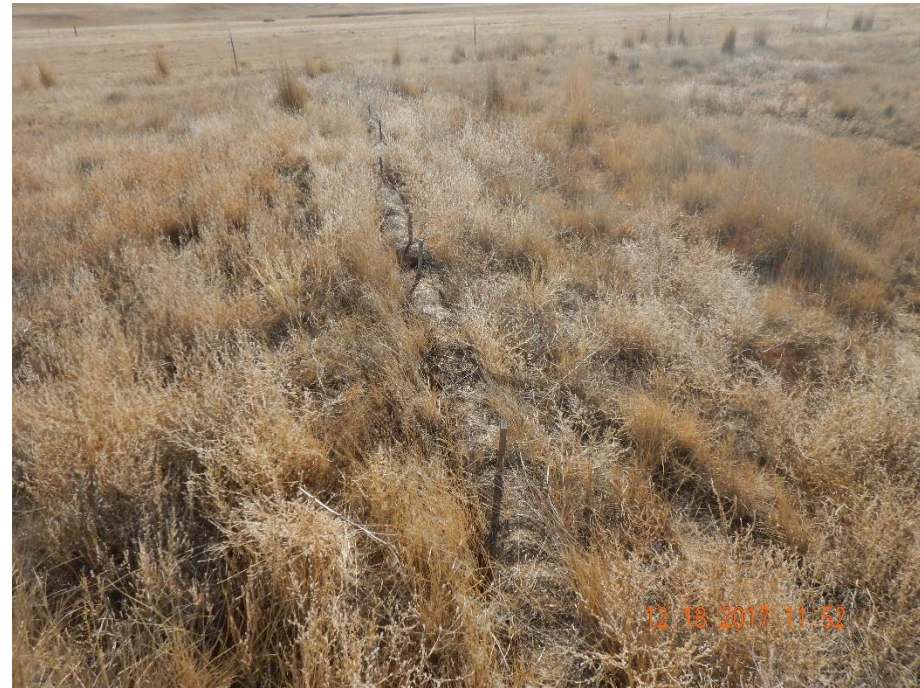
Photo 10: Photo taken from within the fenced remediation area, facing south. Previous inspections identified areas within the remediation area that remain bare and unvegetated, or predominantly undesirable weedy plant species and required additional reclamation to be performed. Photo shows areas where vegetation is predominantly undesirable weedy plant species. Unable to find evidence that additional reclamation activities have been conducted on these areas per the corrective action.

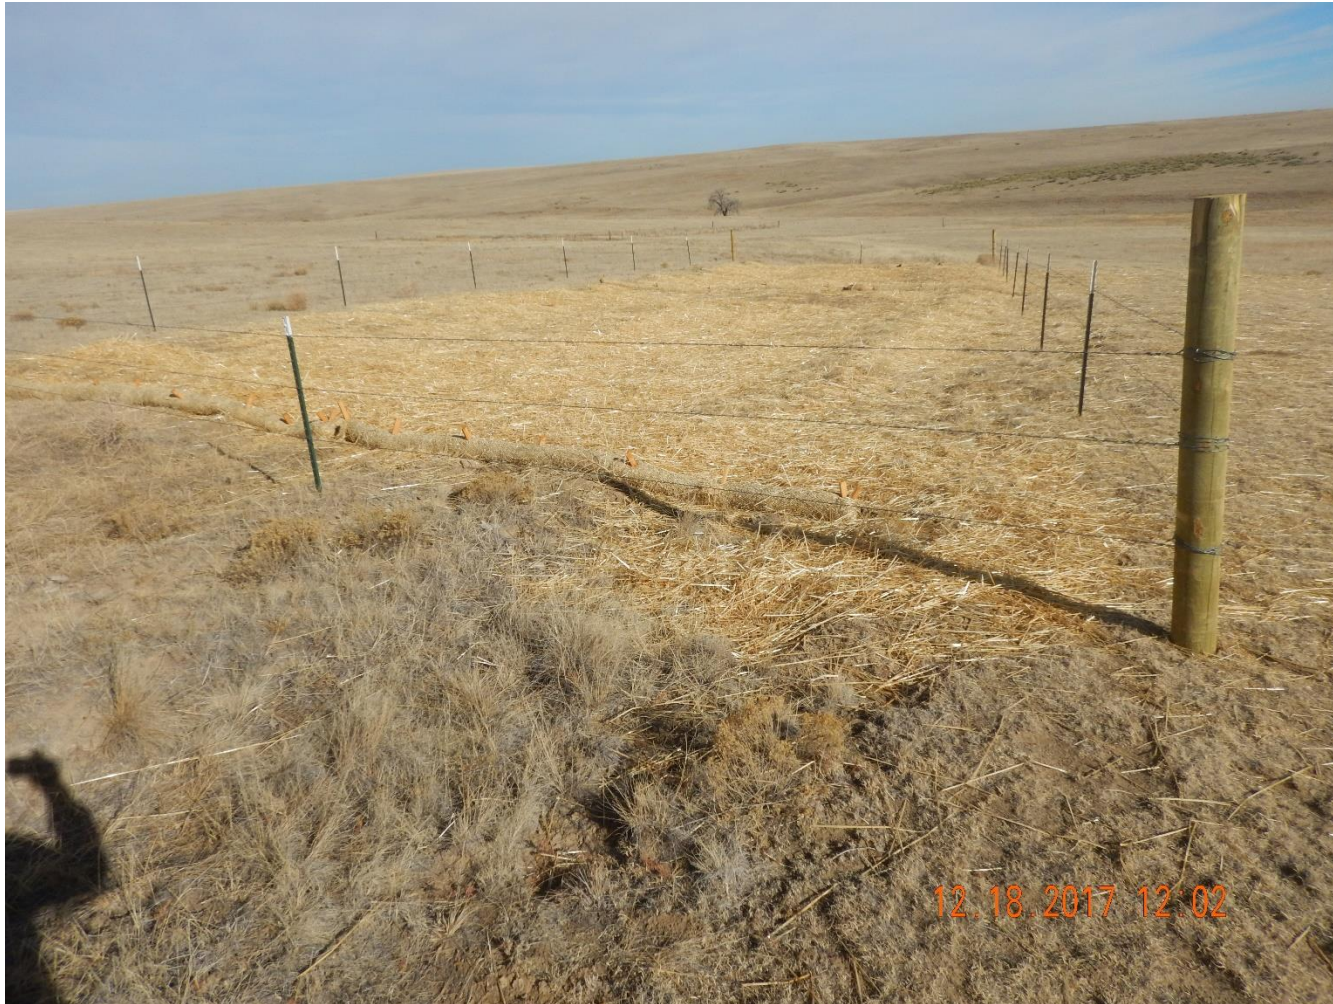
Photo 11: Photo taken from the access road, facing east. Photo shows area of access road that appears to have been regraded, seeded and crimped with straw for stabilization.
