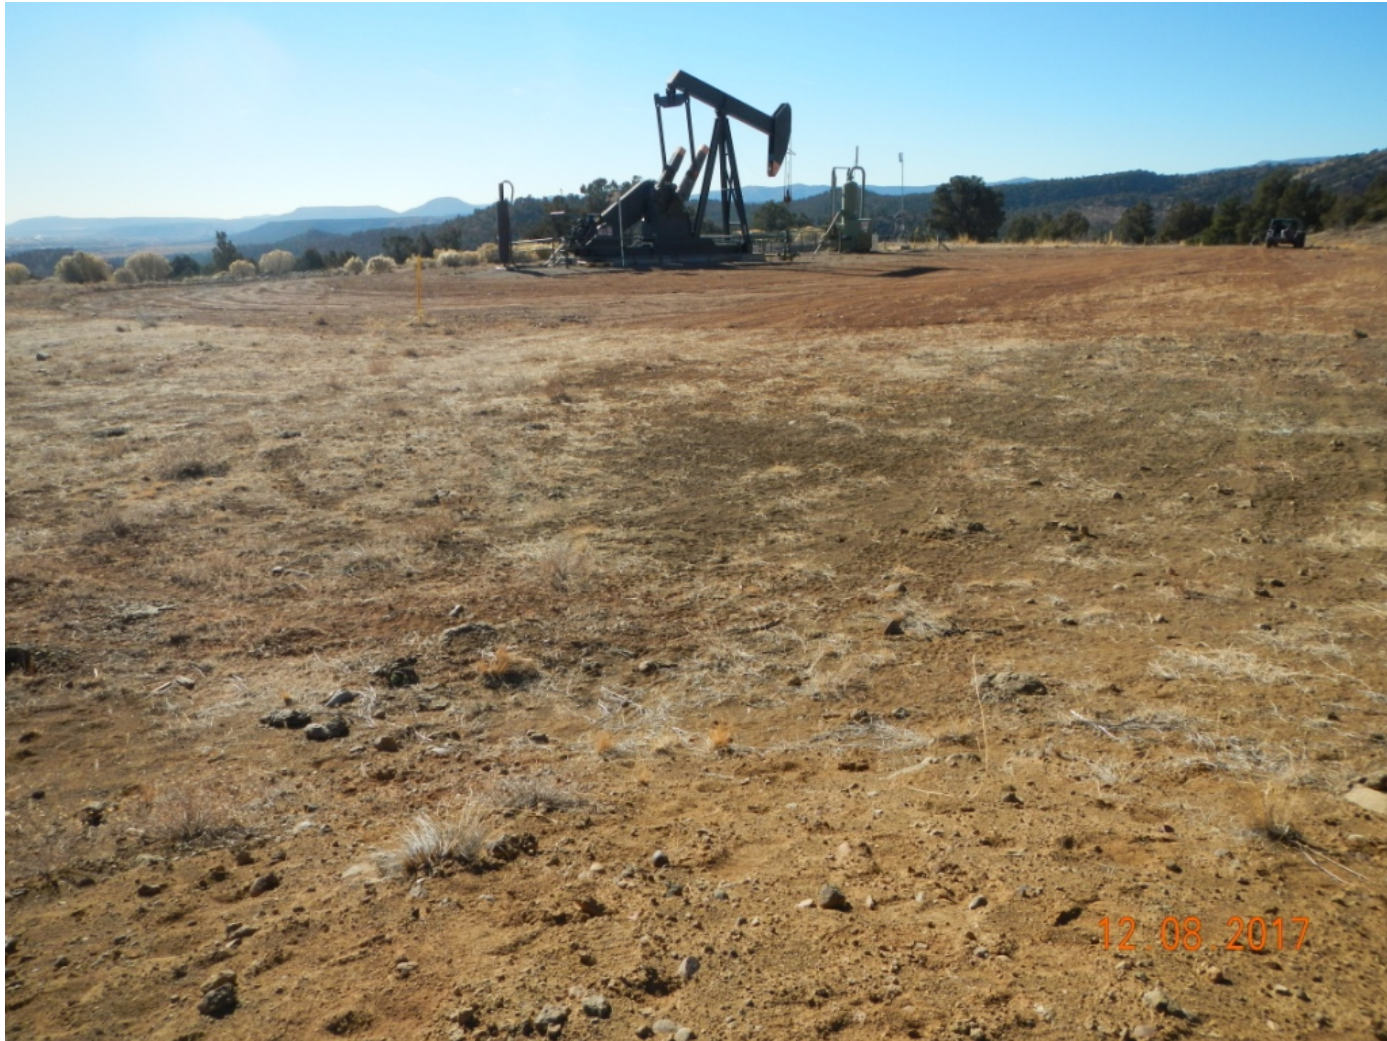
Photo 1. View of the project area from the northeastern corner facing center.

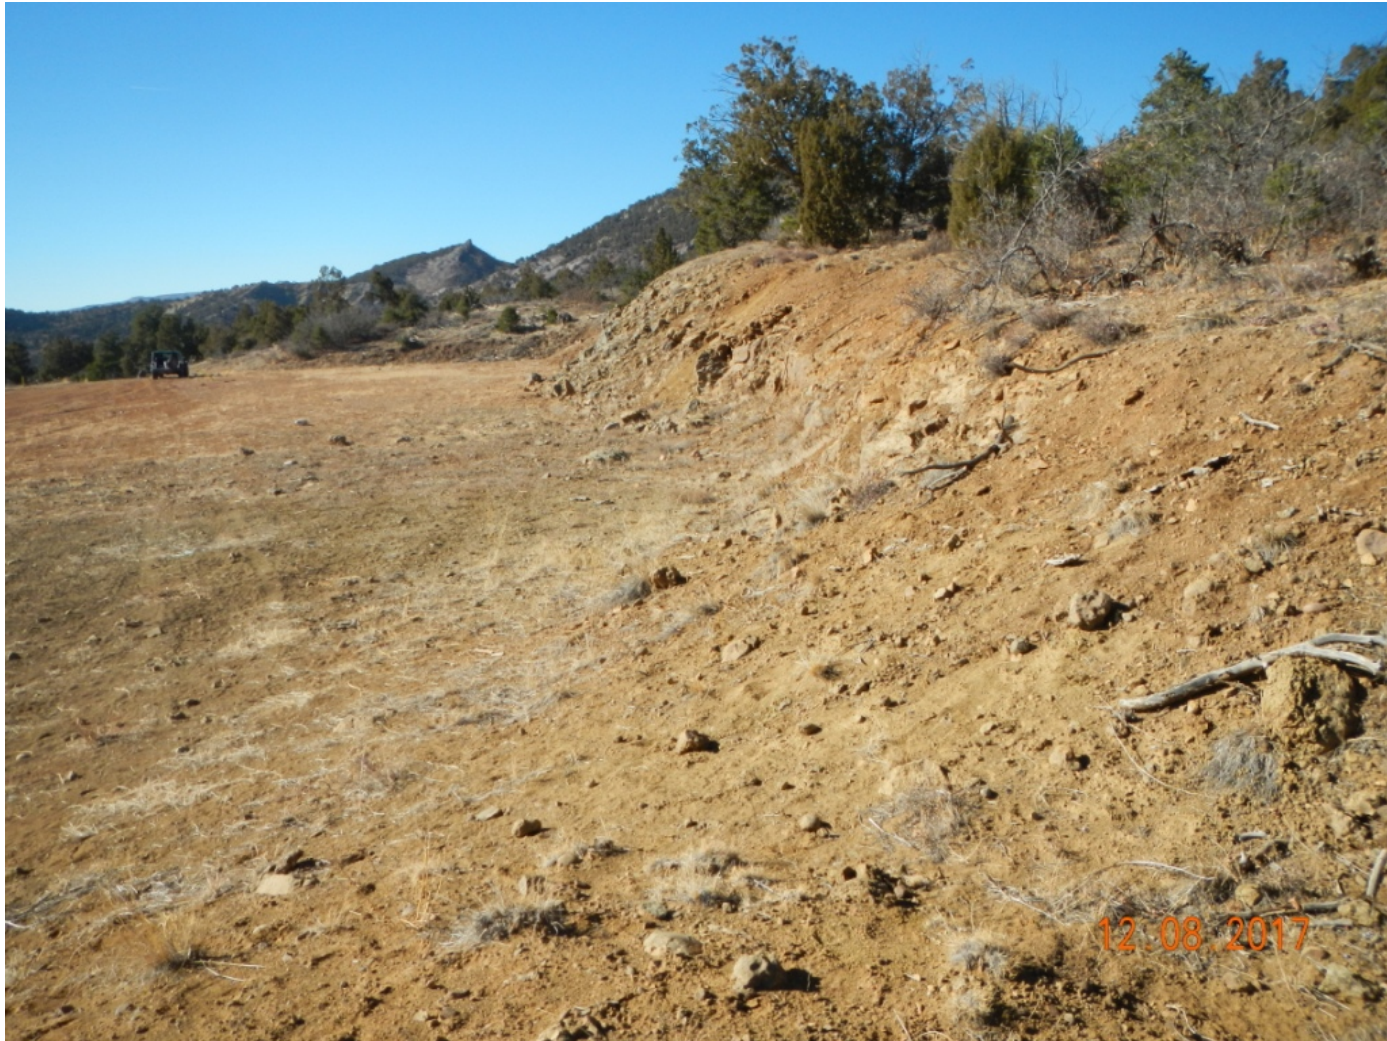
Photo 2. View of the northern portion of the project area from the northeastern corner facing westward.

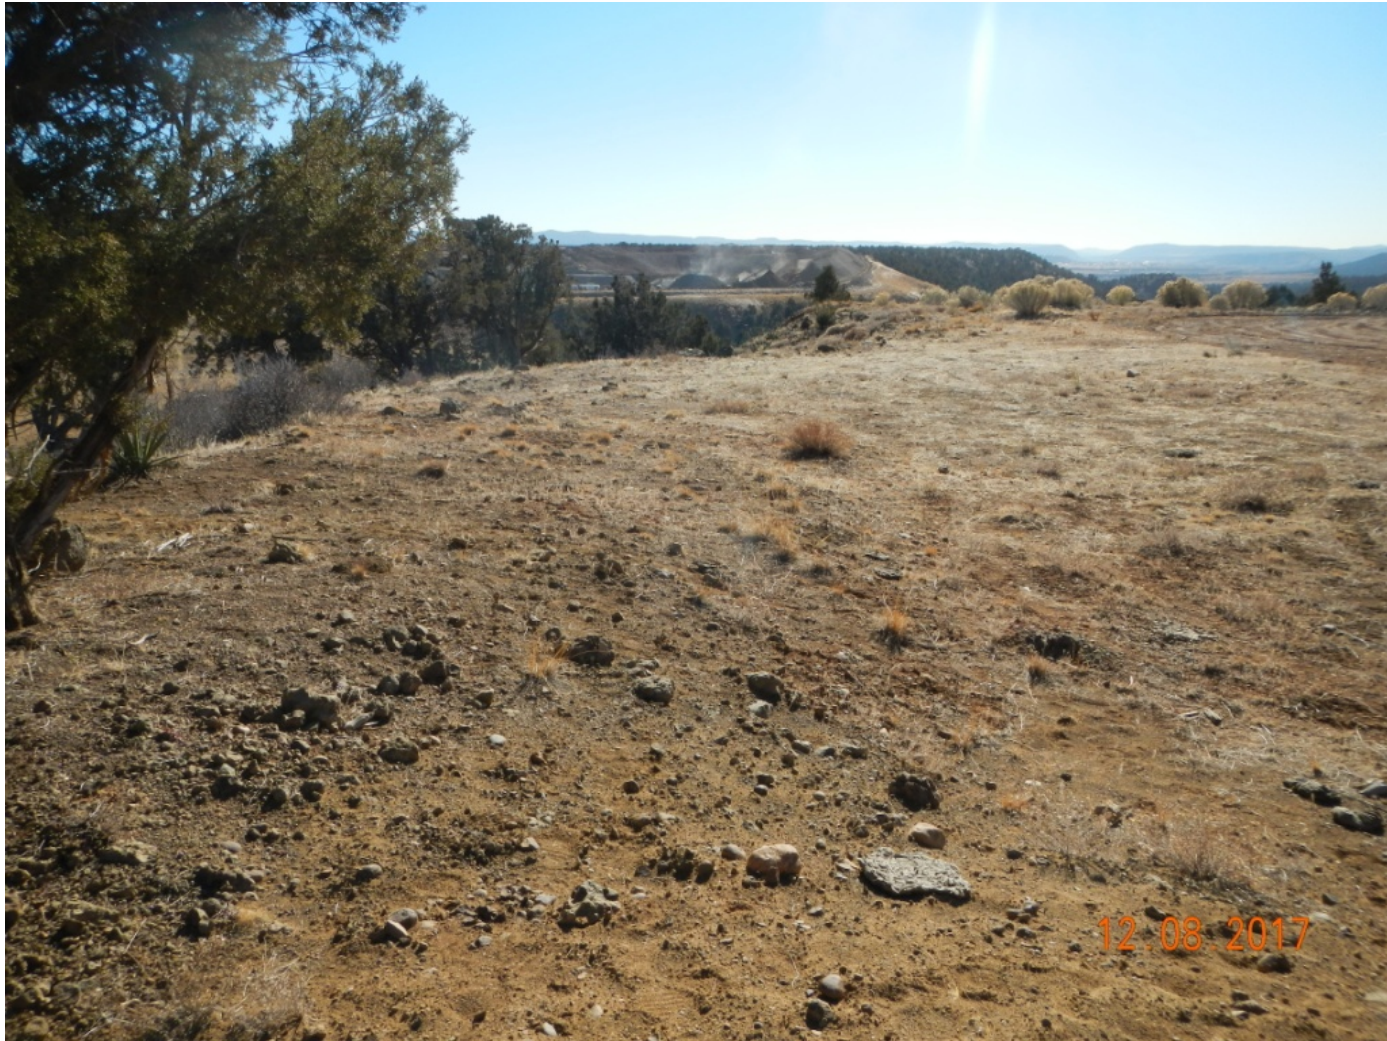
Photo 3. View of the eastern portion of the project area from the northeastern corner facing southeastward. Little soil is present in interim reclamation areas due to dense rocks. Revegetation is progressing in areas with soil.

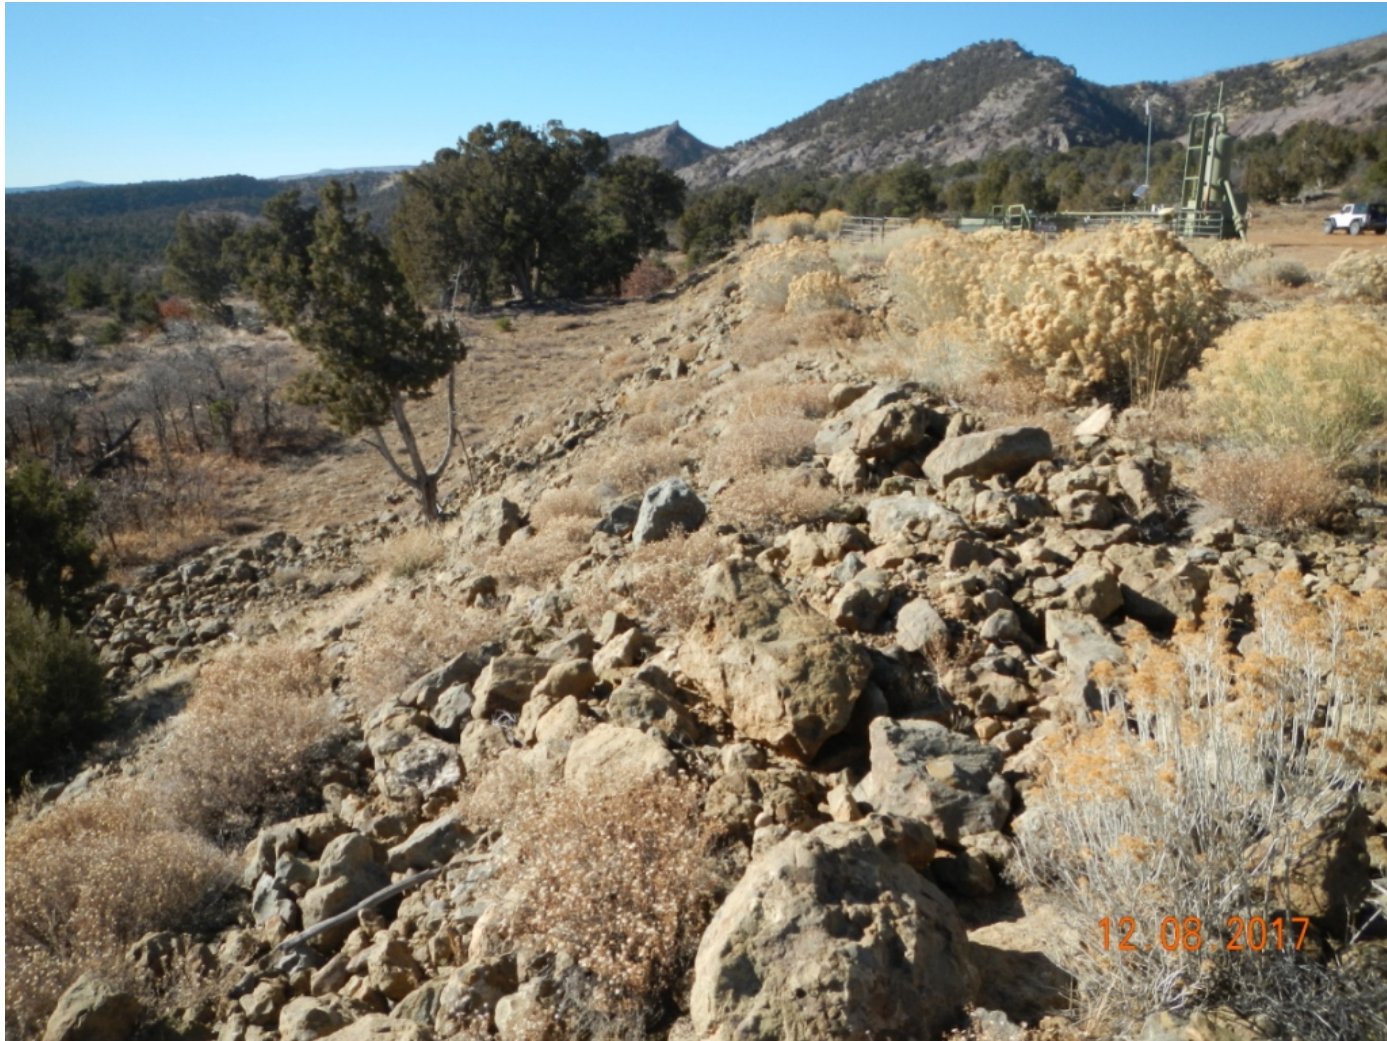
Photo 4. View of the southern portion of the project area from the southeastern corner facing westward.
