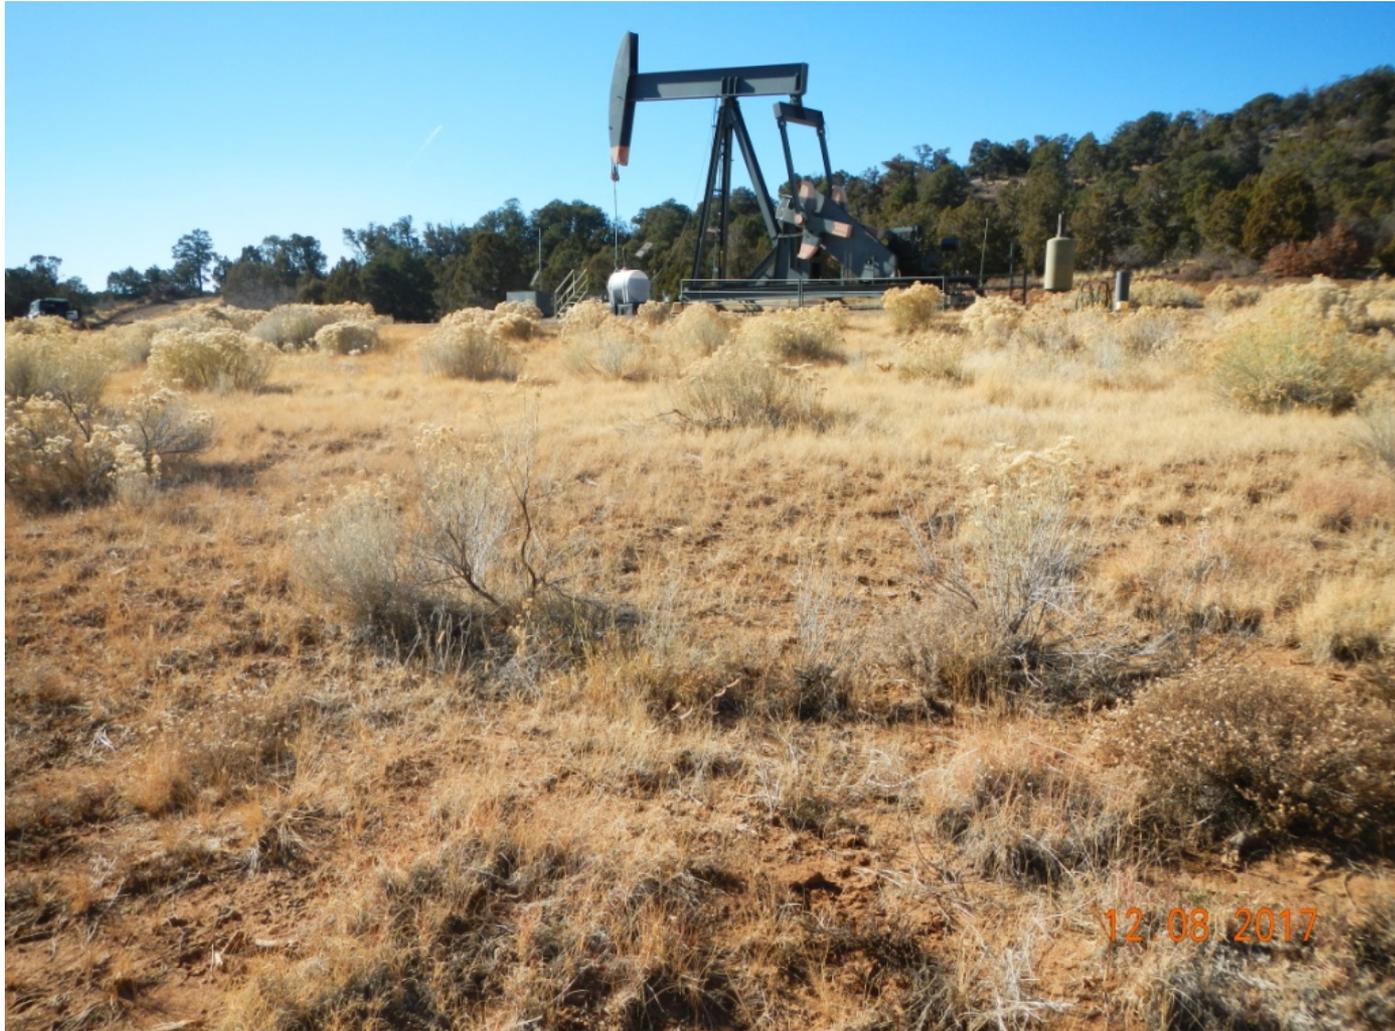
Photo 1. View of the project area from the northeastern corner facing center.

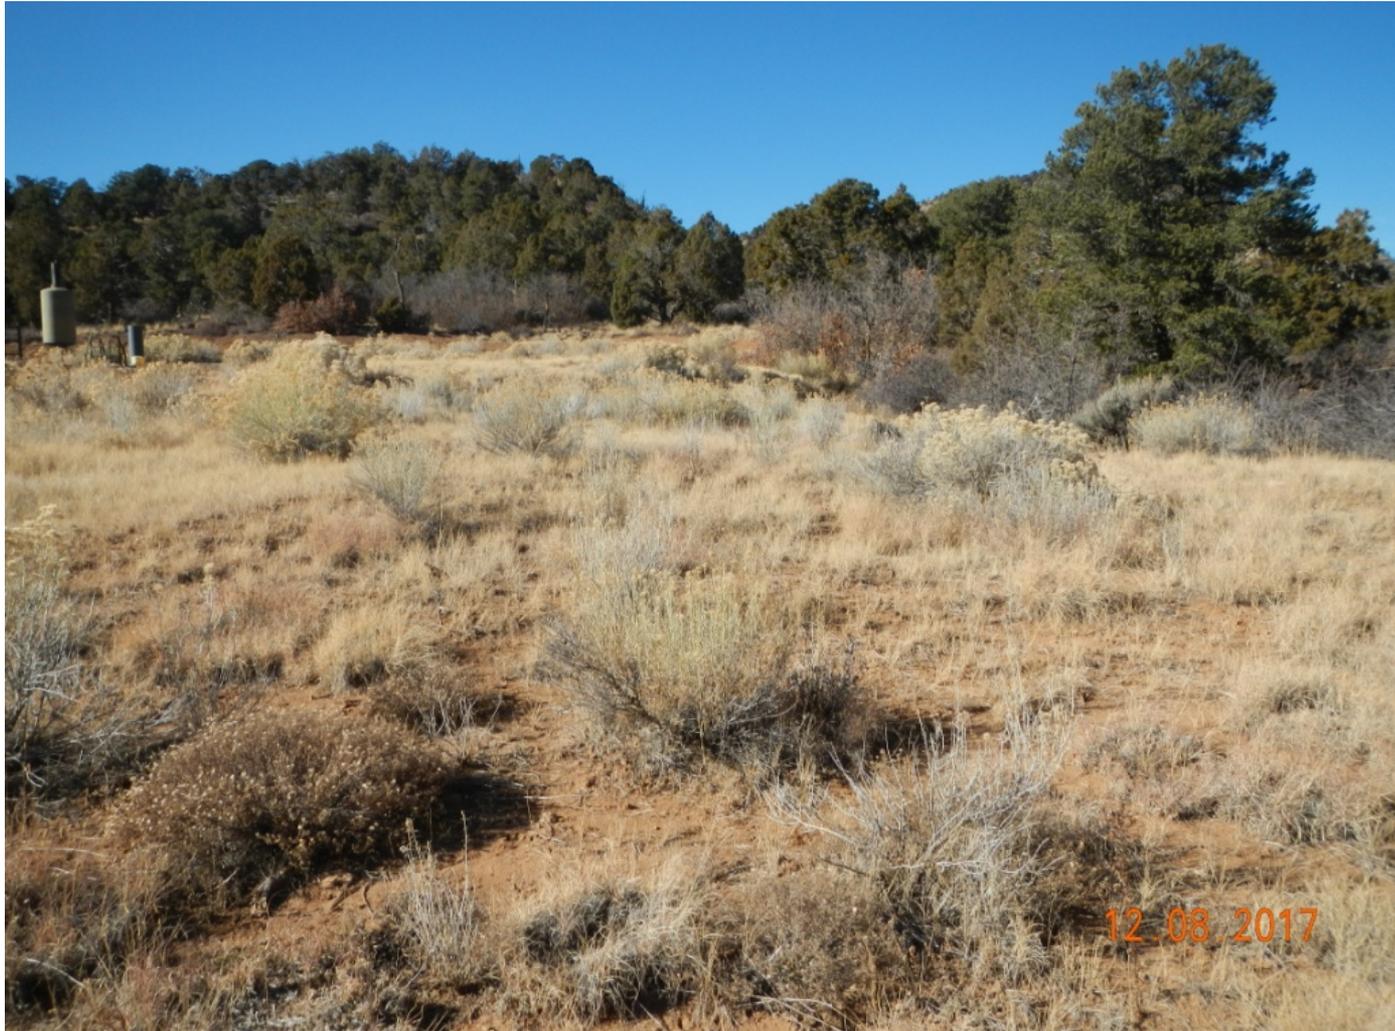
Photo 2. View of the northern portion of the project area from the northeastern corner facing westward.

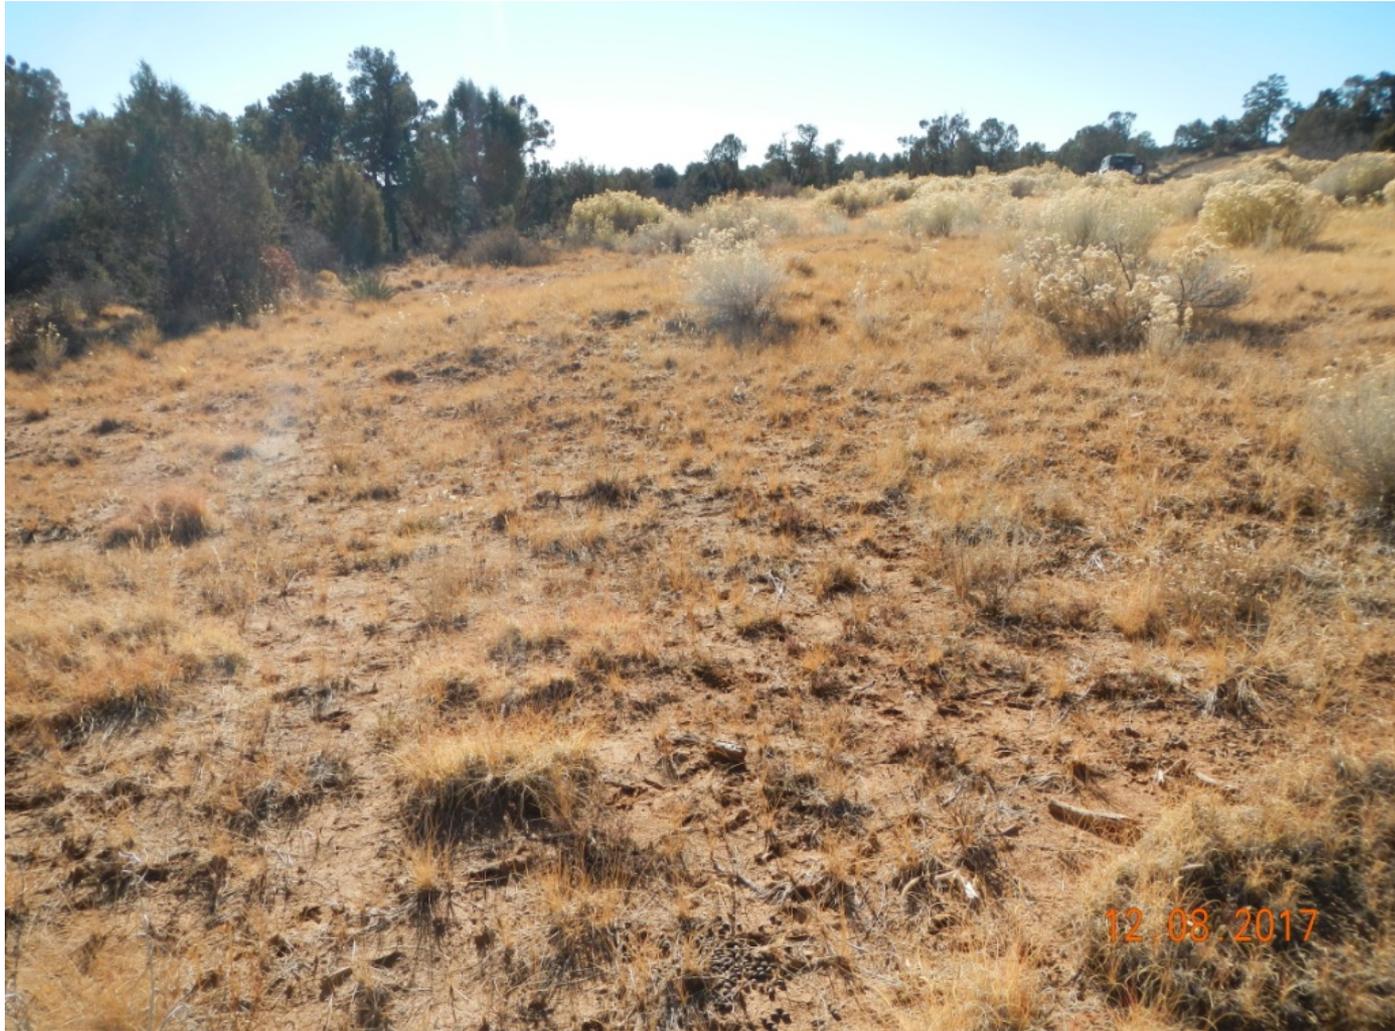
Photo 3. View of the eastern portion of the project area from the northeastern corner facing southeastward. Revegetation is progressing with grasses and shrubs such as crested wheatgrass (*Agropyron cristatum*), blue grama (*Bouteloua gracilis*), western wheatgrass (*Pascopyrum smithii*), and rubber rabbitbrush (*Chrysothamnus nauseosus*).

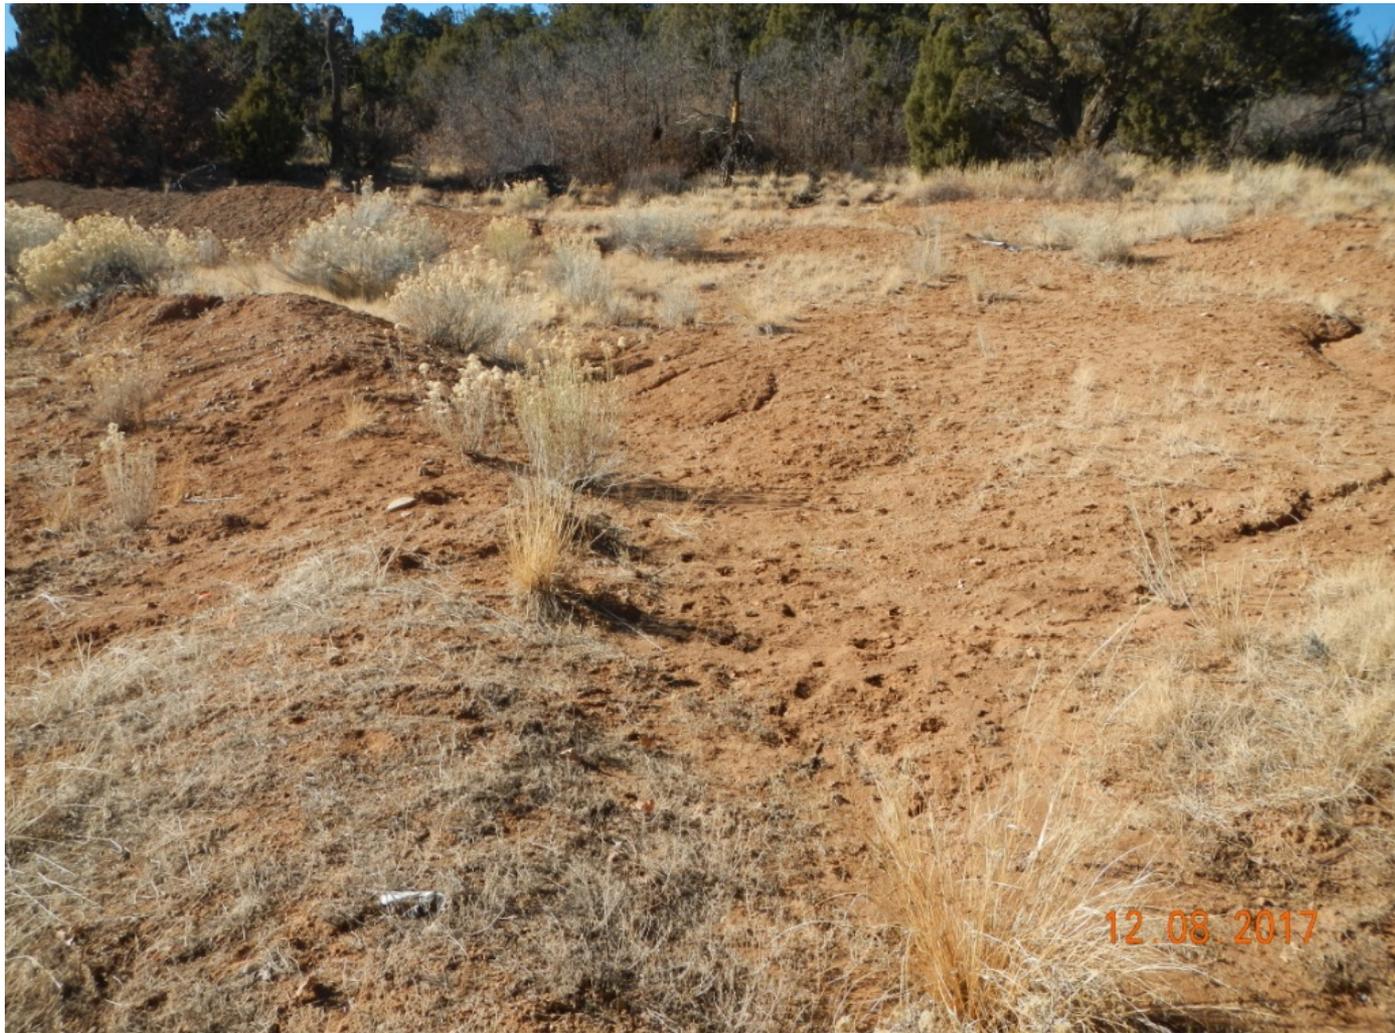
Photo 4. View of area in the northwestern portion of the project area where it appears stormwater causing erosion from run-on and concentrated stormwater flows off of the project area. This should be monitored and stormwater controls applied if it worsens.

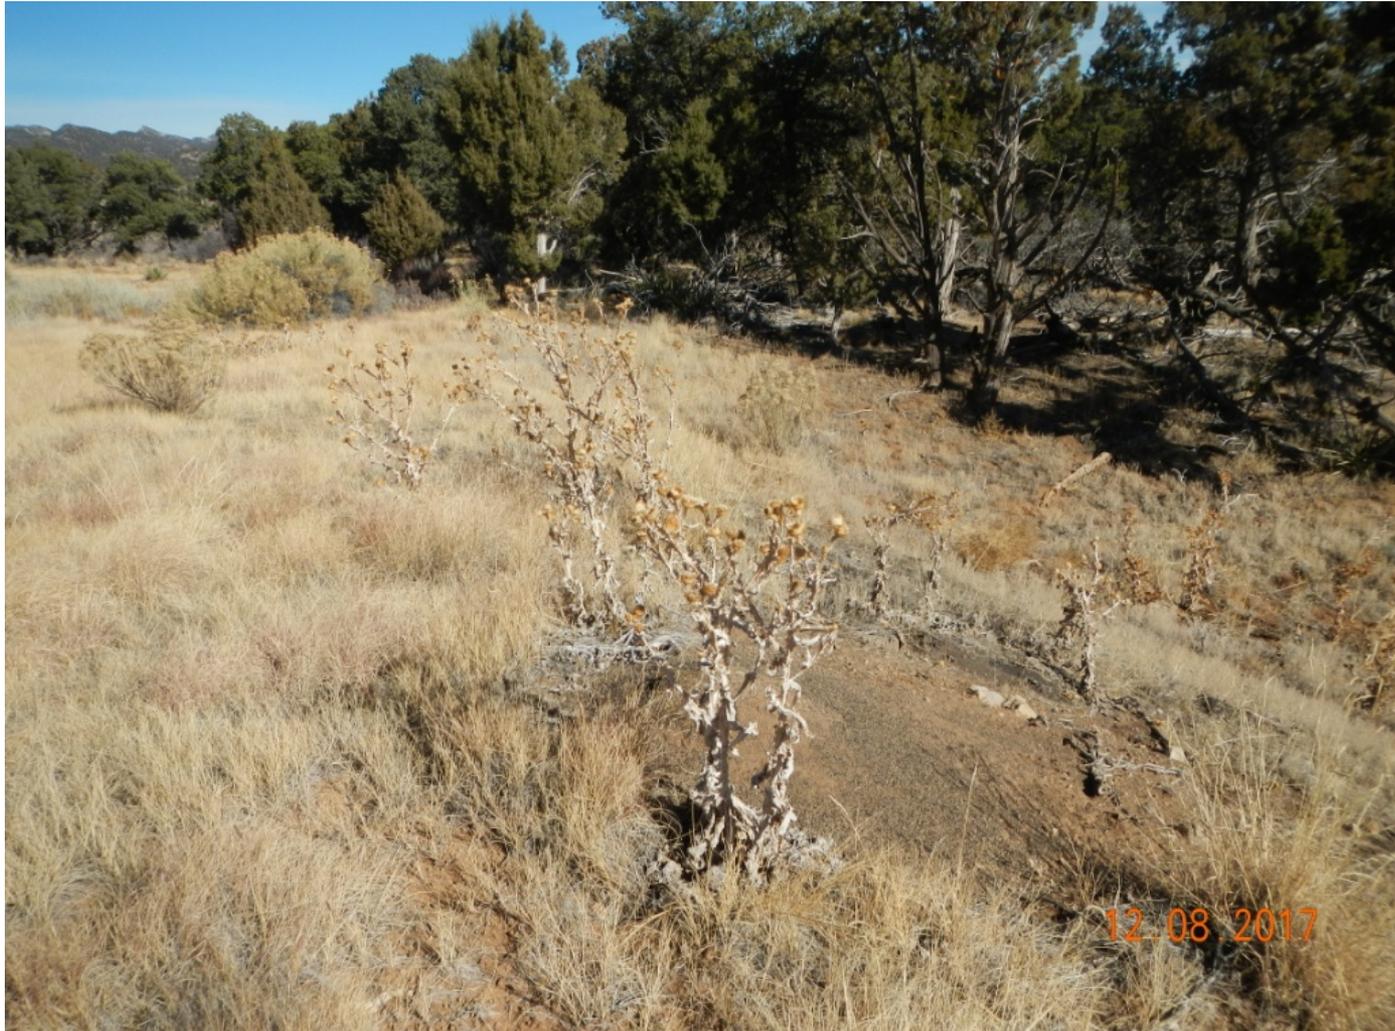
Photo 5. View of Scotch thistles (*Cirsium arvense*) within the eastern portion of the project area.

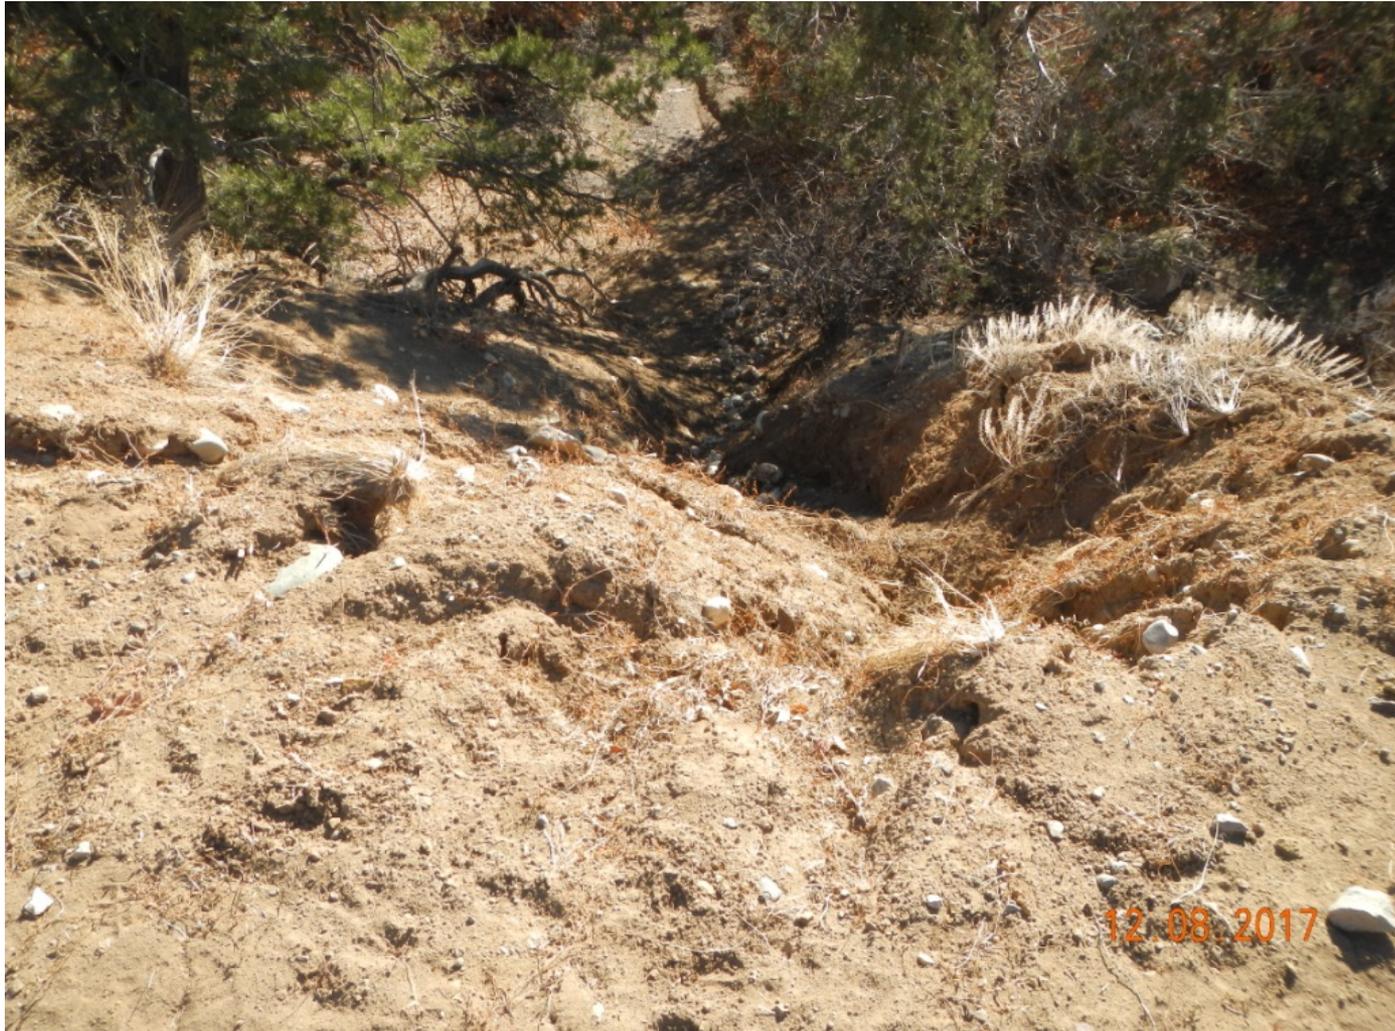
Photo 6. View of erosion occurring along the access road where stormwater is flowing off of the road and eroding roadsides.

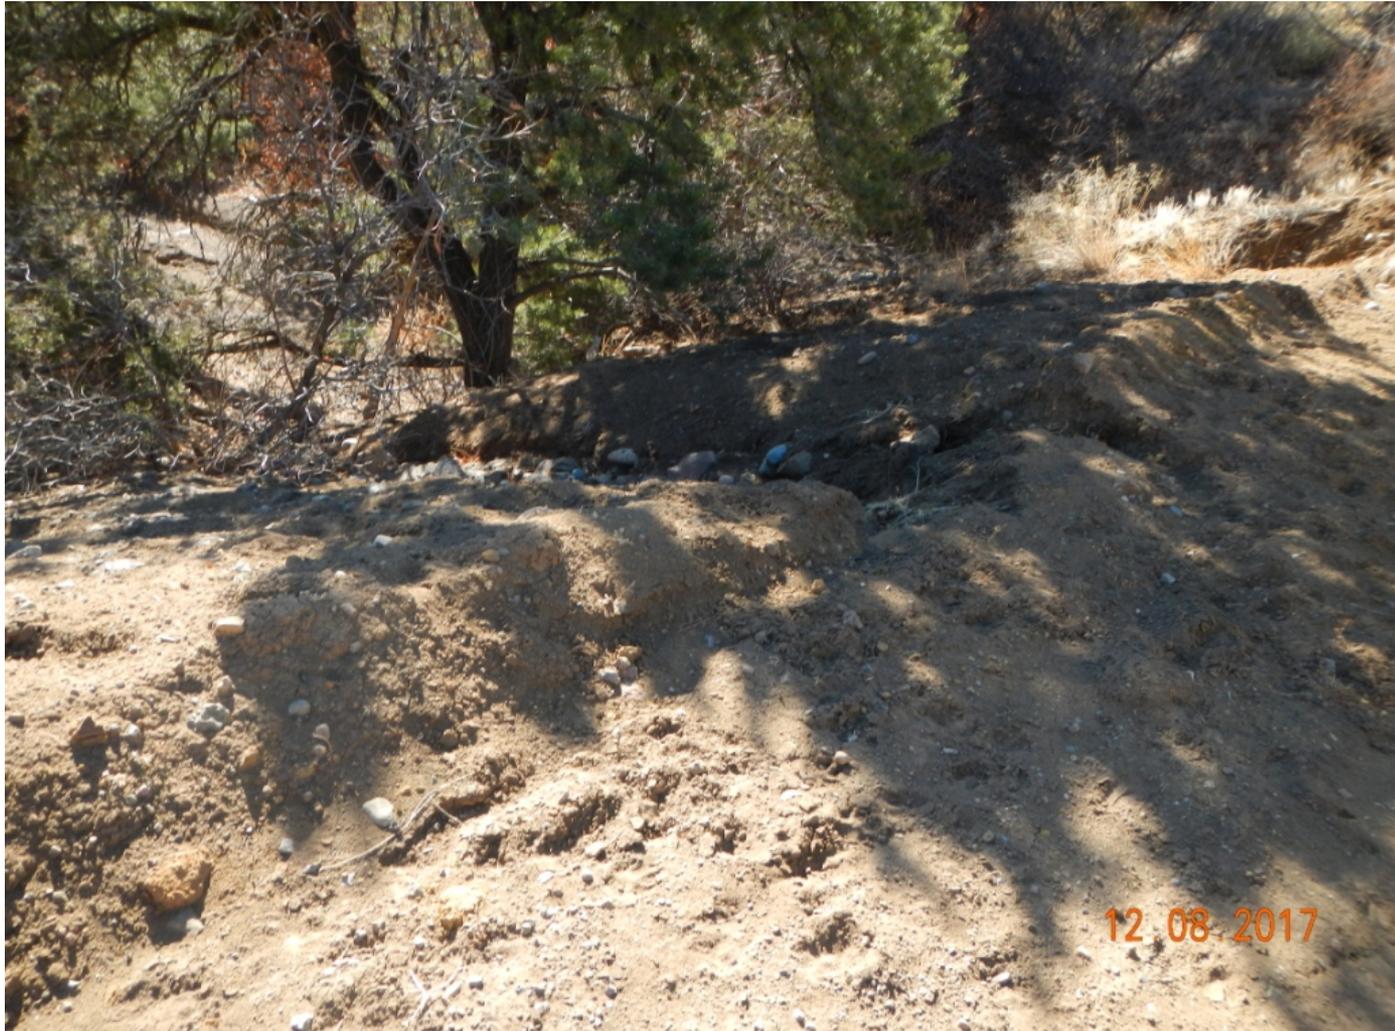
Photo 7. View of another area along the roadside where stormwater flows off of the roadsides and is causing erosion.

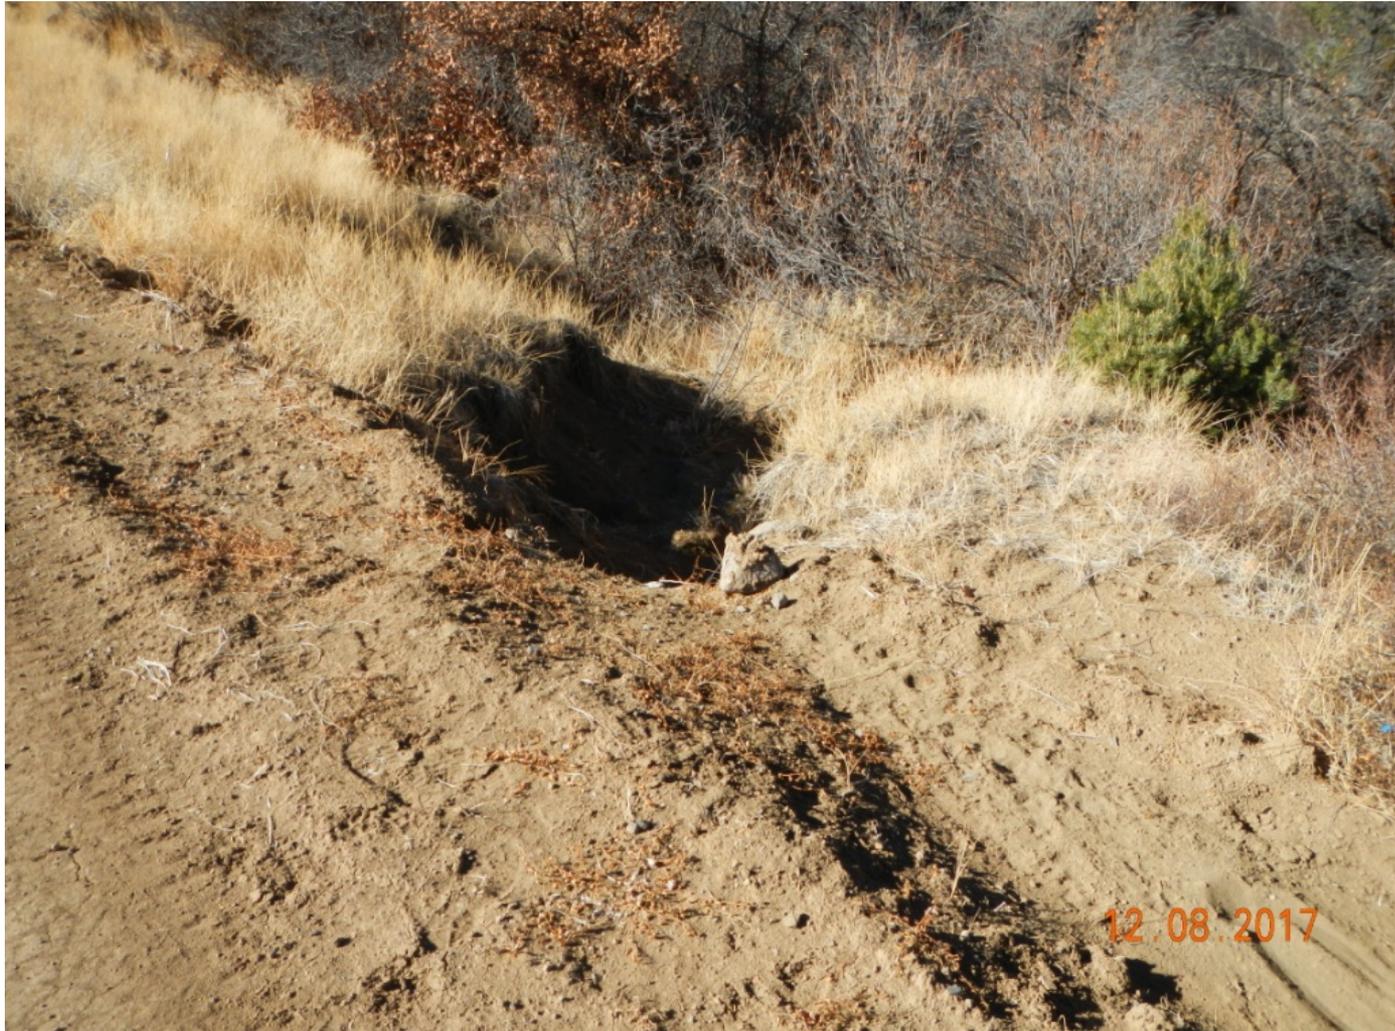
Photo 8. View of another area where erosion is occurring along the access road.
