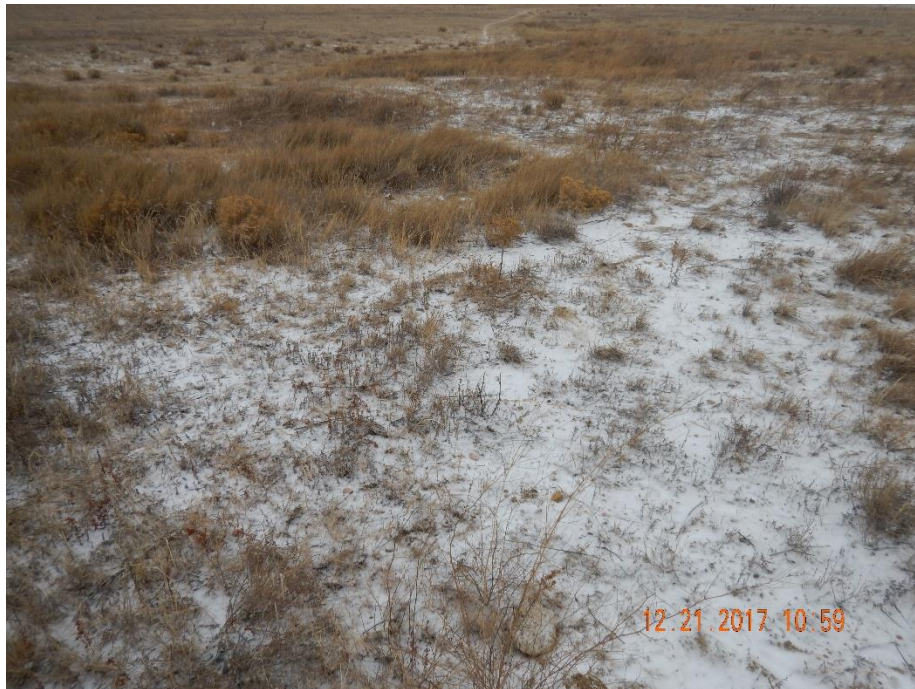
**Photo 1:** Photo taken from the west end of the location facing east. Previous inspections documented that location had not achieved a uniform desirable perennial vegetative cover of 80% and required operator to perform reclamation. Photo shows areas of the location where additional reclamation was required. Though partially snow-covered, unable to find evidence that additional reclamation activities have been conducted.

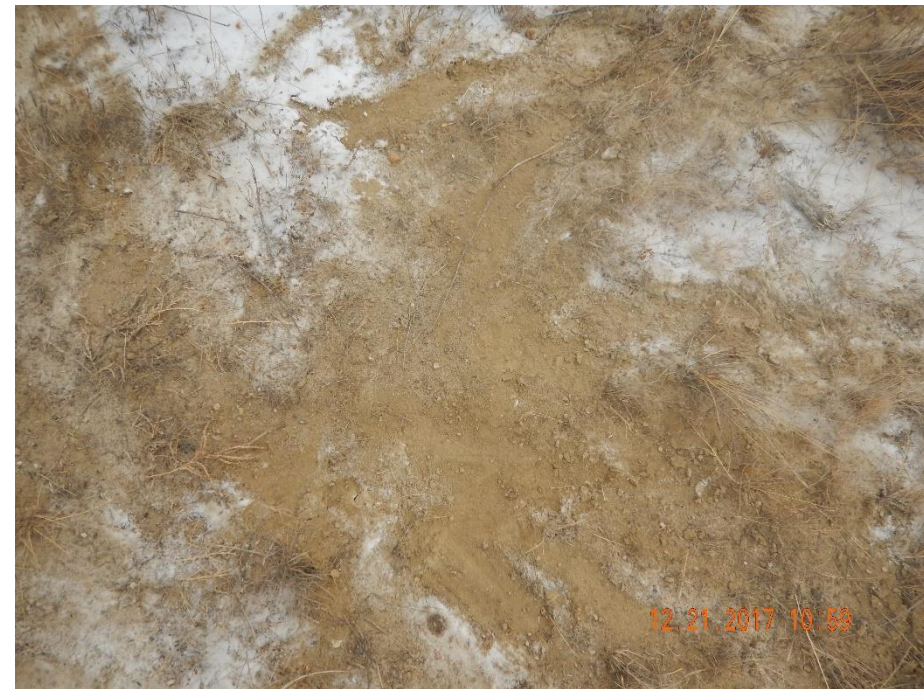
**Photo 2:** Photo taken from the bare areas seen in photo 1. Photo shows soil; unable to find evidence that additional reclamation activities have been conducted per the corrective action.
