**Inspection Photos**  
**Location Name: State-Hoppe 16-2**  
**API #: 05-123-12520**  
**Location ID: 323075**

## Inspection Photos

Location Name: State-Hoppe 16-2

API #: 05-123-12520

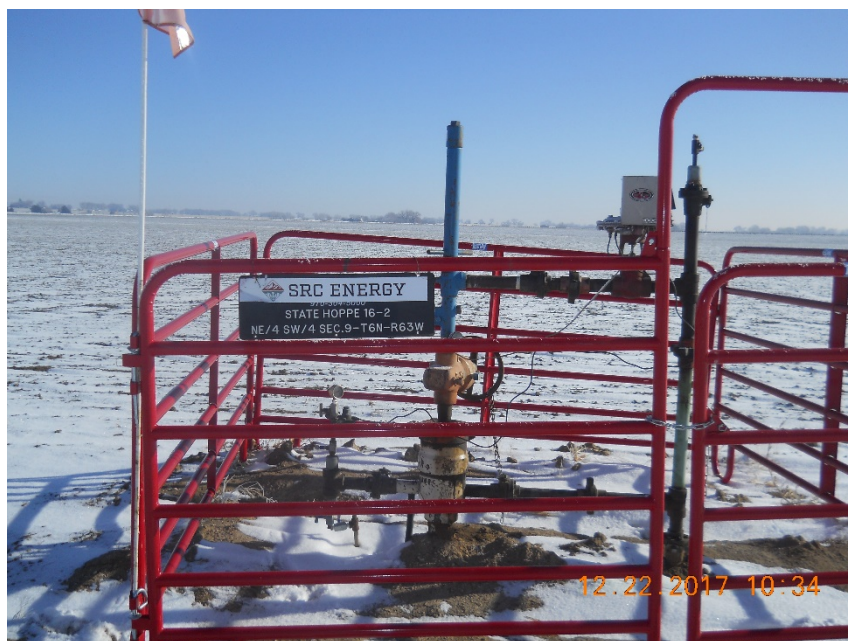
**Wellhead looking east**

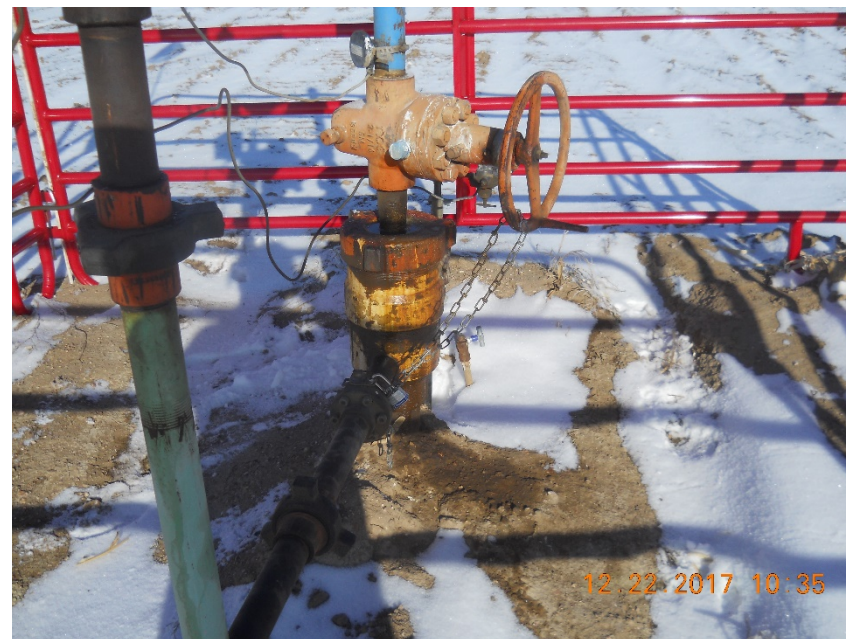
**Stained soil under master valve. Appears to be leaking/have leaked from wellhead packing**

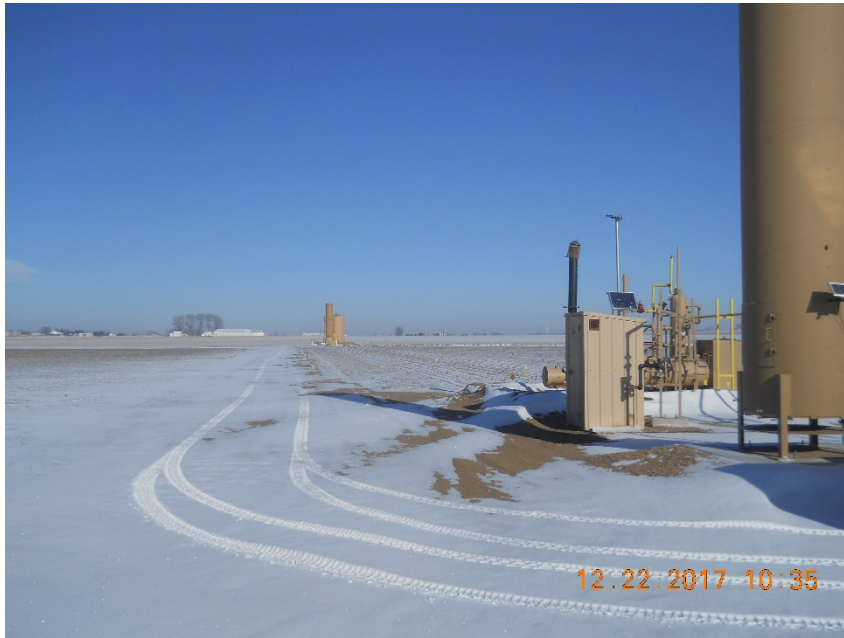
Battery looking north. Crude oil tank is north approx. 190 yards from separator
