## Inspection Photos

Location Name: Little Beaver Unit Injection Plant and Tank Battery

Facility IDs: #451505 and #451504

Inspection Date: December 19, 2017

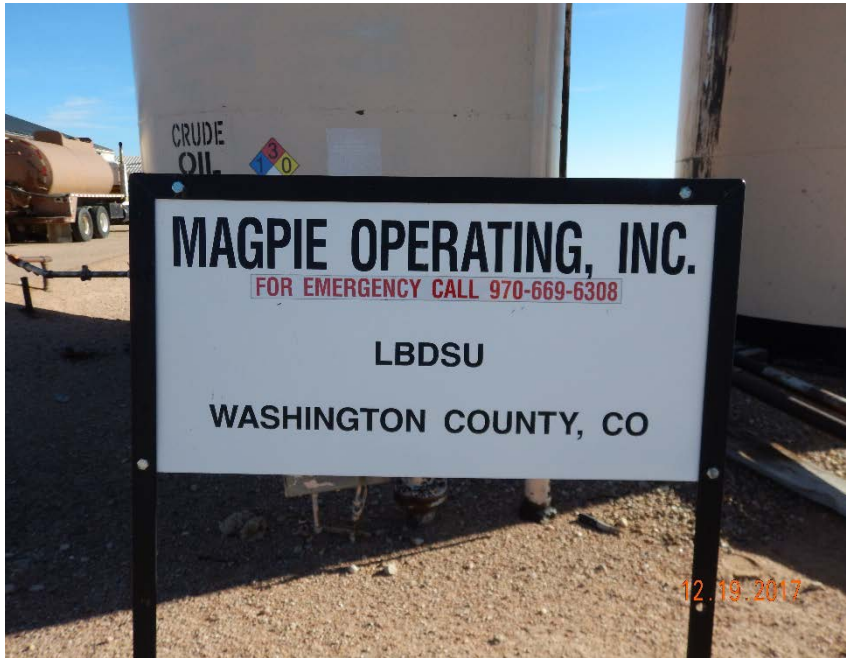
Photo #1 – Battery sign for crude oil ASTs located at SW corner of facility.

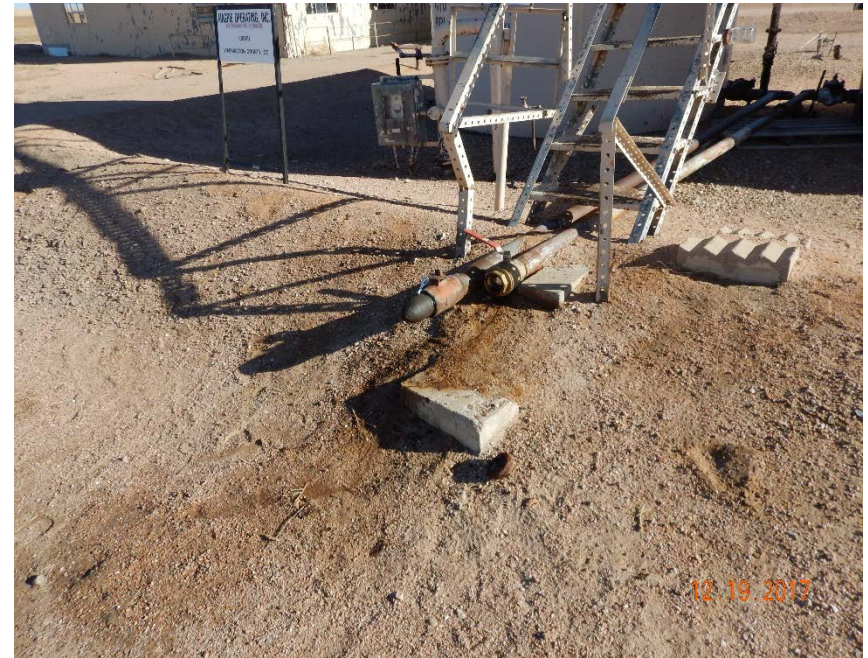
Photo #2 – Stained soil at crude oil AST loadout. Note shallow earthen berm.

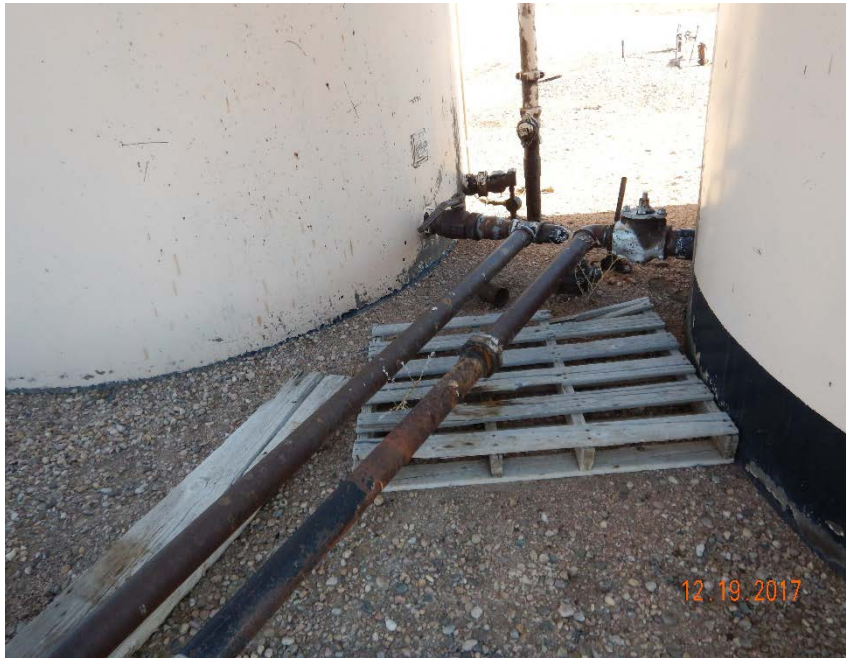
**Photo #3 – Wood debris remaining at crude oil ASTs.**

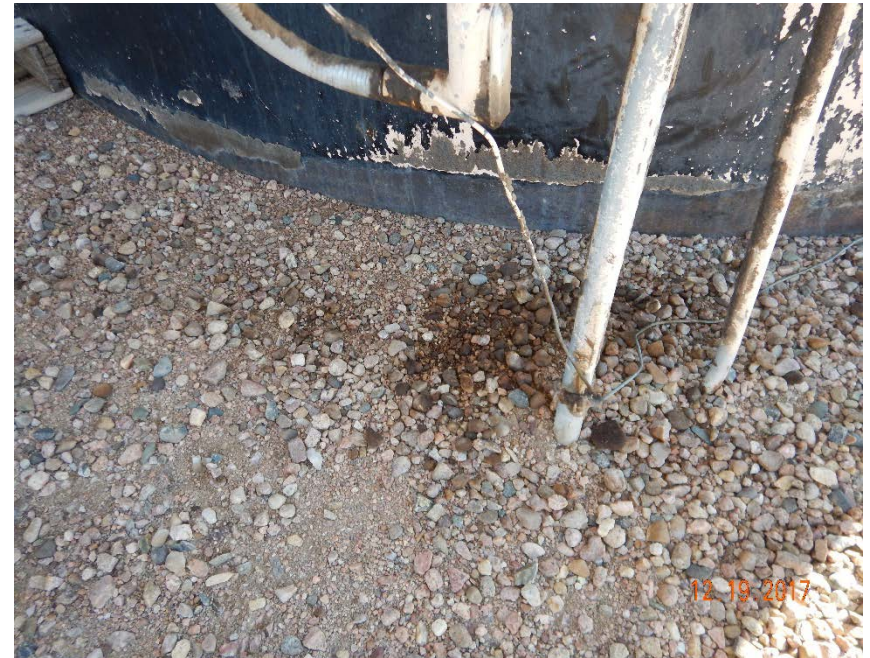
**Photo #4 – Localized accumulations of oily waste underlying valves and equipment at crude oil tank battery (1).**

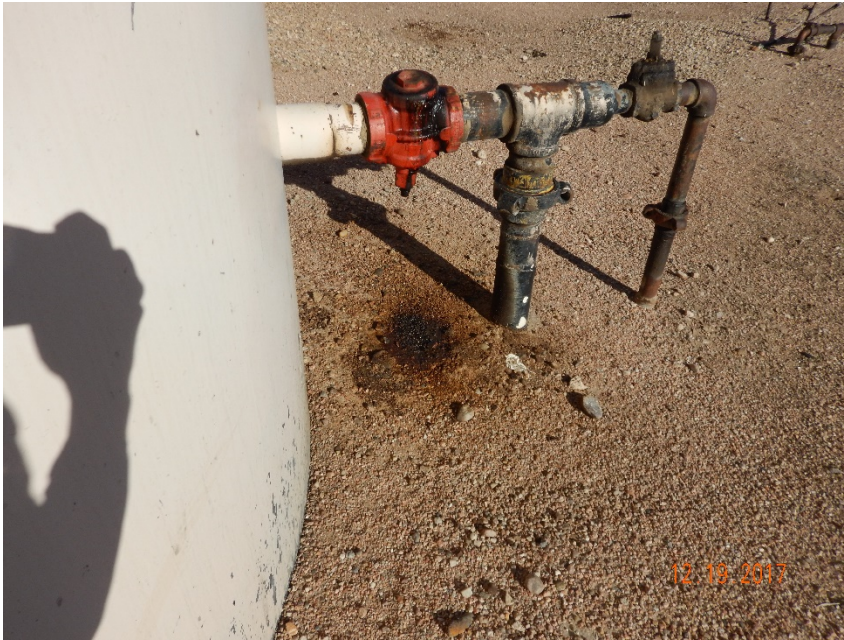
**Photo #5 - Localized accumulations of oily waste underlying valves and equipment at crude oil tank battery (2). Note red valve was observed to be actively leaking on inspection date.**

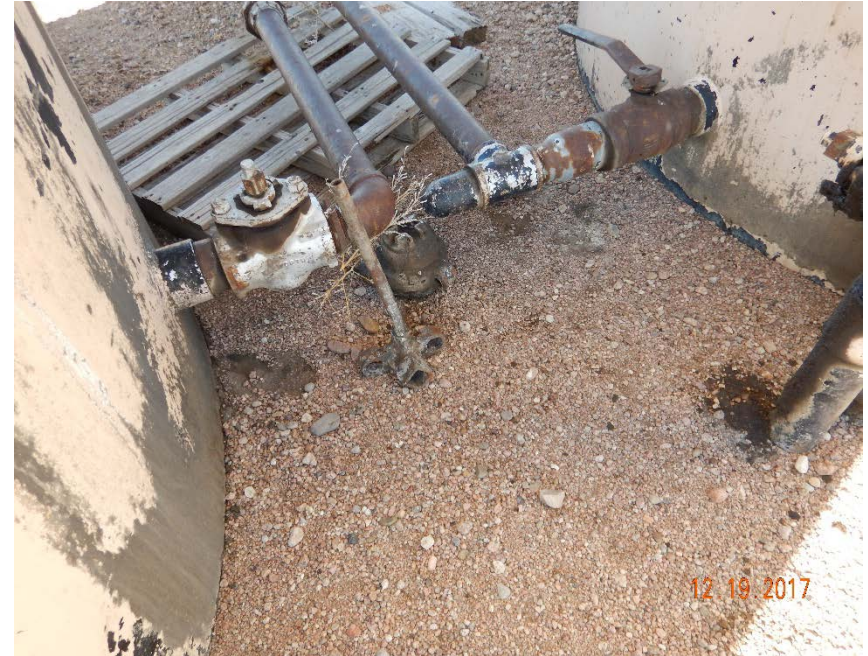
**Photo #6 - Localized accumulations of oily waste underlying valves and equipment at crude oil tank battery (3).**

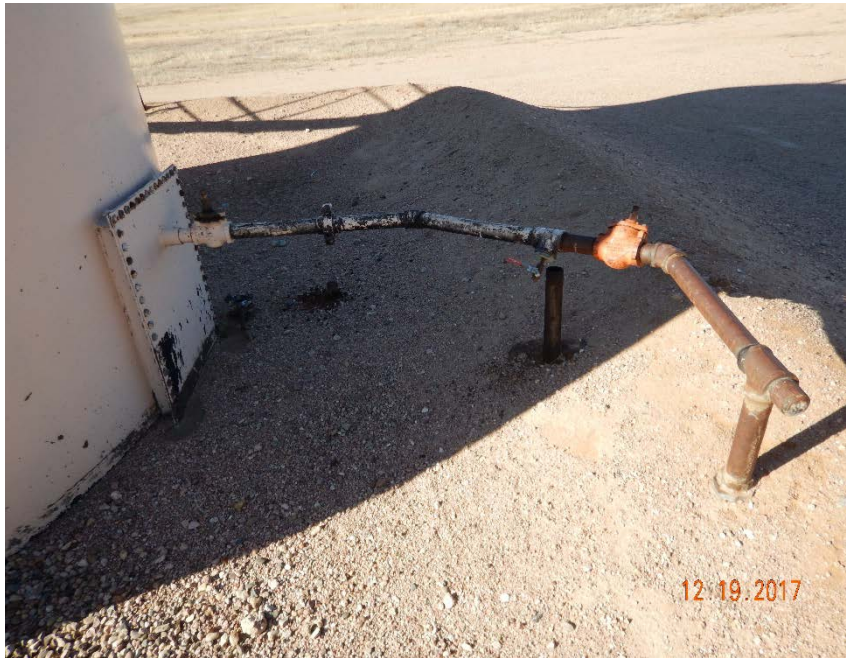
**Photo #7 - Localized accumulations of oily waste underlying valves and equipment at crude oil tank battery (4). Note abandoned flowline risers north of crude oil ASTs and shallow earthen berm.**

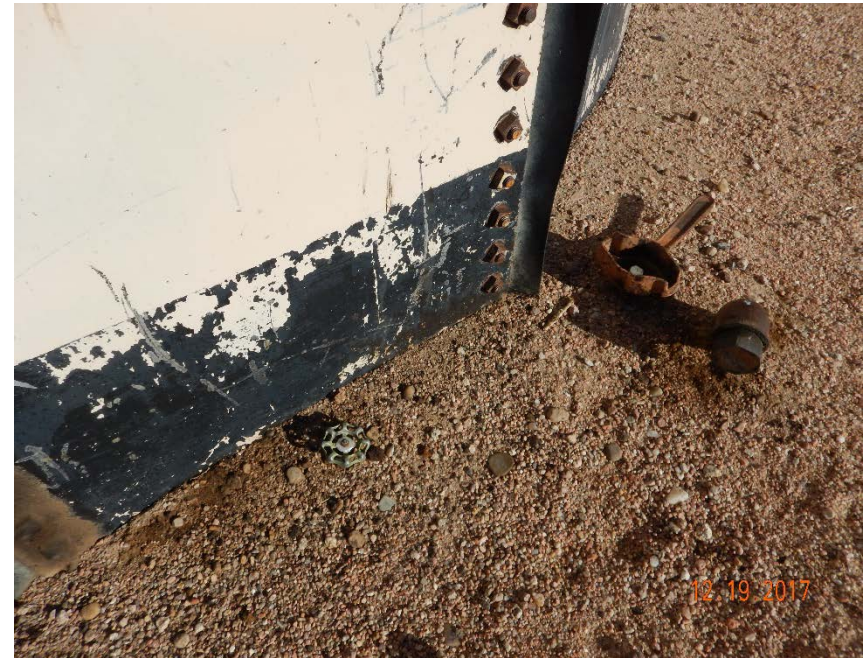
**Photo #8 – Flowline riser and valves daylight south of crude oil ASTs.**

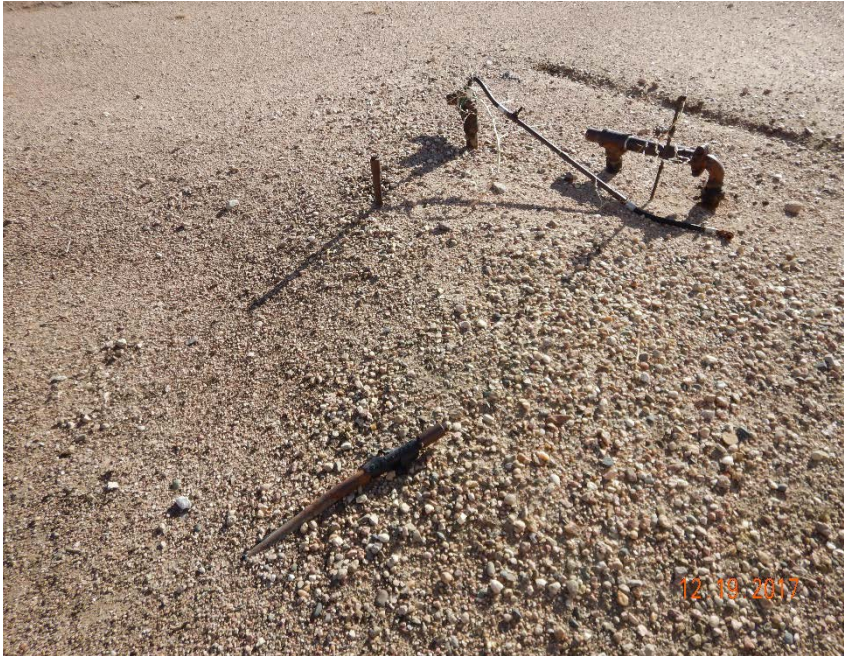
**Photo #9 – Unmarked, unused flowline risers daylight east of crude oil ASTs.**

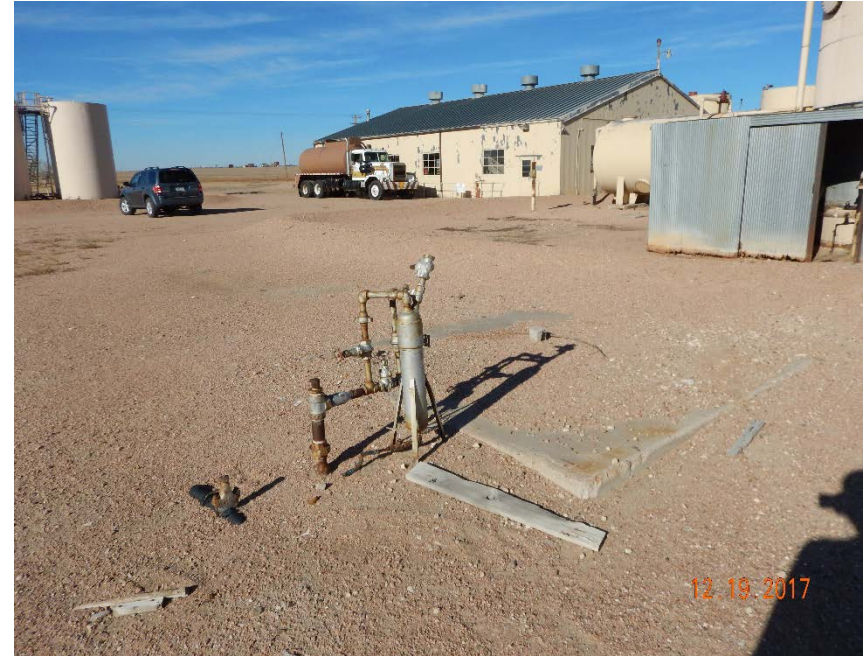
**Photo #10 – Unused flowline manifold with concrete slab and wood debris located at SE corner of facility.**

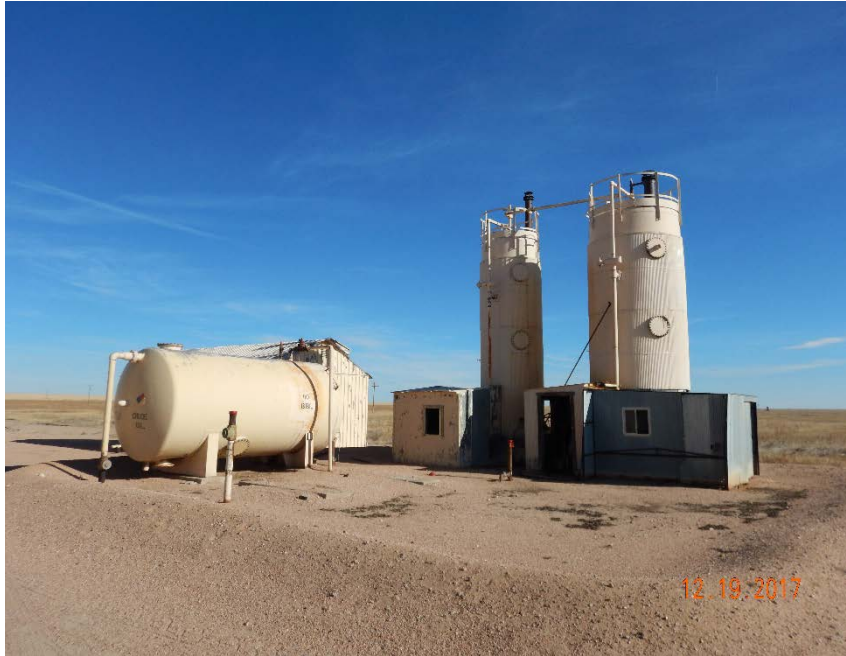
**Photo #11 – Horizontal crude oil AST with VHT sheds located at SE corner of facility. Note shallow earthen berm.**

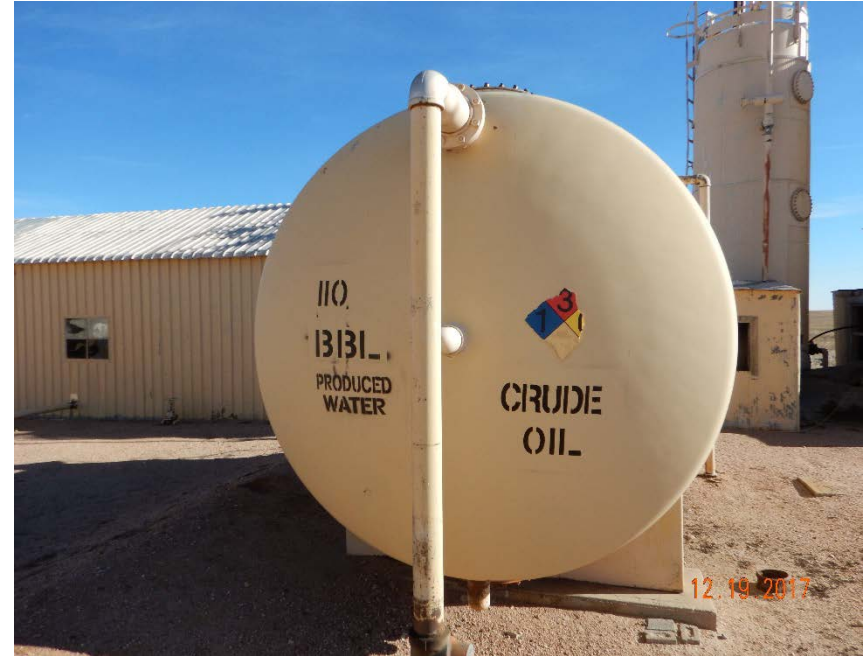
**Photo #12 – NFPA placard affixed to west side of horizontal crude oil AST in need of replacement.**

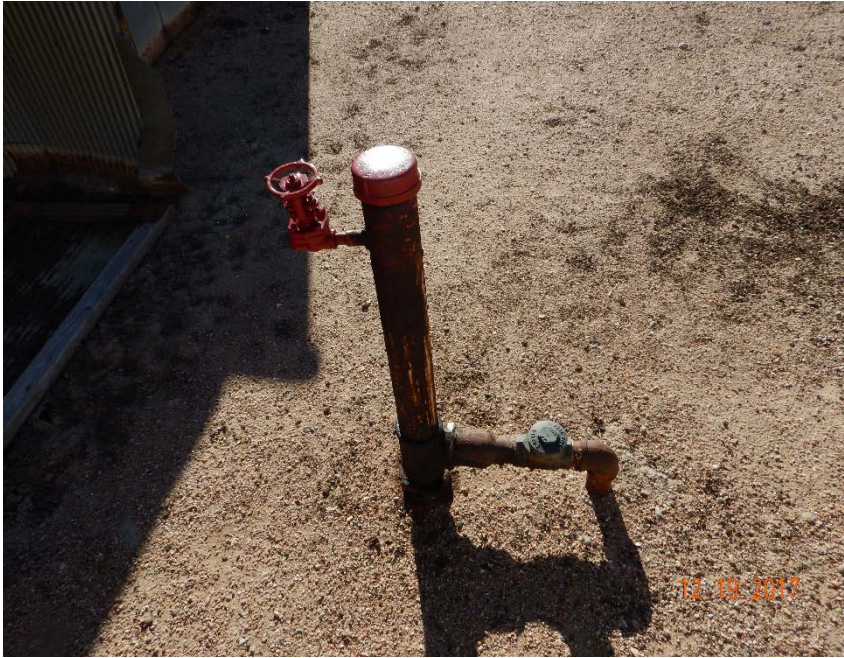
**Photo #13 – Flowline risers south of horizontal crude oil AST have been marked by operator in response to previous FIR.**

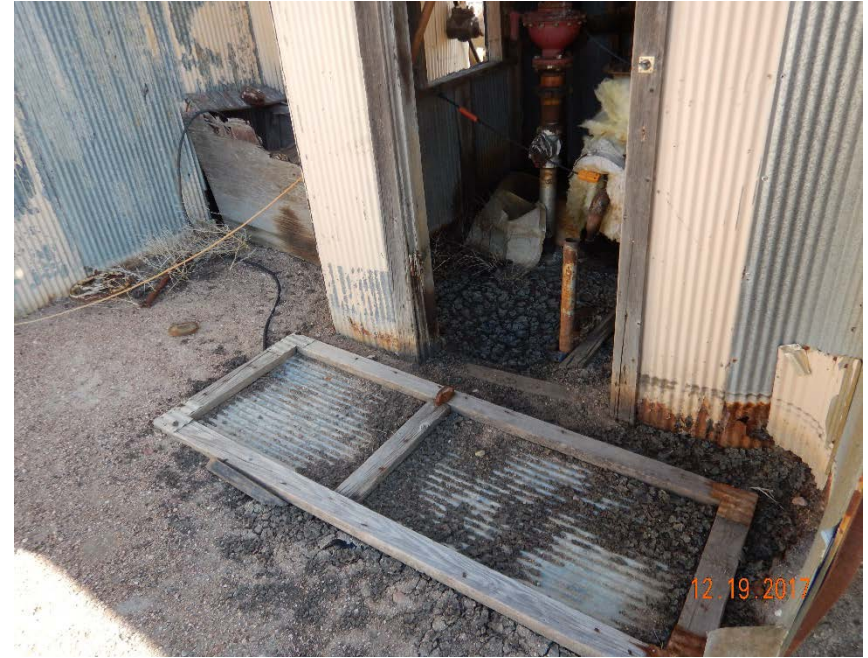
**Photo #14 – Junk, debris, stained soil, and unmarked/uncapped flowline riser at entrance to south VHT remain unaddressed from previous FIR. Note that strong hydrocarbon odor and audible gas leak were observed on inspection date.**

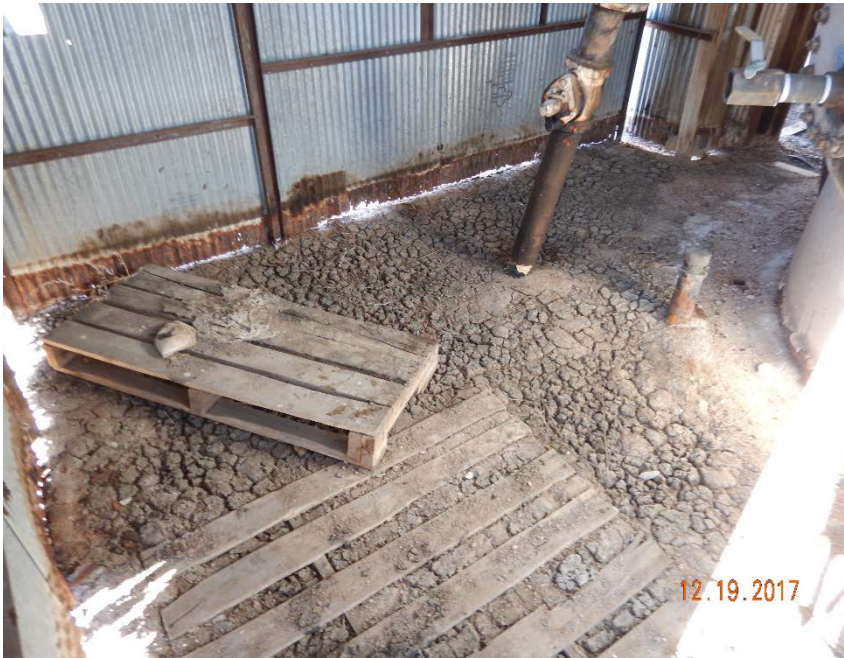
**Photo #15 – Oil-stained soil, strong hydrocarbon odor, audible gas leak, and wood debris were observed inside of south VHT shed on inspection date.**

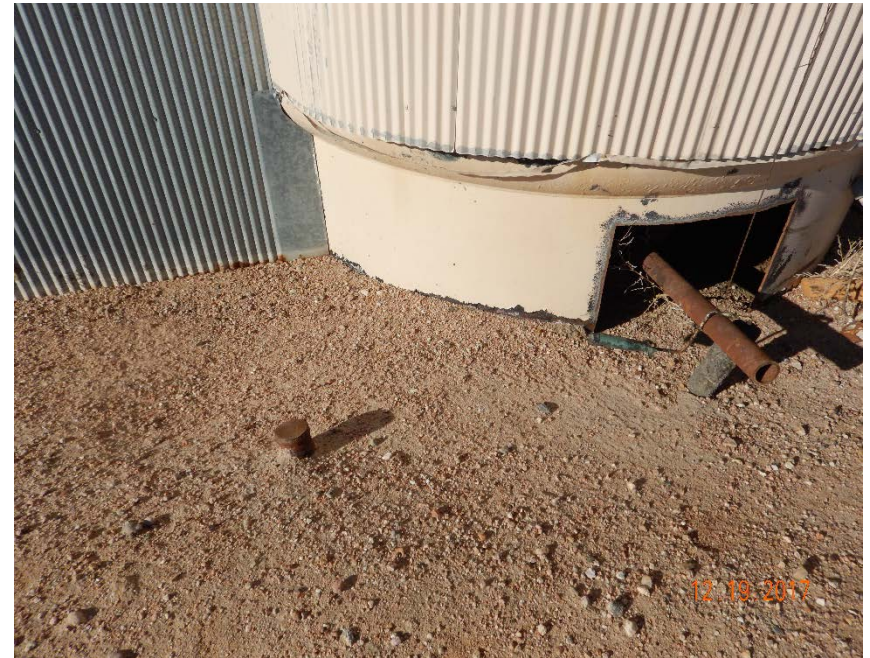
**Photo #16 – Capped flowline riser observed on east side of south VHT shed, as indicated in previous FIRs.**

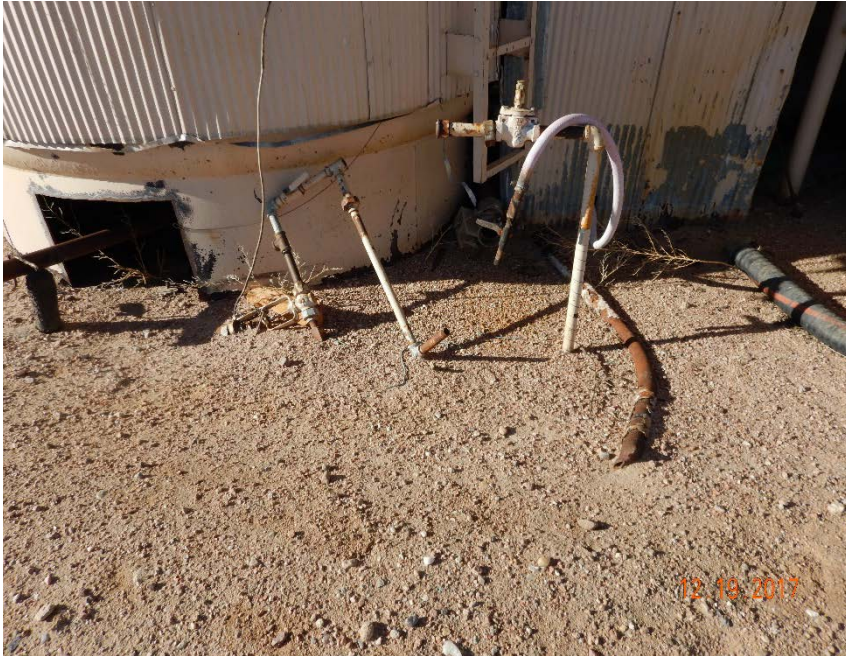
**Photo #17 – Assorted equipment and junk on east side of south VHT shed.**

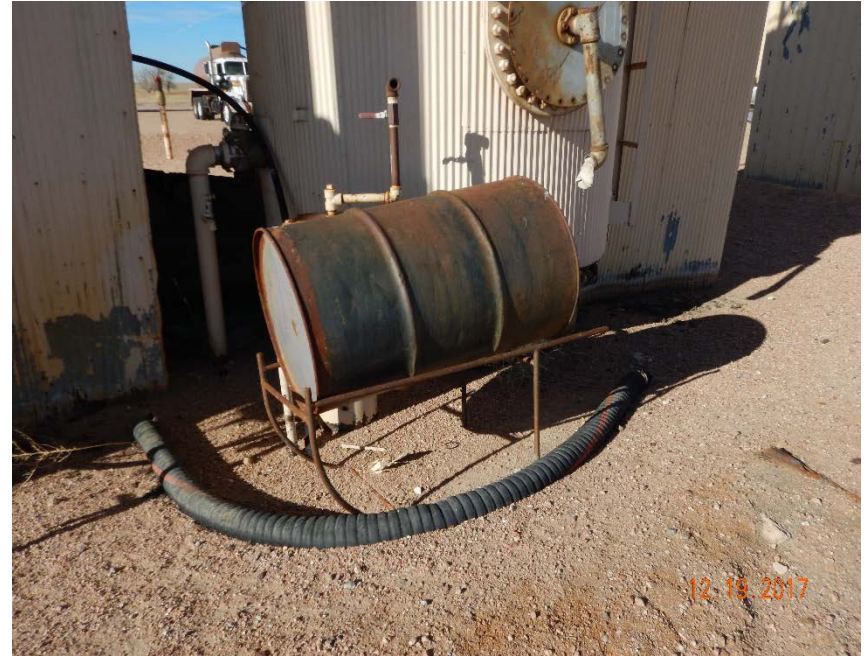
**Photo #18 – 55-gallon drum located inside of shallow earthen berm on east side of VHT sheds.**

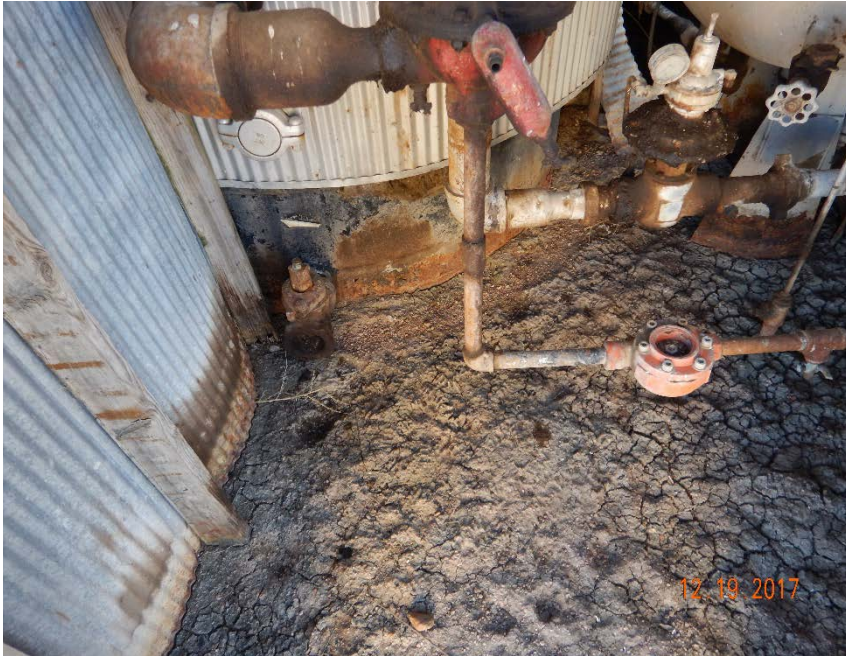
**Photo #19 – Oil-stained soil and strong hydrocarbon odor were observed inside of north VHT shed on inspection date.**

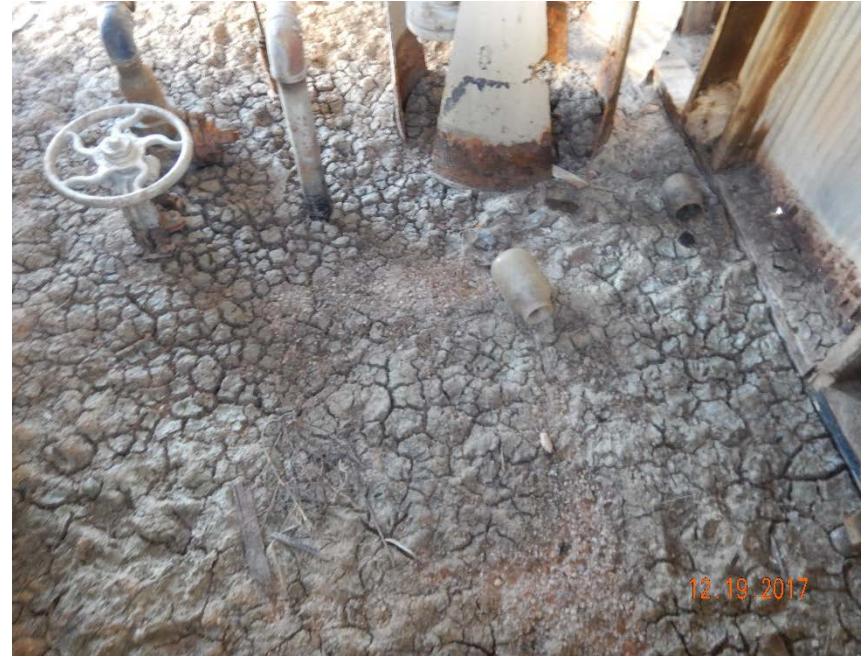
**Photo #20 – Trash and weeds inside of north VHT shed.**

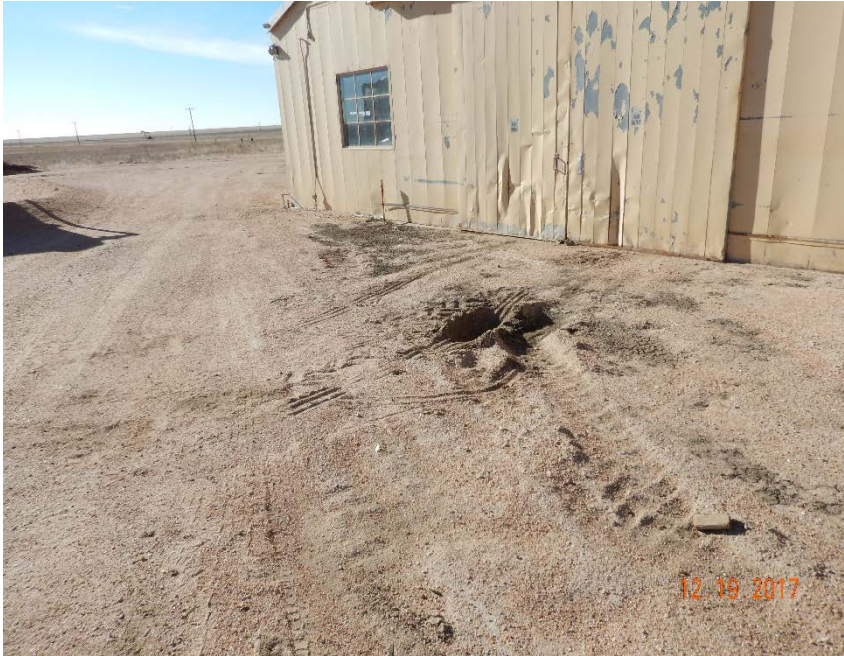
**Photo #21 - View of rutted area on east side of main building.**

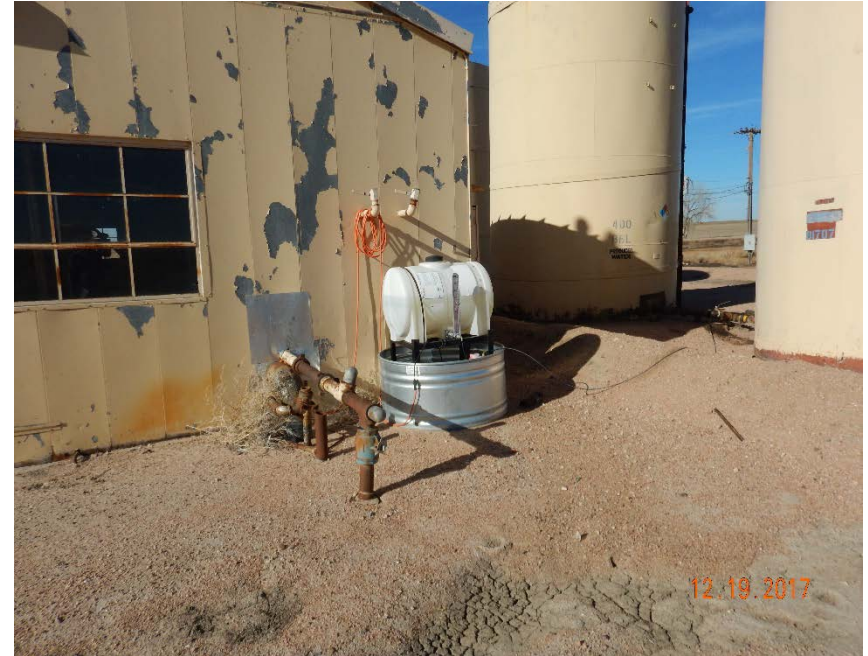
**Photo #22 – View of chemical storage tank with metal berm and unused flowline risers at NE corner of main building. Note shallow earthen berm surrounding produced water ASTs.**

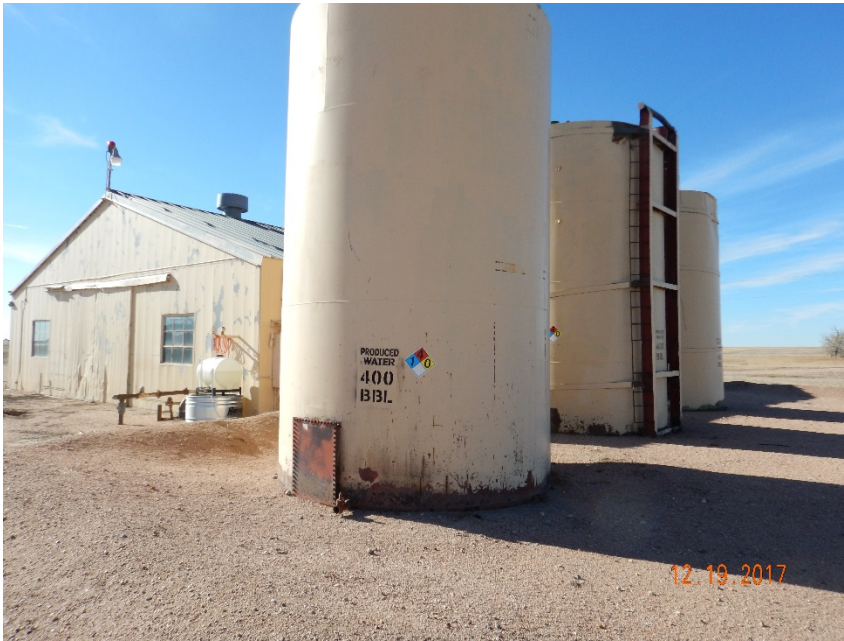
**Photo #23 – View of produced water ASTs located north of main building. Note shallow earthen berm.**

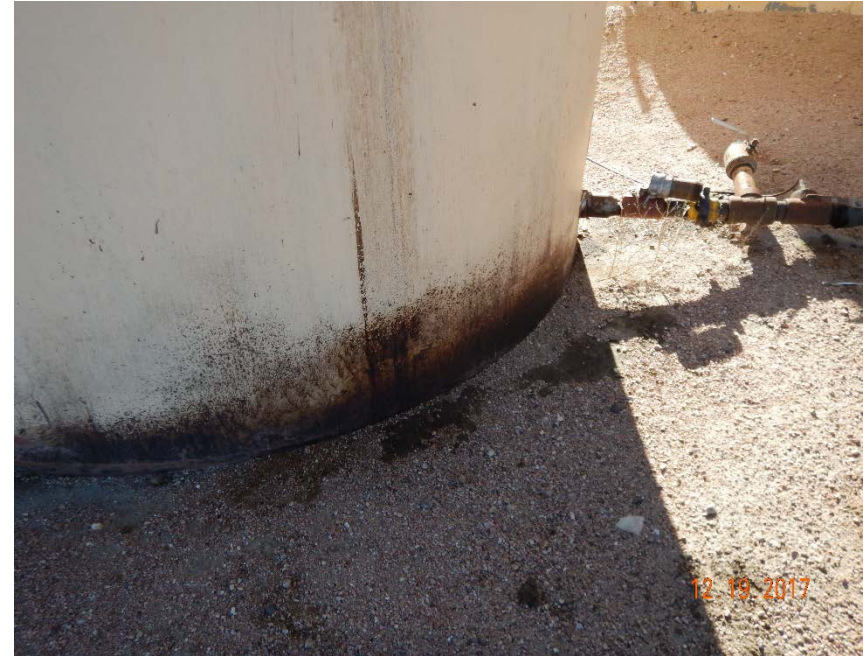
**Photo #24 – Localized accumulations of oily waste beneath produced water ASTs and associated equipment (1).**

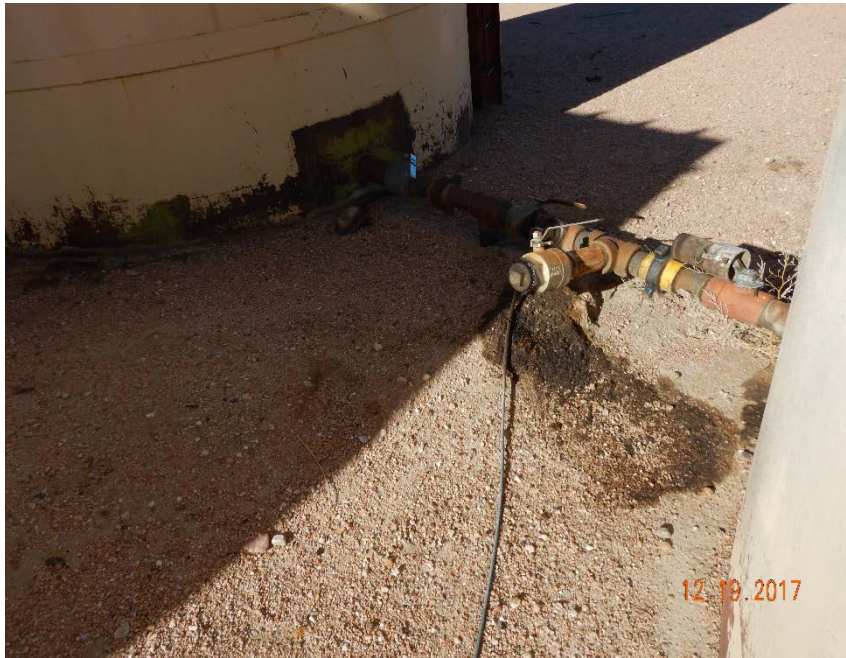
**Photo #25 - Localized accumulations of oily waste beneath produced water ASTs and associated equipment (2).**

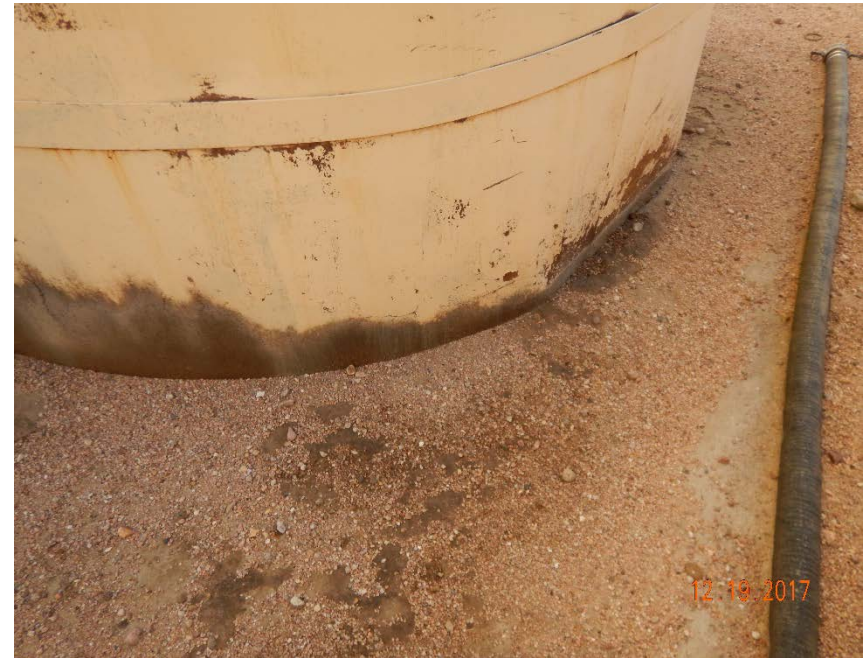
**Photo #26 - Localized accumulations of oily waste beneath produced water ASTs and associated equipment (3).**

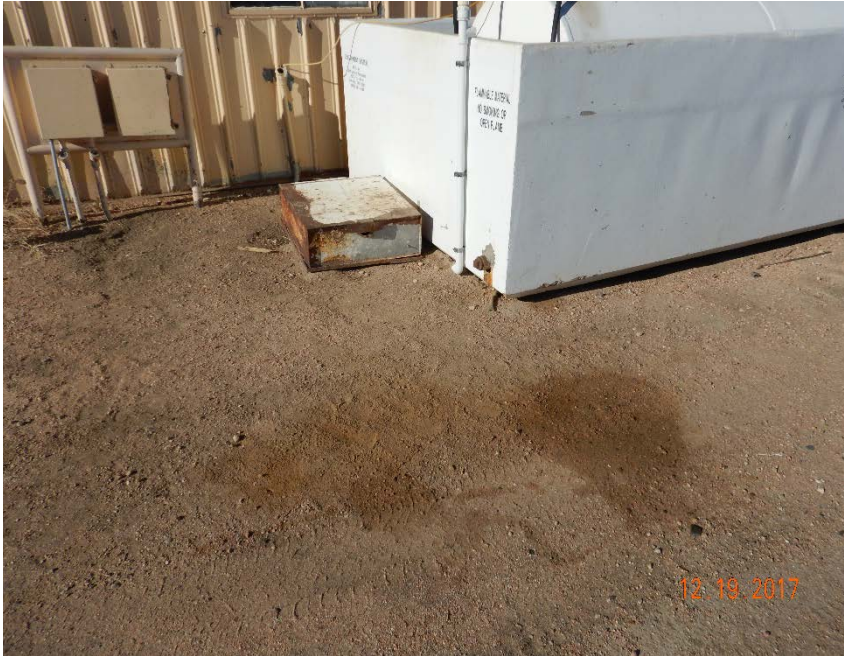
**Photo #27 – Localized, oil-stained soil at SE corner of diesel AST.**

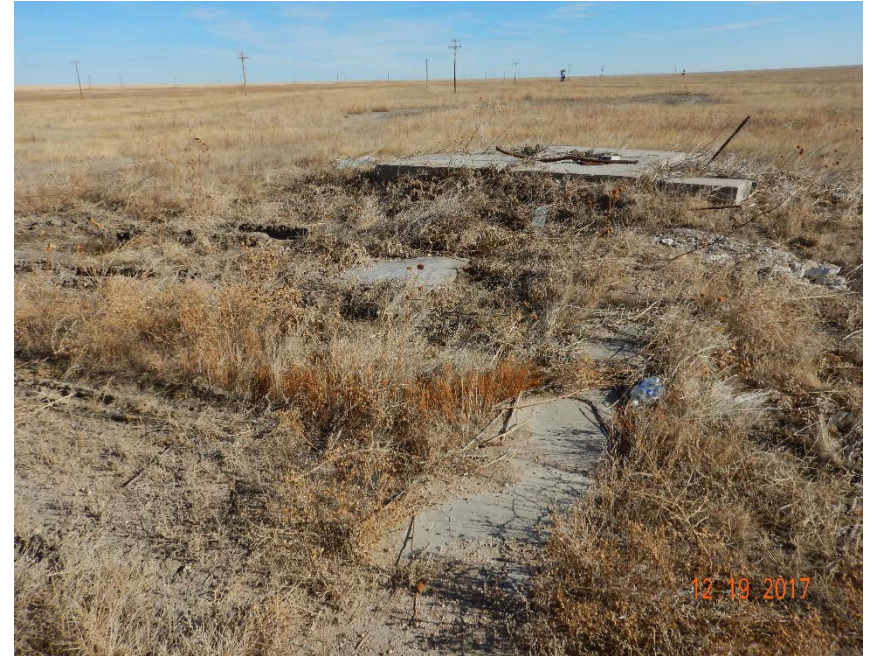
**Photo #28 – Unidentified concrete pad with weeds and debris located ~50' east of smaller building on location.**

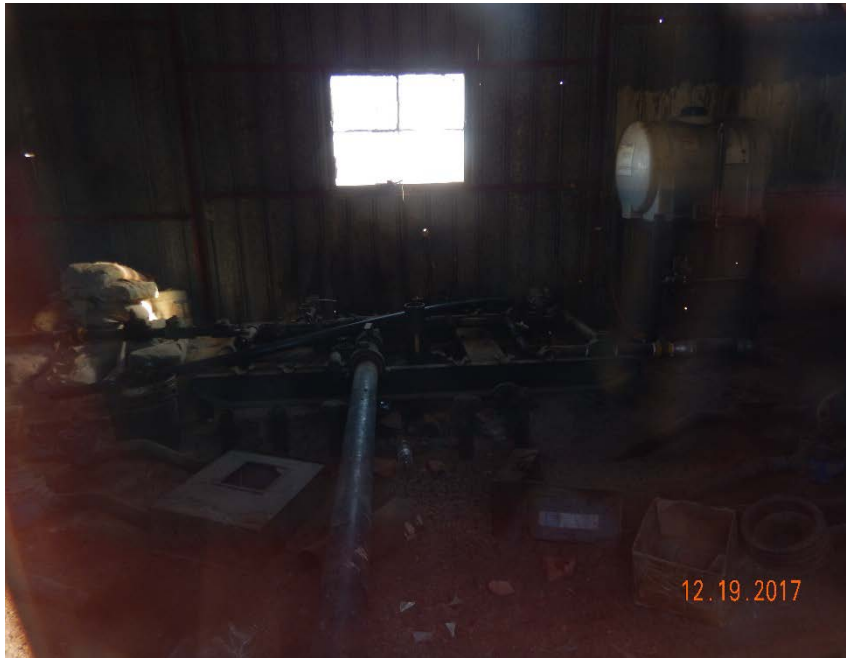
Photo #29 – View inside of small, east building located on east side of facility. See field inspection report #681700672 for additional photos and COGCC instruction to operator to file Form 27 for remediation of environmental impacts.

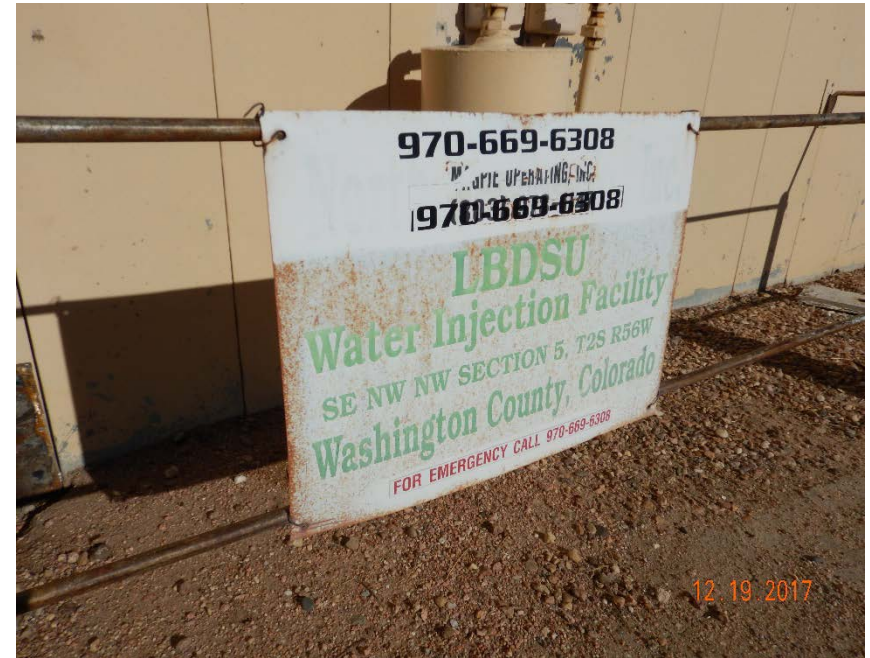
Photo #30 – Operator sign located on south side of main injection building. Note that operator name is illegible.

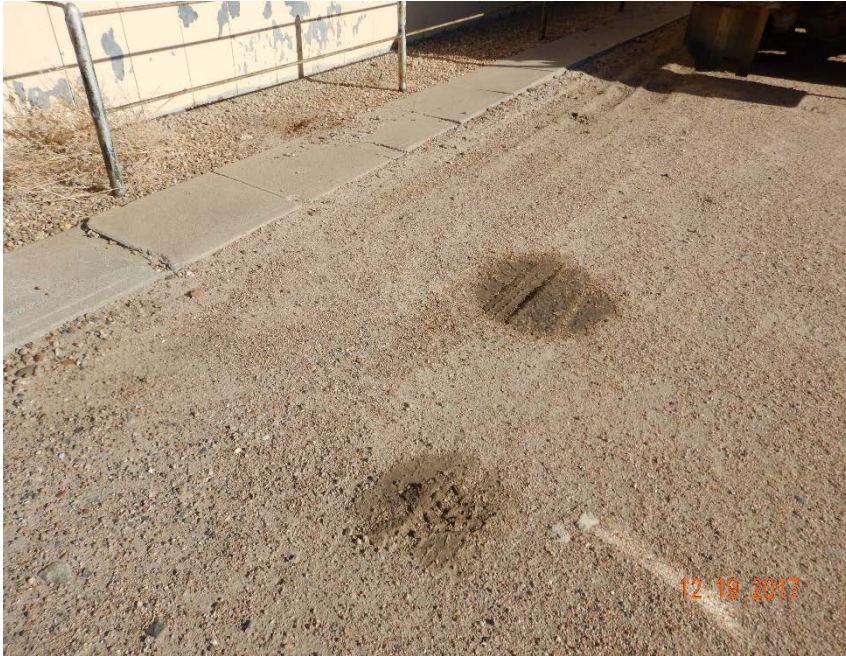
**Photo #31 – Localized, oil-stained soil located at SW corner of main building.**
