Inspection Photos
Location Name: Linhart 3-33
API #: 05-123-13438
Location ID: 323735

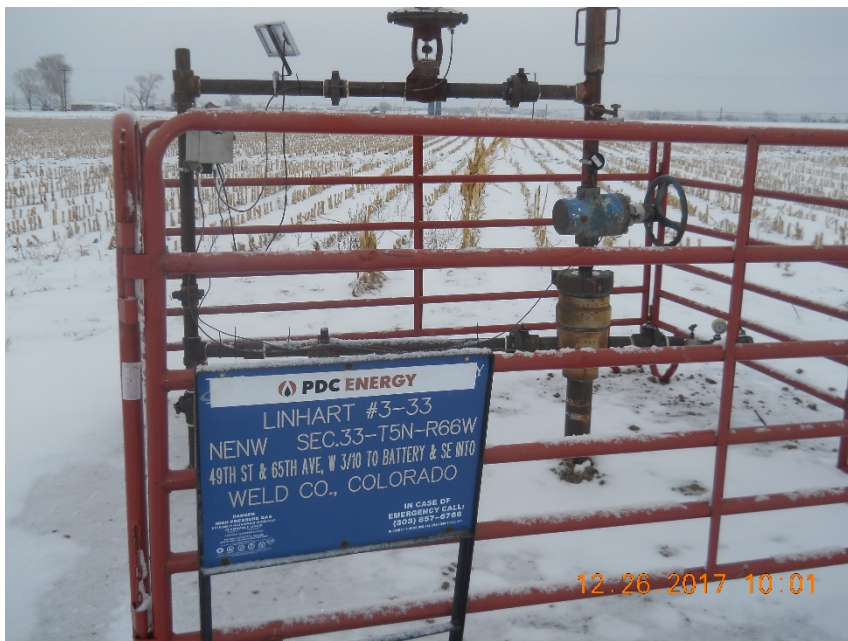
Wellhead looking east.

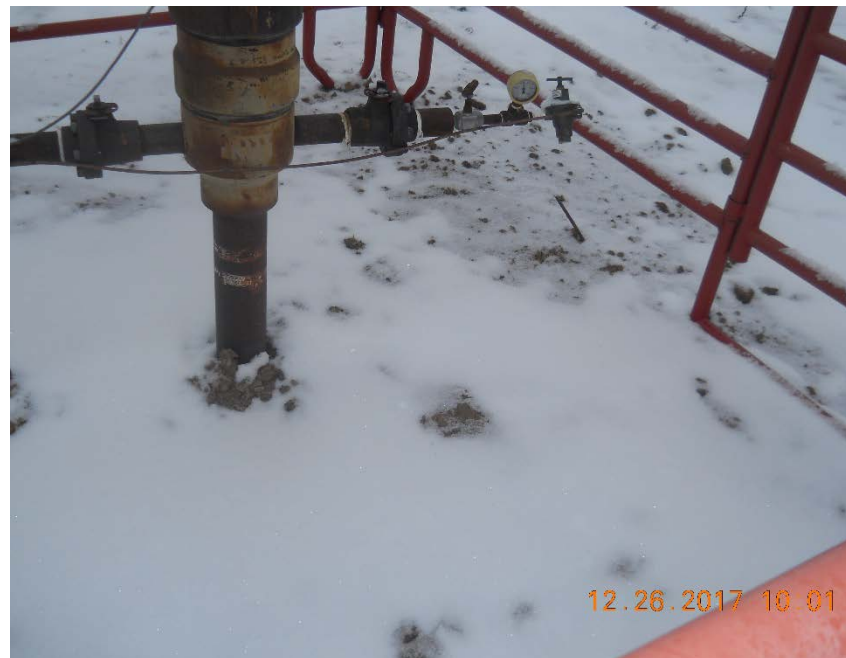
1" steel riser has been cut/capped below surface

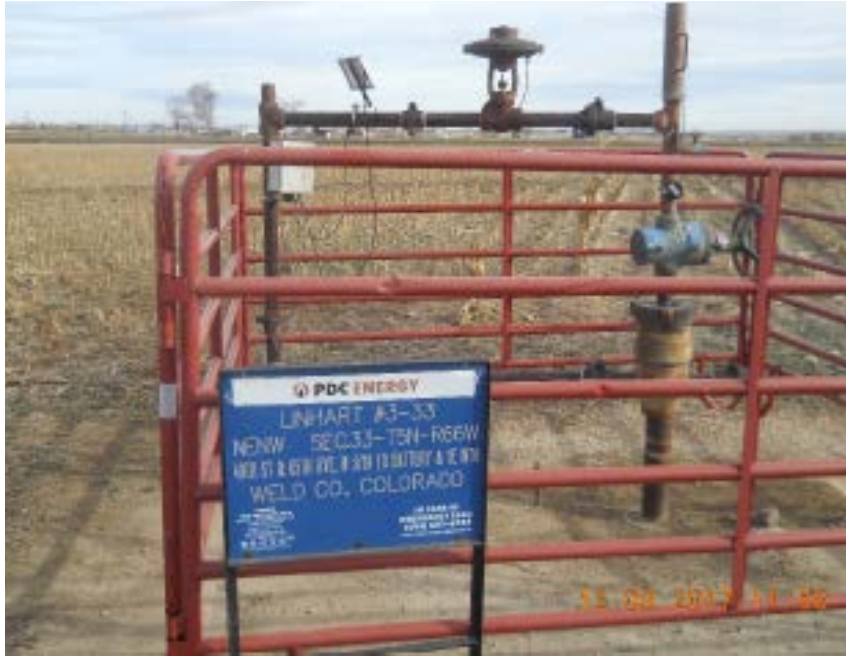
Wellhead looking east from previous inspection

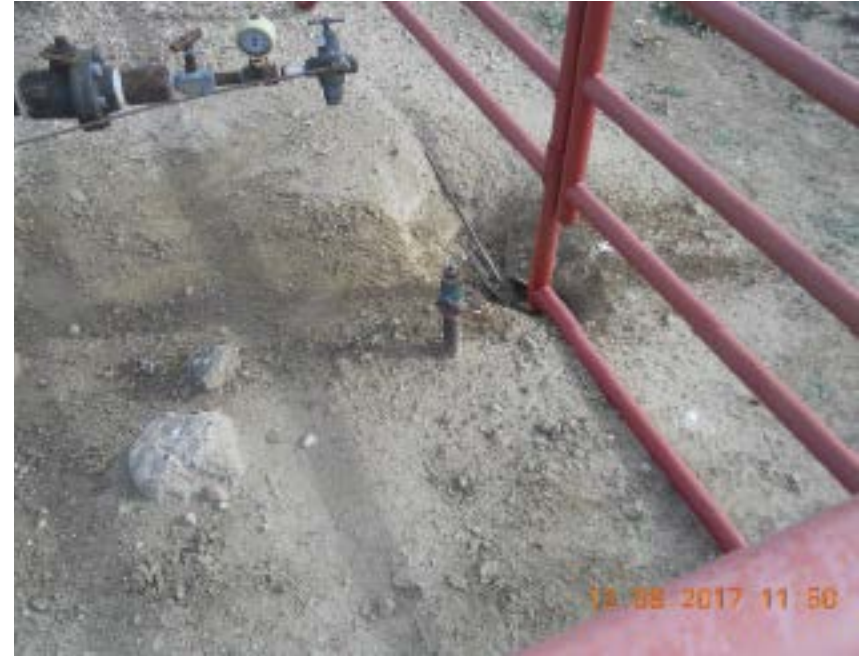
1" steel riser at wellhead from previous inspection
