COLORADO
Oil & Gas Conservation
Commission
Department of Natural Resources

Inspection Photos: Dolphin Energy Loc#335691

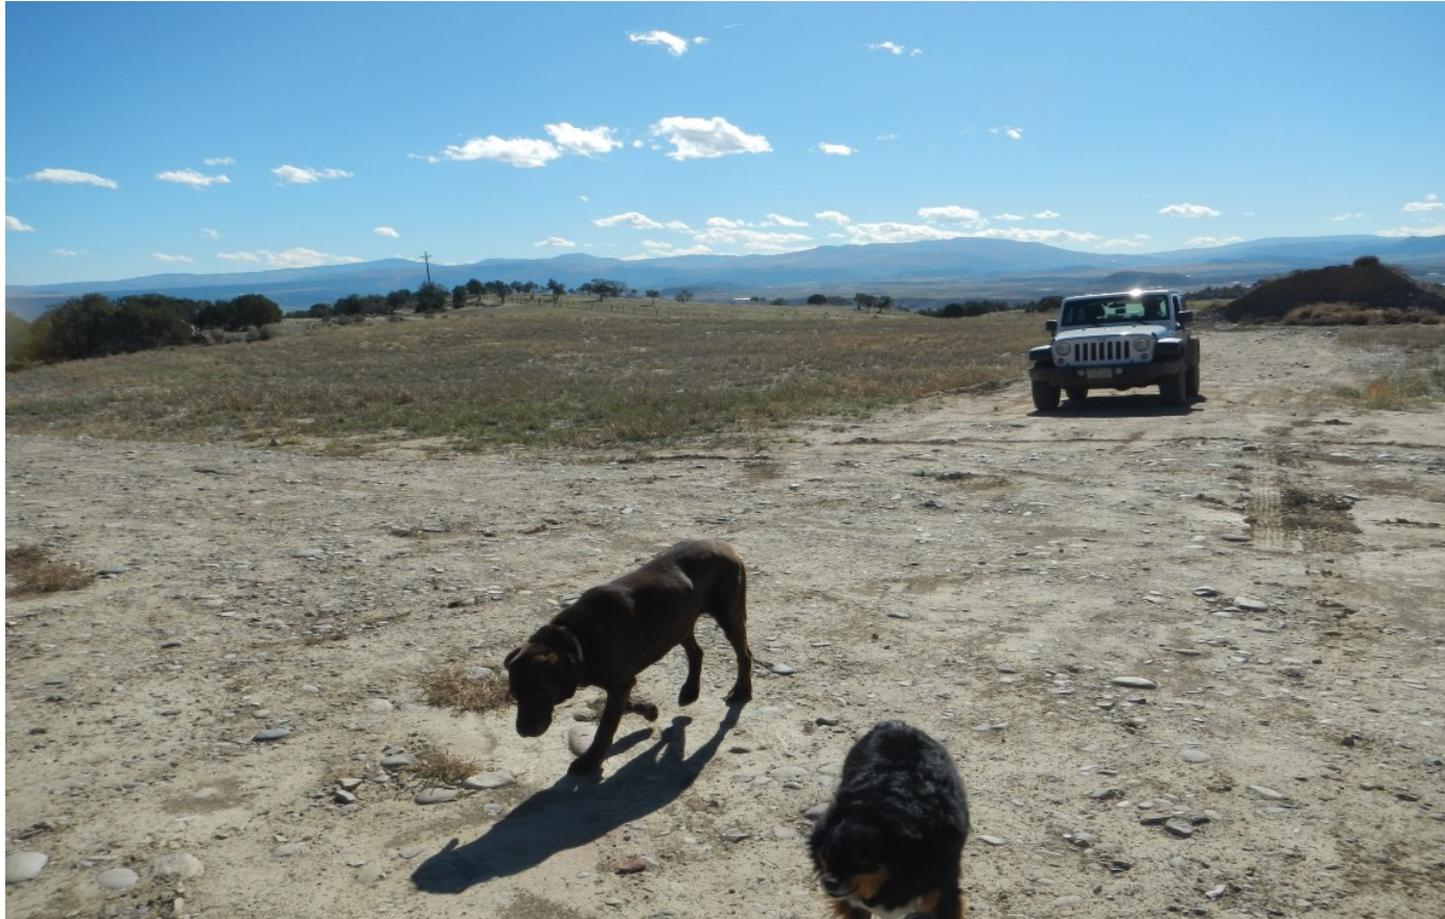
Photo#1:
Overview of Location from Entry to SE.

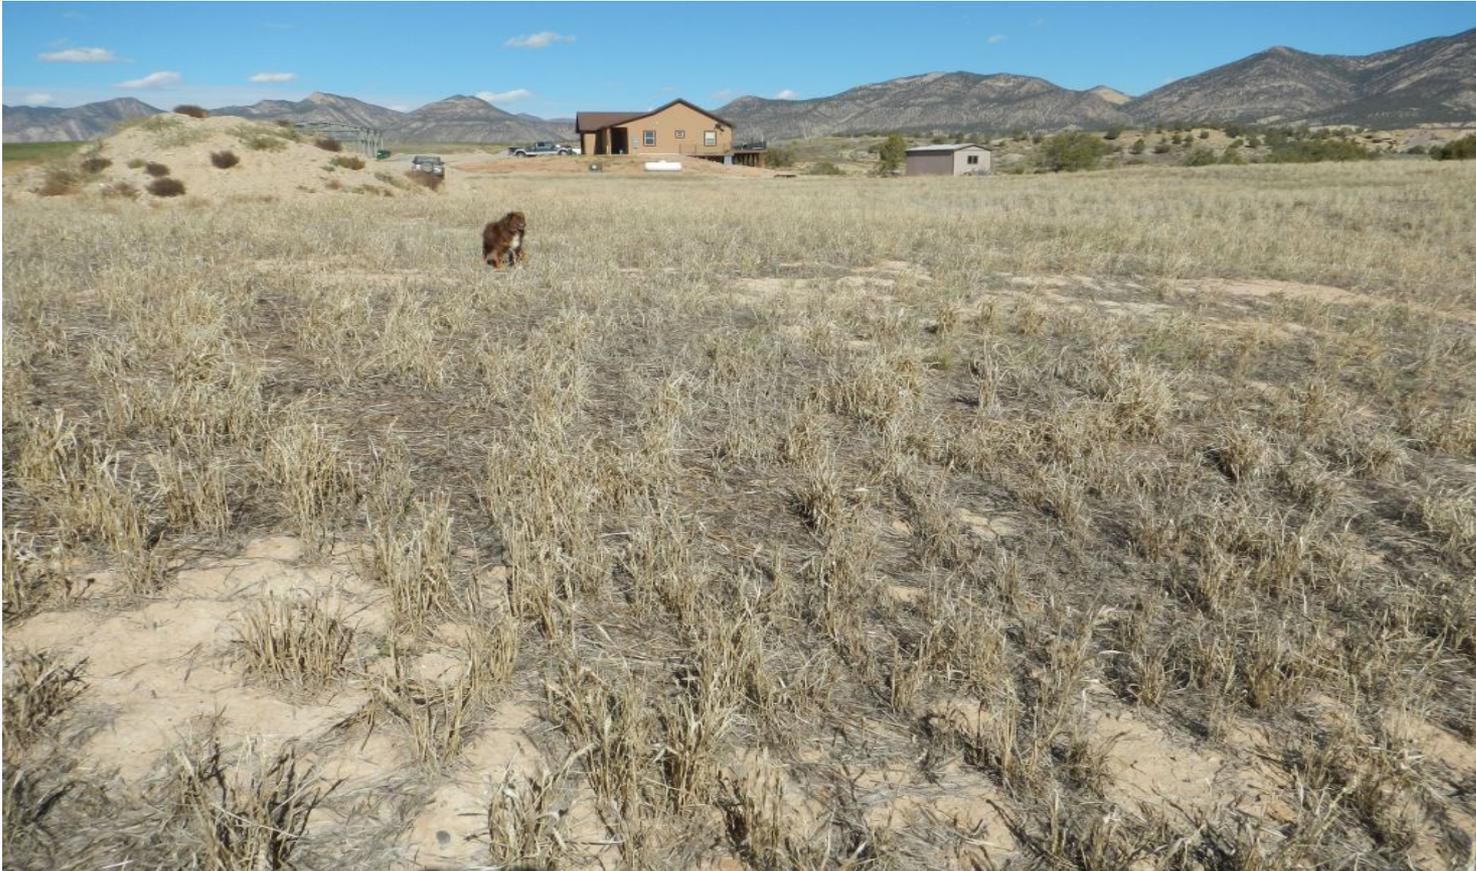
Photo#2:
Overview of Location to North.

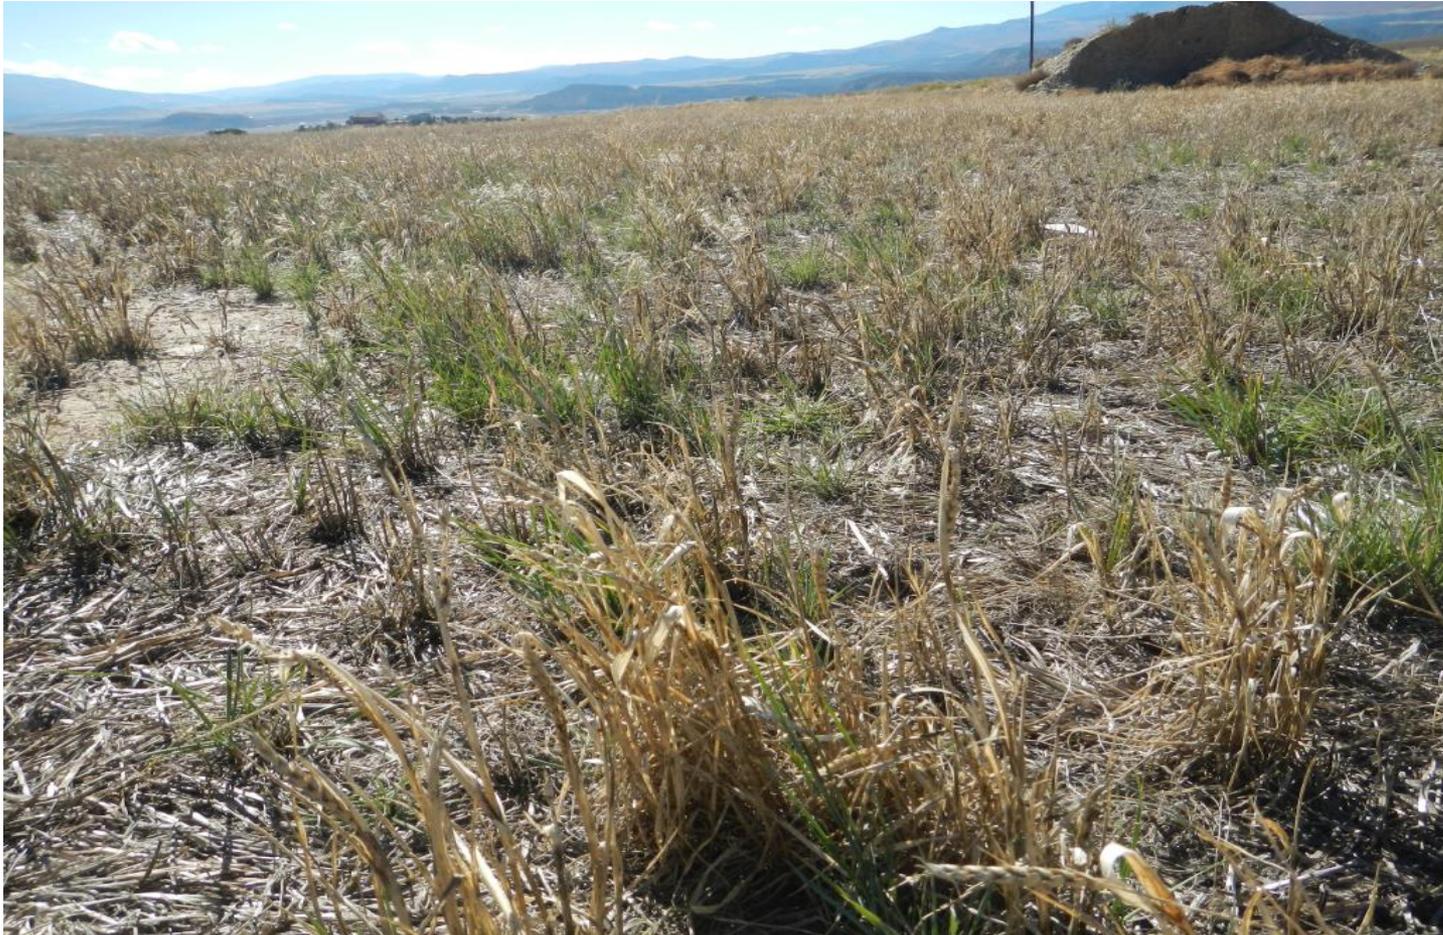
Photo#3:
Close up View of Vegetation to South.

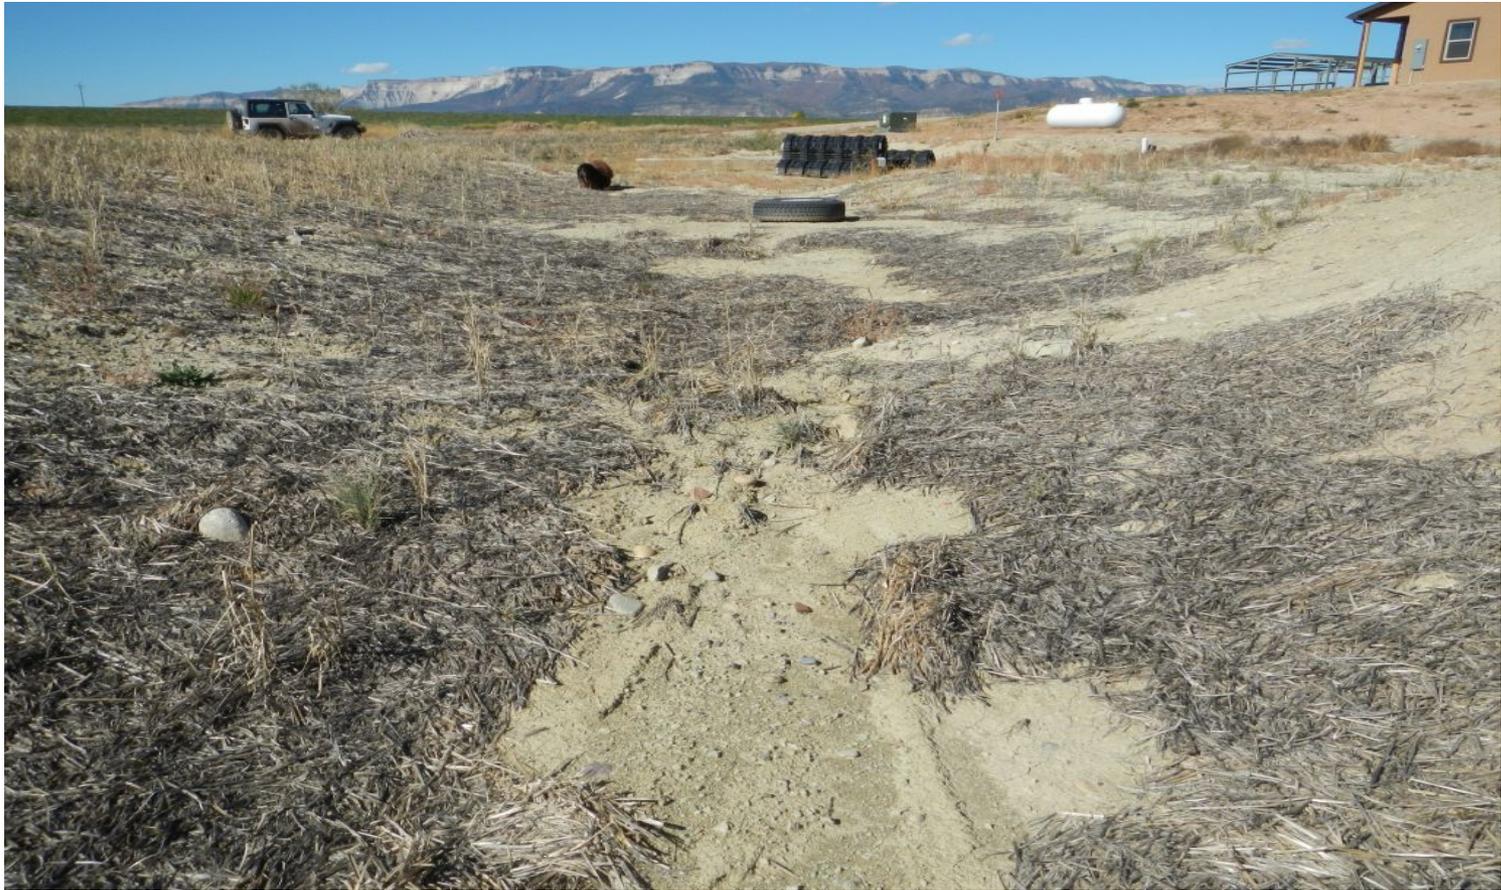
Photo#4:

View of Swale area where Vegetation has Failed & mulch has washed.

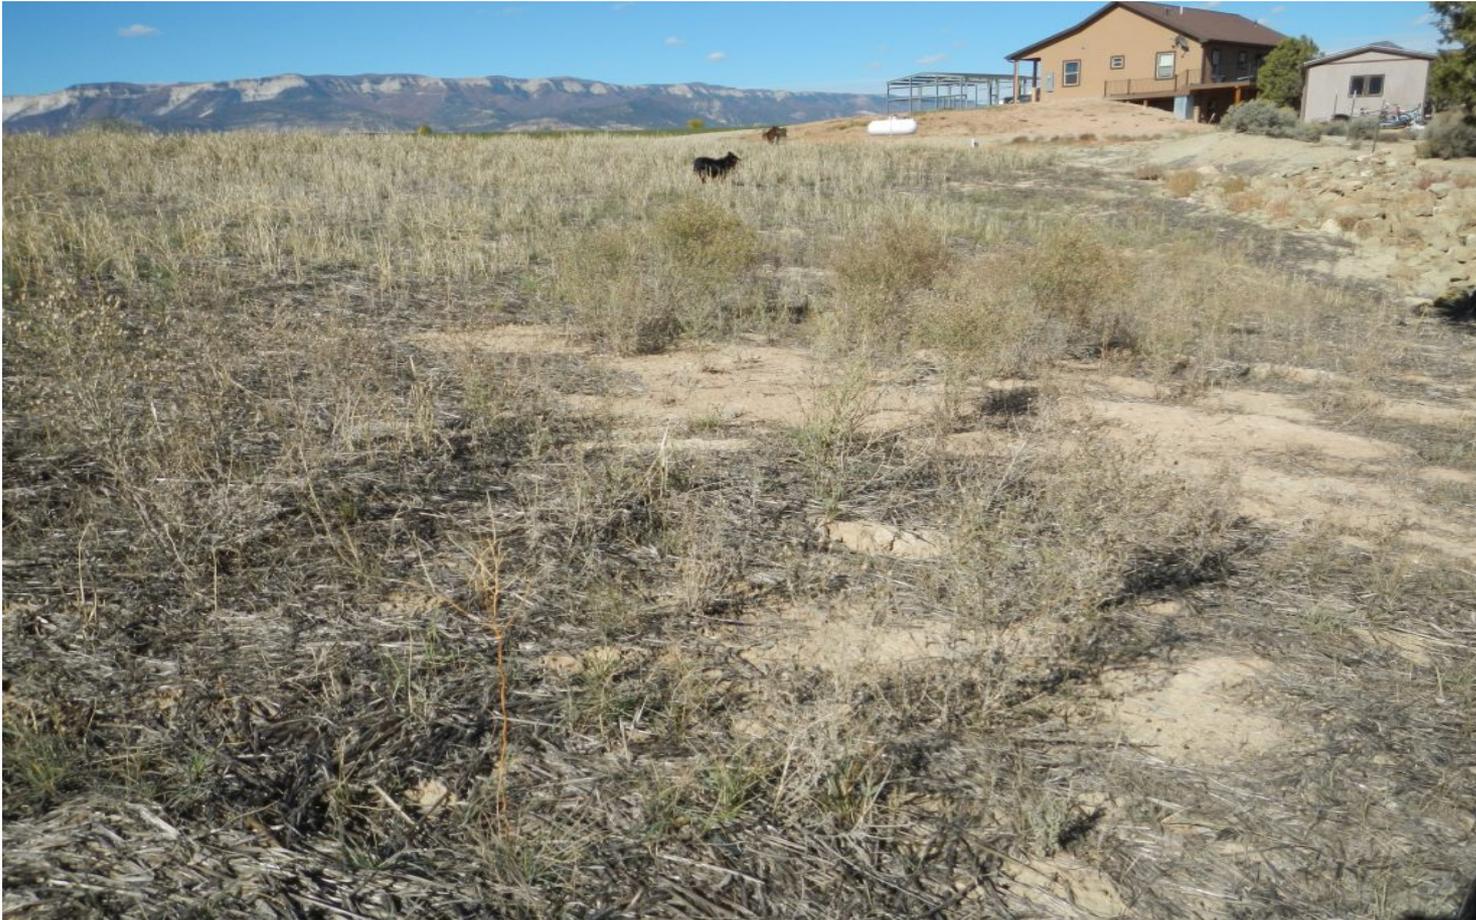
Photo#5:

Knap weed has established in some areas of Location.
