Inspection Photos
Operator: NOBLE ENERGY INC - 100322
Location ID: 326968

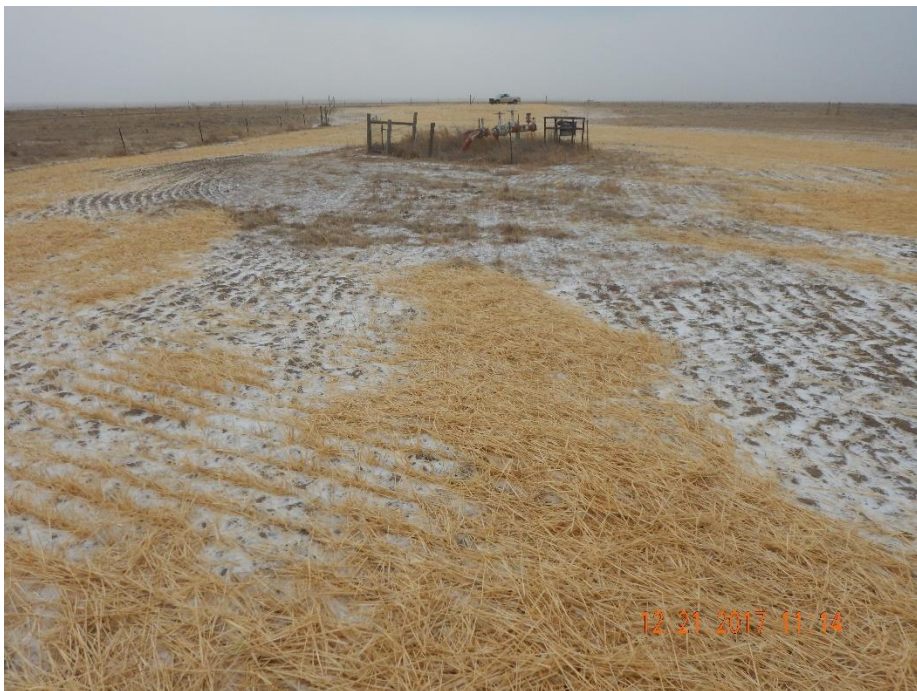
Photo 1: Photo taken from the northeast end of the location, facing south. Previous inspections required operator to perform additional reclamation on the location. Photo shows location appears to have been recontoured/regraded, seeded and crimped with straw for stabilization per the corrective action.

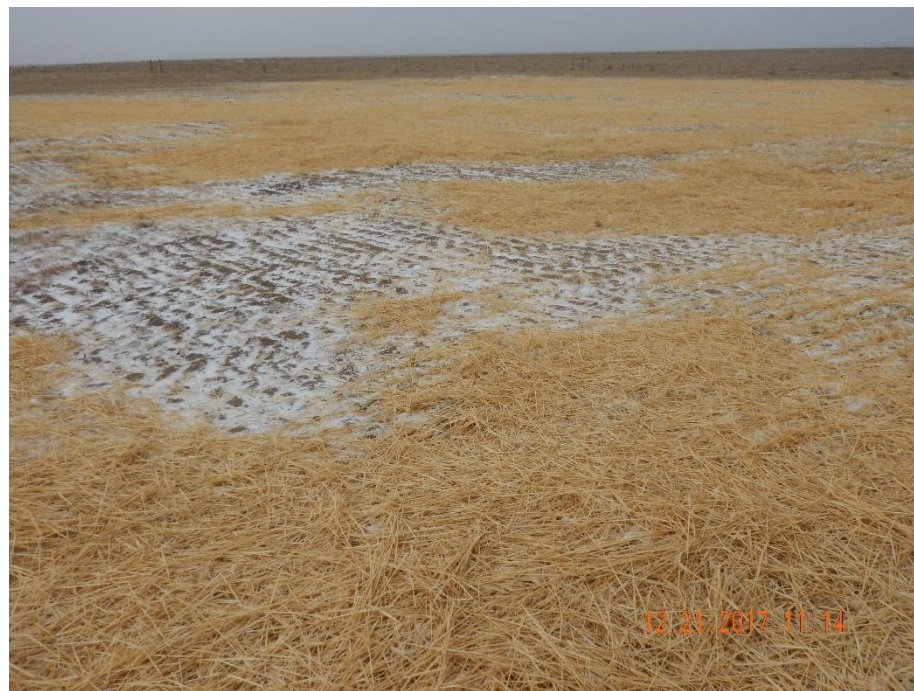
Photo 2: Photo taken from the northeast end of the location, facing south. See comments under photo 1.

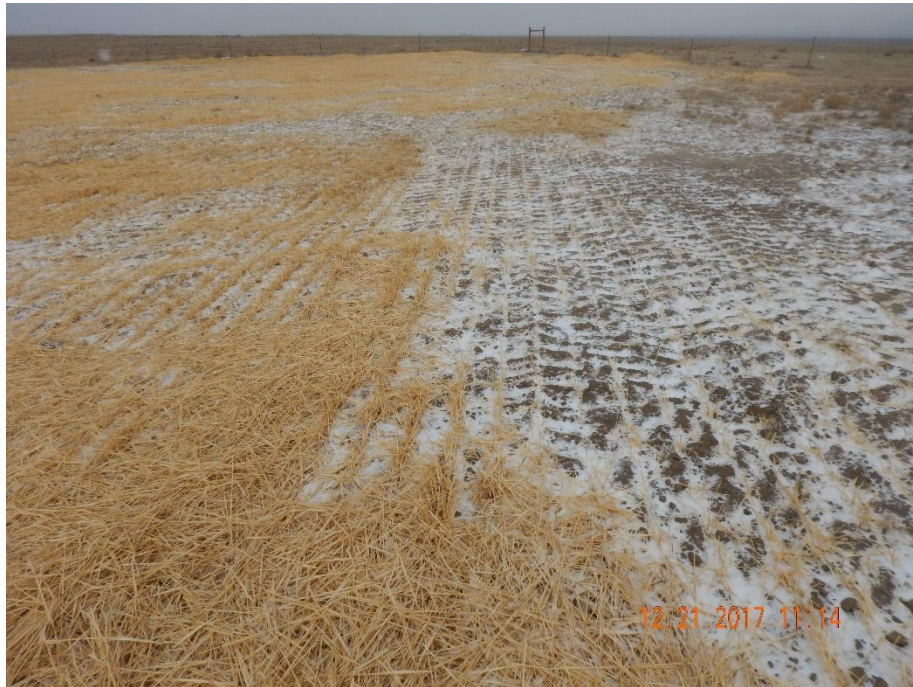
Photo 3: Photo taken from the northeast end of the location, facing west. See comments under photo 1.

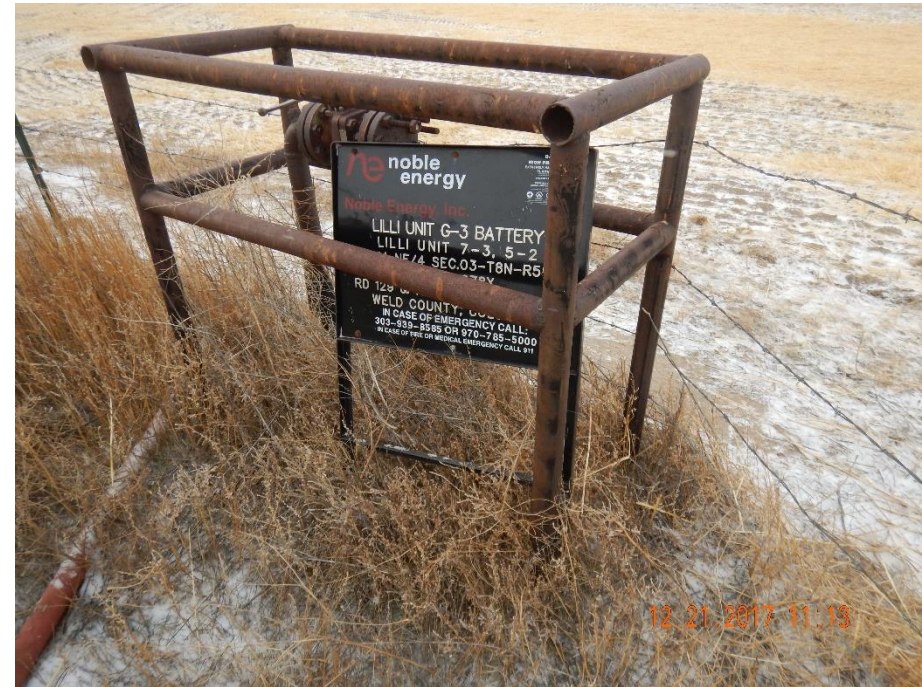
Photo 4: Photo taken from the location. Photo shows pipe riser equipment with Noble sign remaining on the location.

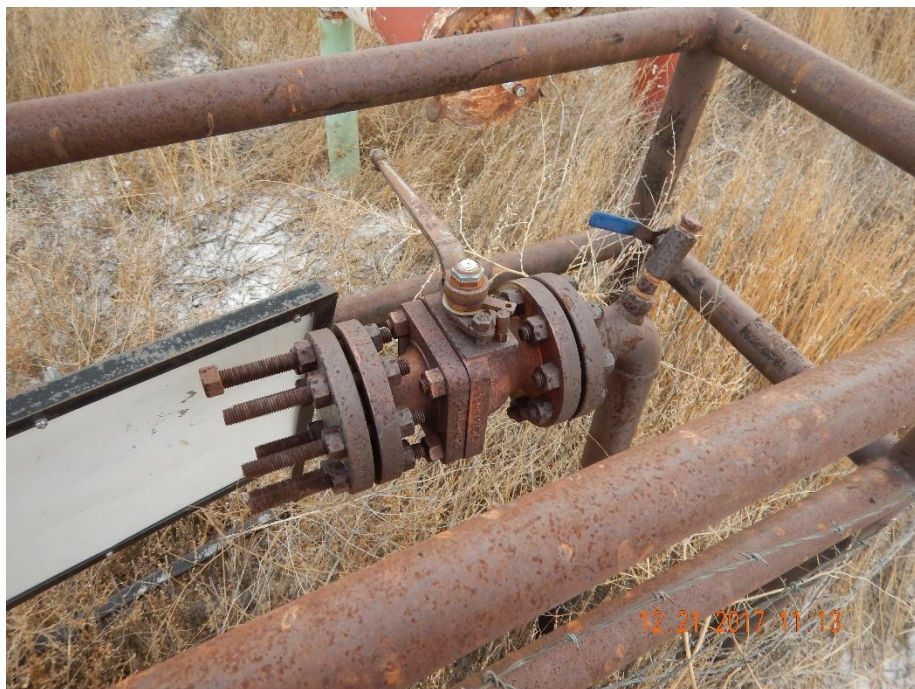
Photo 5: Photo of pipe riser from photo 4.

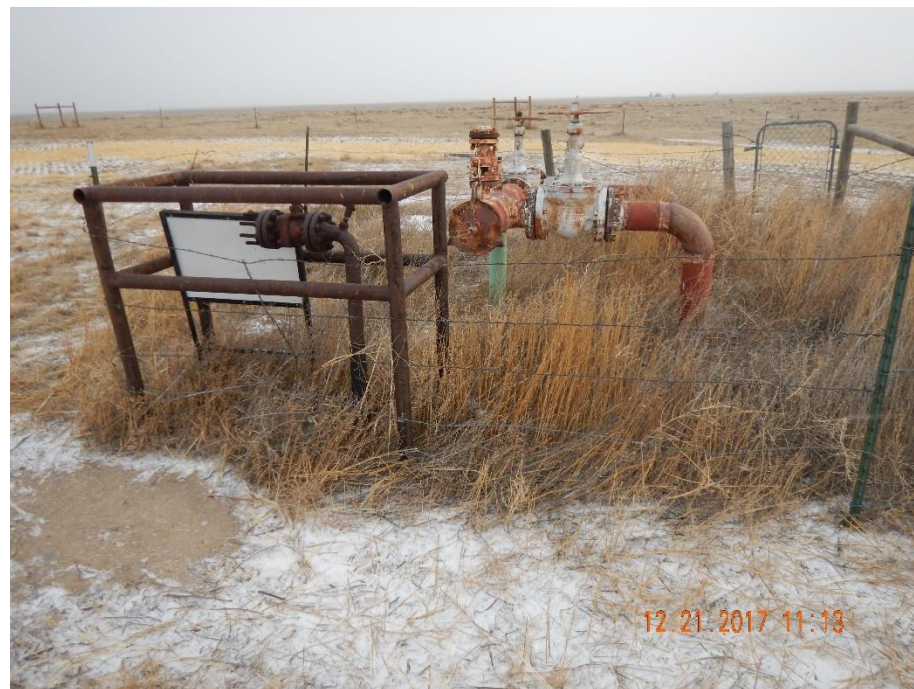
Photo 6: Photo taken from the location, facing east. Photo shows two (2) pipe risers remaining on the location. Riser seen in cage to the left is pipe seen in photo 4 and 5. Equipment to the right possibly belongs to DCP as a DCP flag was observed at its base.

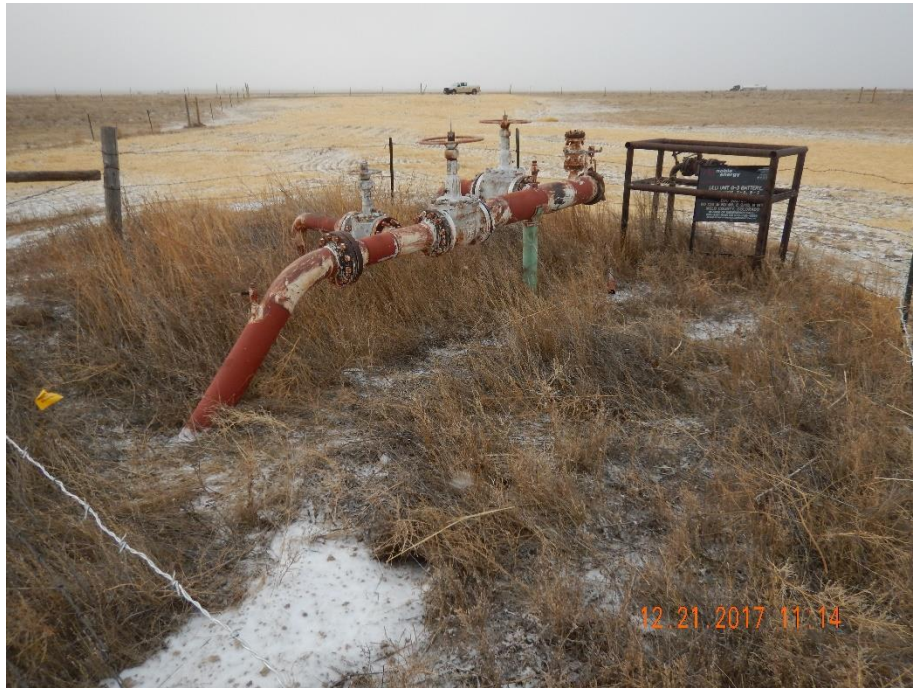
Photo 7: Photo of equipment seen in photo 6 from the east, facing west.

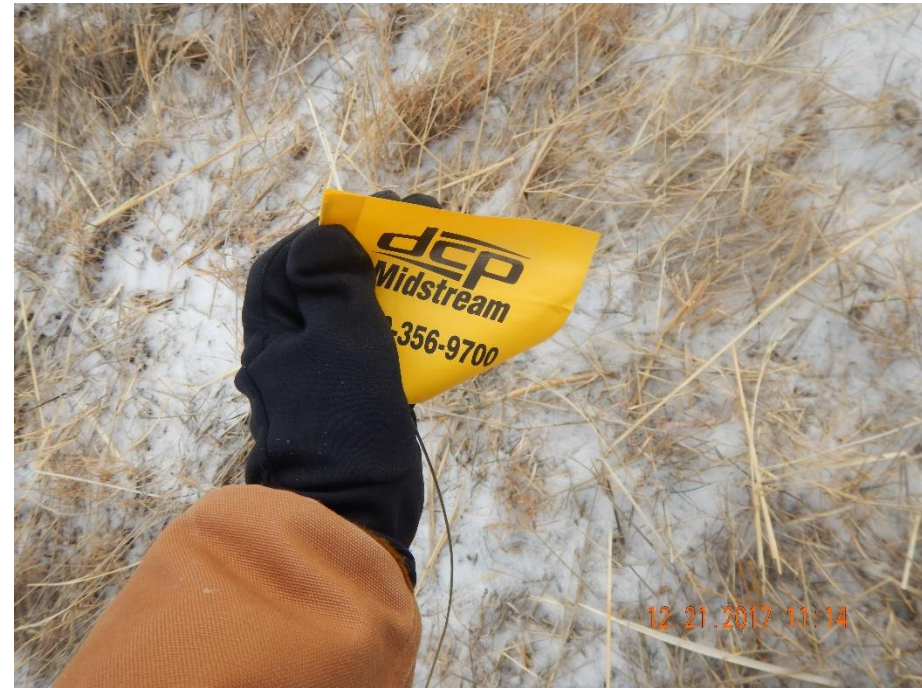
Photo 8: Photo of DCP flag observed next to riser equipment. This flag can be seen in the left side of photo 7.
