Location Name: TEP API 045-06918

12/18/2017

TEP 045-06918

Inspection 12/18/17

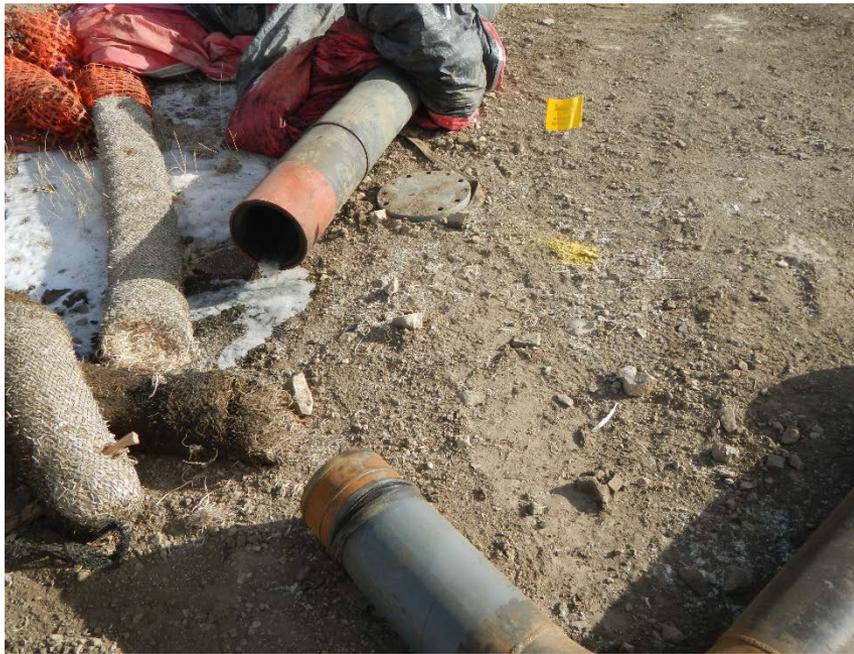
Failed Frac line elbow

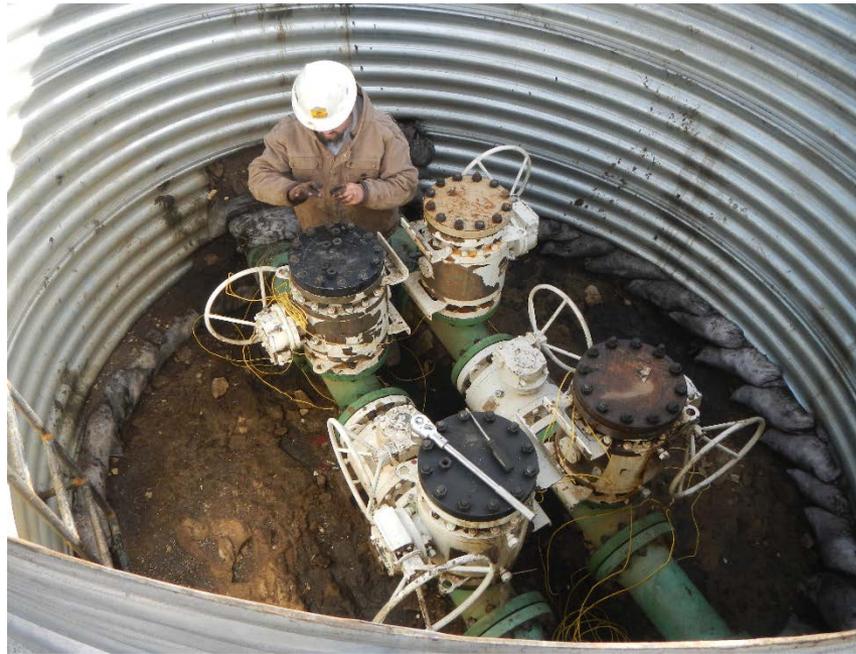
PW line being re-capped in valve can

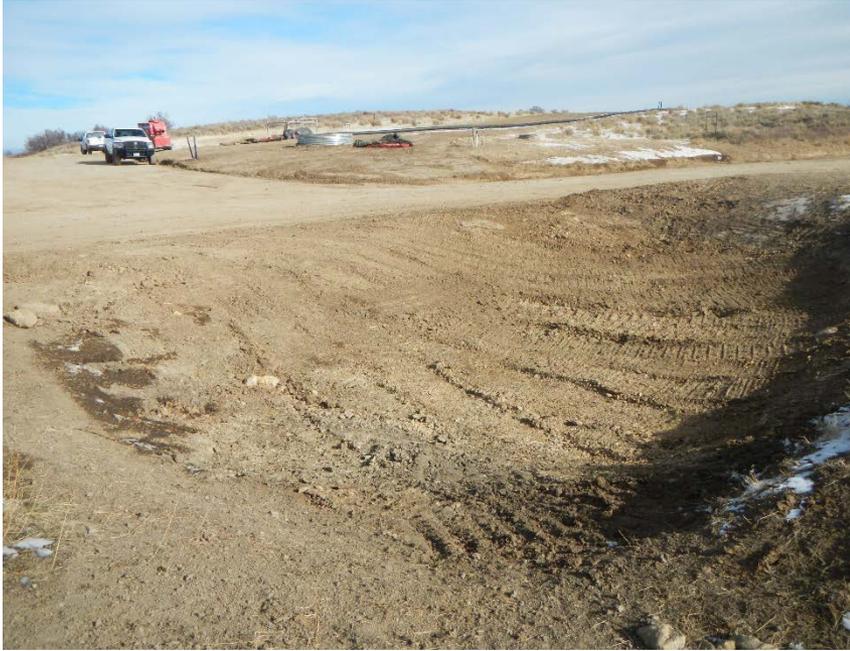
Stormwater pond looking north towards spill point

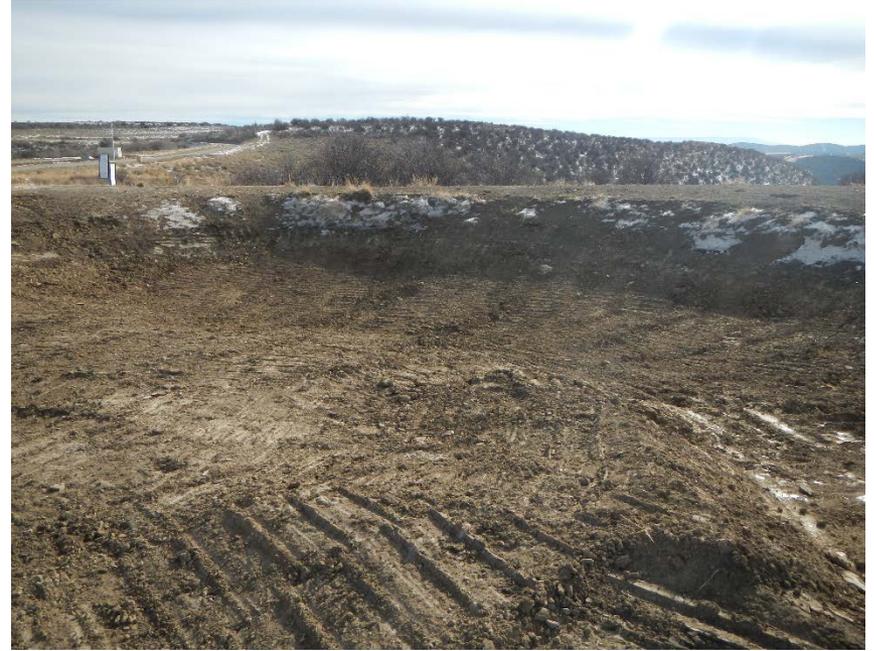
Stormwater pond post-spill excavation looking east
