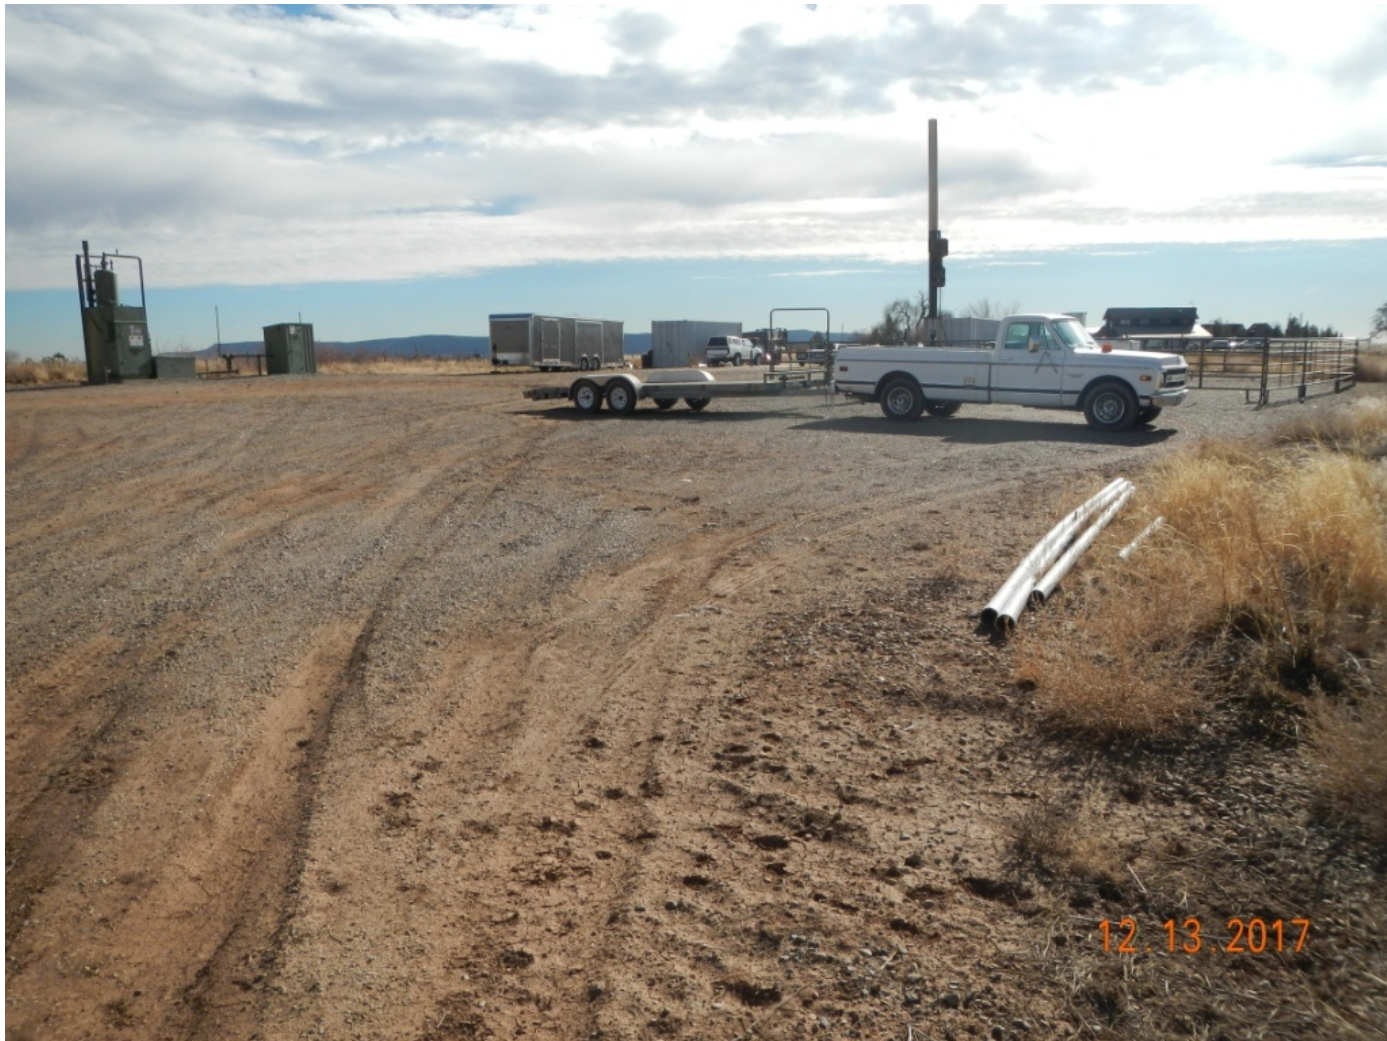
**Photo 1. View of the project area from the northwestern entrance facing center. Truck, trailer and pipes should be removed.**

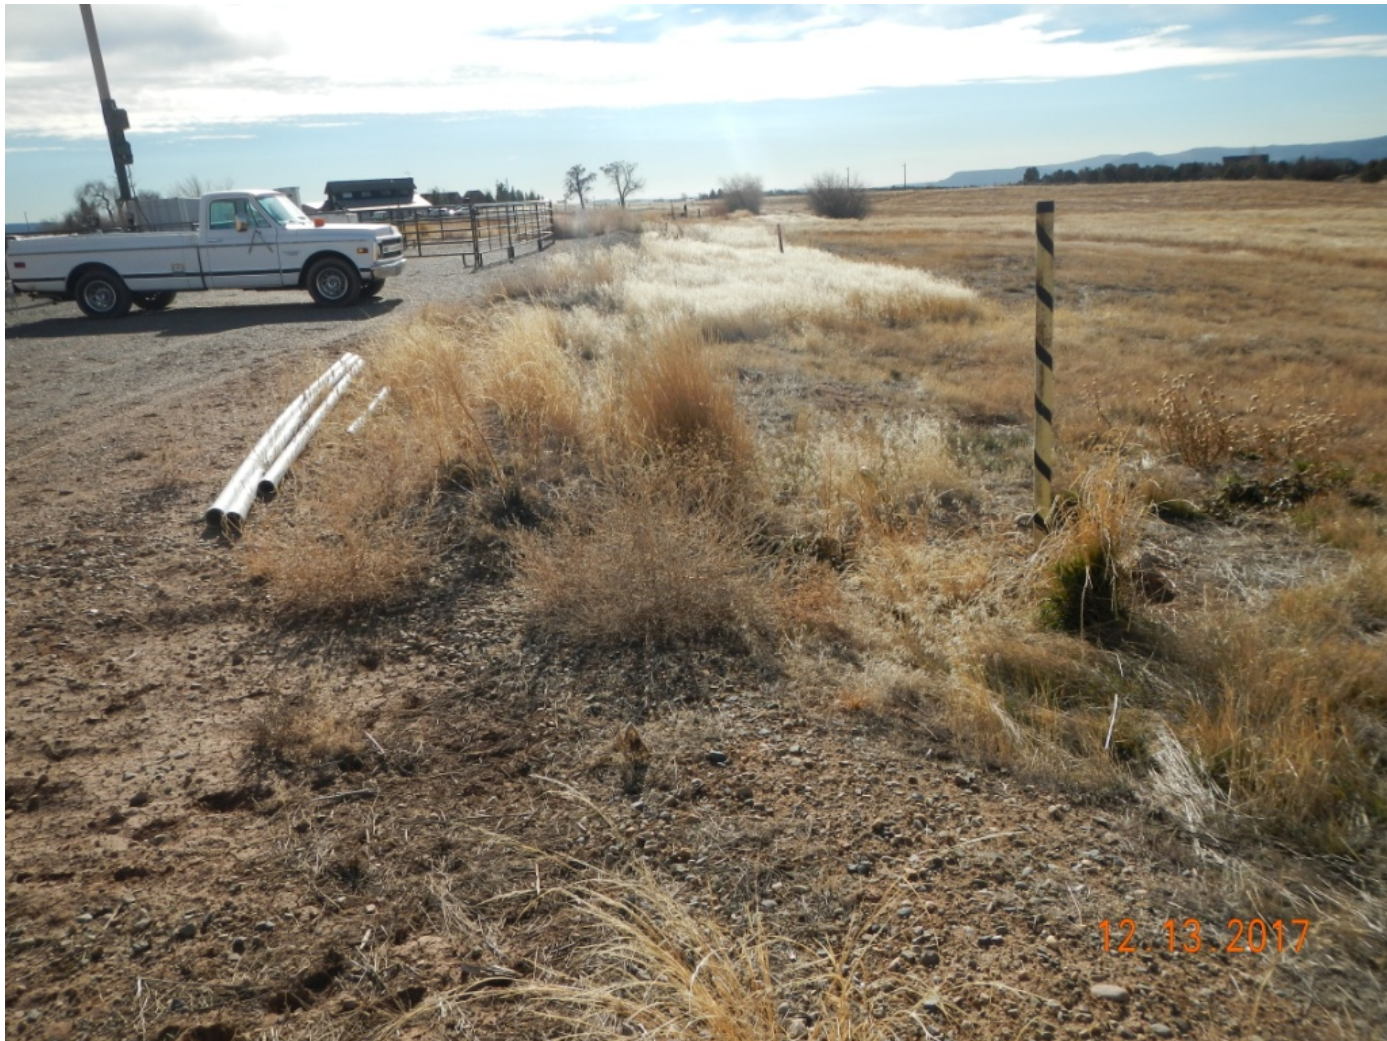
**Photo 2. View of the western portion of the project area from the northwestern corner facing southward.**

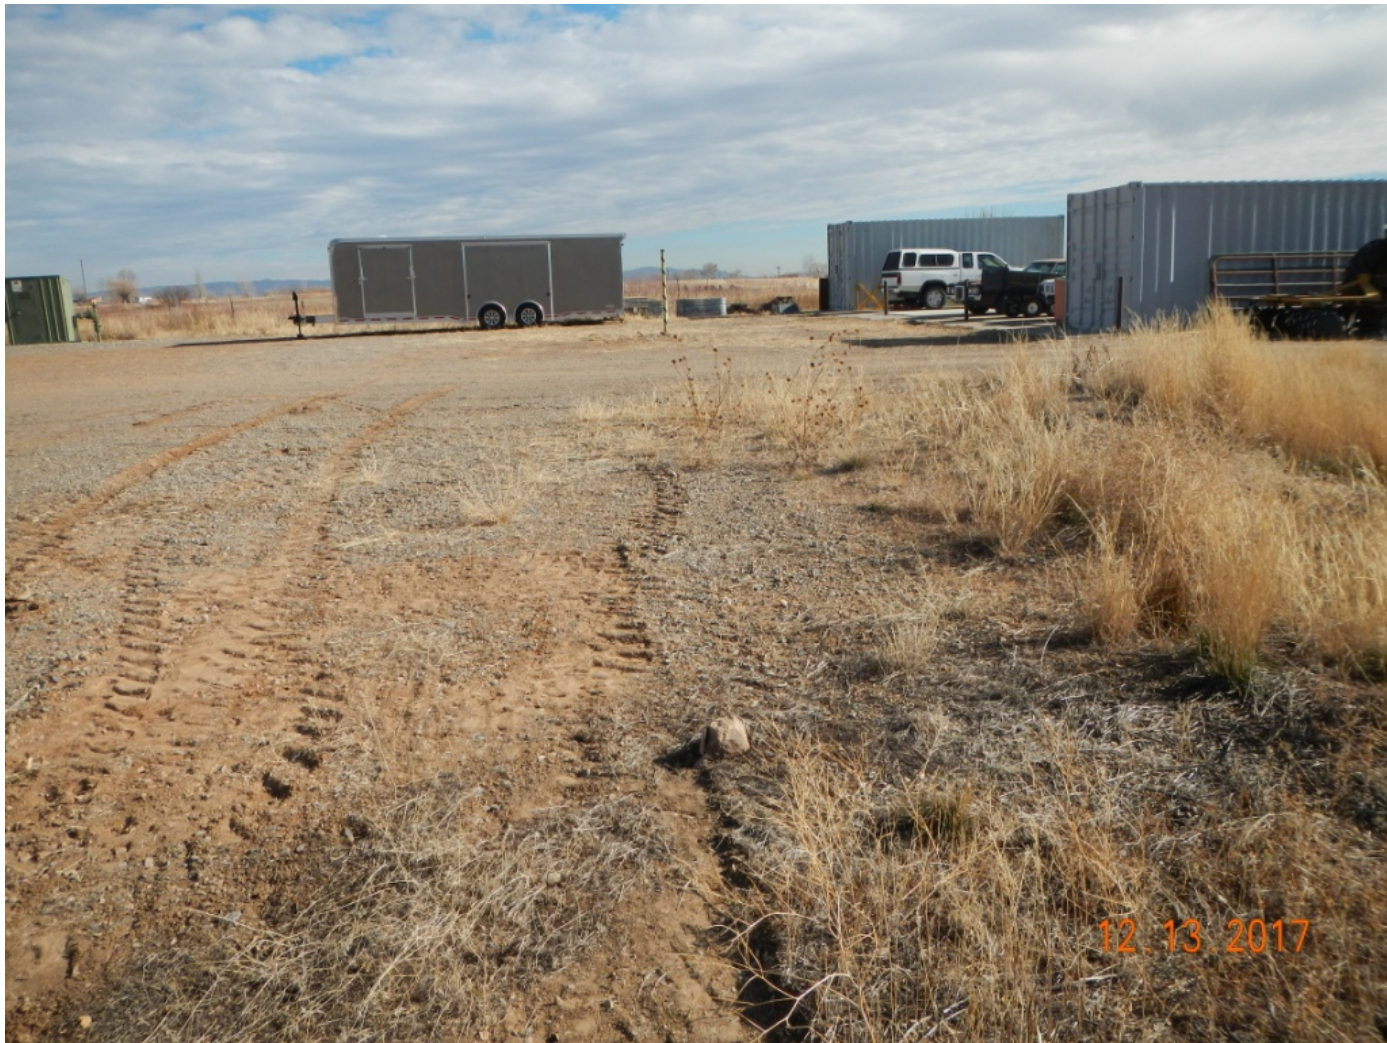
**Photo 3. View of the southern portion of the project area from the southwestern corner facing eastward. Trailers and vehicles in right portion of photo are parked on cement pad and appear to be outside of the project area.**

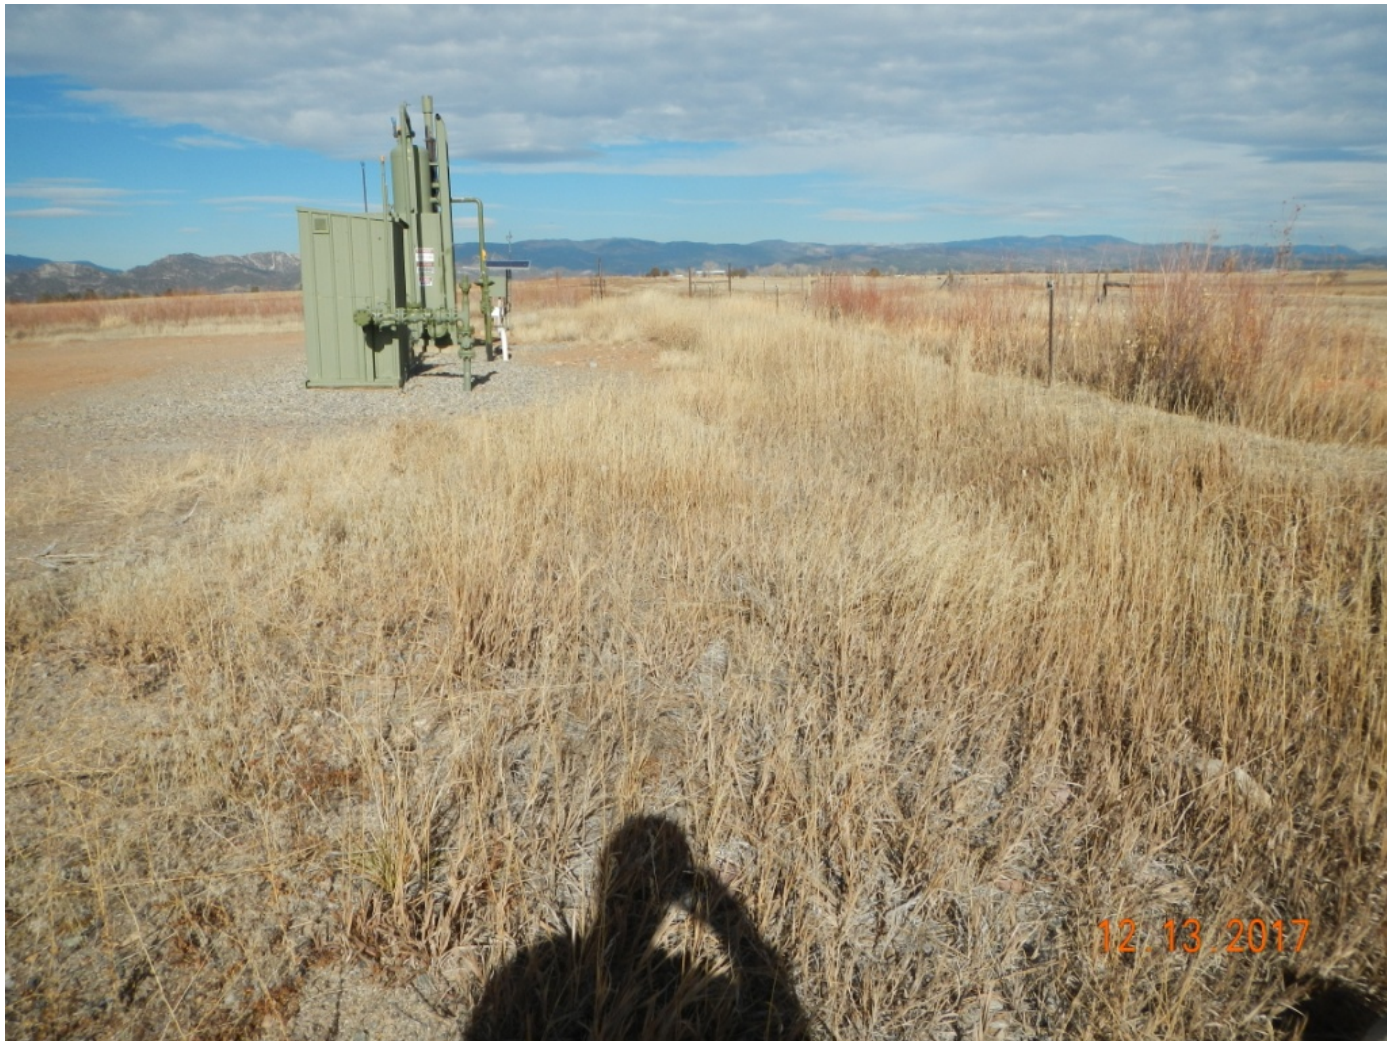
**Photo 4. View of the eastern portion of the project area from the southeastern edge facing northward. Revegetation is largely comprised of smooth brome (*Bromus inermis*) and dropseed (*Sporobolus* sp.).**

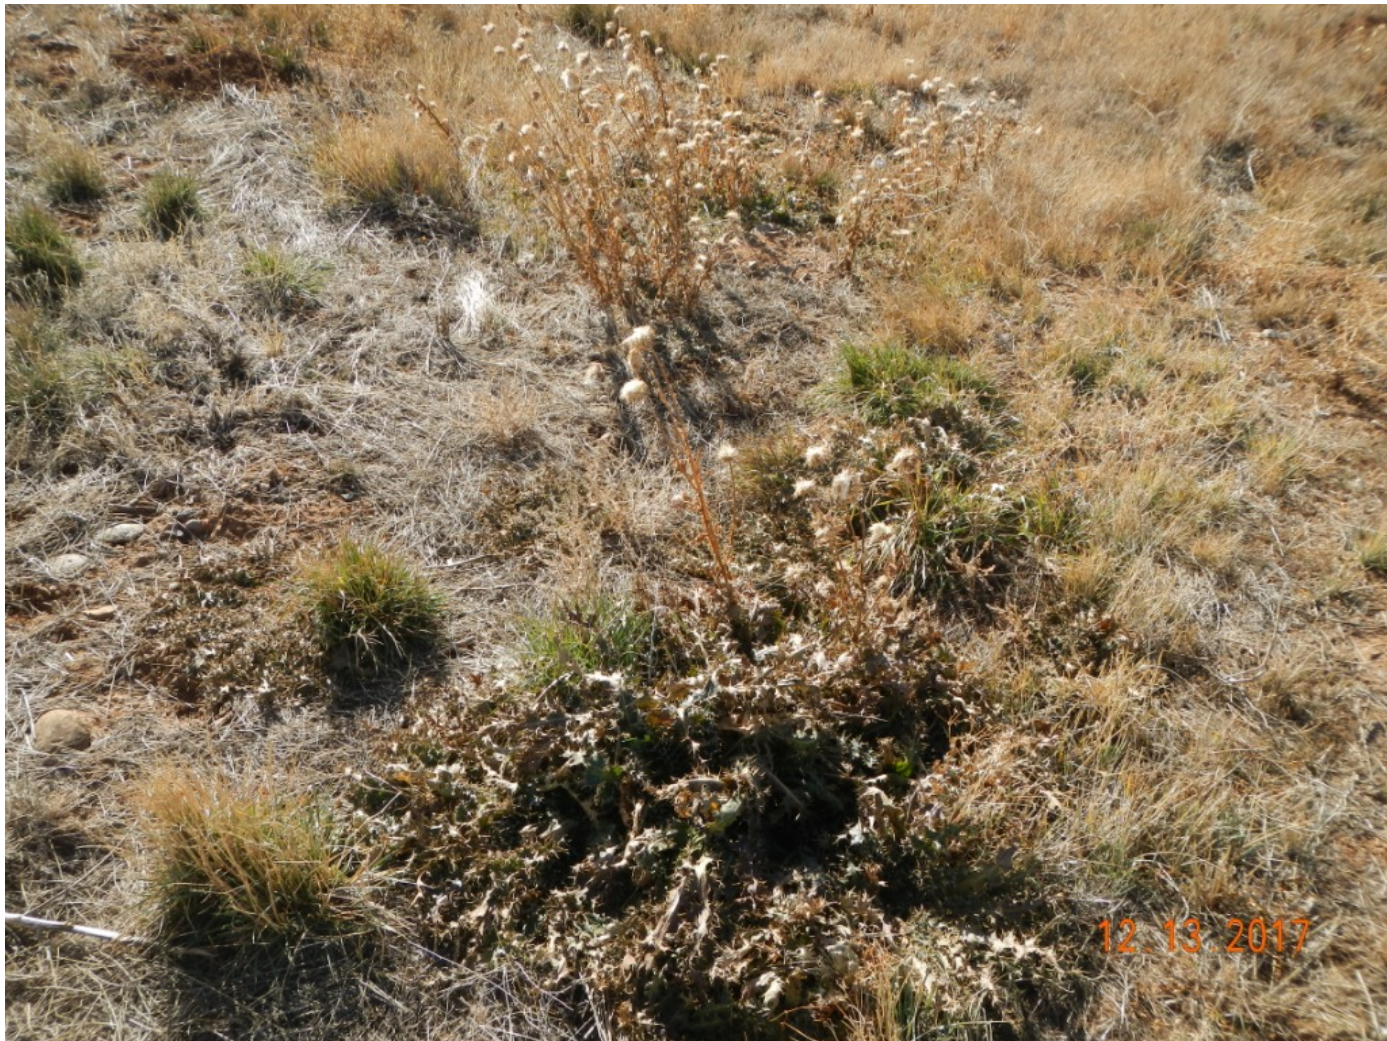
**Photo 4. View of musk thistles (*Carduus nutans*) in the western portion of the project area.**
