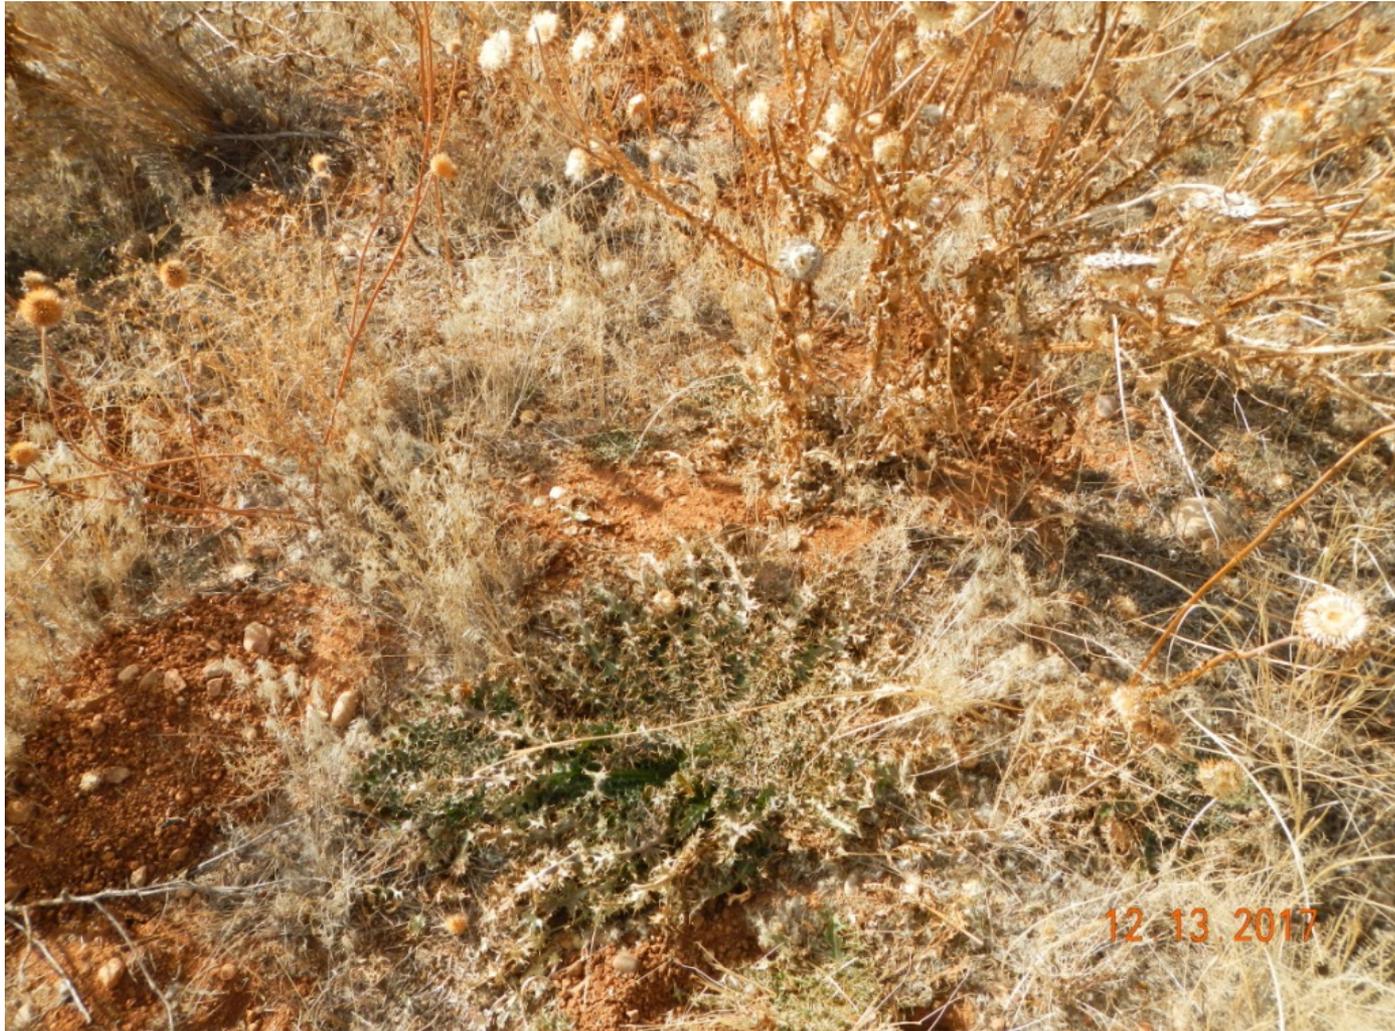
**Photo 4. View of musk thistles (*Carduus nutans*) within the interim reclamation area. Project area is infested with musk thistles.**

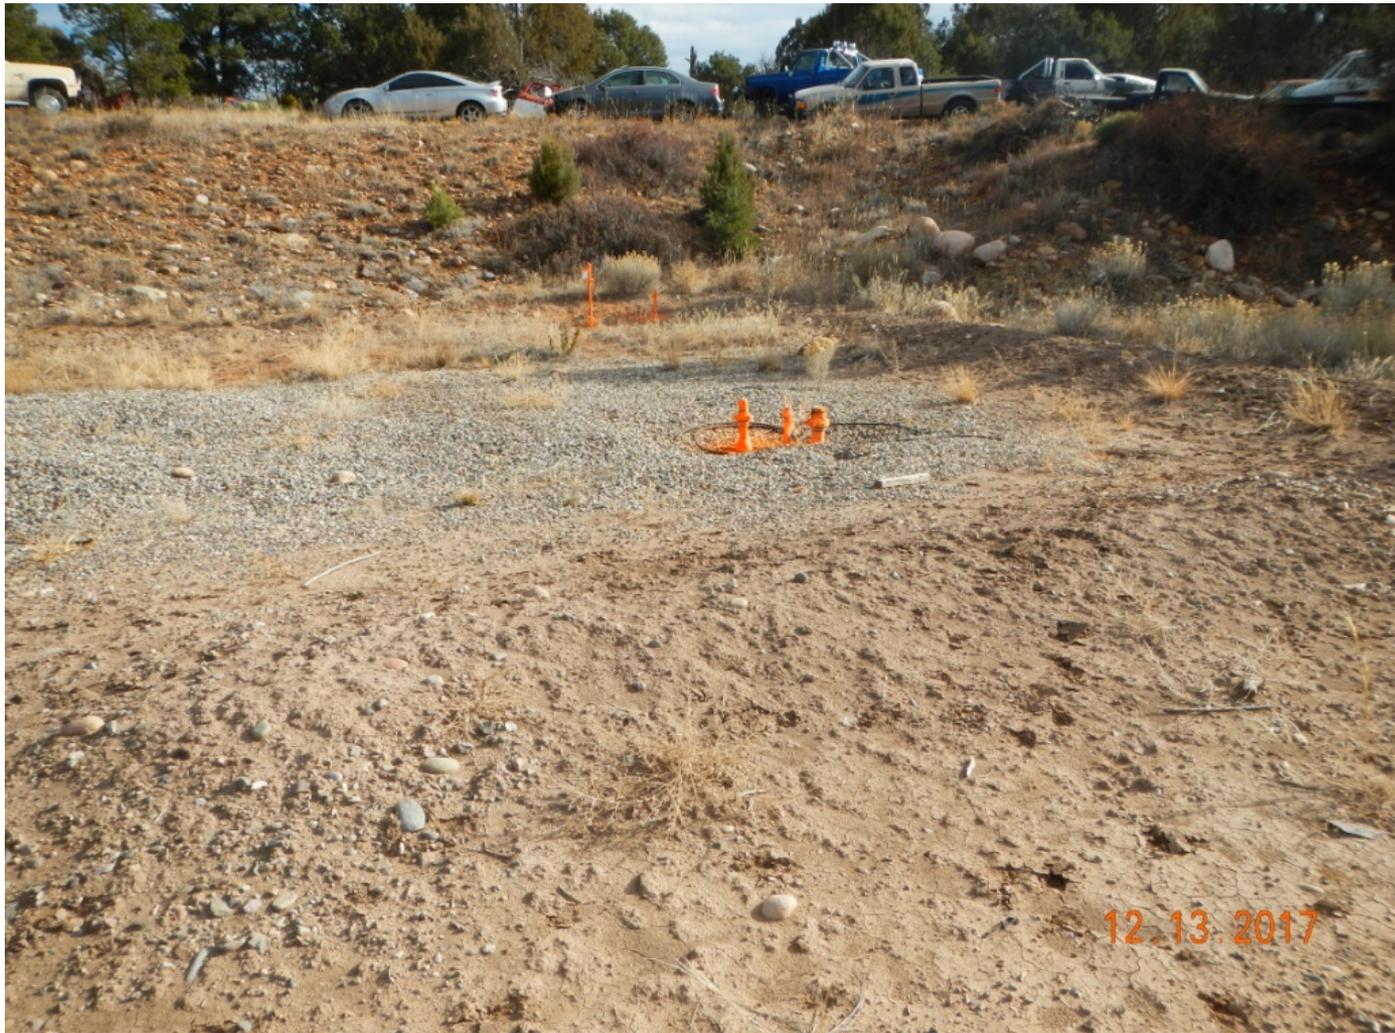
**Photo 5. View of area in the southeastern portion of the project area that does not appear to be in use and should be revegetated.**

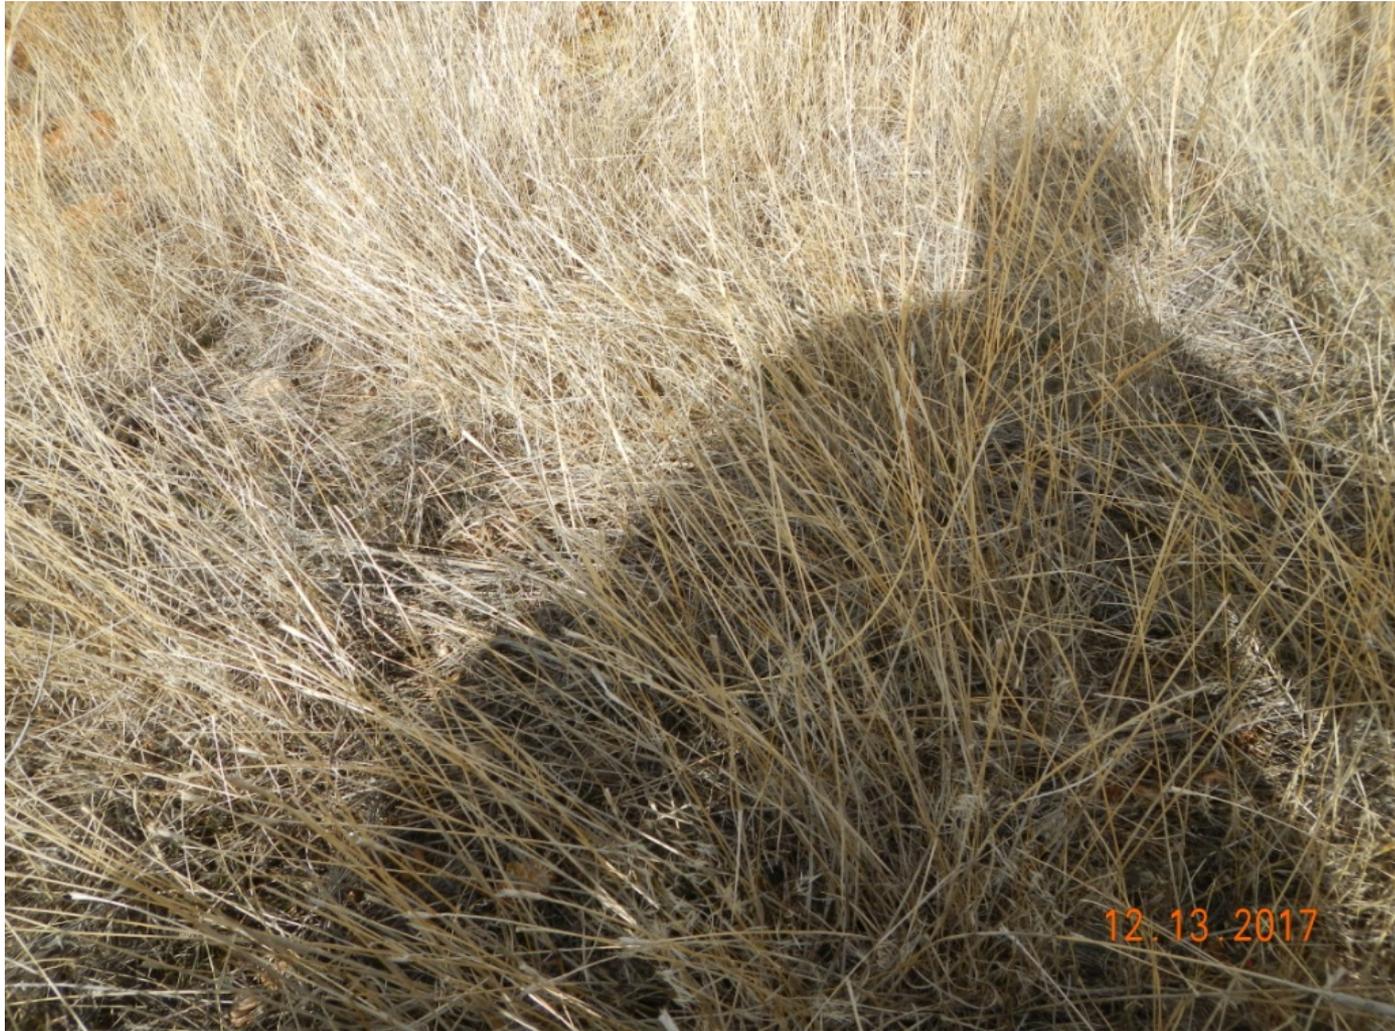
**Photo 6. View of jointed goatgrass (*Aegilops cylindrica*) in the western portion of the project area.**
