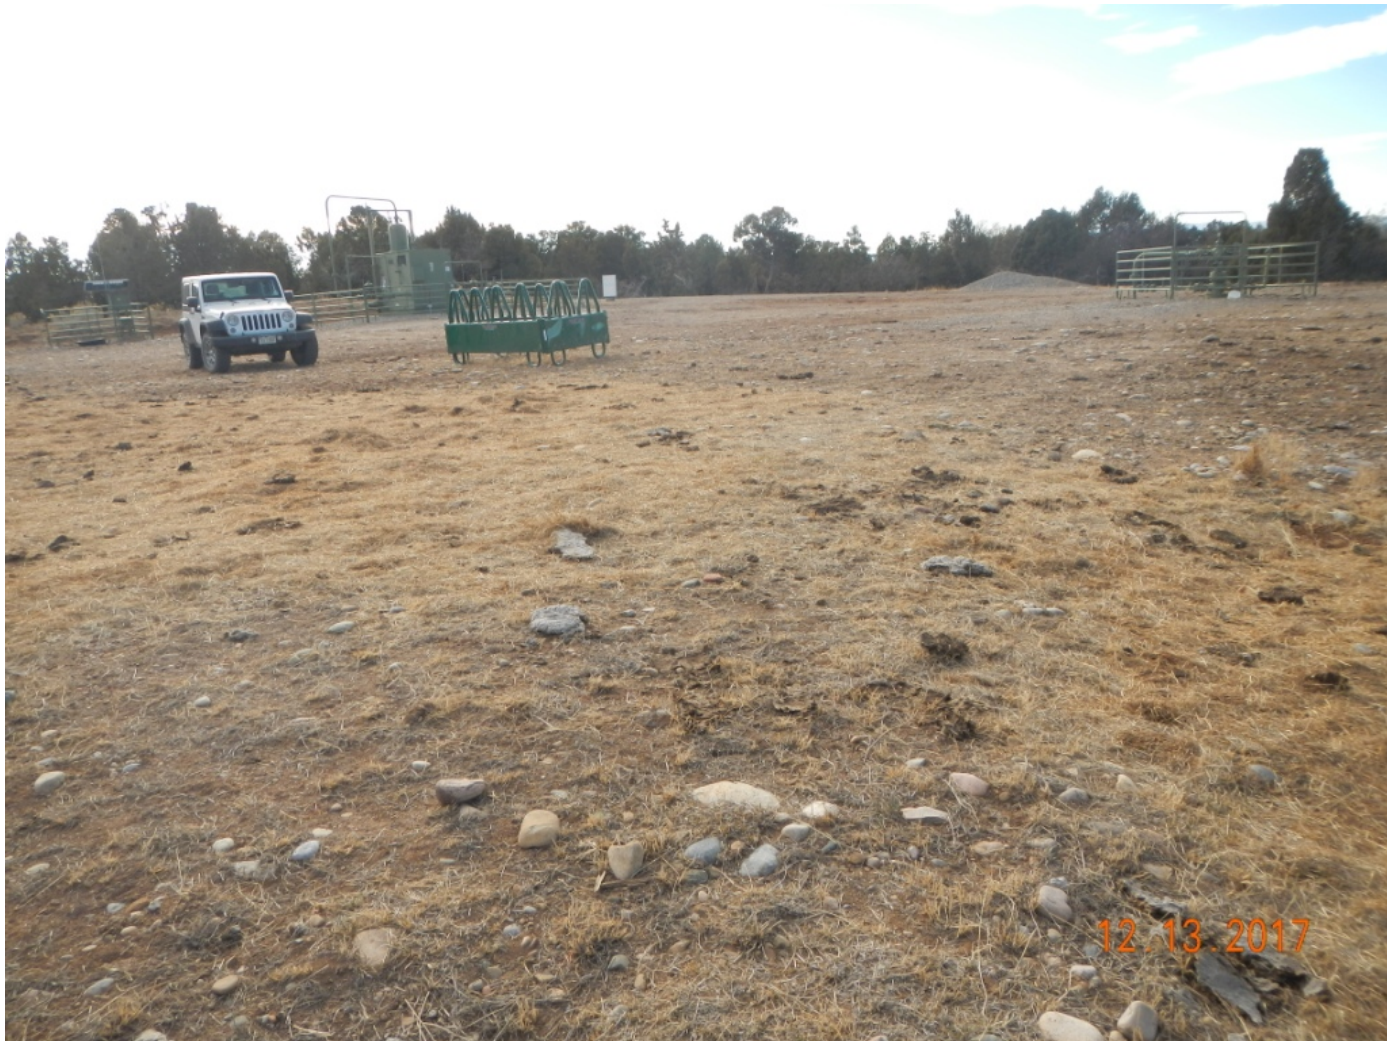
Photo 1. View of the project area from the northeastern corner facing center. It appears that cattle are being fed on the well pad.

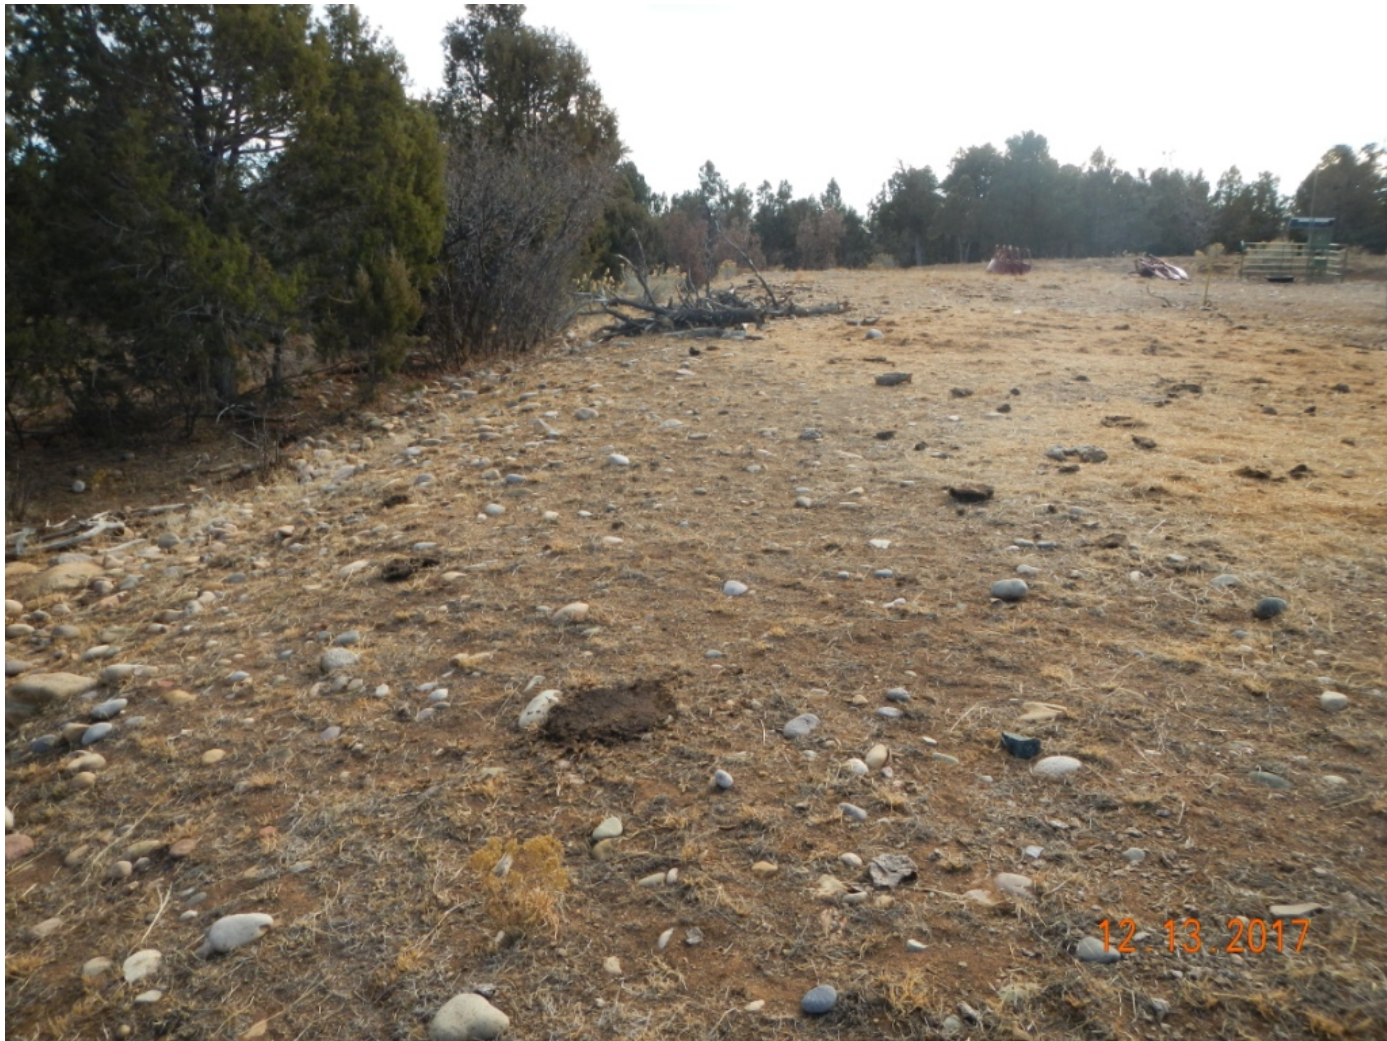
Photo 2. View of the eastern portion of the project area from the northeastern corner facing southward.

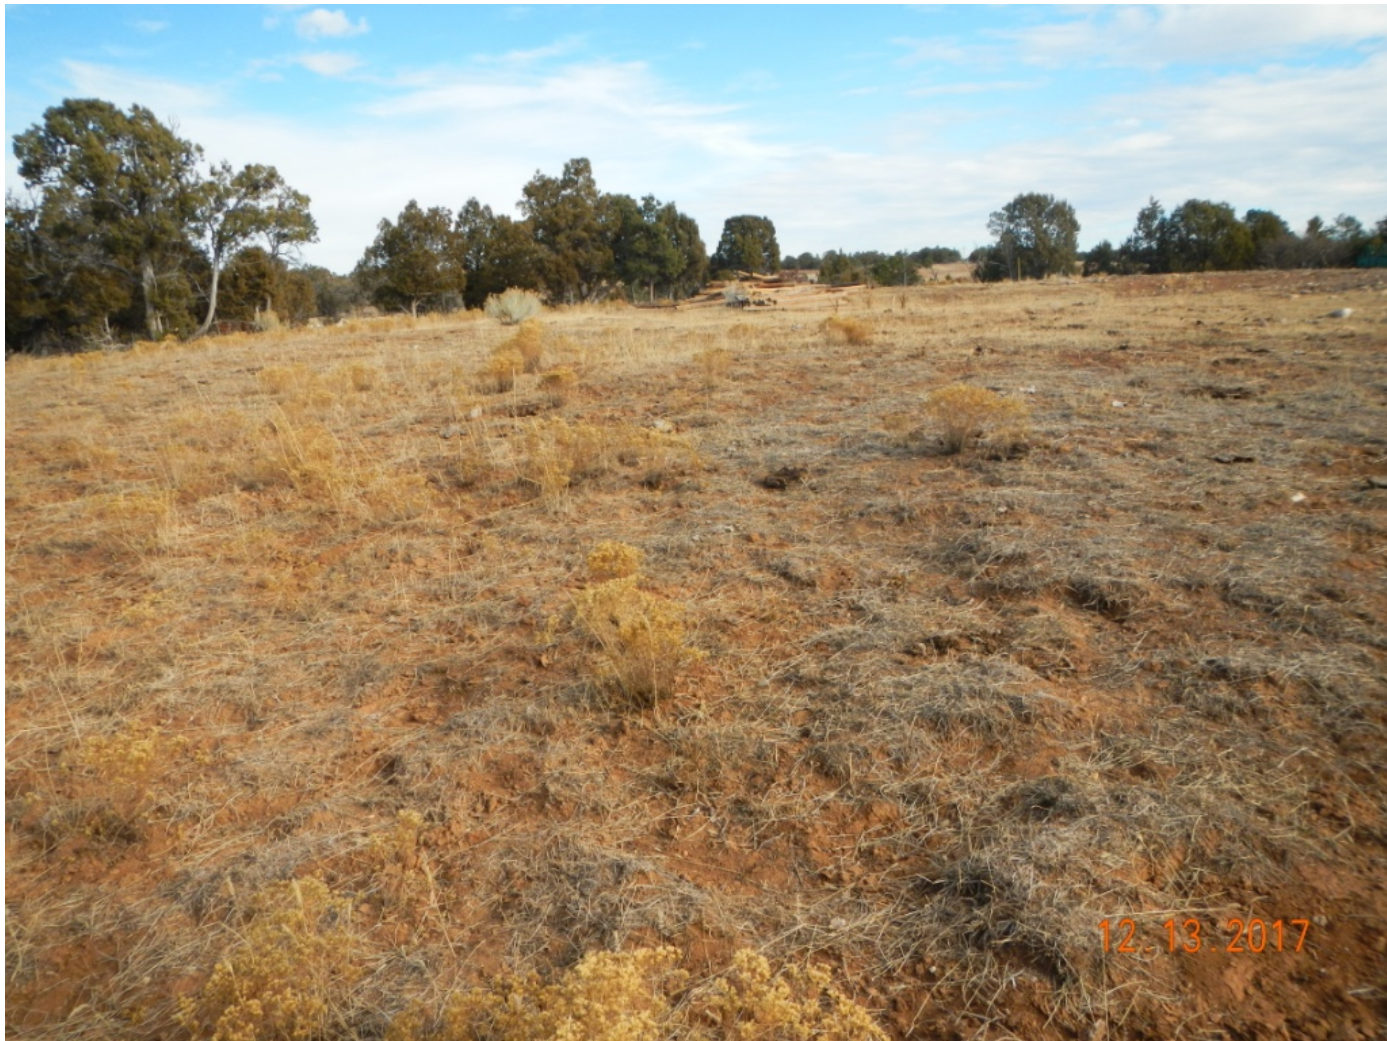
Photo 3. View of the northern portion of the project area from the northwestern corner facing eastward. Revegetation is progressing, but significantly grazed. Snakeweed (*Gutierrezia sarothrae*) and crested wheatgrass (*Agropyron cristatum*) are observable.

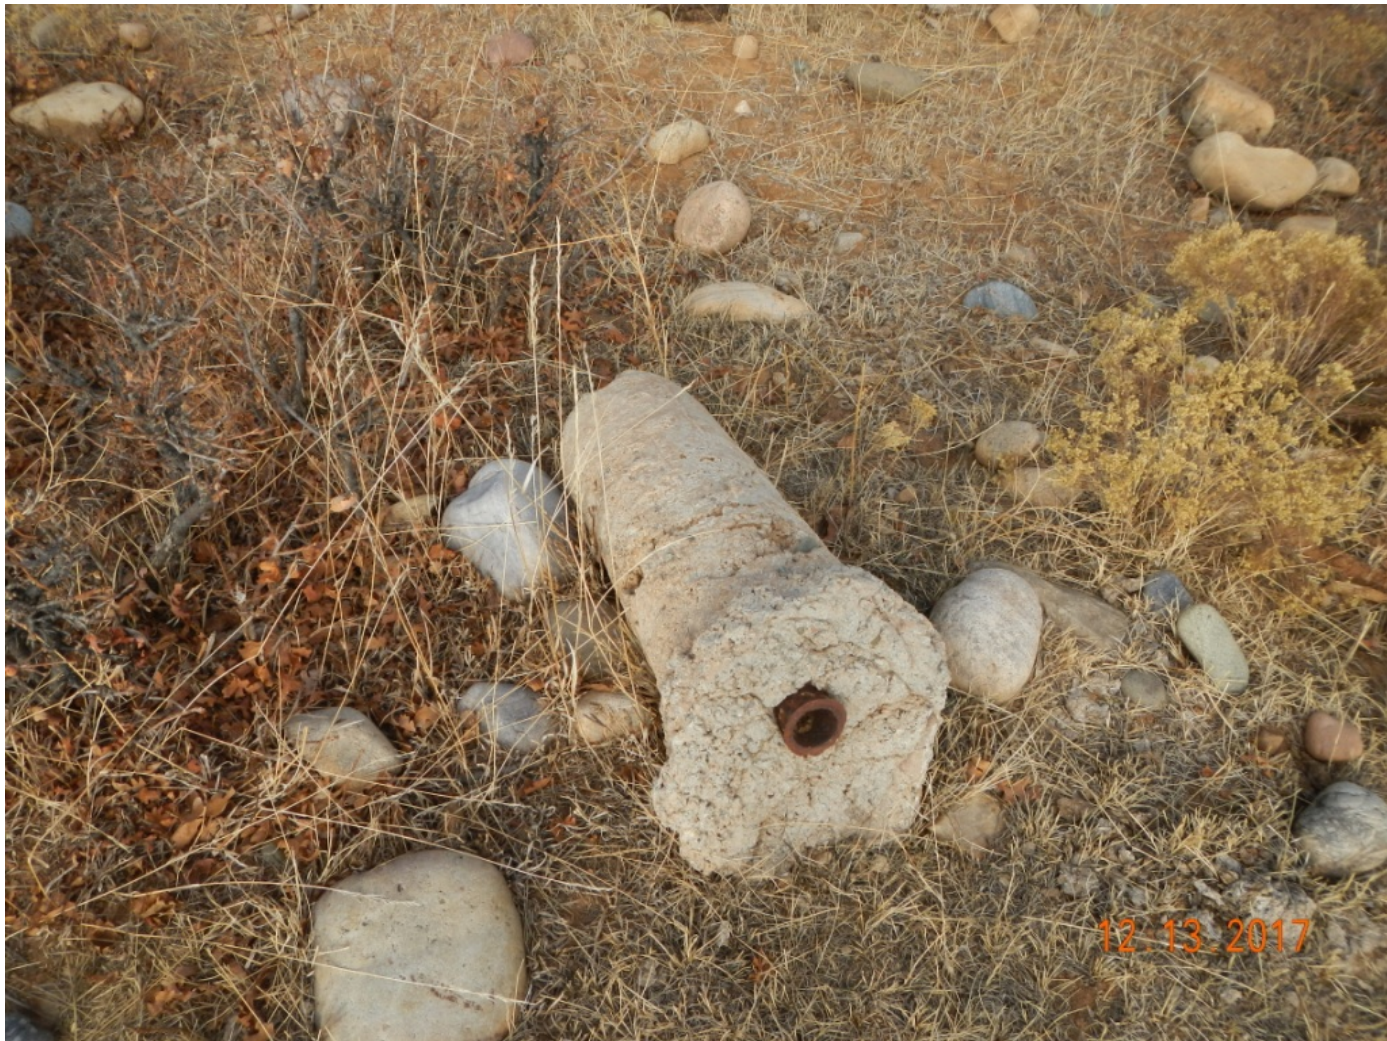
Photo 4. View of cement debris within the northern portion of the project area.

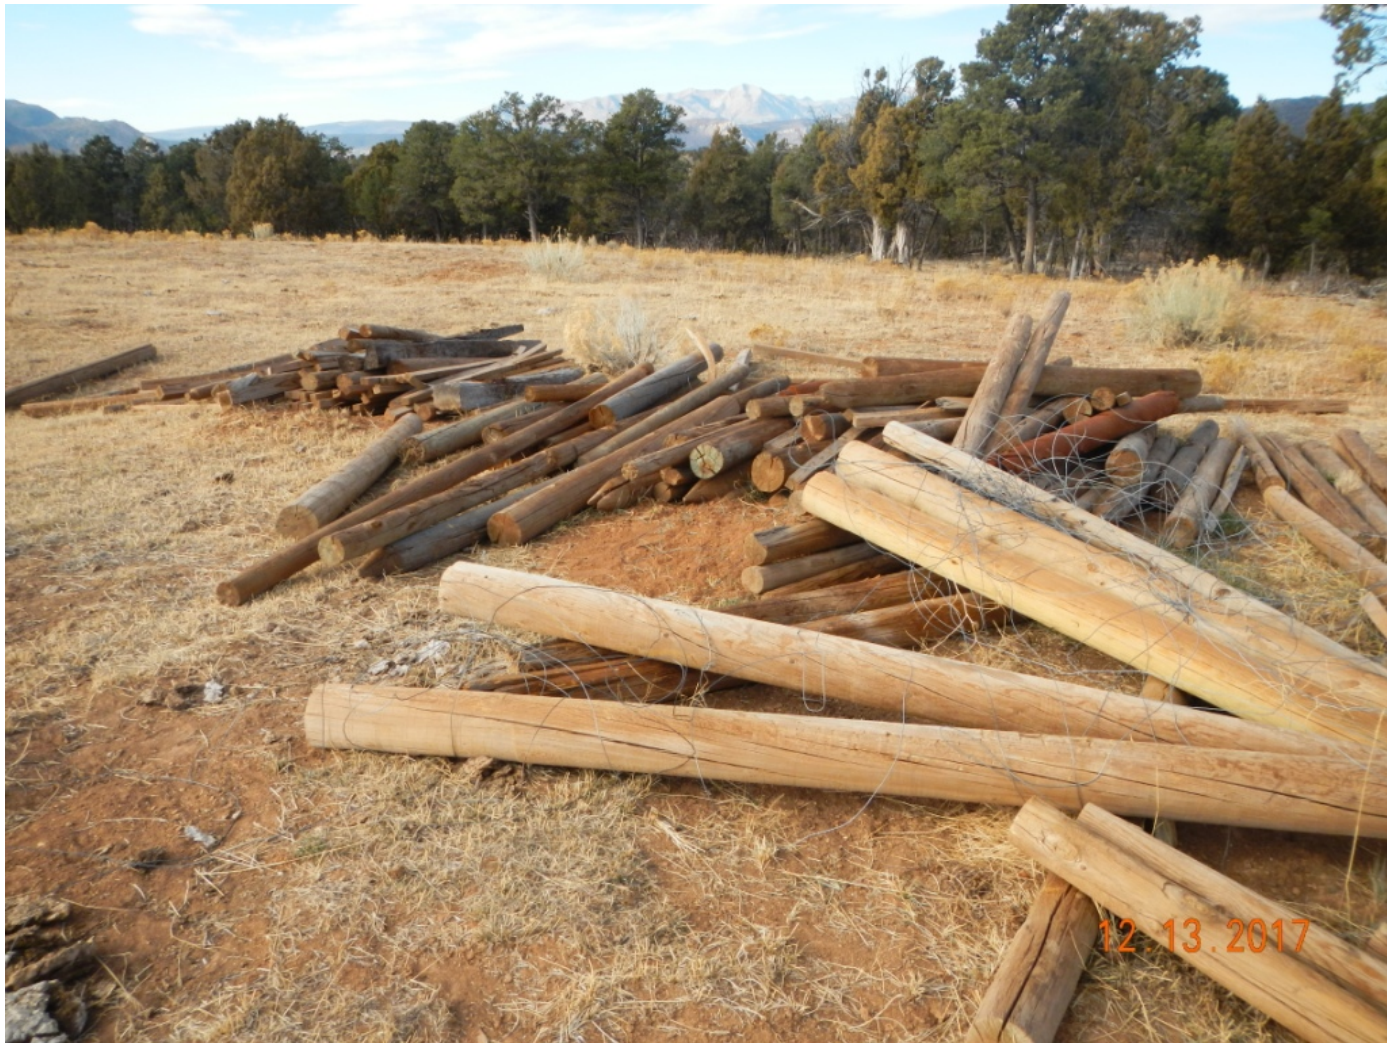
Photo 5. View of wood debris in the northeastern portion of the project area.

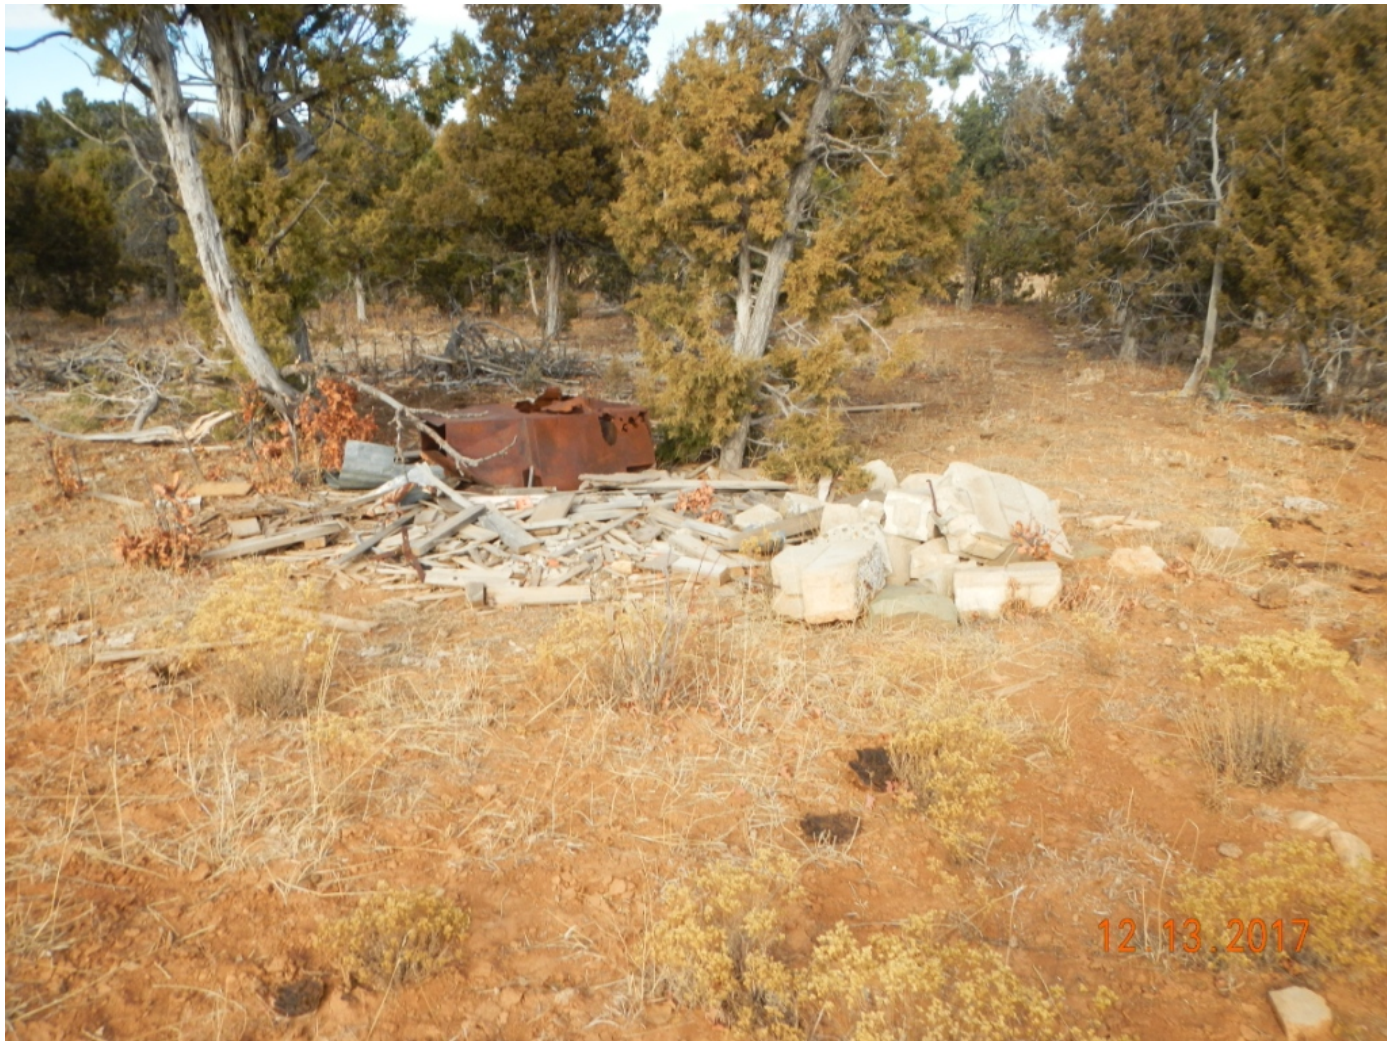
Photo 6. View of wood and cement debris along the northern edge of the well pad.
