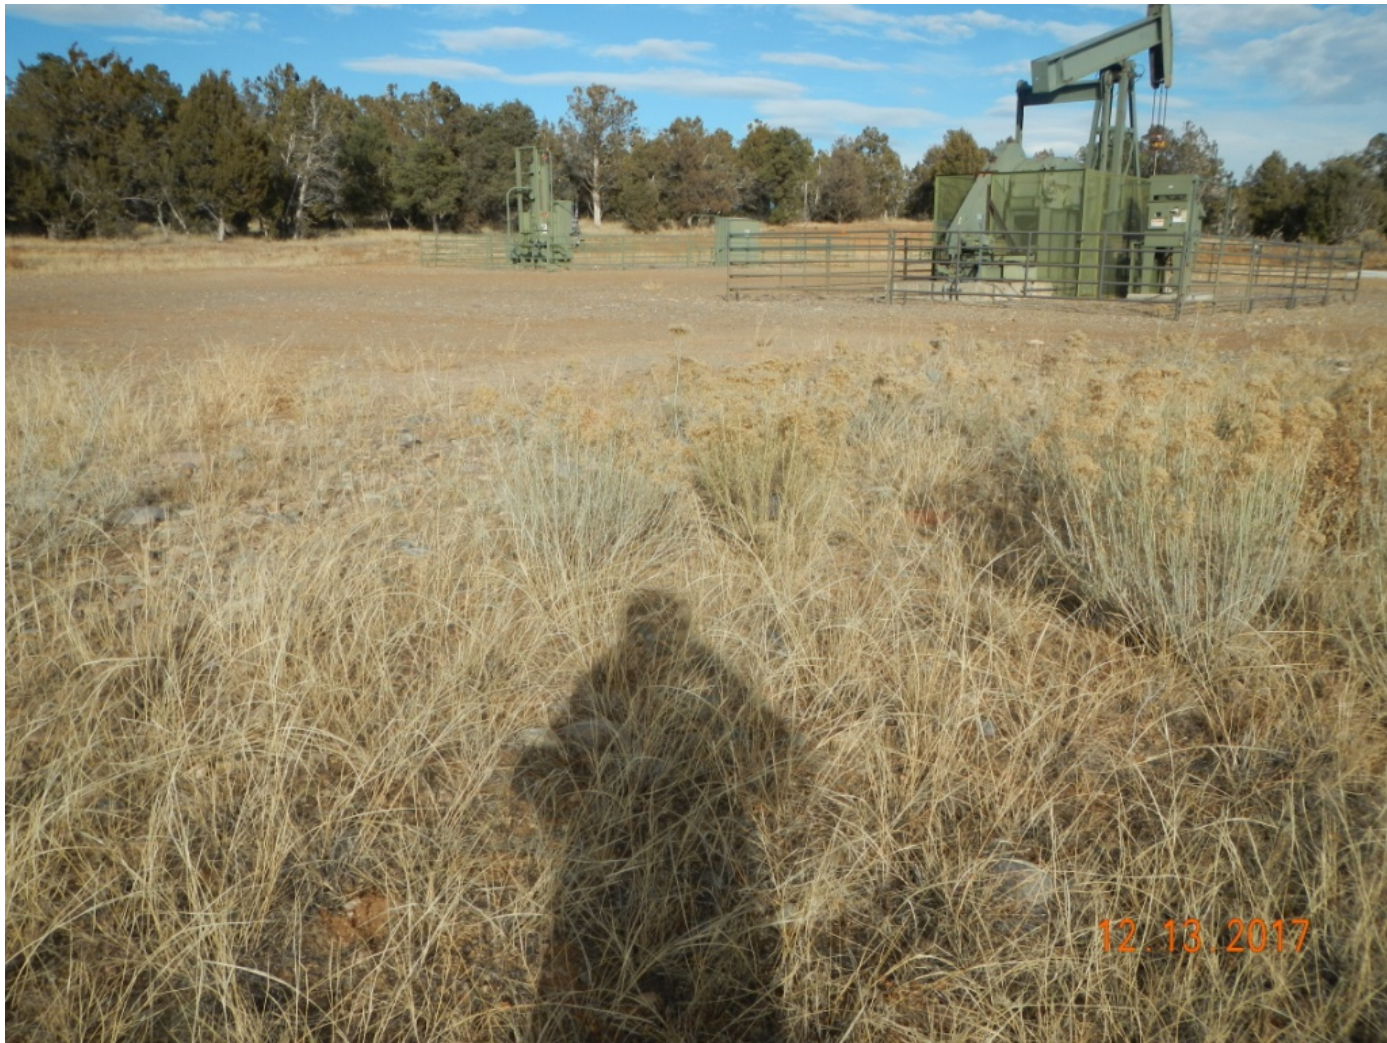
Photo 1. View of the project area from the southwestern corner facing center.

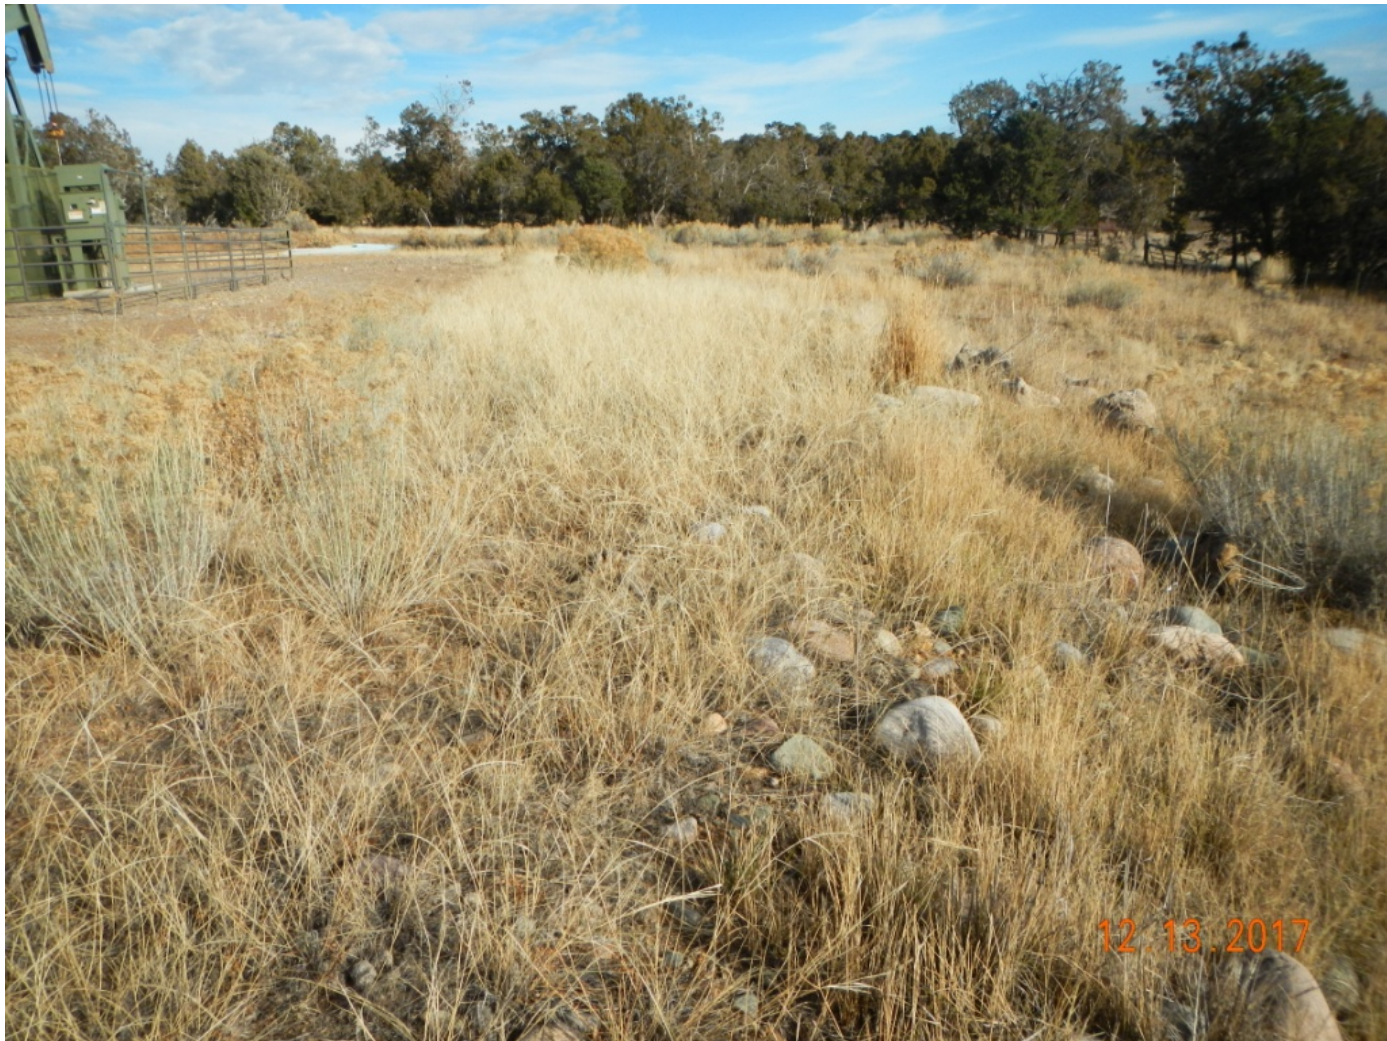
Photo 2. View of the southern portion of the project area from the southwestern corner facing eastward.

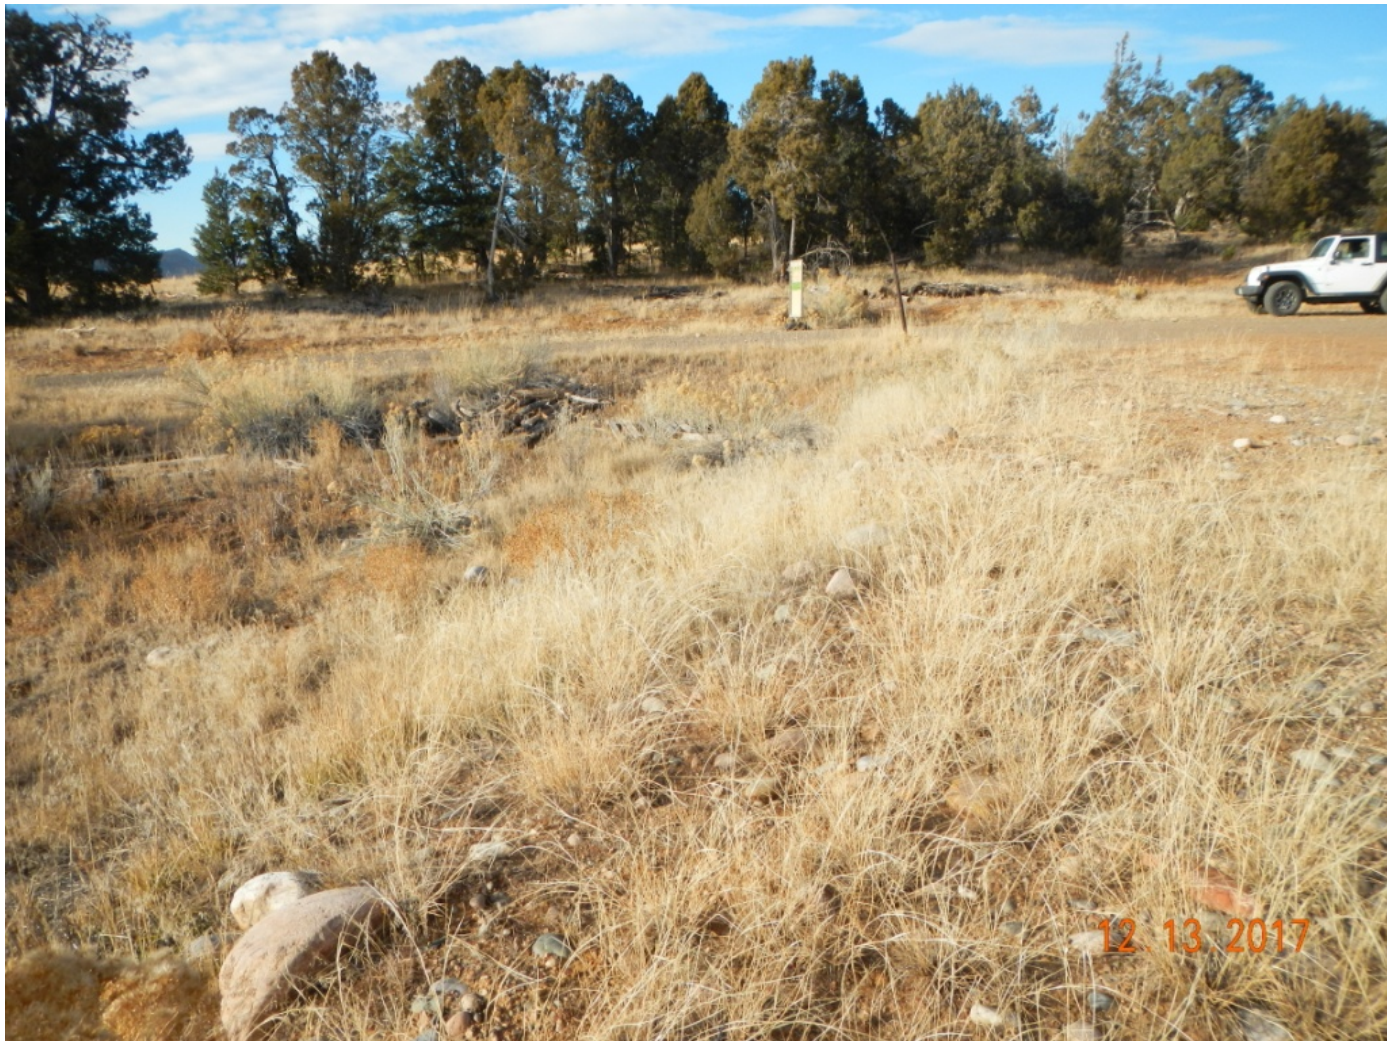
Photo 3. View of the western portion of the project area from the southwestern corner facing northward. Revegetation is progressing with grasses such as western wheatgrass (*Pascopyrum smithii*), and dropseed (*Sporobolus* sp.).

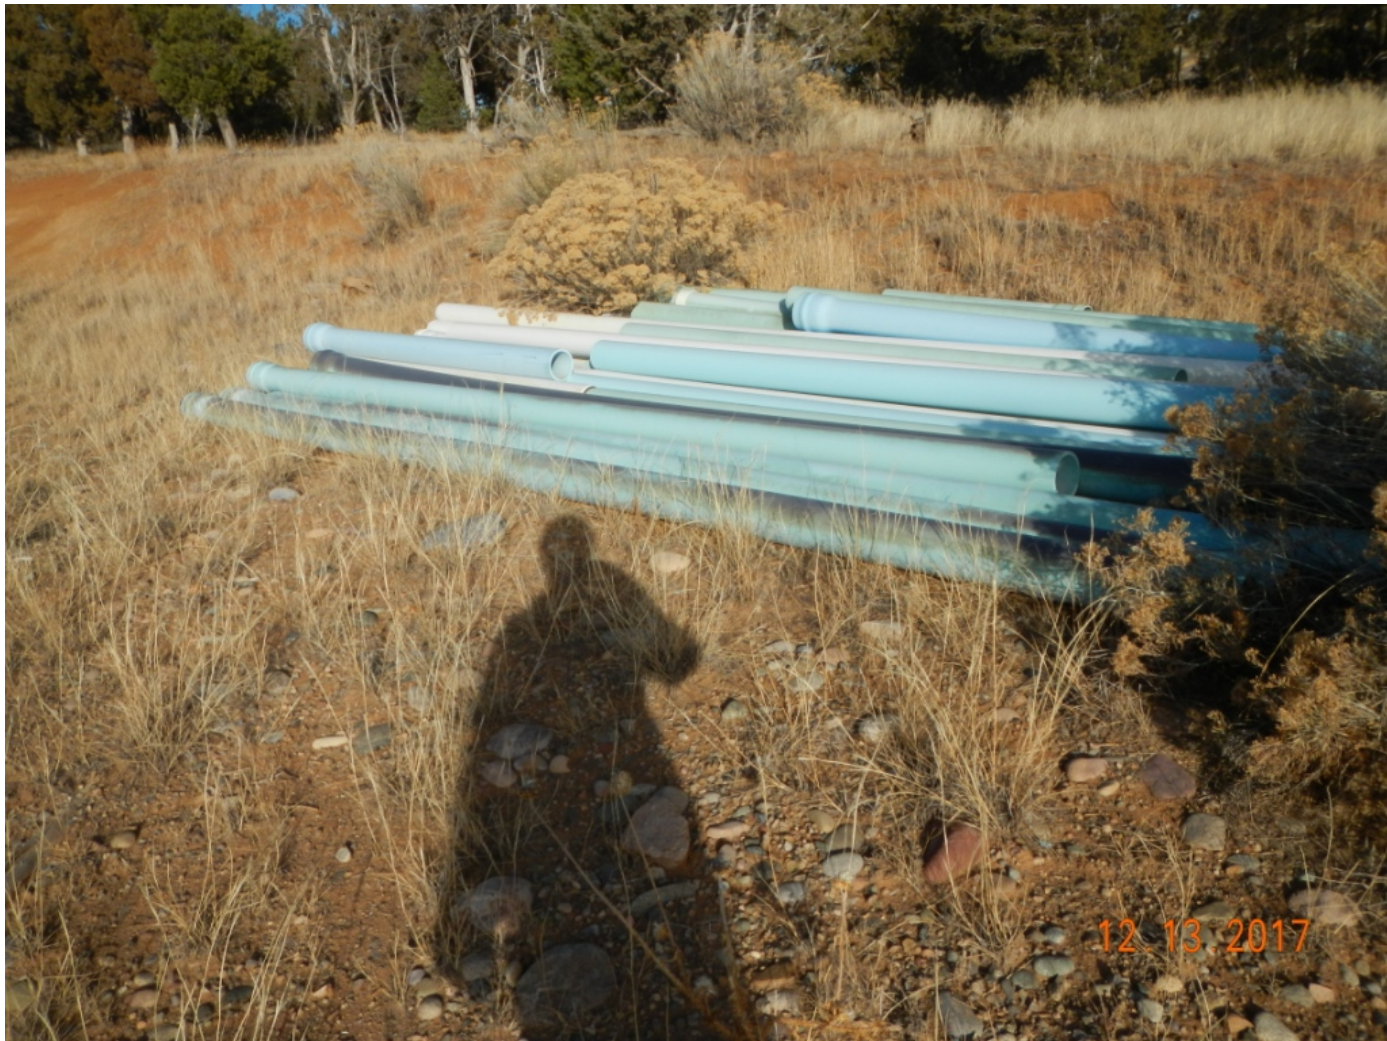
Photo 4. View of pipes stored in the southeastern project area.

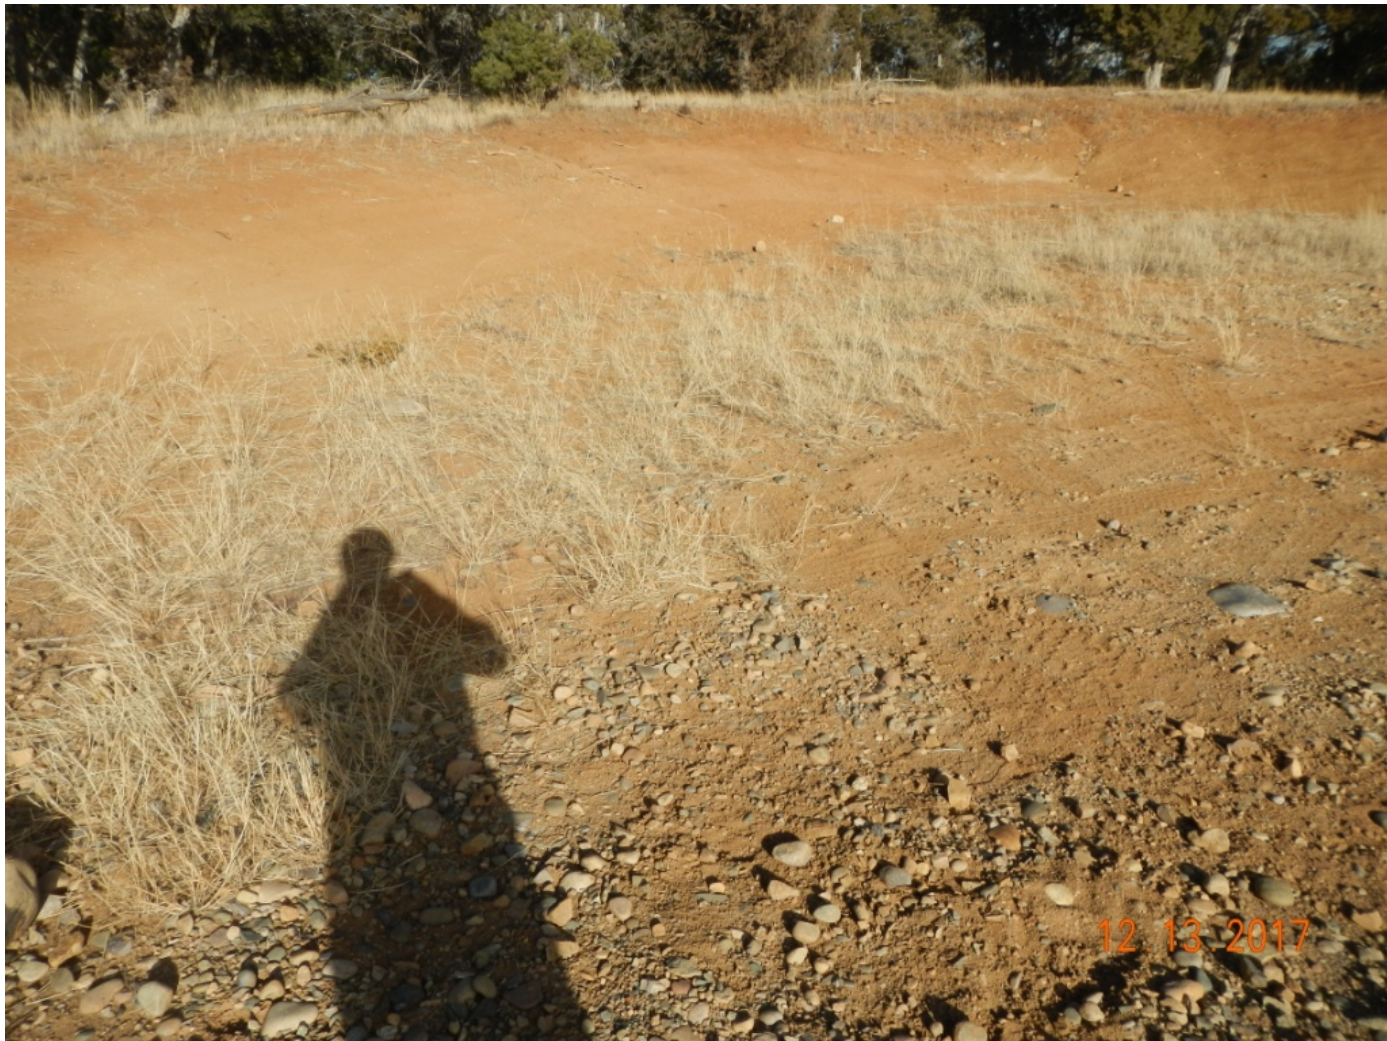
Photo 5. View of area along the cut-slope where vehicles are driving and have damaged vegetation. This area needs to be stabilized.
