- Robin Frazier GU PLA 9 1
- 05-067-07588

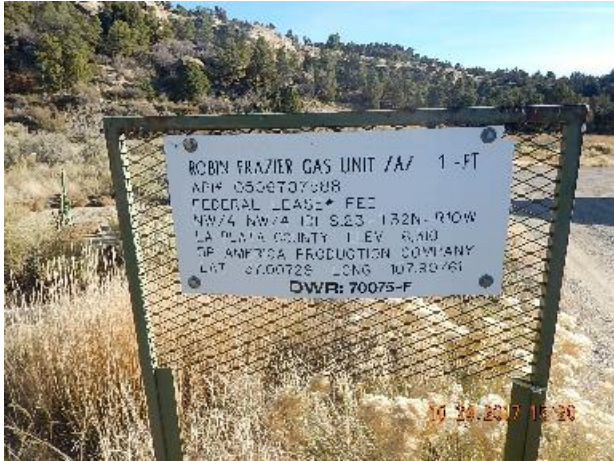
Photo 1: Wellhead sign. Previous inspection document number 685303916.

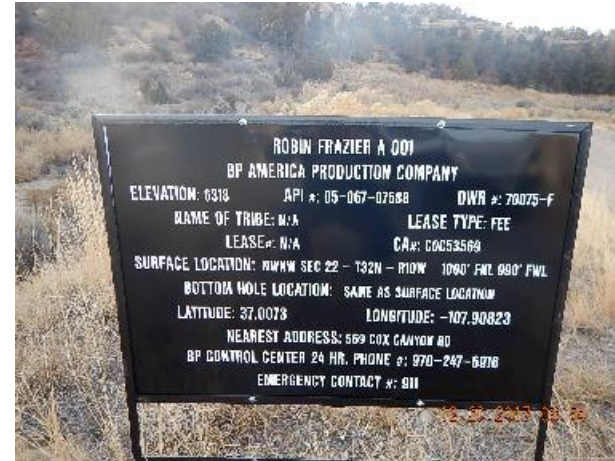
Photo 2: New wellhead sign. Current inspection.

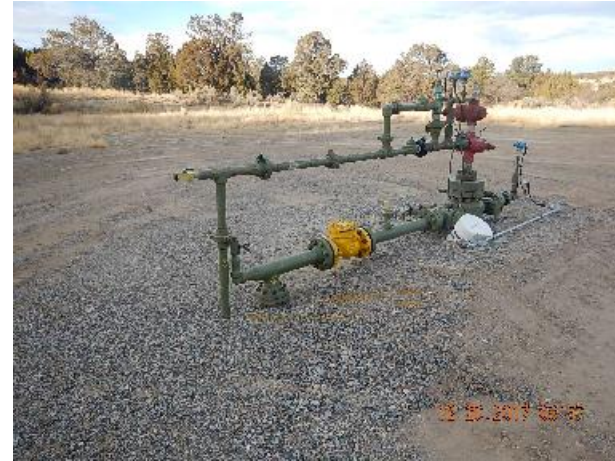
Photo 4: Removed production related materials at wellhead. Current inspection.

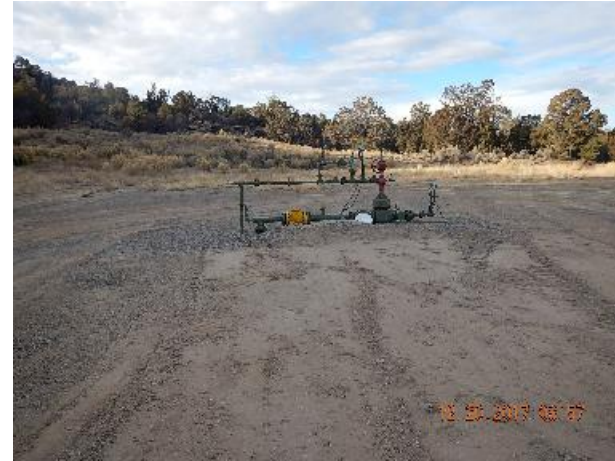
Photo 6: Removed polished rod at wellhead. Current inspection.

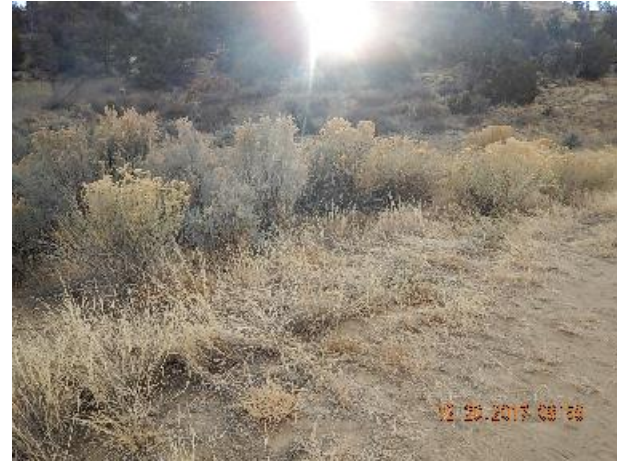
Photo 8: Plastic debris along E access road 2. Current inspection.
