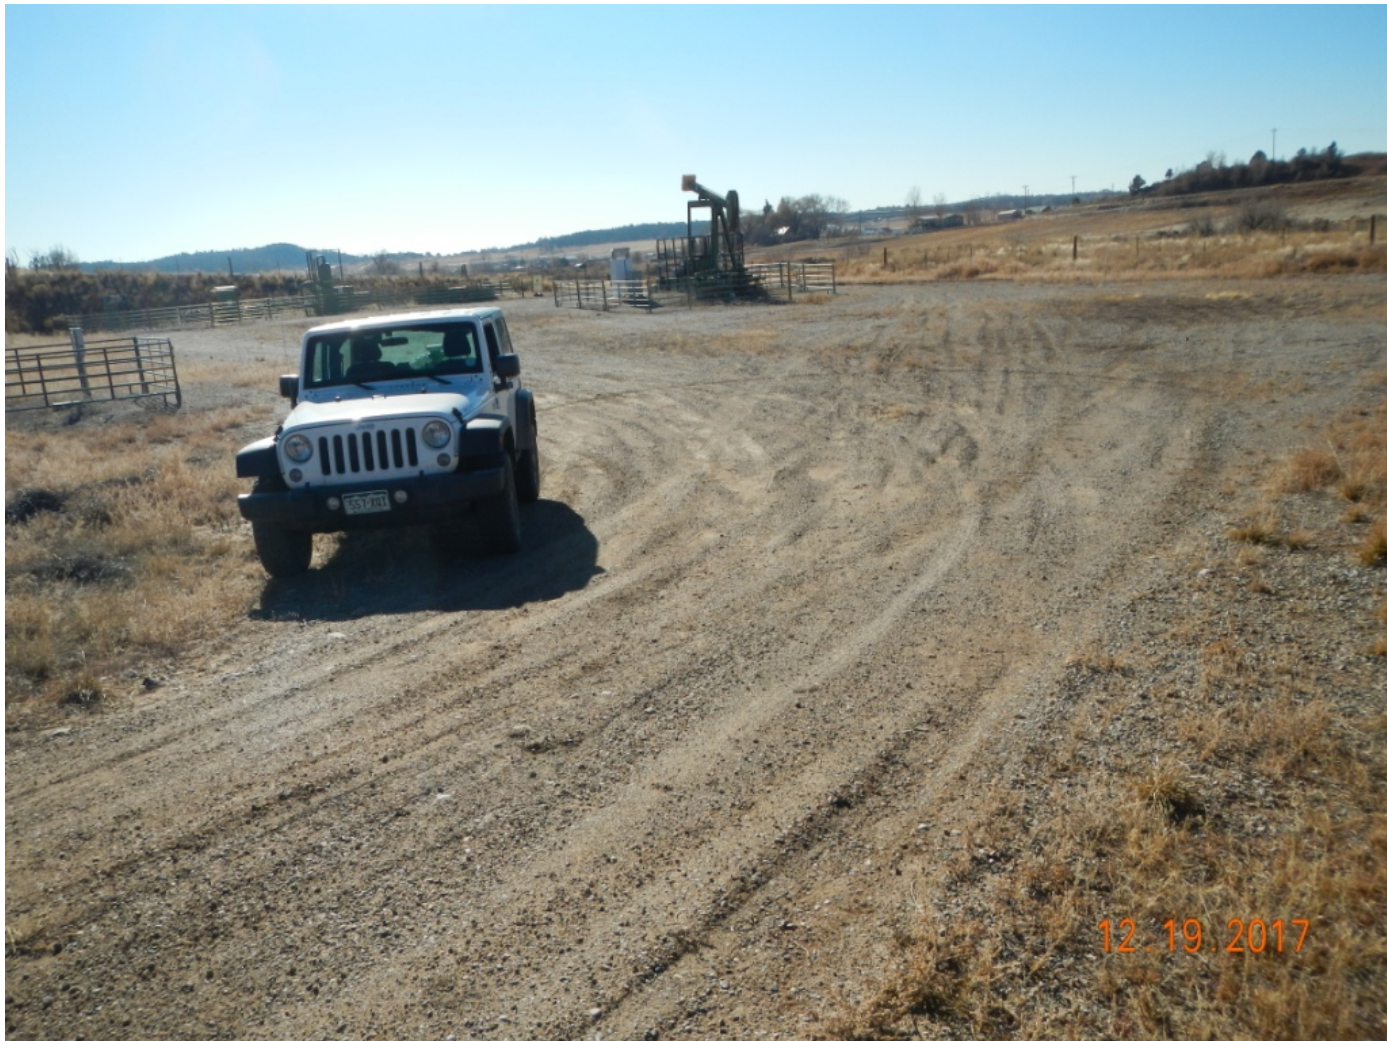
Photo 1. View of the project area from the northeastern corner facing center.

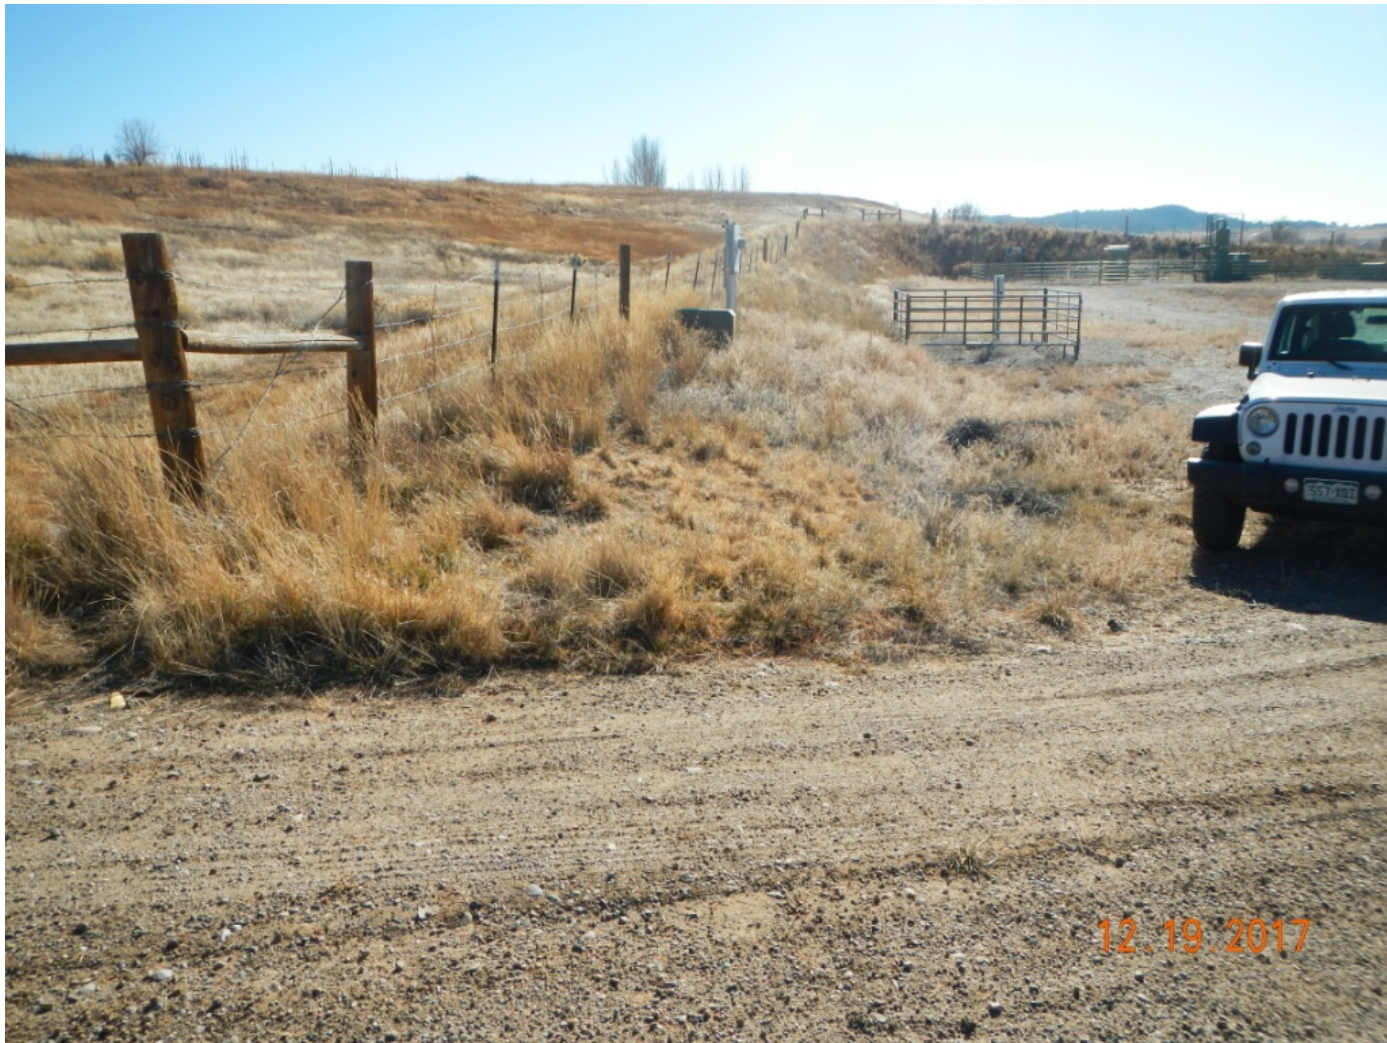
Photo 2. View of the eastern portion of the project area from the northeastern corner facing southward.

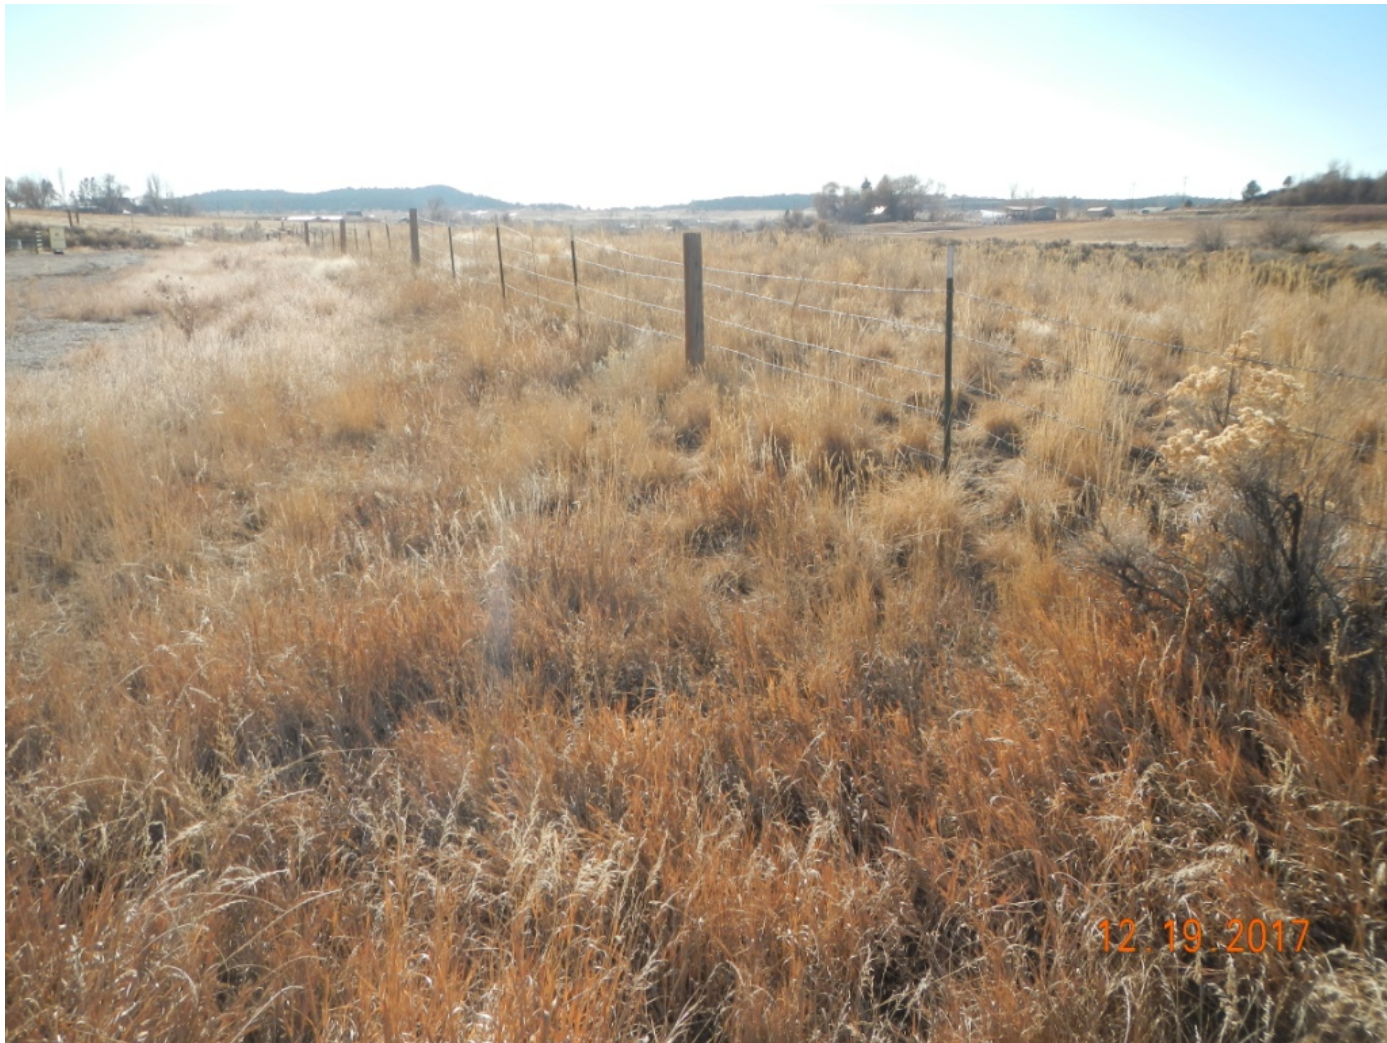
Photo 3. View of the western portion of the project area from the northwestern corner facing southward. Vegetation is progressing within the interim reclamation areas with grasses such as smooth brome (*Bromus inermis*), western wheatgrass (*Pascopyrum smithii*), and weeds such as cheatgrass (*Bromus tectorum*) and kochia (*Kochia scoparia*).

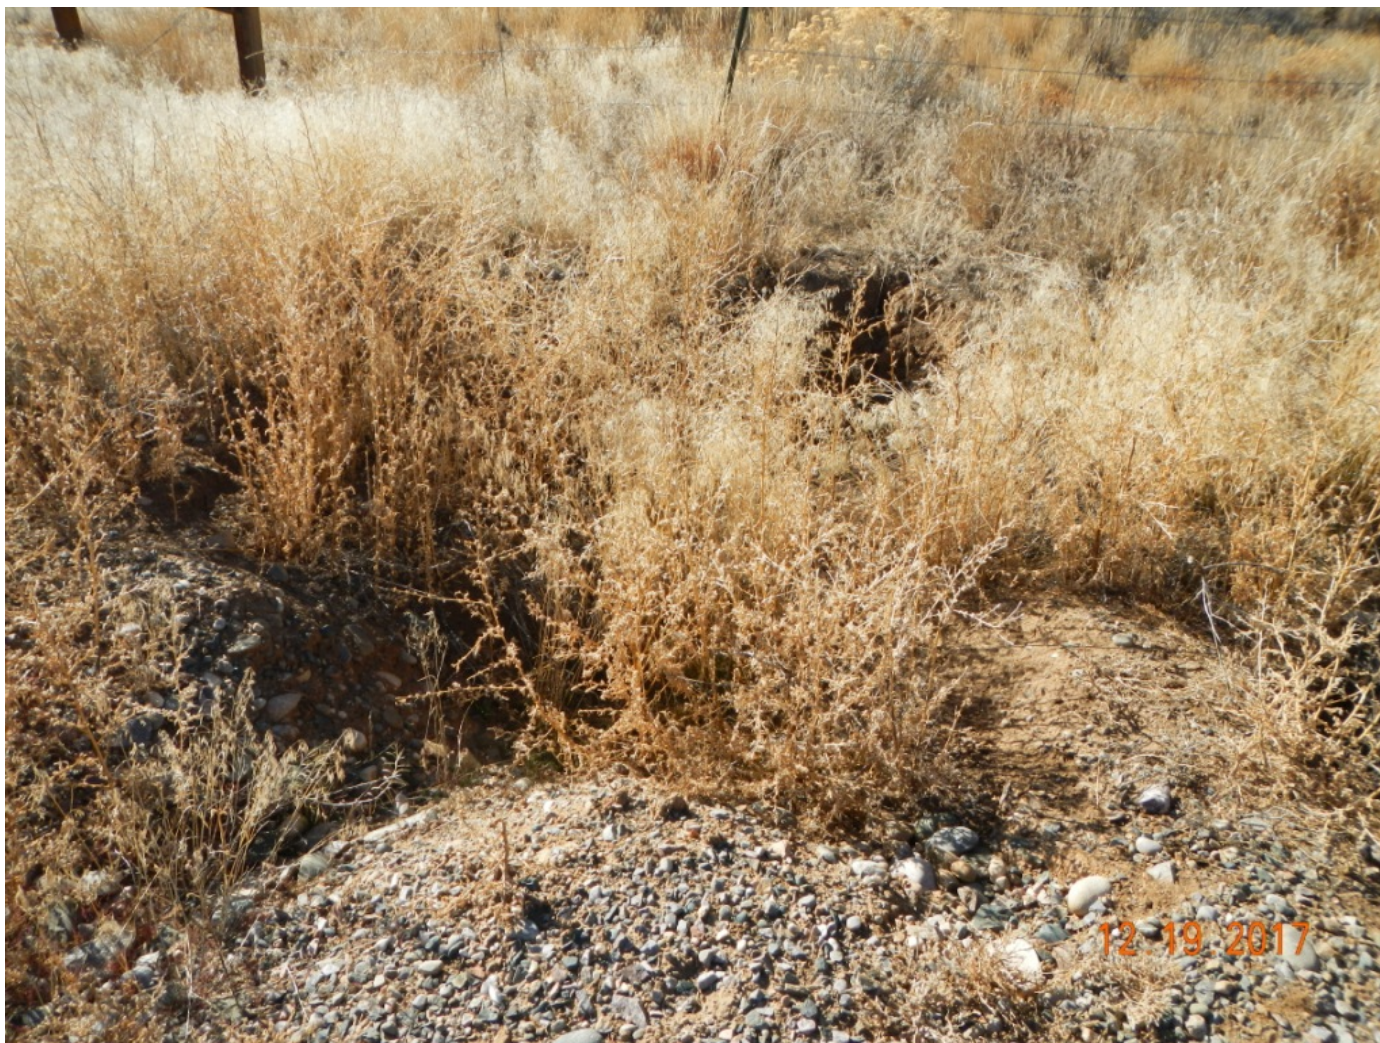
Photo 4. View of area where concentrated stormwater flows off of the southwestern corner of the well pad and tunnels through the interim reclamation area.

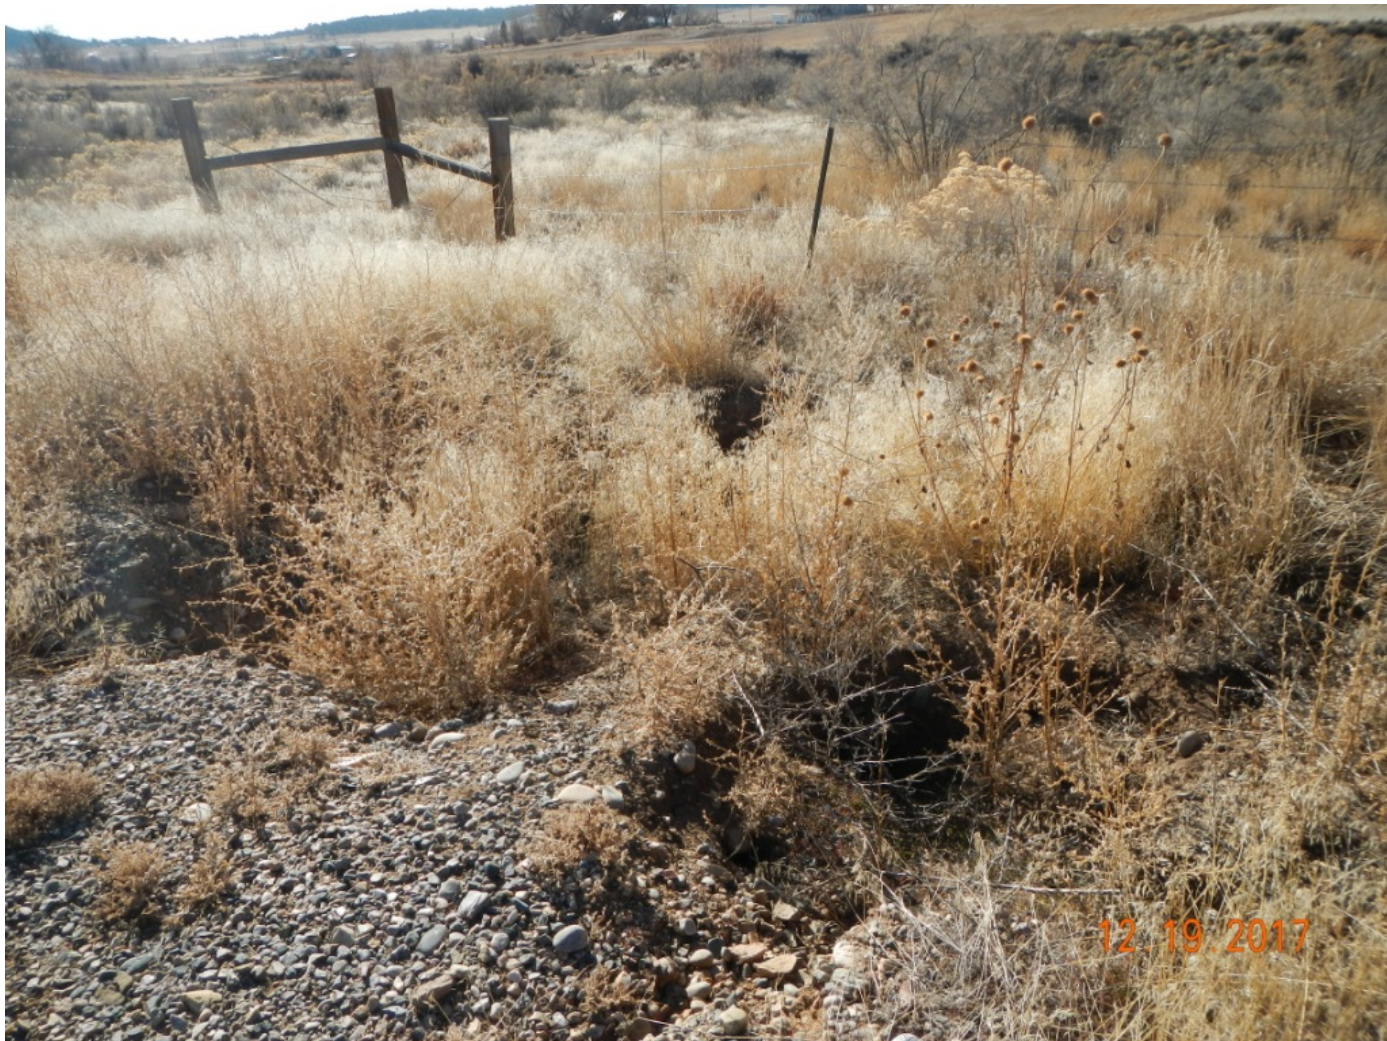
Photo 5. Another view of area in southwestern portion of the project area where erosional channels are tunneling through the interim reclamation area. This area needs stabilization.
