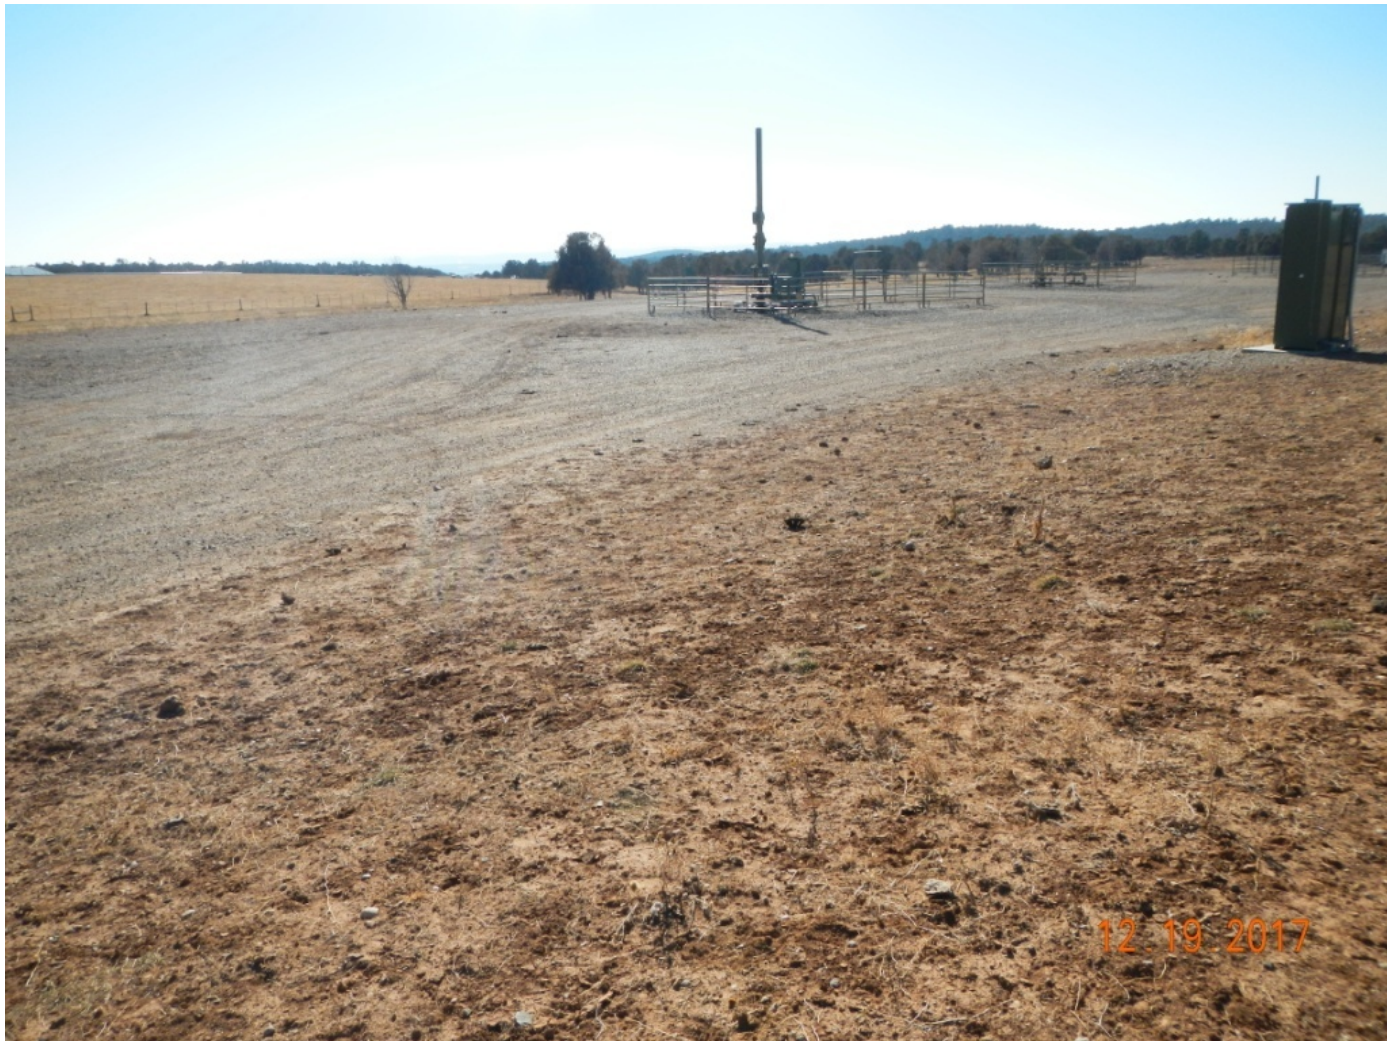
Photo 1. View of the project area from the northeastern corner facing center.

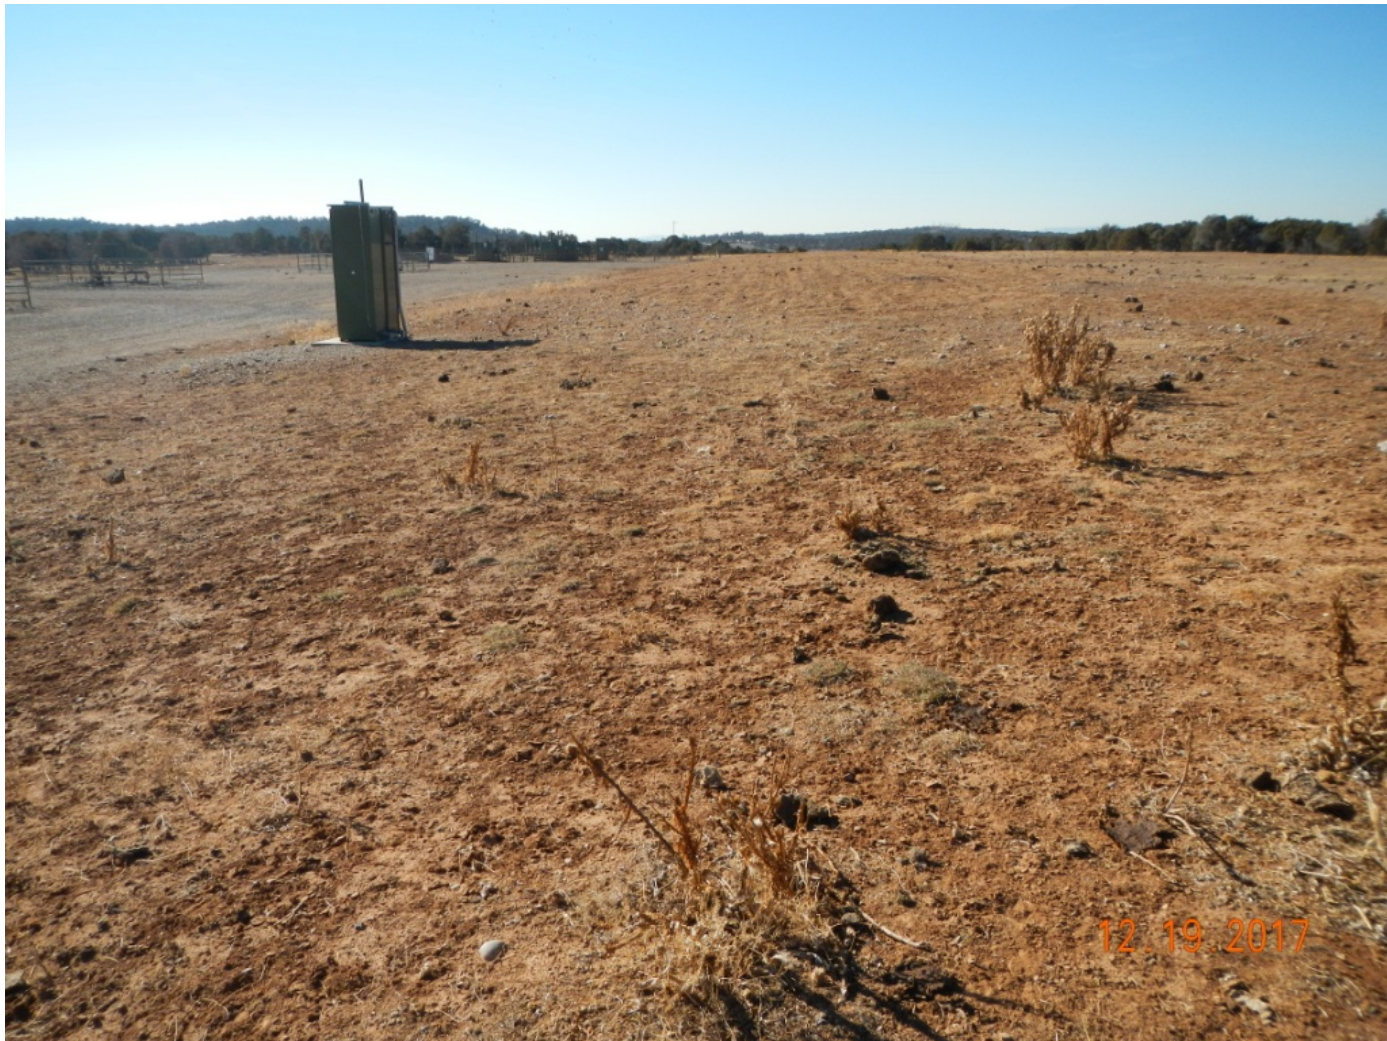
Photo 2. View of the northern portion of the project area from the northeastern corner facing westward.

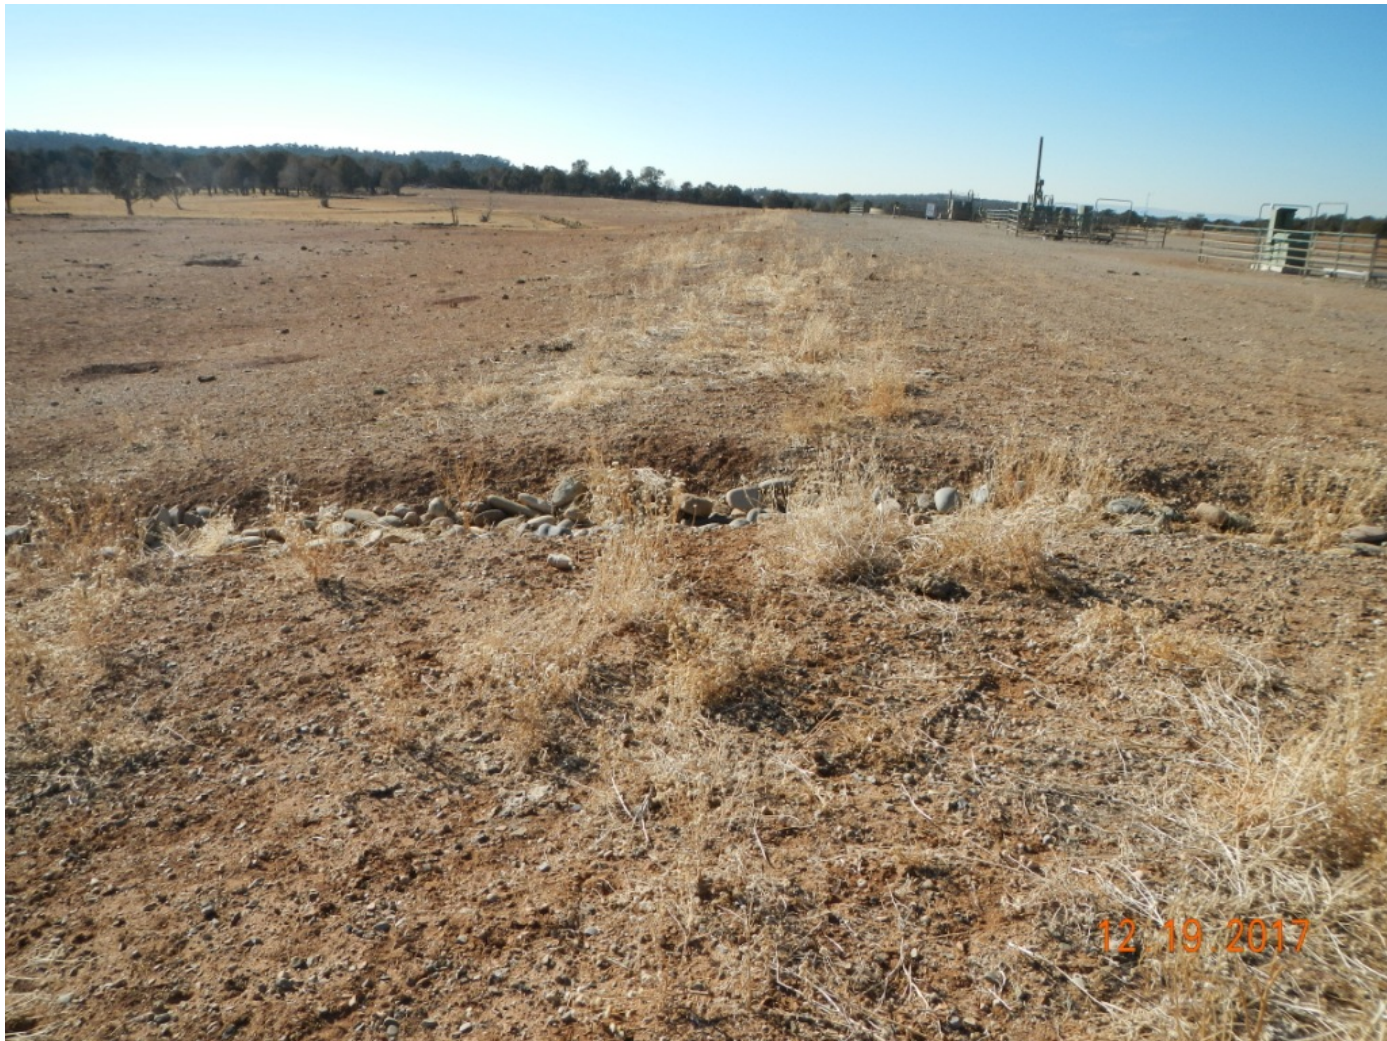
Photo 3. View of the southern portion of the project area from the northeastern corner facing westward. Revegetation is grazed and not in identifiable form.

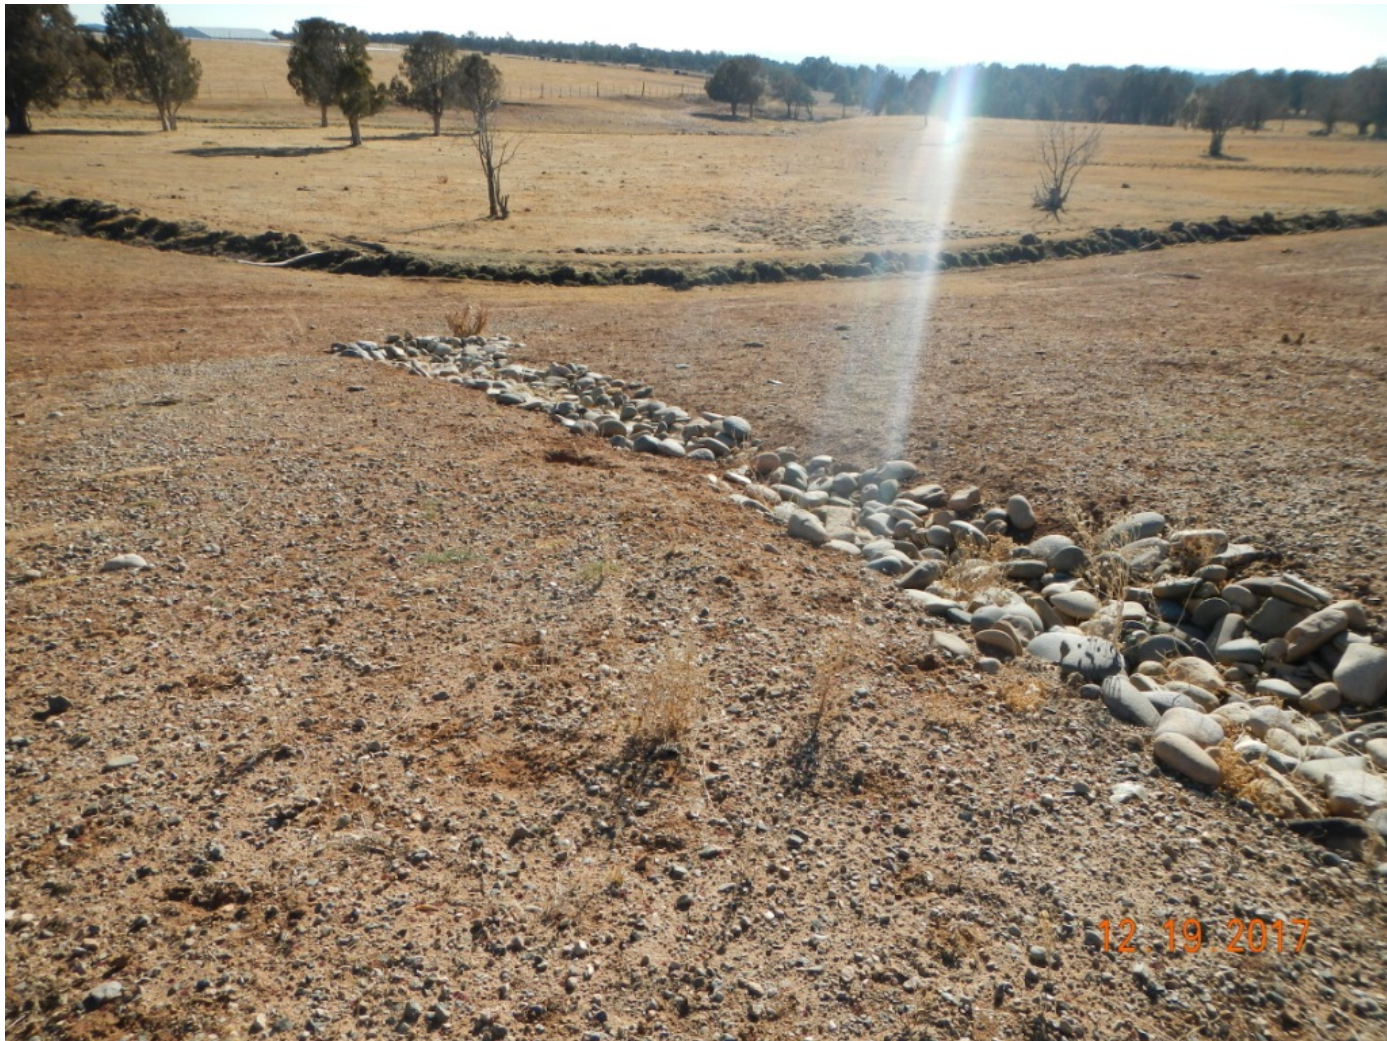
Photo 4. View of stormwater controls in the southern portion of the project area, appear to be functioning.

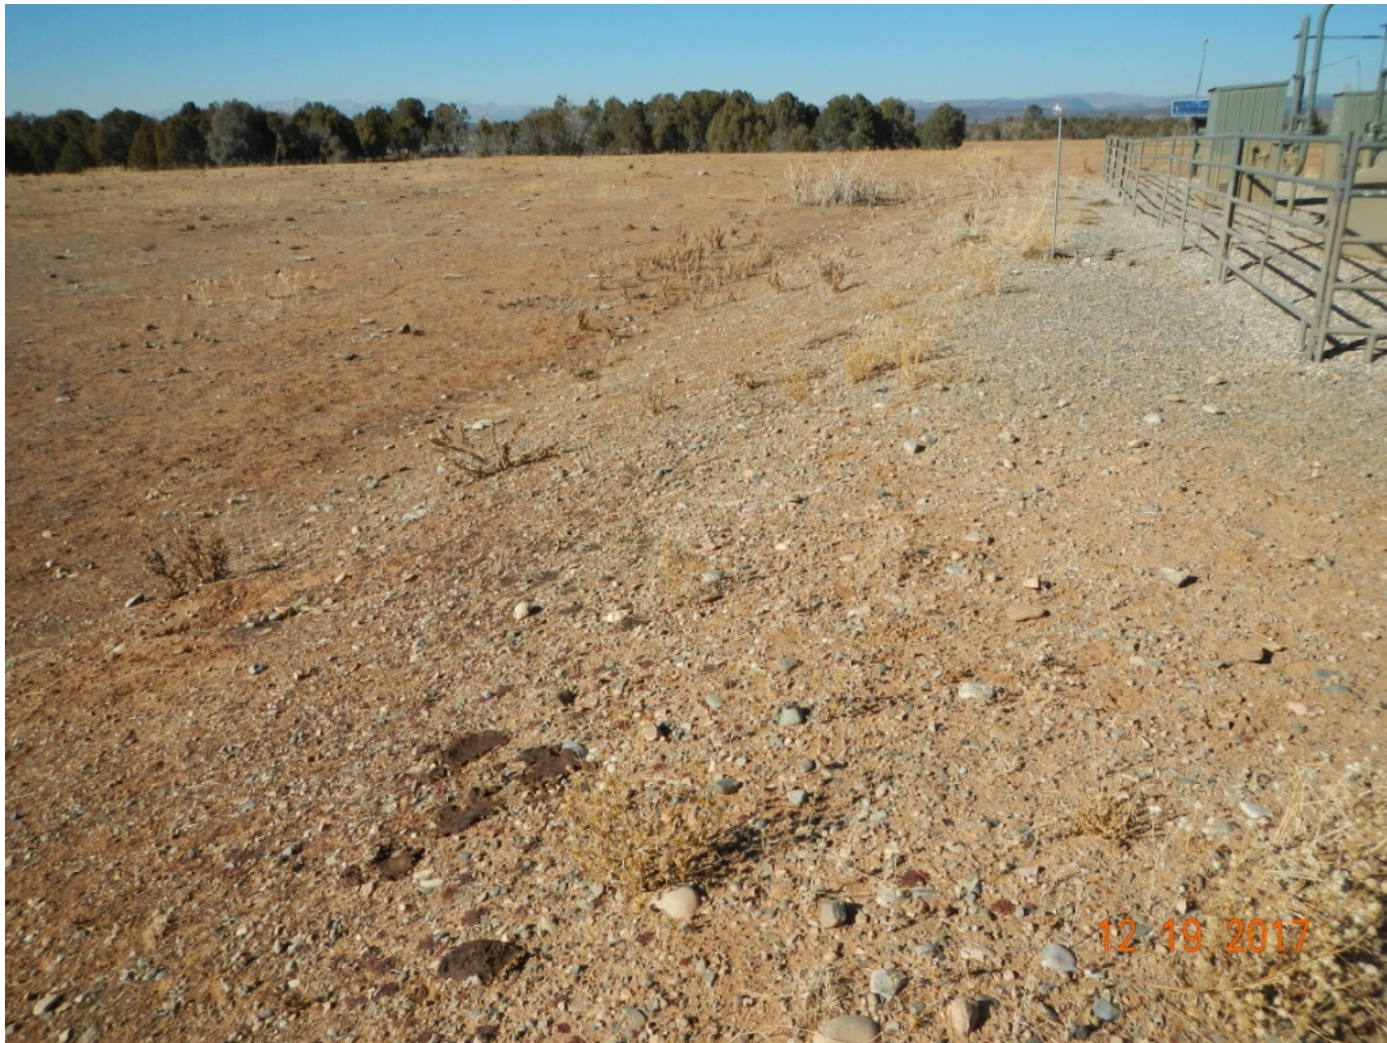
Photo 5. View of the western portion of the project area from the southwestern corner facing northward. Scotch thistles (*Onopordum acanthium*) and musk thistles (*Carduus nutans*) are growing here.

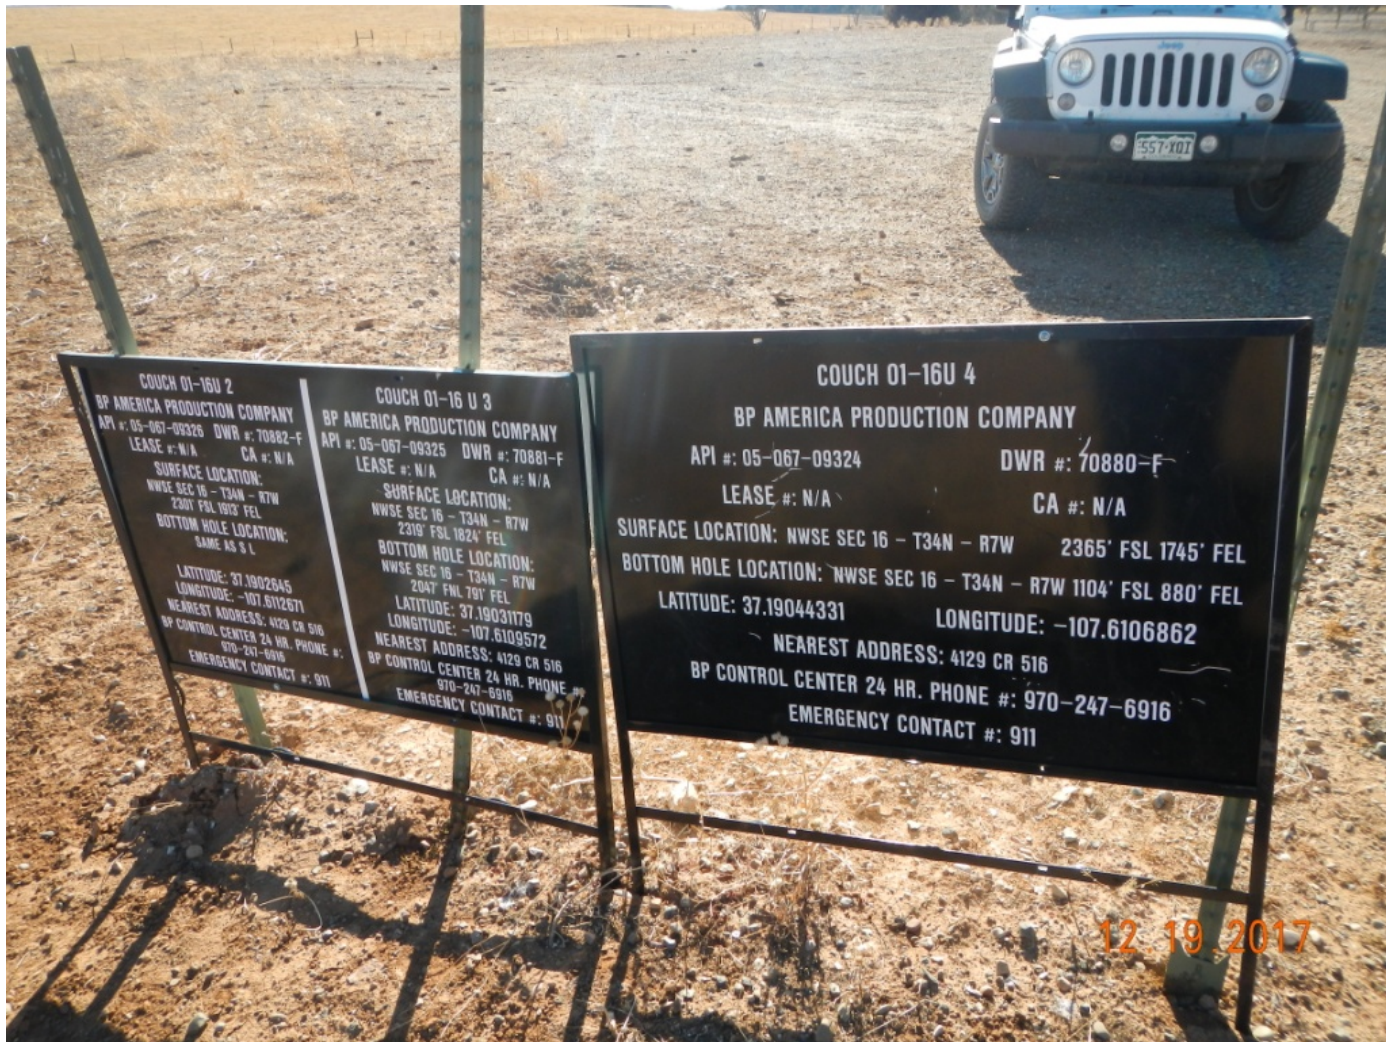
Photo 5. View of signs that appear to have been replaced since last inspection.
