Inspection Photos
Location Name: Federal 1-2 #2
API: 05-067-09066

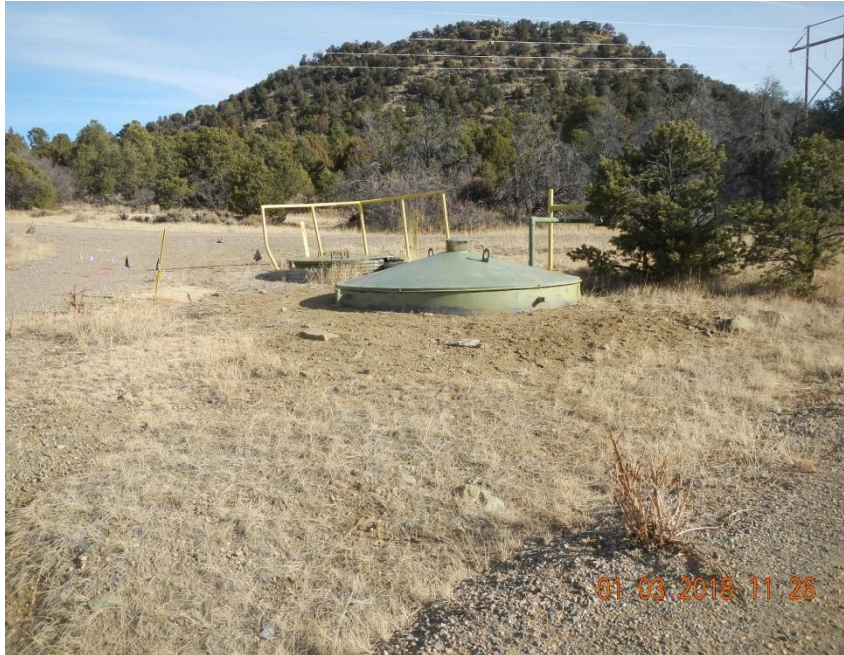
95 bbl. PBV without secondary containment.

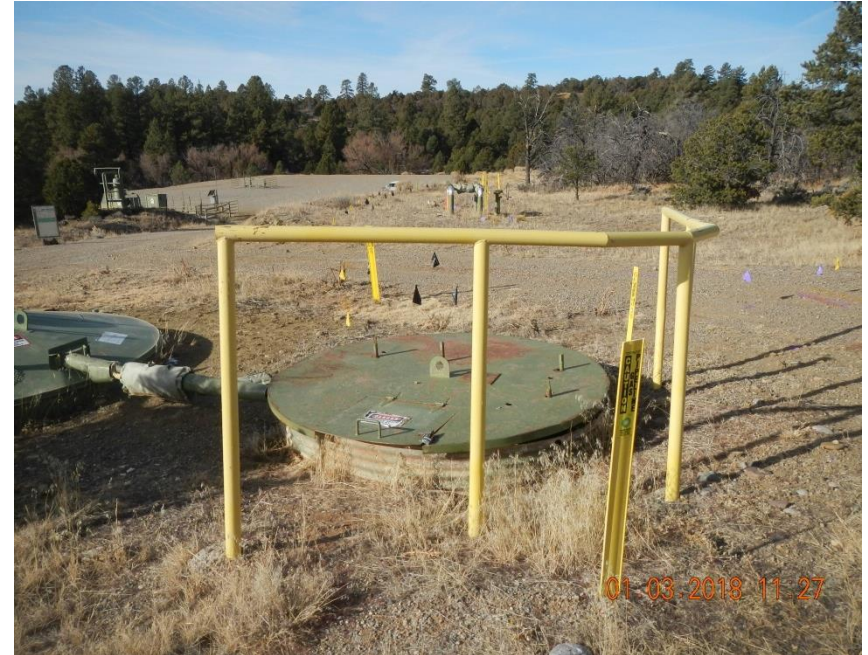
PBV and valve can with location in the background.

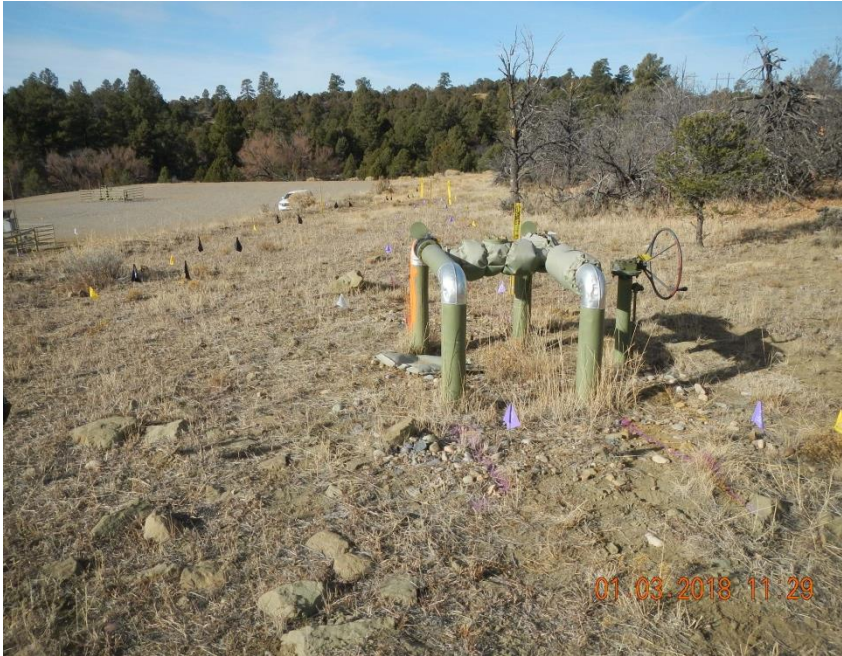
Pipeline risers north of well pad.

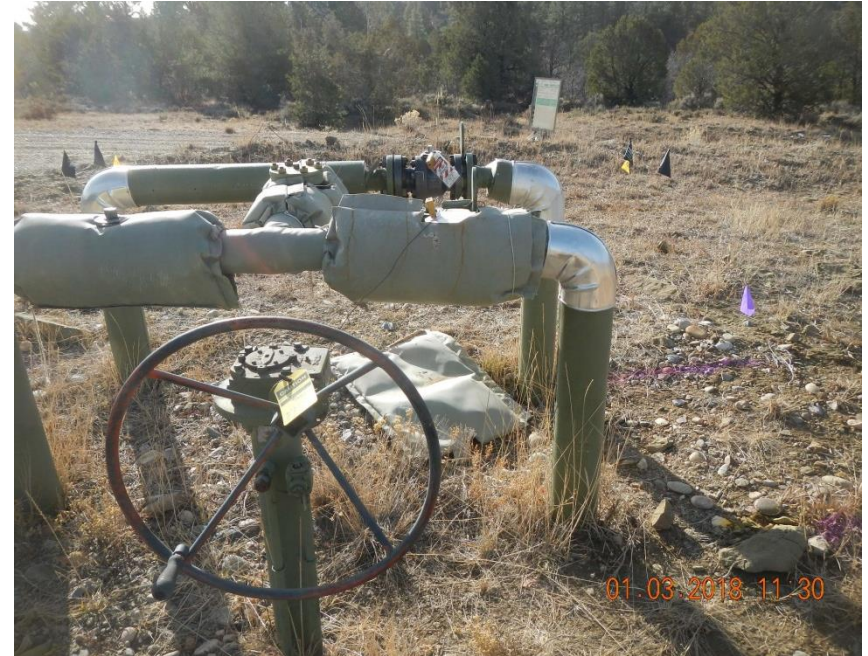
Valves are locked out on risers.

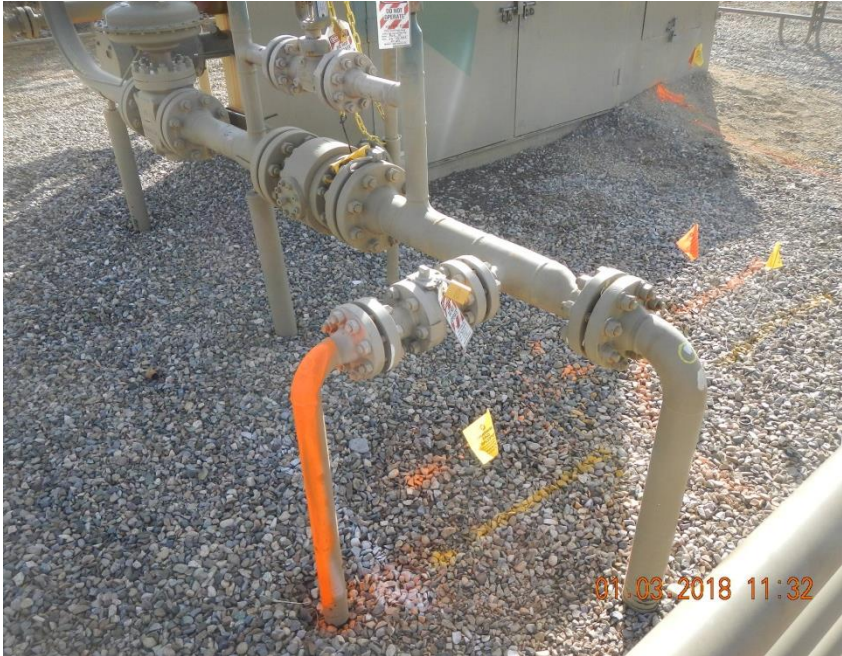
Equipment on location is locked out and flow lines are painted.

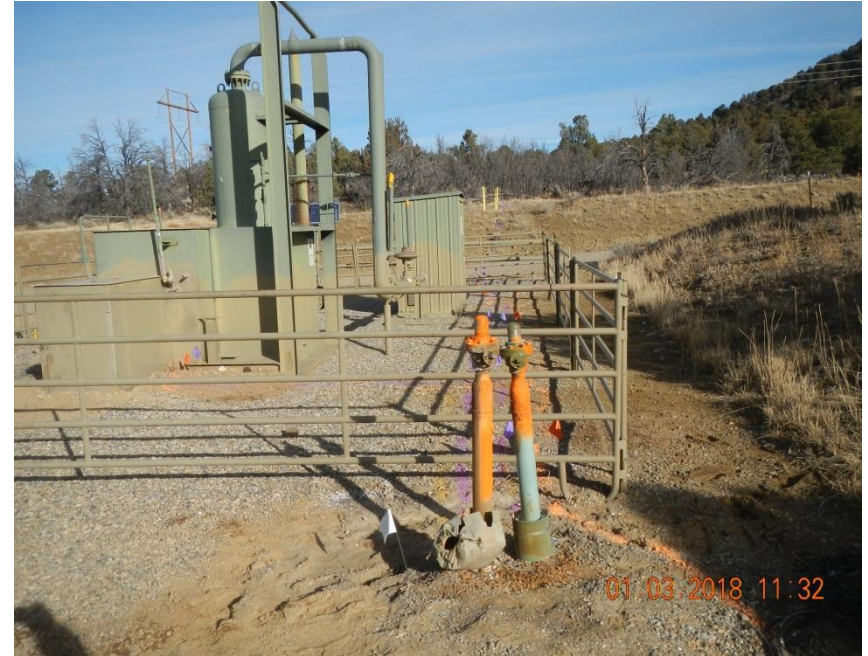
Two risers painted orange with bull plugs.

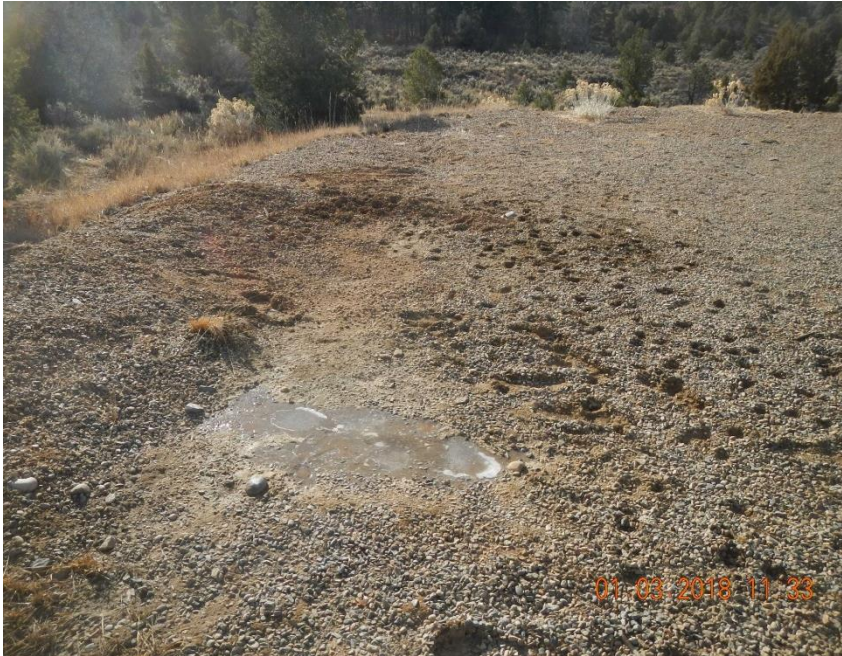
Area where release may have occurred.

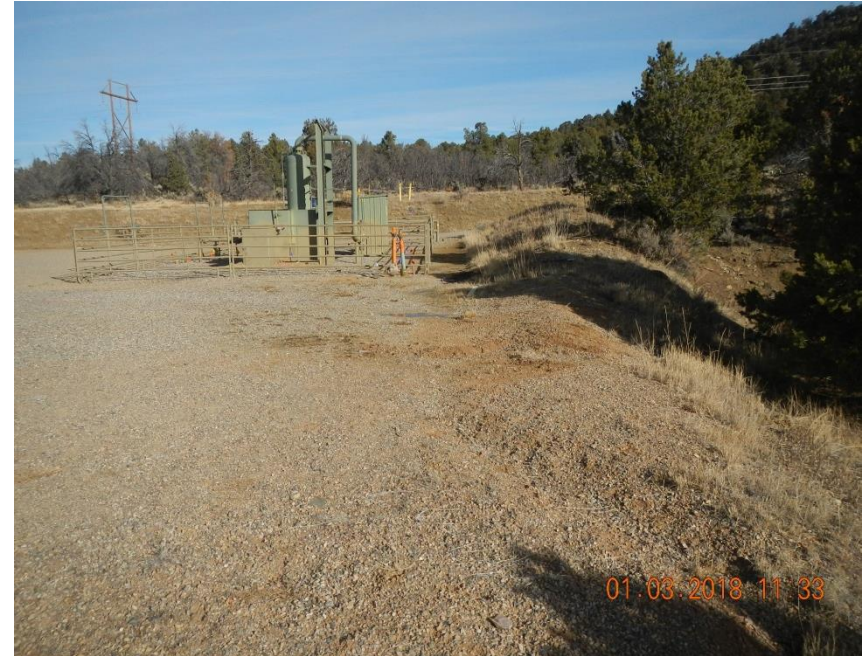
Area down gradient of previous picture.

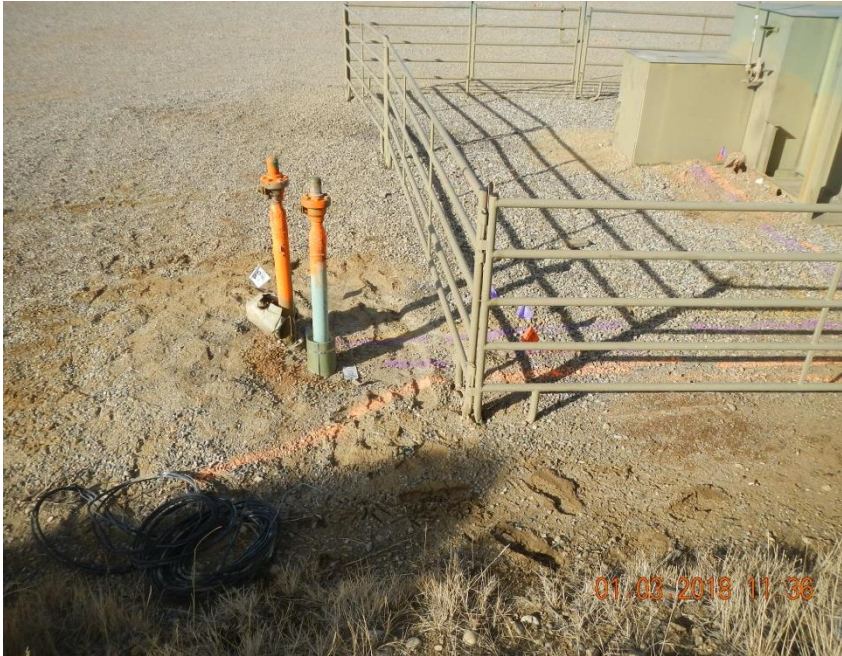
Disturbed area where release may have occurred.

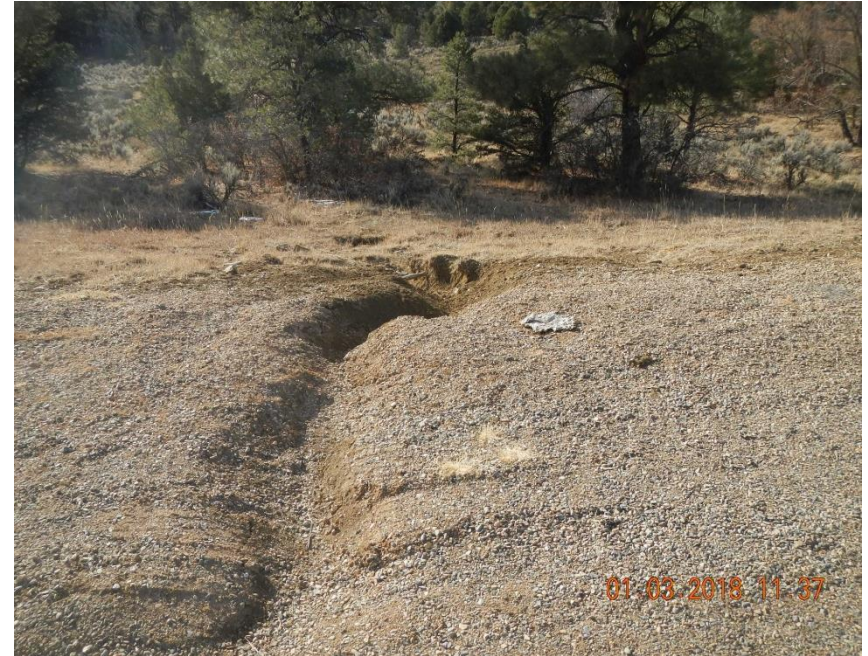
Erosional channel along southern edge of location.
