**Inspection Photos**  
**Location Name: Black 21-22 #4**  
**API: 05-067-09600**

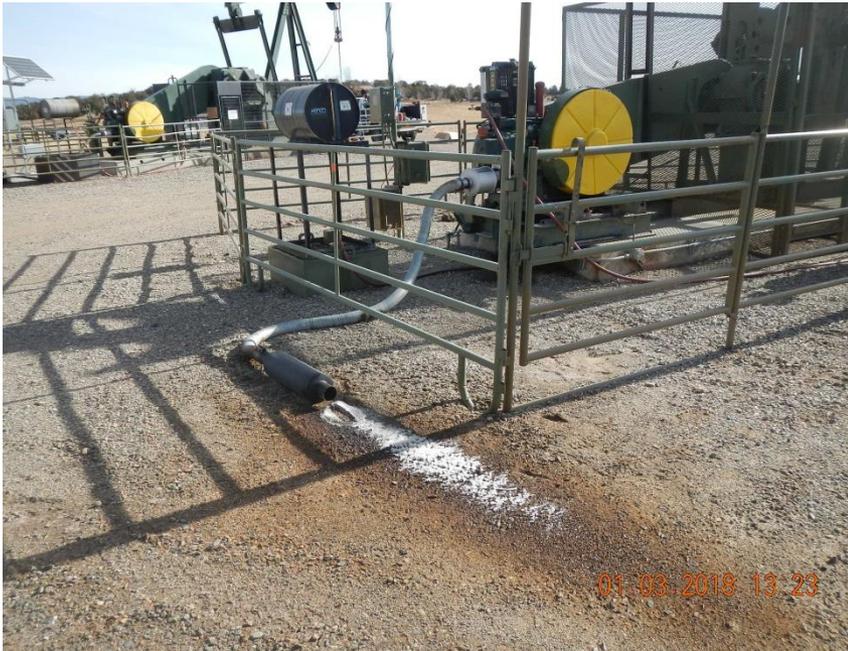
**Stained soil and gravel near muffler exhaust for #2 prime mover.**

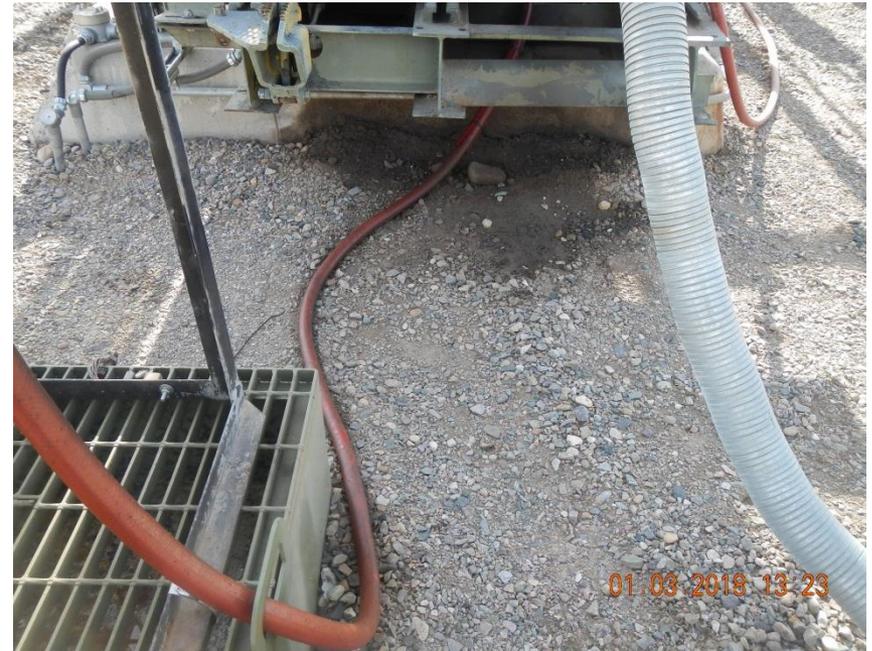
**Stained soil beneath prime mover for #2 pump jack.**

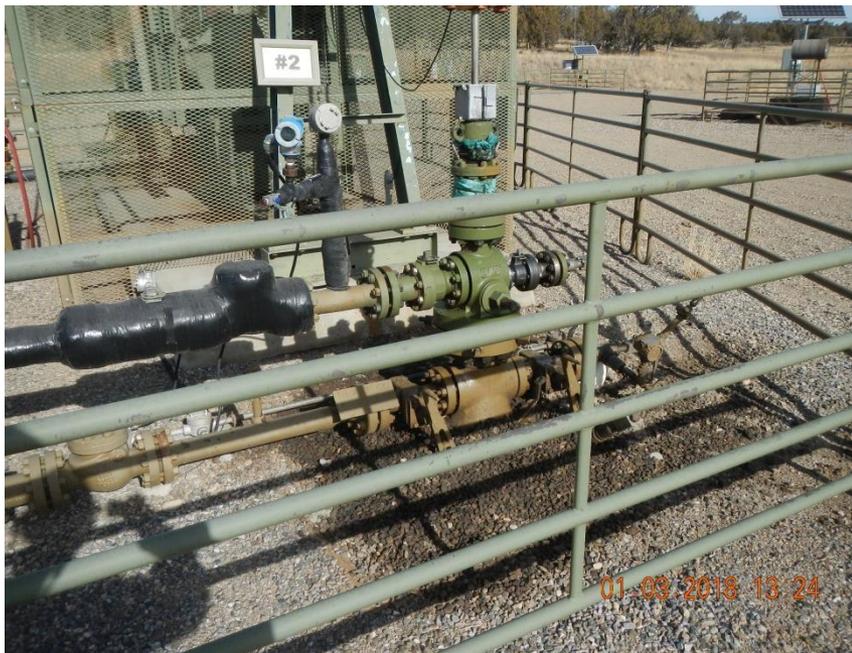
**Stained soil around #2 well head. Absorbent rags tied to well head are saturated.**

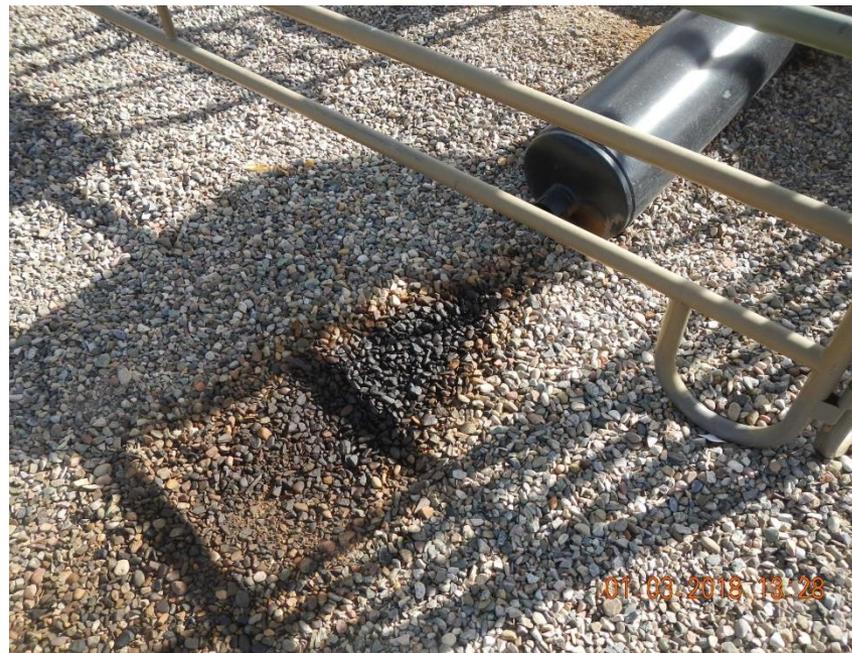
**Stained soil and gravel near muffler exhaust for #4 prime mover.**

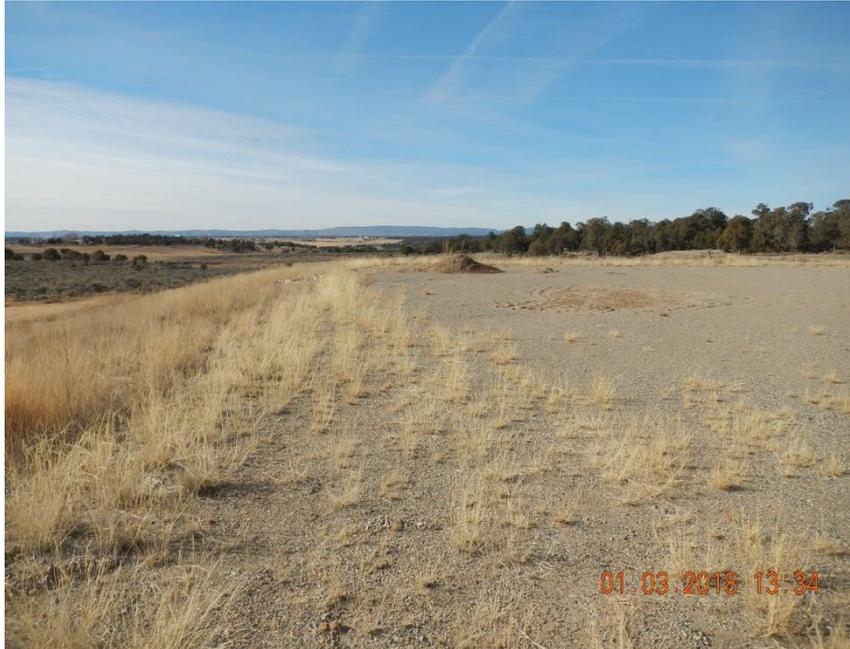
**Dirt pile in SW corner of location.**
