Inspection Photos

Operator: DECLAR OIL & GAS INC - 23320

Location ID: 404096

Inspection Doc. Number: 682503015

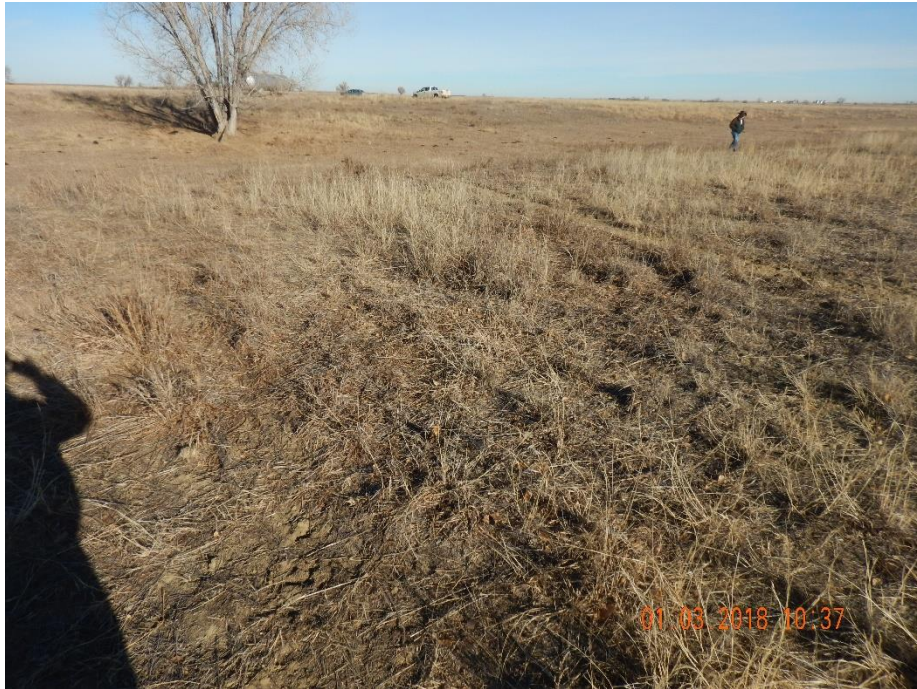
Photo 1: Photo taken from the well location, facing north.

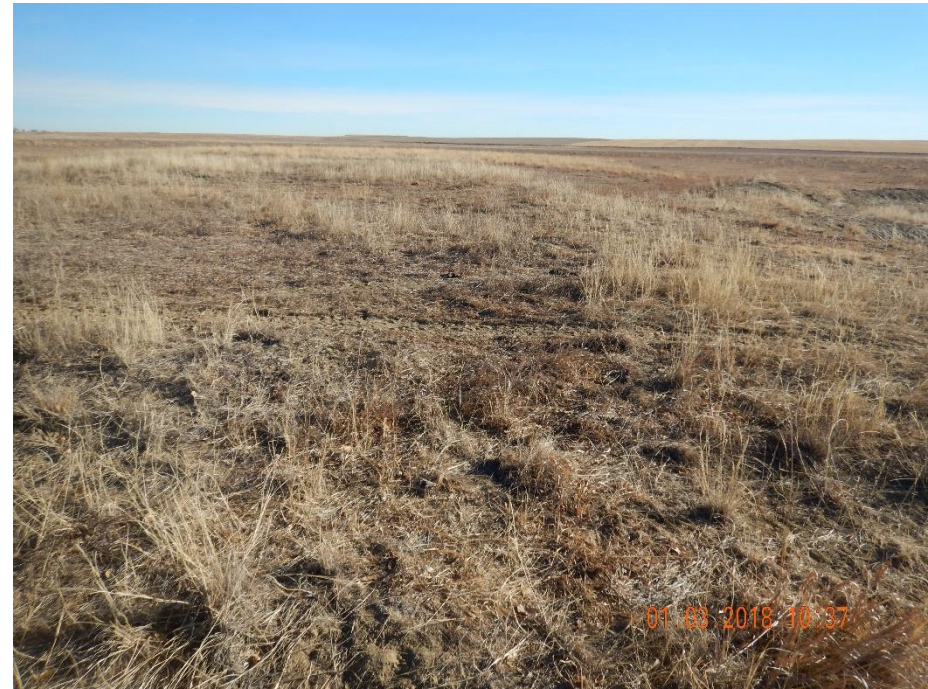
Photo 2: Photo taken from the well location, facing east.

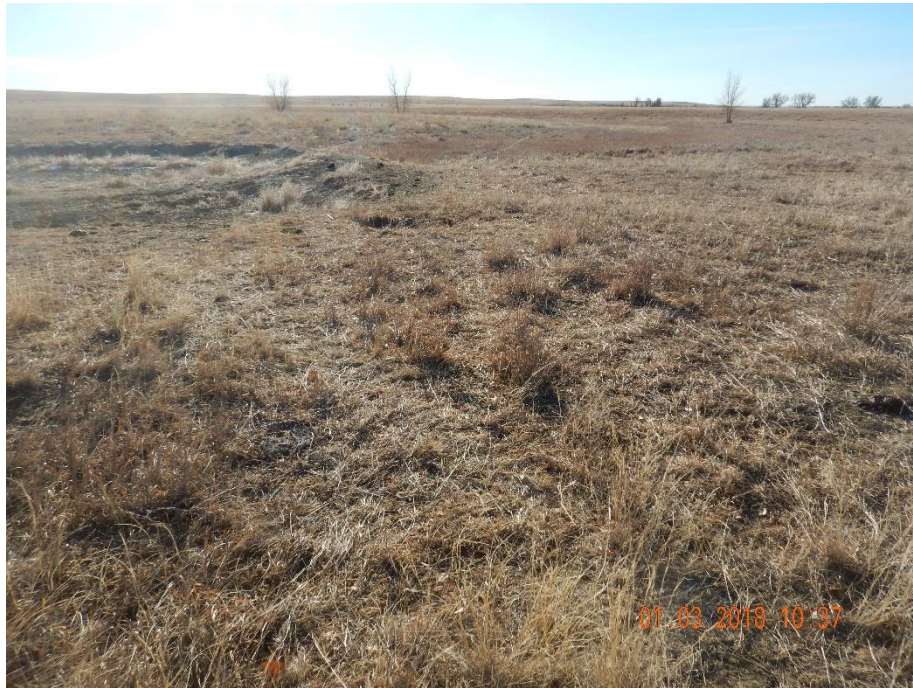
Photo 3: Photo taken from the well location, facing south.

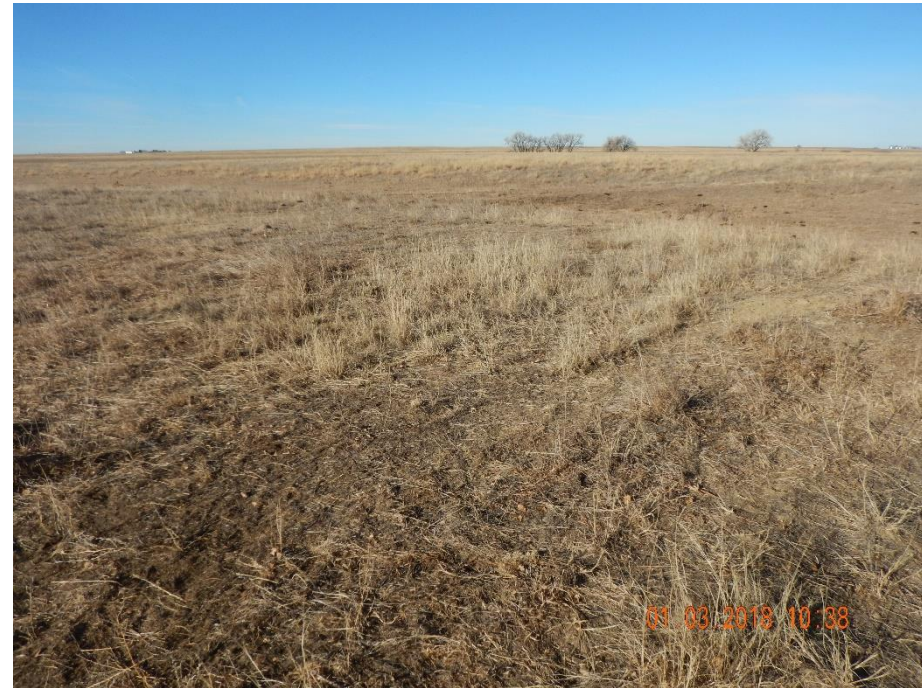
Photo 4: Photo taken from the well location, facing west.

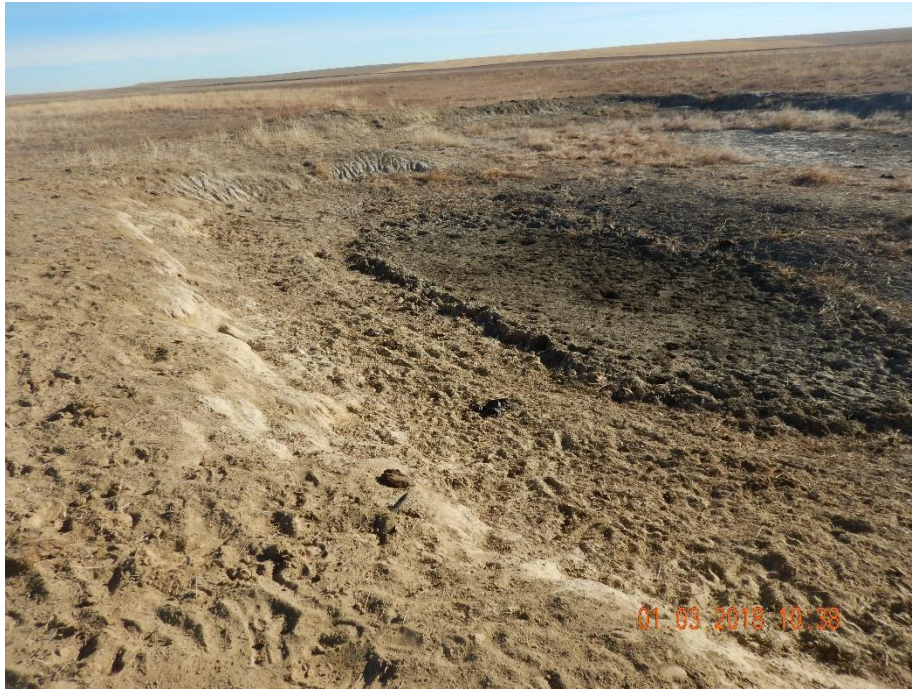
Photo 5: Photo taken from the west end of the pit, facing east. Photo shows pit on location. Form 27 #2086957 required operator to sample and submit results, and close pit. Pit has not been closed or reclaimed, and no records that sample results have been submitted.

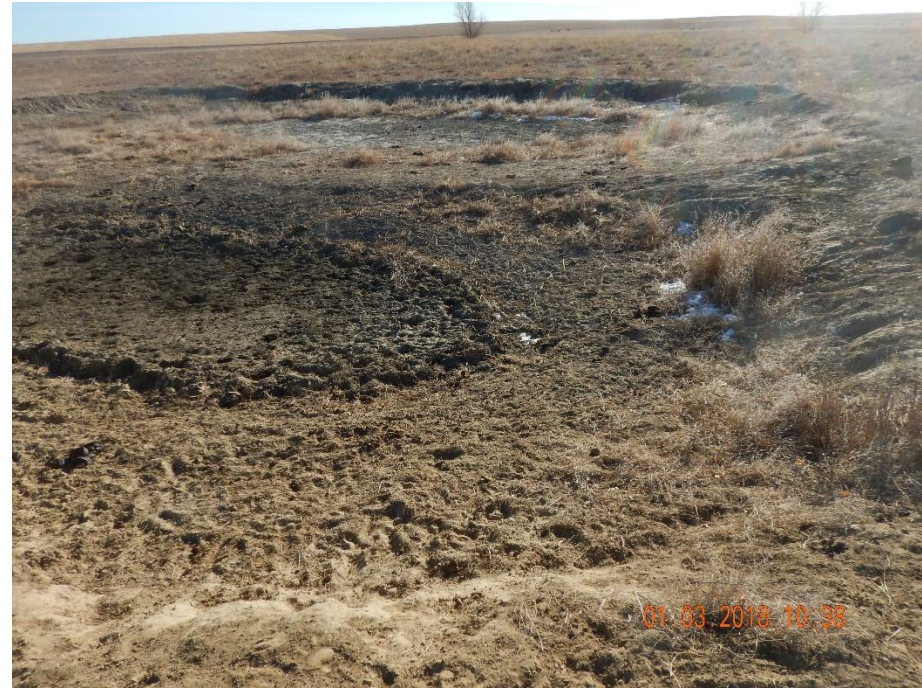
Photo 6: Photo taken from the west end of the pit, facing northeast. See comments under photo 5.

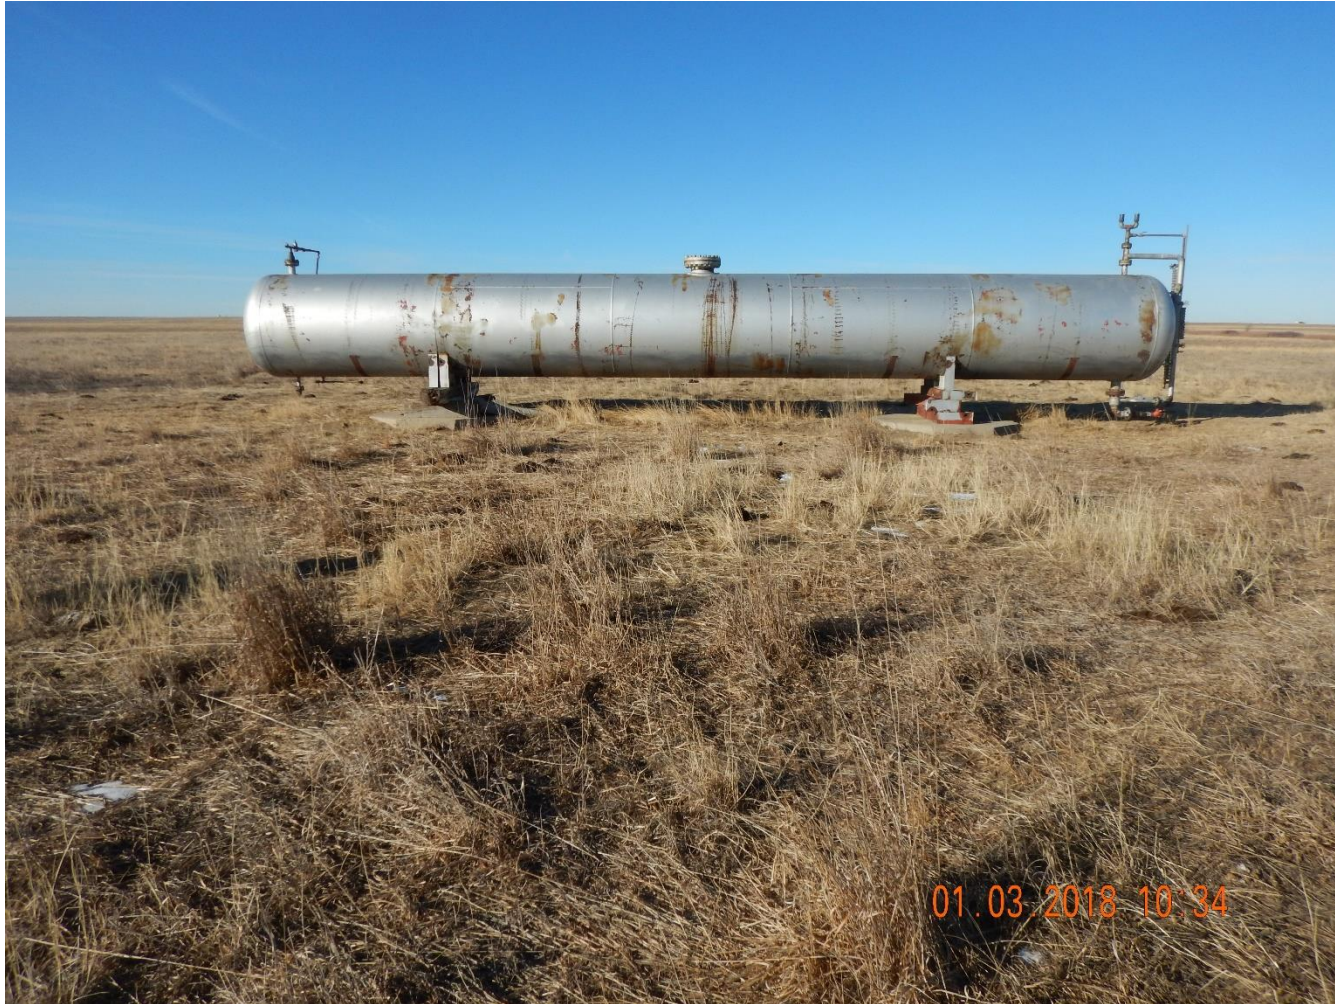
Photo 7: Photo taken from the north end of the location, facing west. Photo shows a ~50 foot “Propane Storage Tank” remaining on the location. Equipment should have been removed in accordance to 1004.a. COAs for form 27 #2086957 also required removal of equipment.

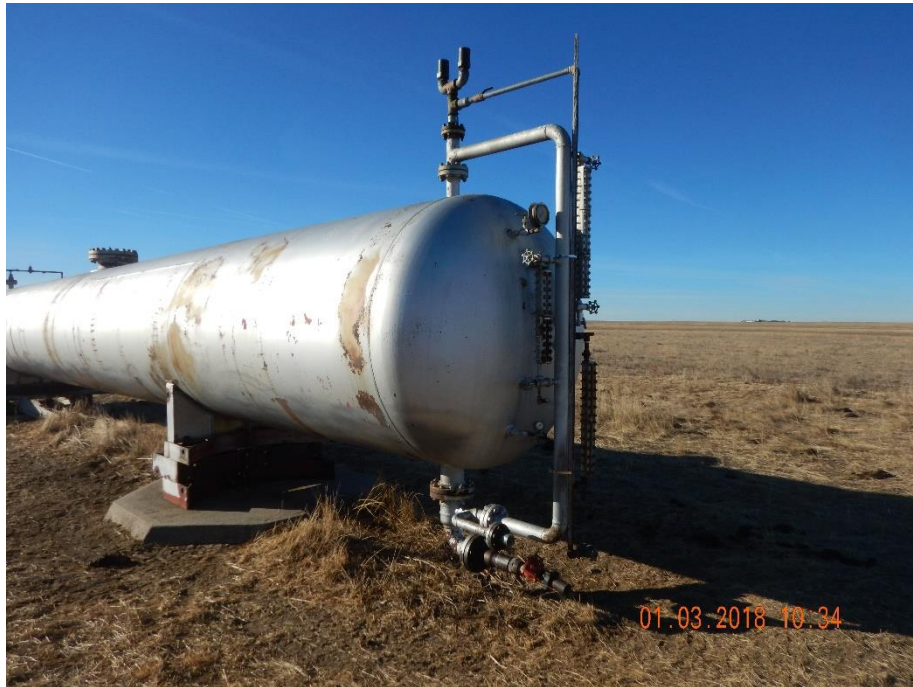
Photo 8: Photo taken from the north end of the tank seen in photo 7, facing southwest.

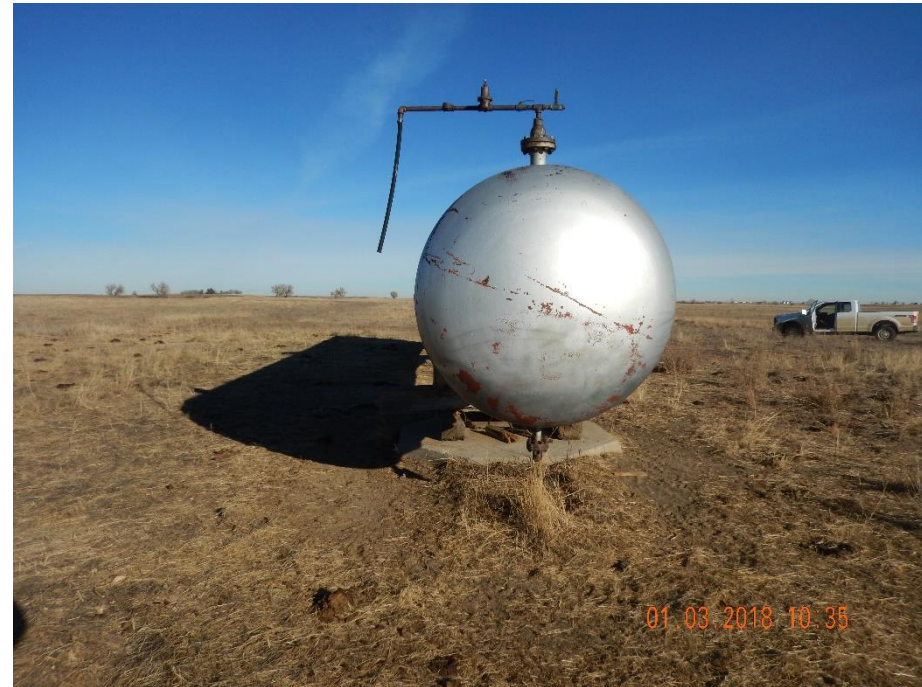
Photo 9: Photo taken from the south end of the tank seen in photo 7, facing north.

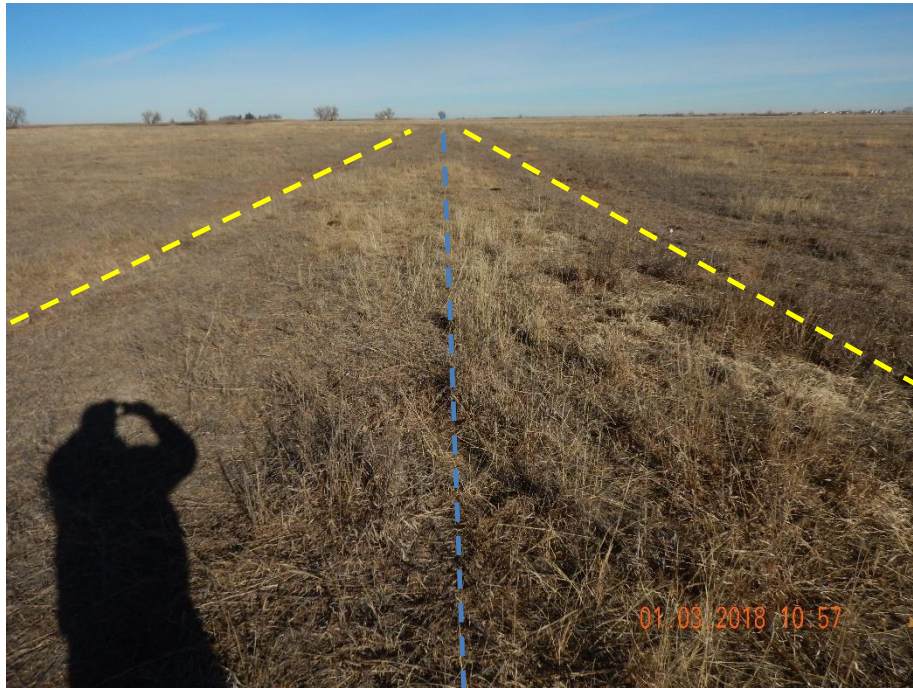
Photo 10: Photo taken from the north end of the location, facing north. Photo shows access road has not been reclaimed in accordance to COGCC 1004.a reclamation requirements. Access road appears to be requiring grading and re-contouring to that of the adjacent reference area. Yellow lines indicate the access road's stormwater ditch running parallel to the road (blue line represents top of access road)

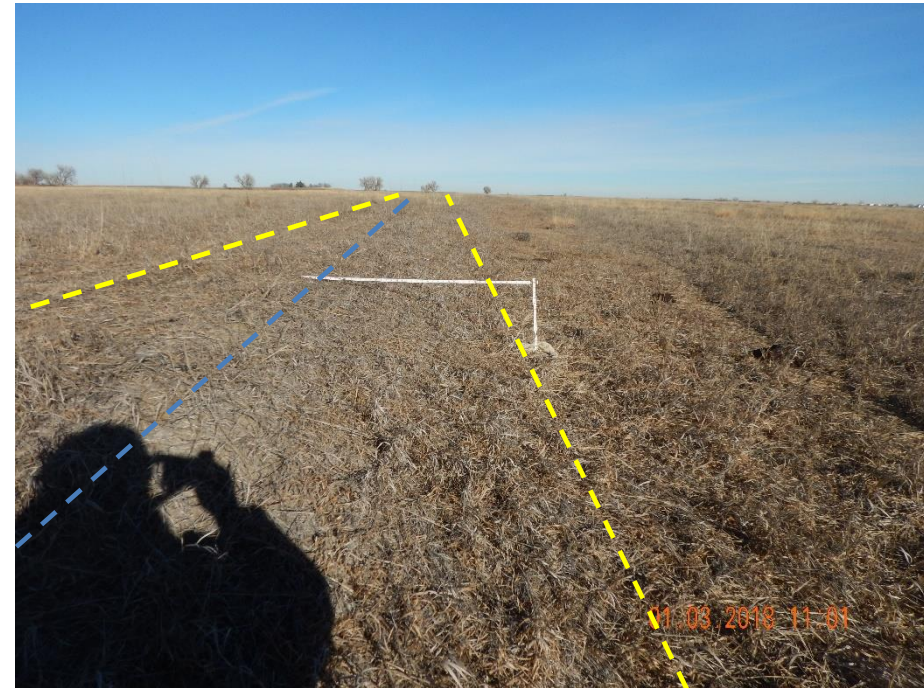
Photo 11: Continued from photo 10. Photo shows access road has not been graded and re-contoured to that of the adjacent reference area. Measuring stick used to provide topographical visual of the access road. Access road measures ~1.5 feet in height from the ditch at this section of the road

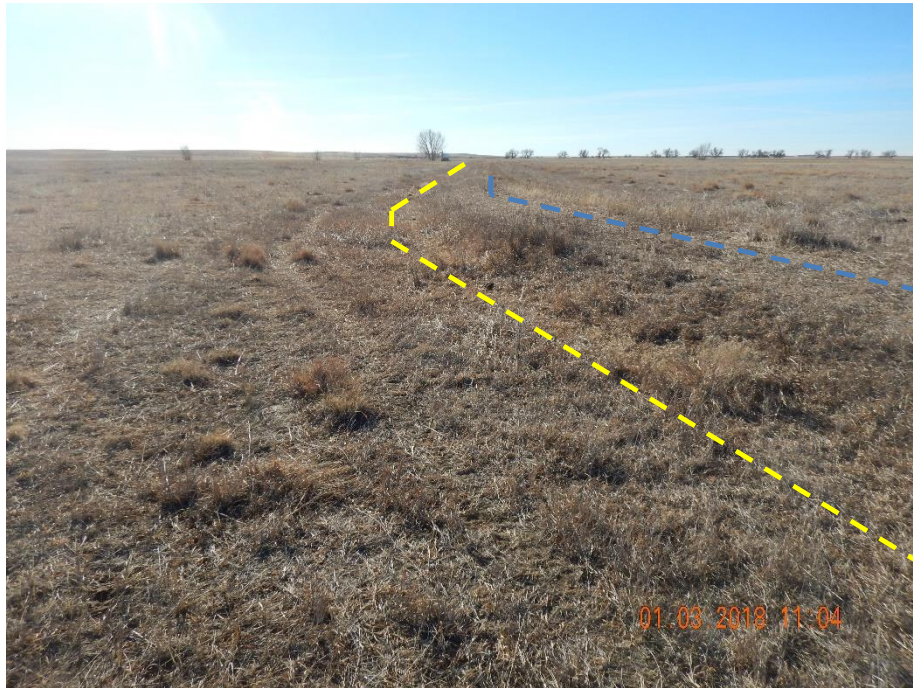
Photo 12: Photo taken north of the location, facing south. Photo shows access road. See comments under photo 10.

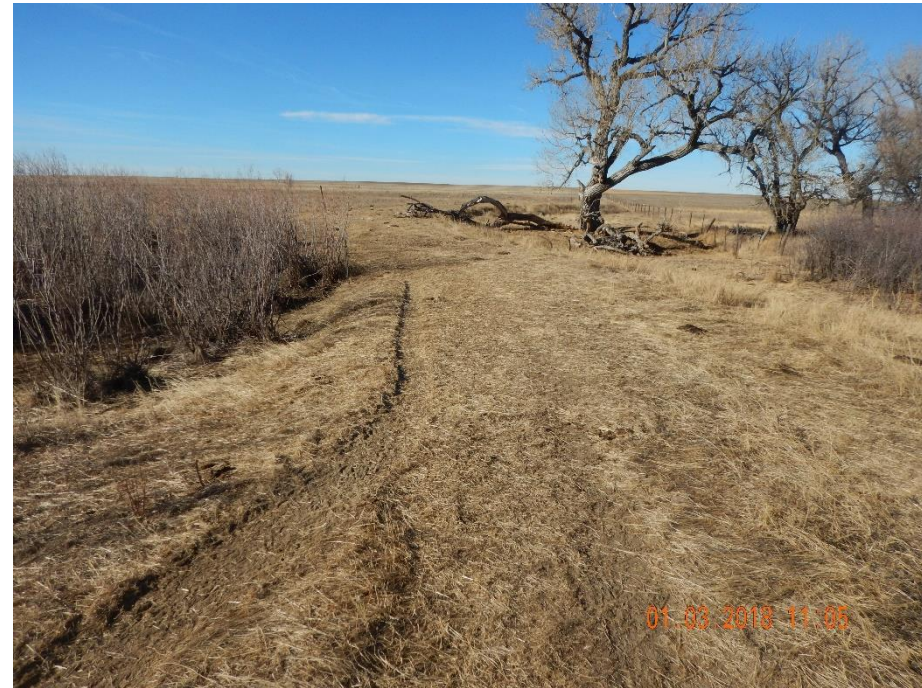
Photo 13: Photo taken north of the location, facing west. Photo shows access road. See comments under photo 10.

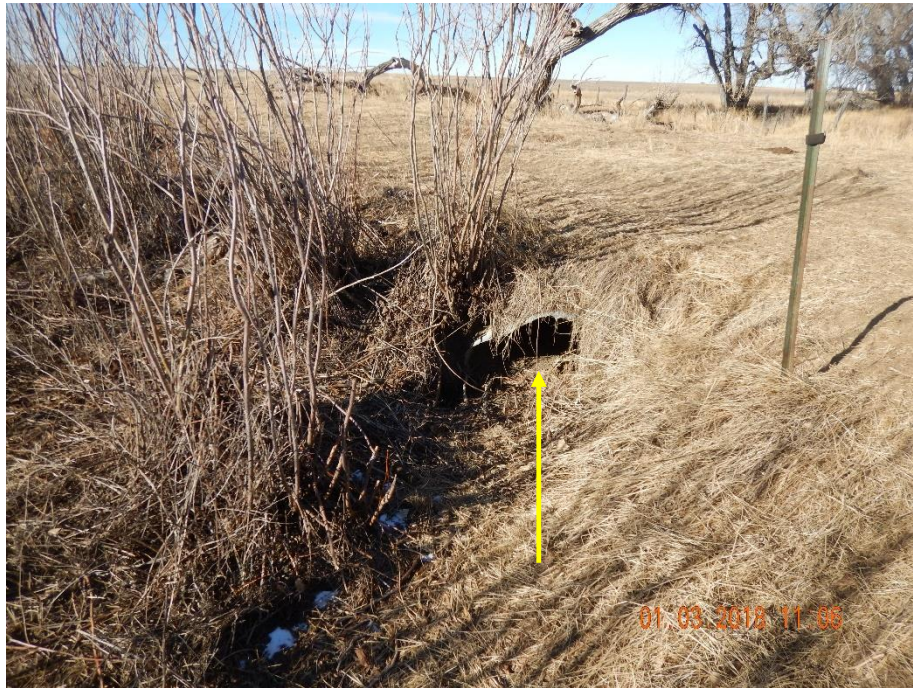
Photo 14: Photo taken from access road, north of the location. Photo shows access road has not been reclaimed and culverts (yellow arrow) have not been removed.

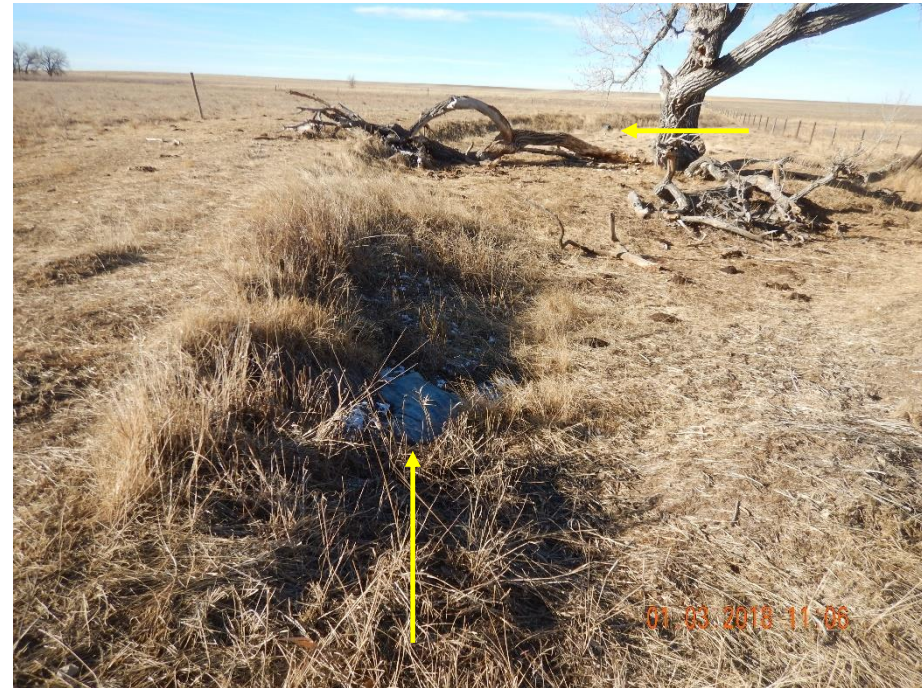
Photo 15: Photo taken from access road, north of the location. Photo shows access road has not been reclaimed and culverts (yellow arrow) have not been removed.

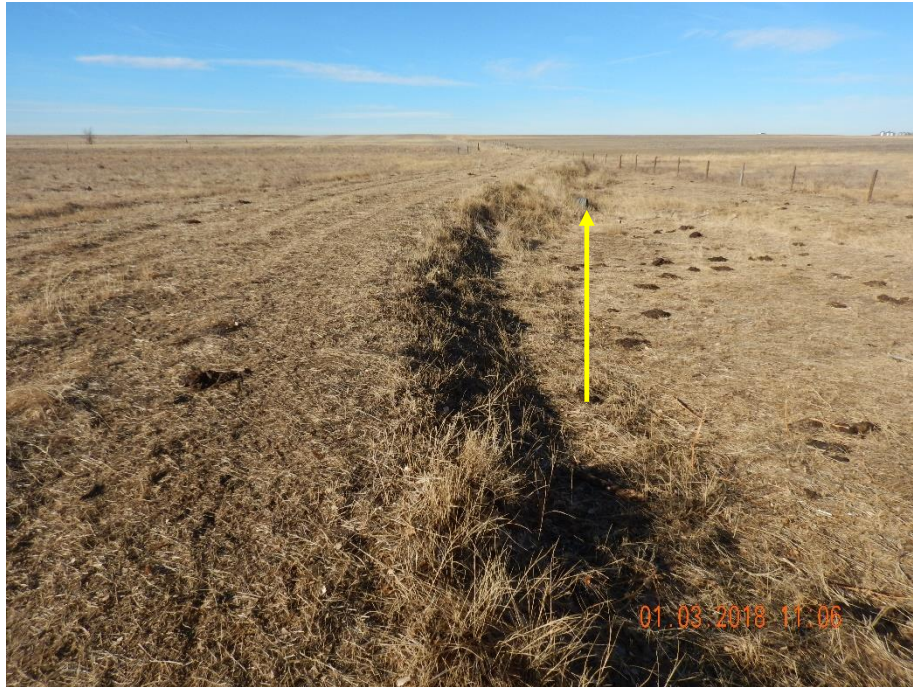
Photo 16: Photo taken from access road, north of the location, facing west. Photo shows access road has not been reclaimed and culverts (yellow arrow) have not been removed.

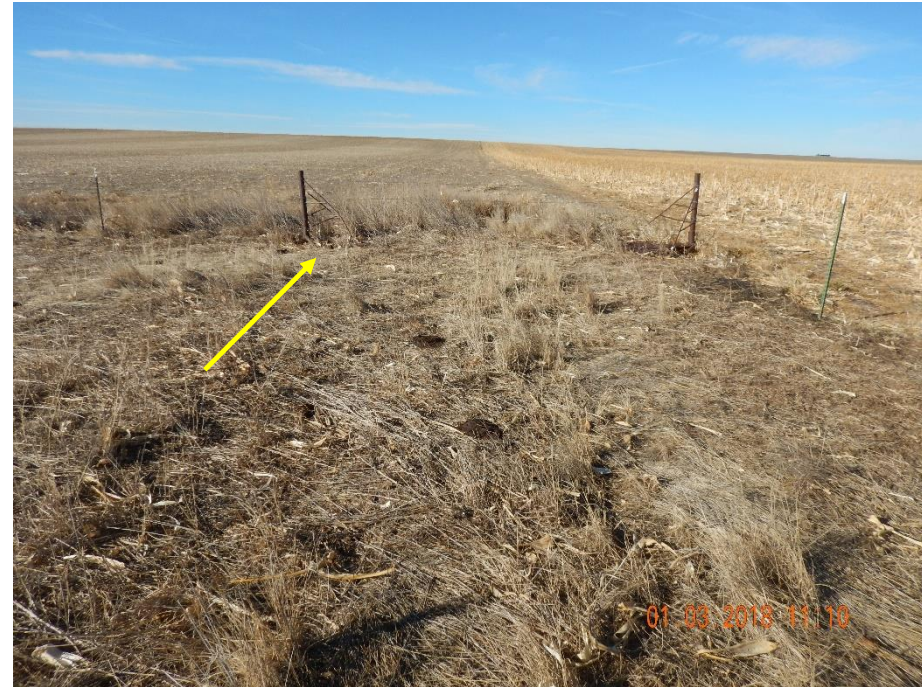
Photo 17: Photo taken from the western most end of the access road (where access road ends at the start of an adjacent property) facing west. Photo shows cattle guard equipment has not been removed.

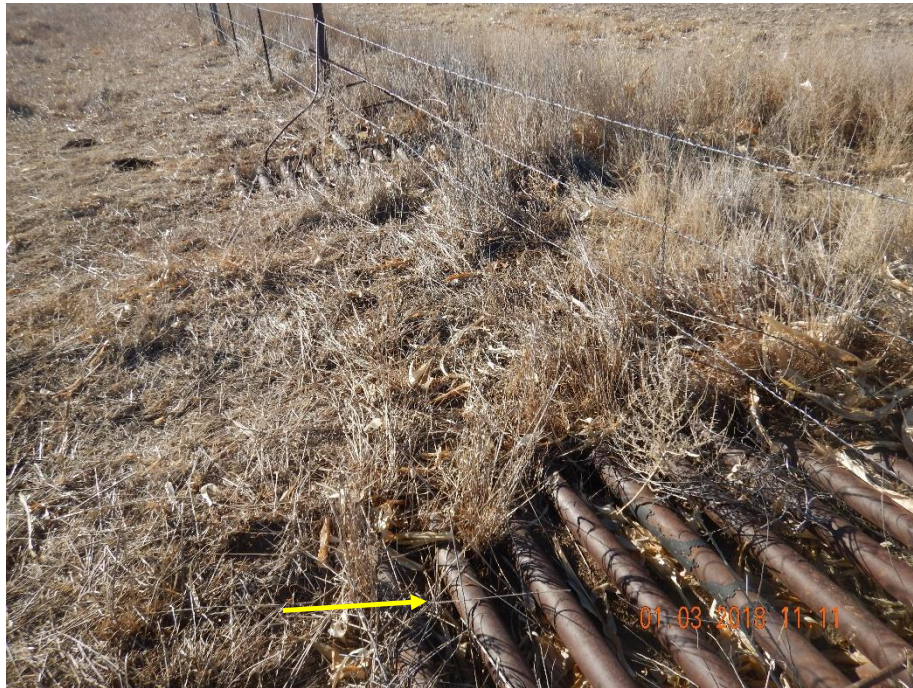
Photo 18: Continued from photo 17. Photo shows point where the un reclaimed access road ends. Photo also shows cattle guard has not been removed.

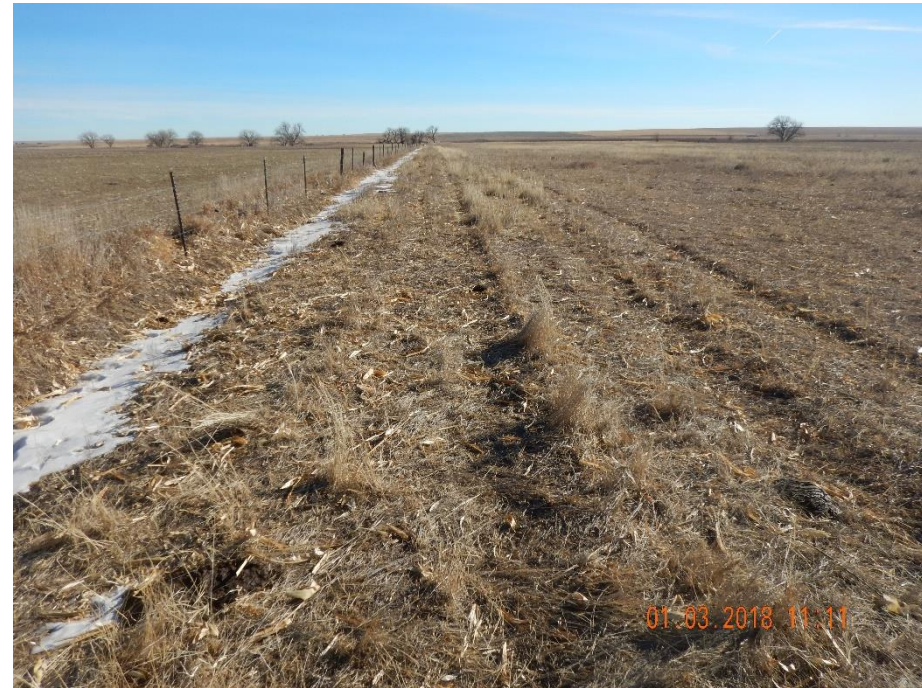
Photo 19: Photo taken from the western most end of the access road (where access road ends at the start of an adjacent property) facing east. Photo shows access road has not been reclaimed in accordance to 1004.a

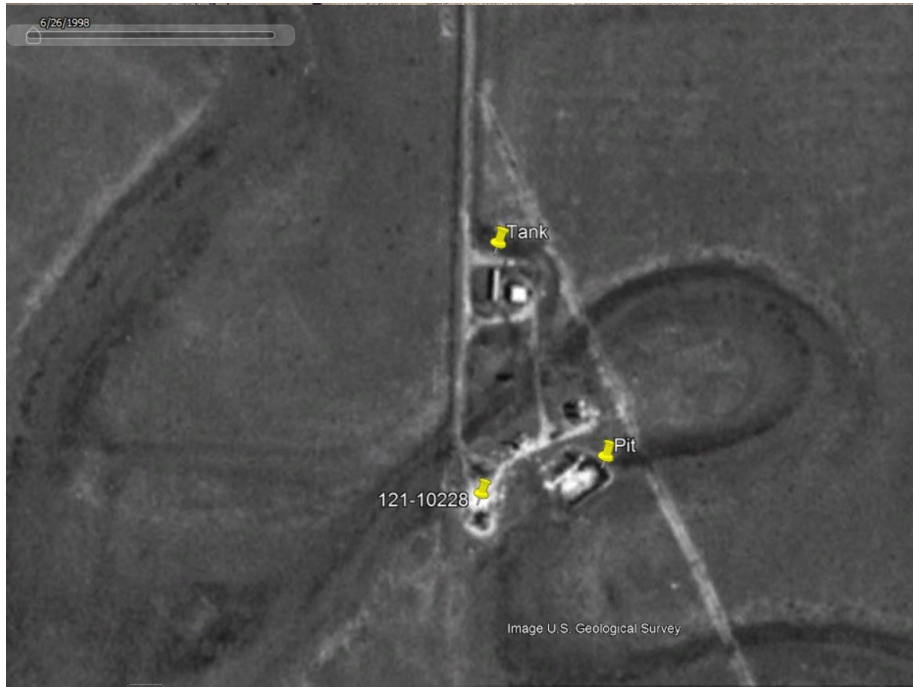
Photo 20: Historic aerial imagery (1999). Photo shows location of the well, pit and facilities prior to plugging and abandonment.

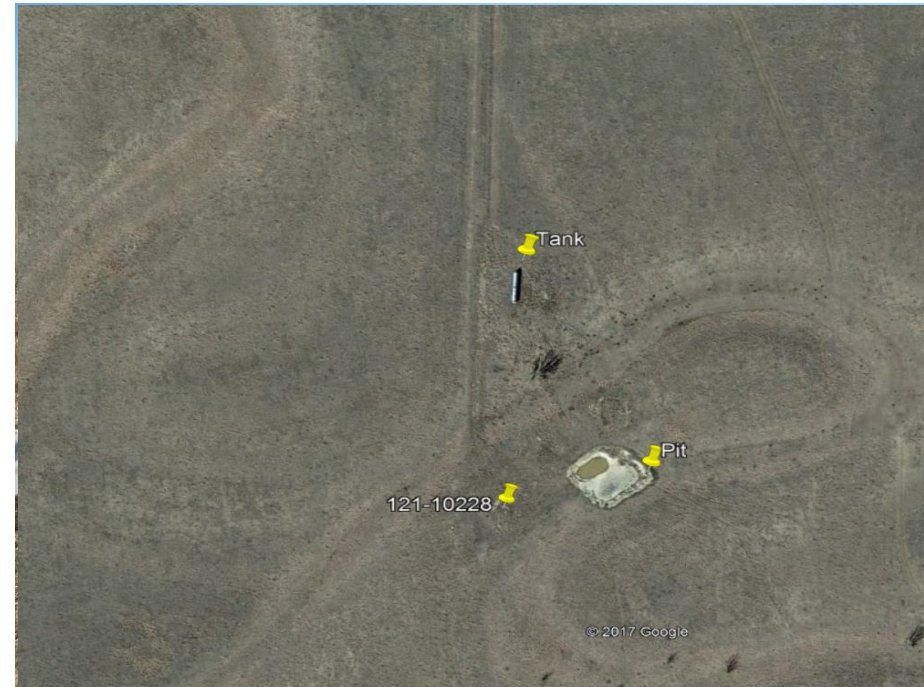
Photo 21: Current available aerial imagery (2016). Photo shows tank and pit seen in photo 21 remains visible. Well was plugged and abandoned on 4/4/2008. All reclamation activities should have been completed by 4/4/2009.

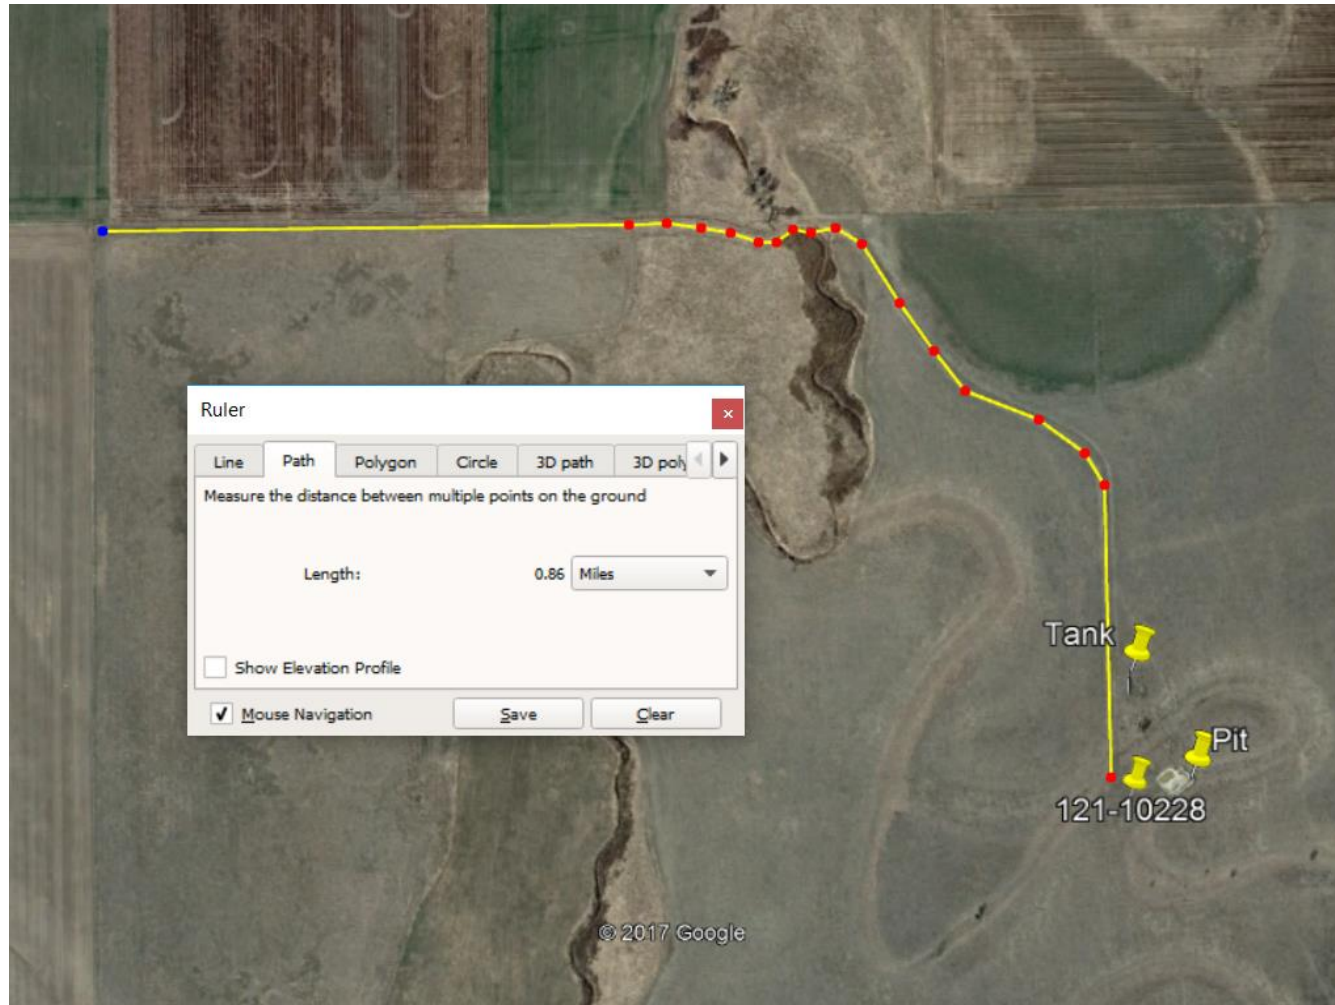
Photo 22: 2016 aerial imagery. Photo shows ~0.86 miles of access road requiring reclamation.
