Interim Reclamation and Stormwater Inspection

January 3, 2018

Operator: GADECO LLC- #10673

Location Name: Grynberg Stateline Federal /24-12-65-4 Pad

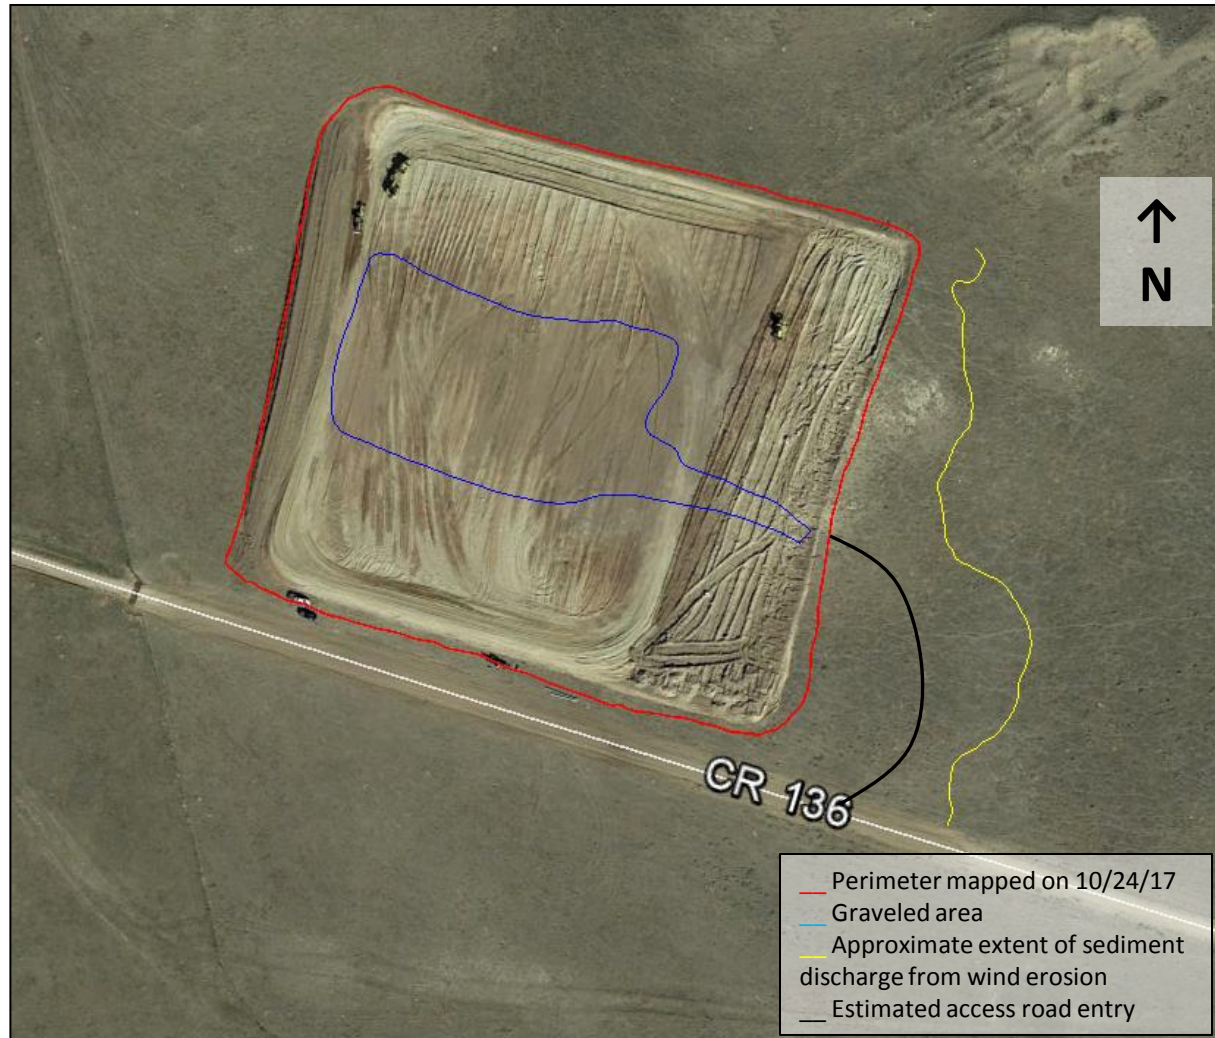
Google Earth aerial imagery taken October 14, 2017. This image does not illustrate the total disturbance with the access road. Sediment discharge was easily observed up to 110' east of the location perimeter but has discharged further. A Trimble Juno 3B handheld device was used to map the features, minus the access road which was estimated.

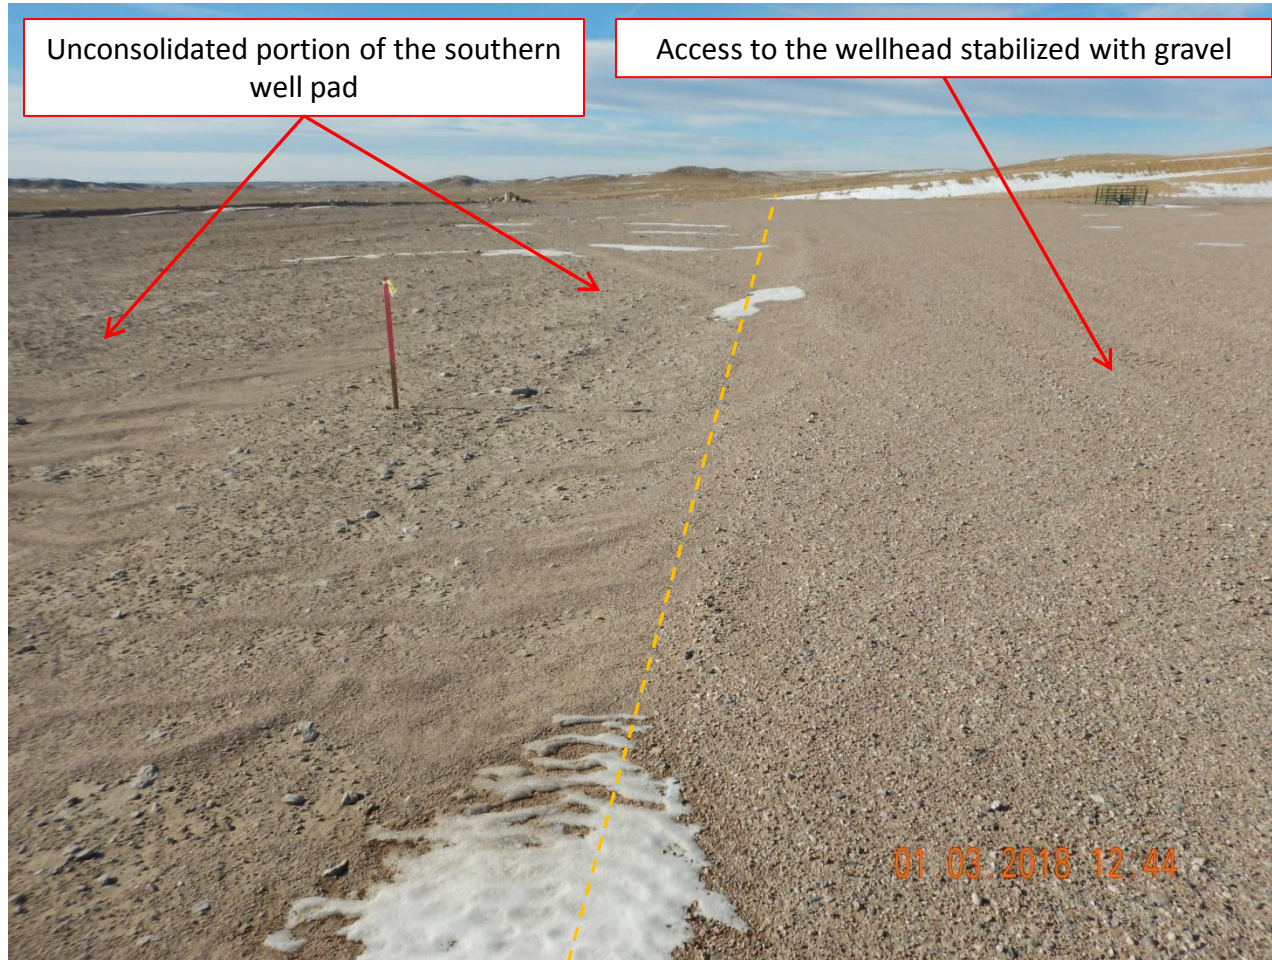
Photo 1. Photo taken from the east central well pad, facing West on January 3, 2018. Sediment discharge off location is evident due to wind erosion from unconsolidated soil material from the well pad. Operator has only stabilized a portion of the well pad with gravel for access to the wellhead and around the wellhead. All other areas of the well pad have been left unconsolidated which appear to be the cause of wind erosion off location.

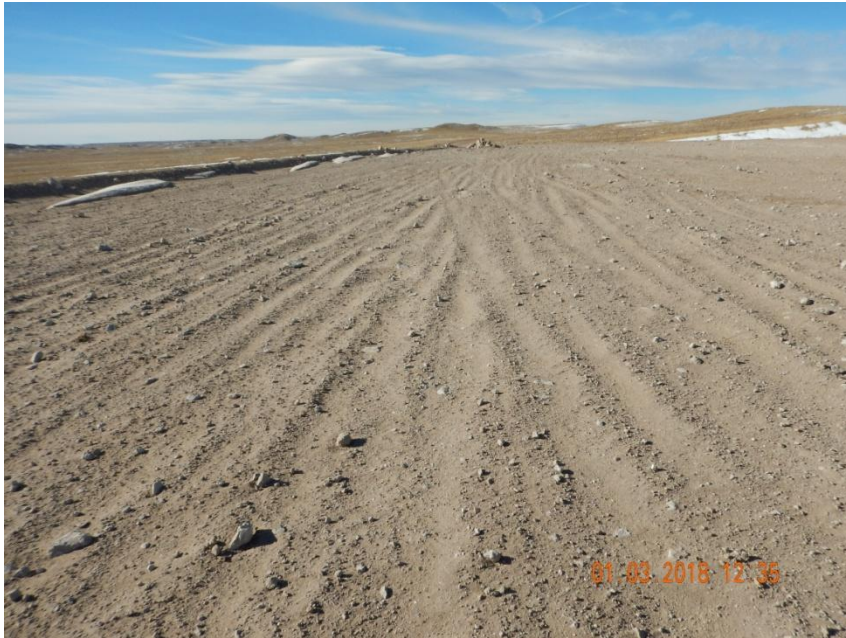
Photo 2. Photo taken from the southern well pad, facing West on January 3, 2018. The southern and northern well pad areas have not been stabilized and left unconsolidated which appears to be the cause of wind erosion off location.

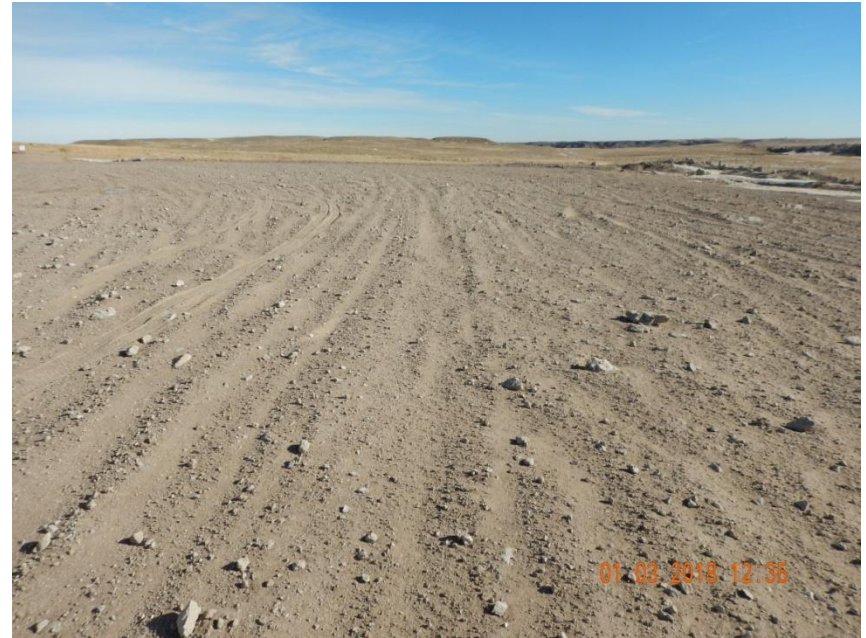
Photo 3. Photo taken from the southern well pad, facing East on January 3, 2018. See comments under Photo 2.

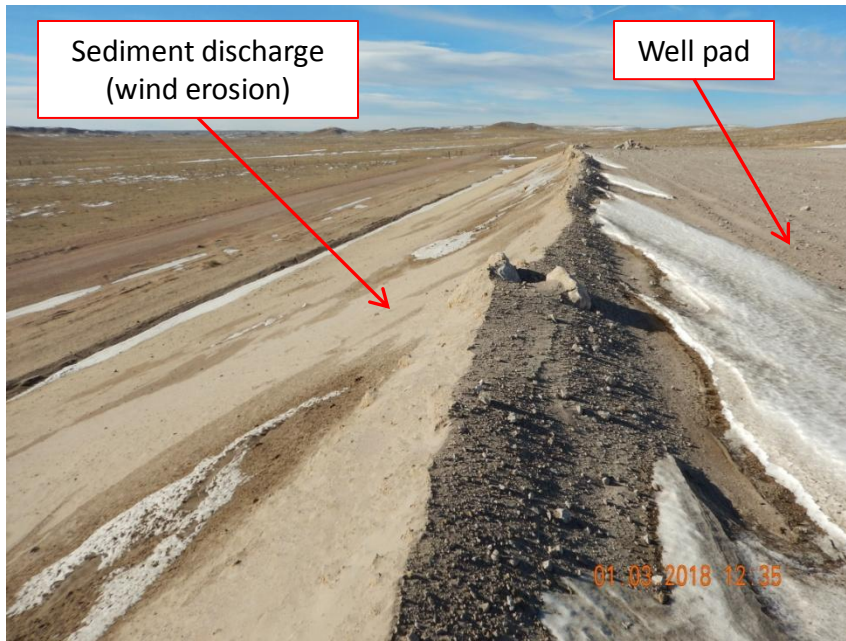
Photo 4. Photo taken from the southern well pad, facing West on January 3, 2018. See comments under Photo 2.

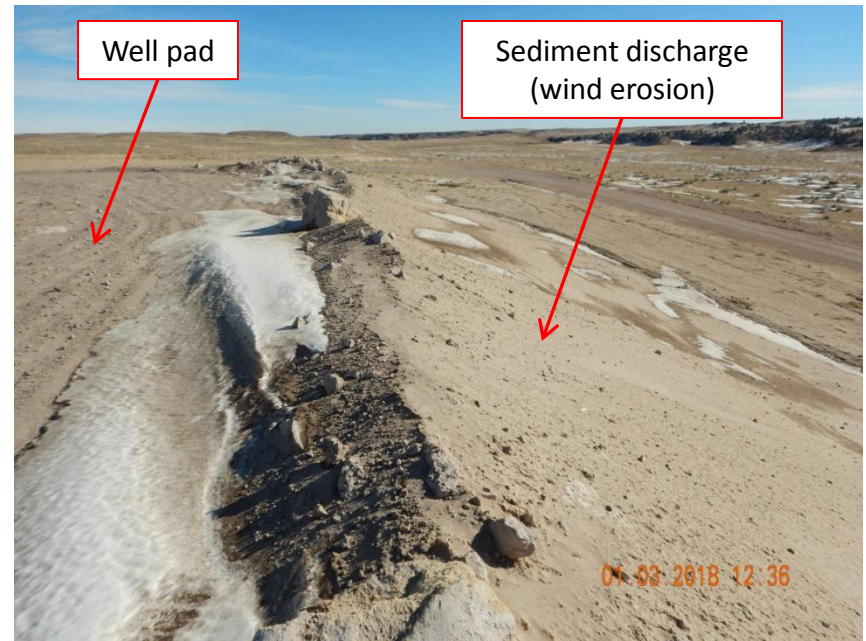
Photo 5. Photo taken from the southern well pad, facing East on January 3, 2018. See comments under Photo 2.

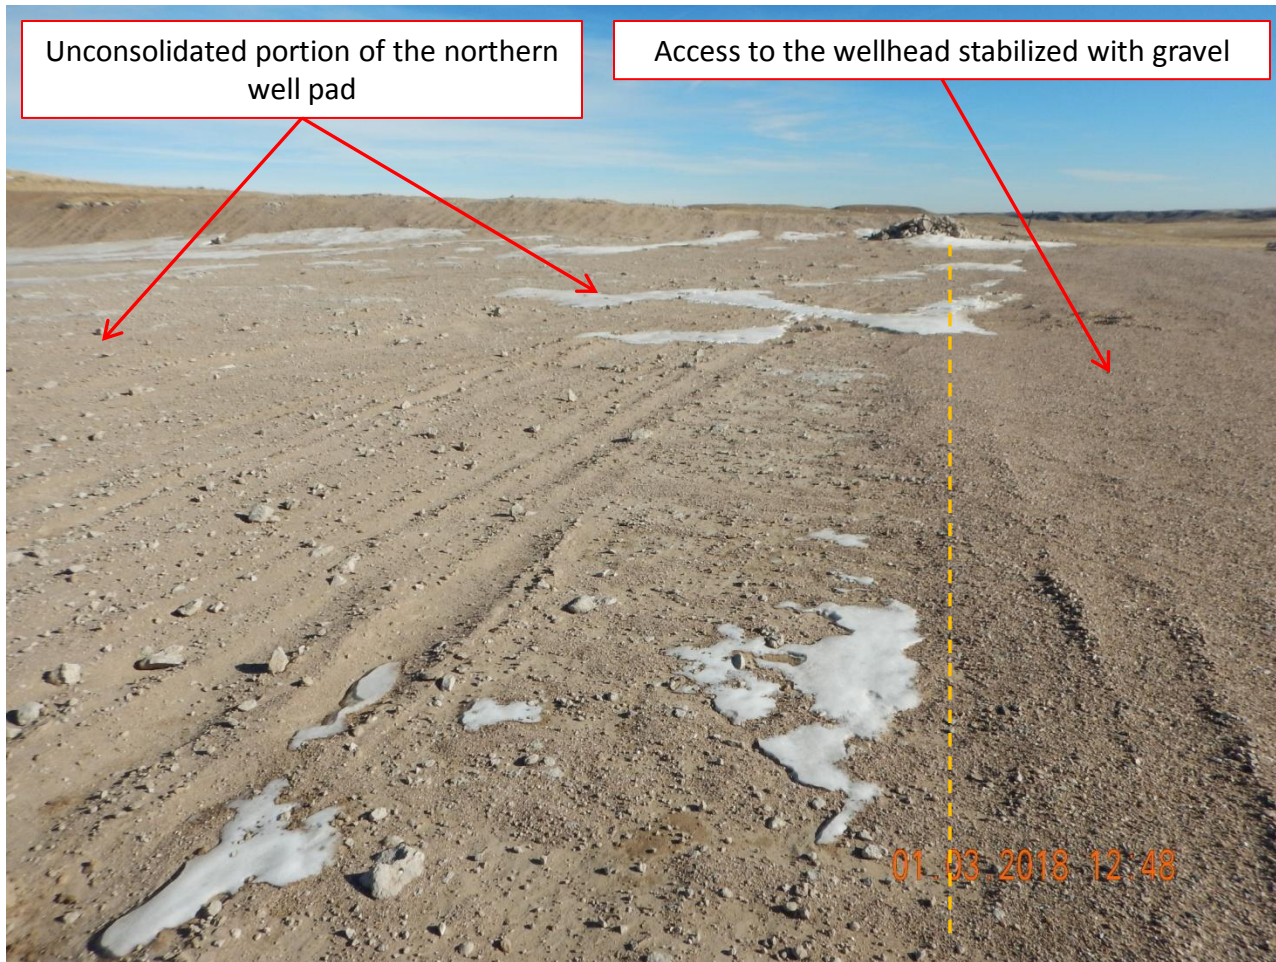
Photo 6. Photo taken from the eastern well pad, facing East on January 3, 2018. See comments under Photo 1.

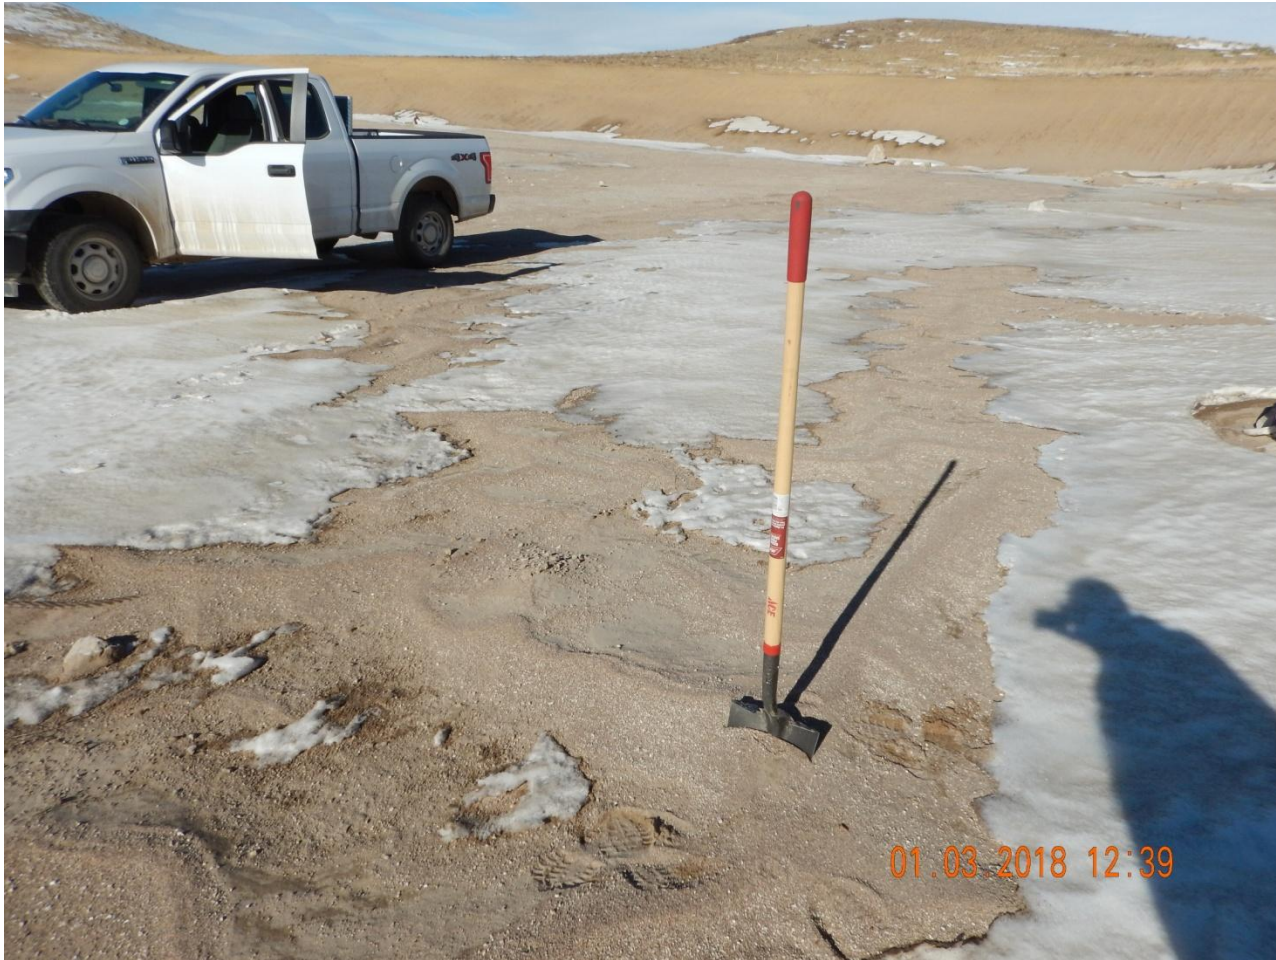
Photo 7. Photo taken from the east well pad, facing North on January 3, 2018. Photo illustrates accumulation of unconsolidated soil material from the well pad which is contributing to sediment discharge off location.

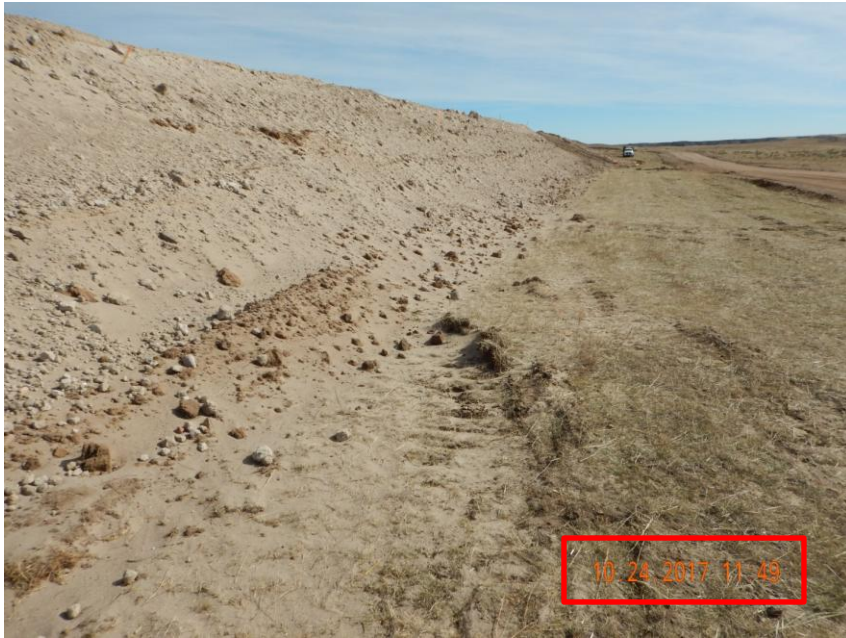
Photo 8. Photo taken from the southwest location, facing East on October 24, 2017.

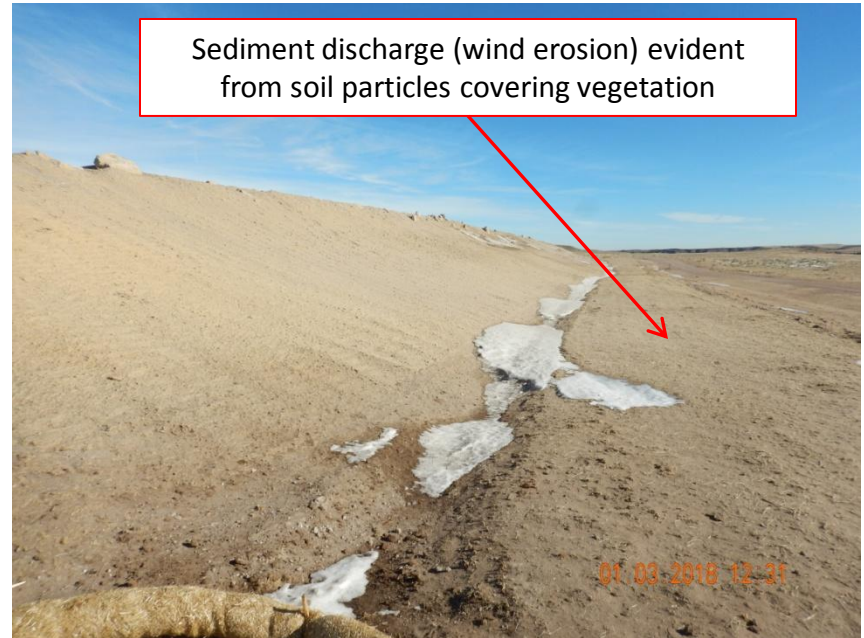
Photo 9. Photo taken from the southwest location, facing East on January 3, 2018. Since the October inspection, it appears the Operator has tracked the fill slope and applied a hydromulch. However, sediment discharge off location is evident due to wind erosion from unconsolidated soil material from the well pad. Sediment material is being deposited onto vegetation off location. Ditch BMP along the perimeter is in need of maintenance and have not been properly installed.

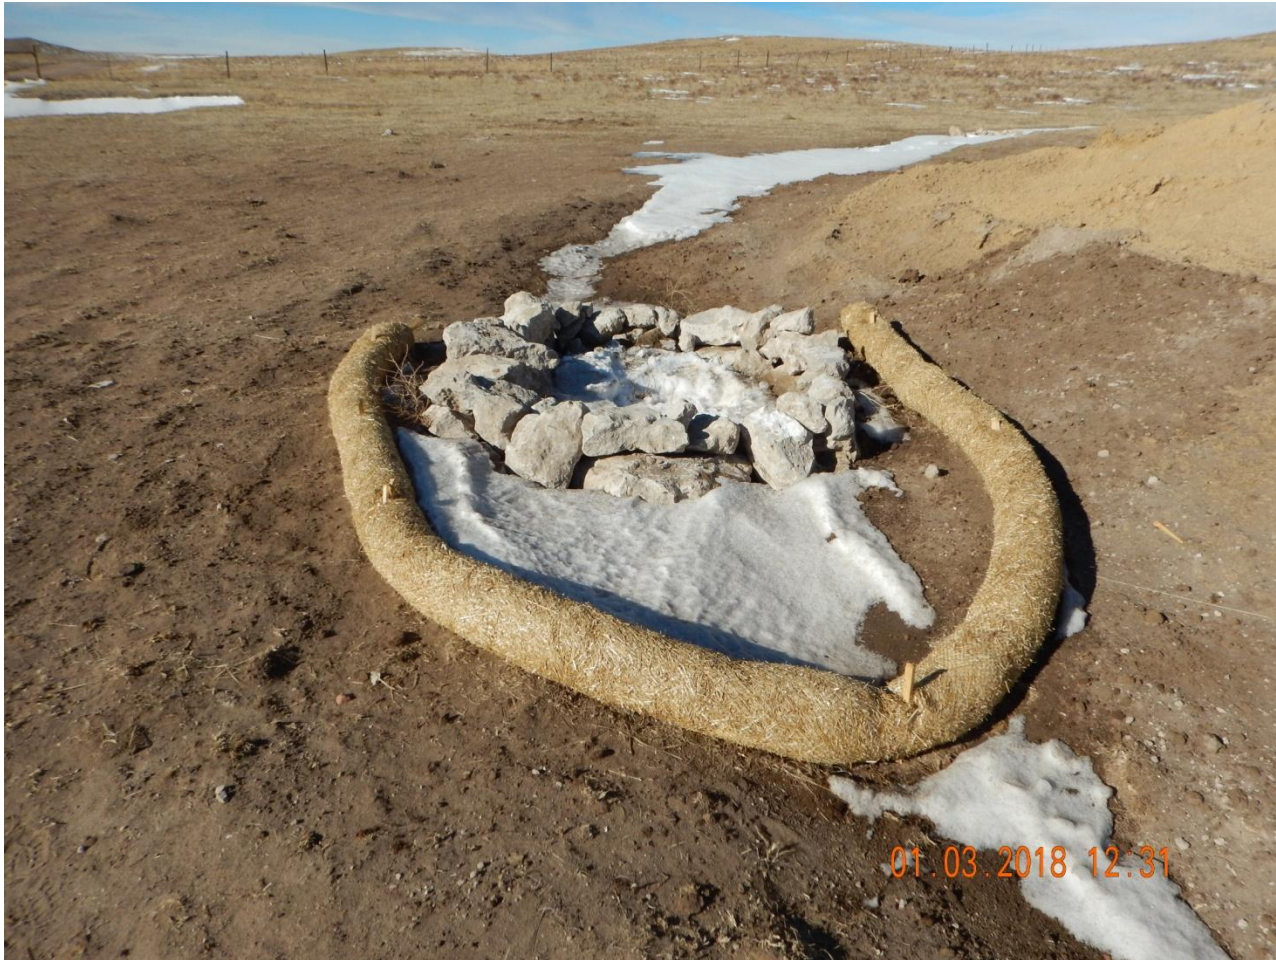
Photo 10. Photo taken from the southwest location, facing West on January 3, 2018. Operator has not installed a sufficient sediment trap for a total disturbance of 9.29 acres (Document #401464525 still IN-PROCESS). Sediment trap size is ~3'x3'x2' and was the only observed sediment trap at location. In addition, the sediment trap has not been installed with good engineering practices.

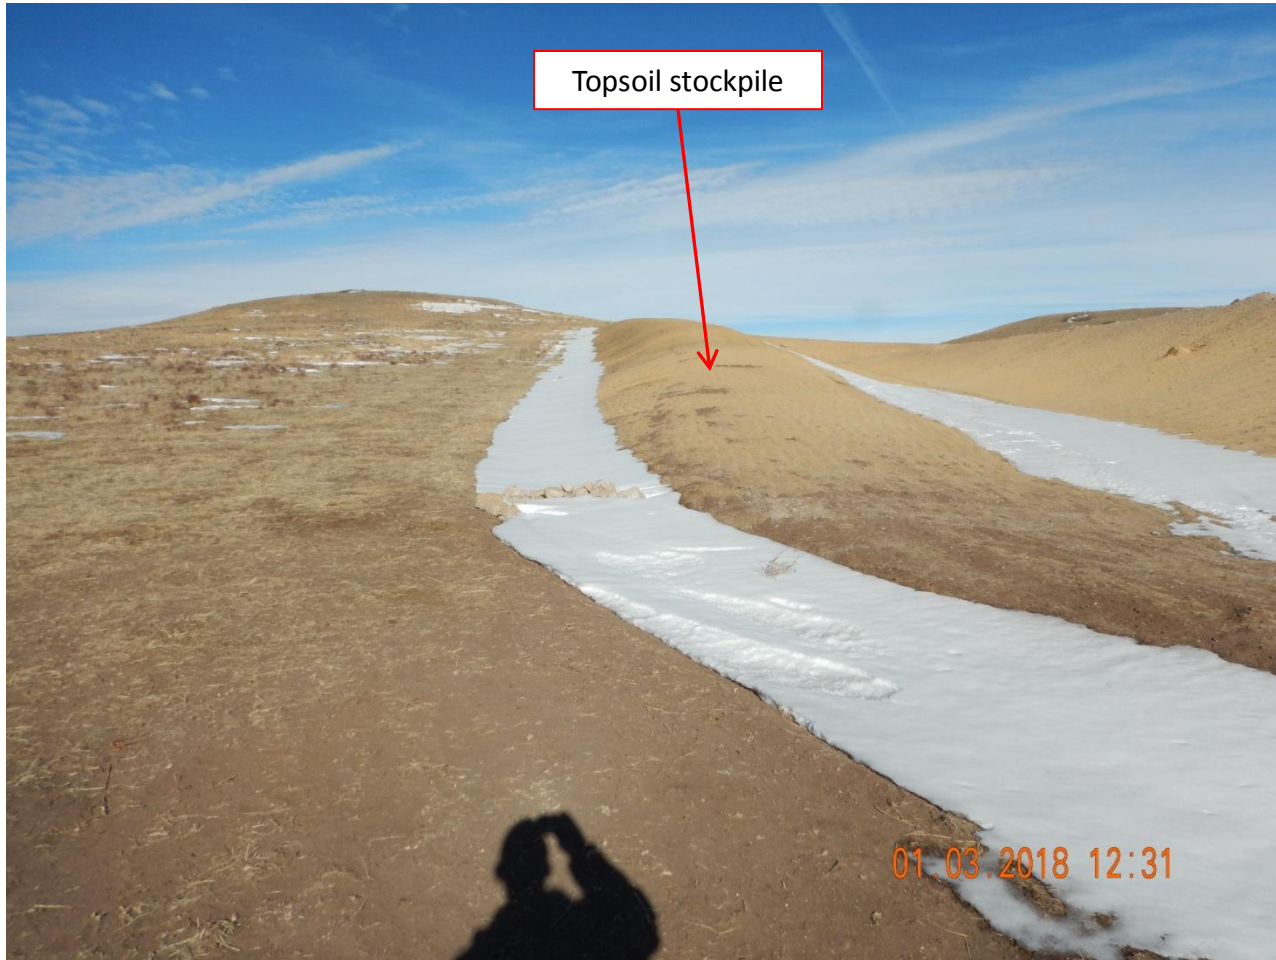
Photo 11. Photo taken from the southwest location, facing North on January 3, 2018. Since the October inspection, it appears the Operator has installed a perimeter ditch along the outer perimeter of the location in conjunction with check dams (rip-rap) and applied a hydromulch to the topsoil stockpile, fill and cut slopes.

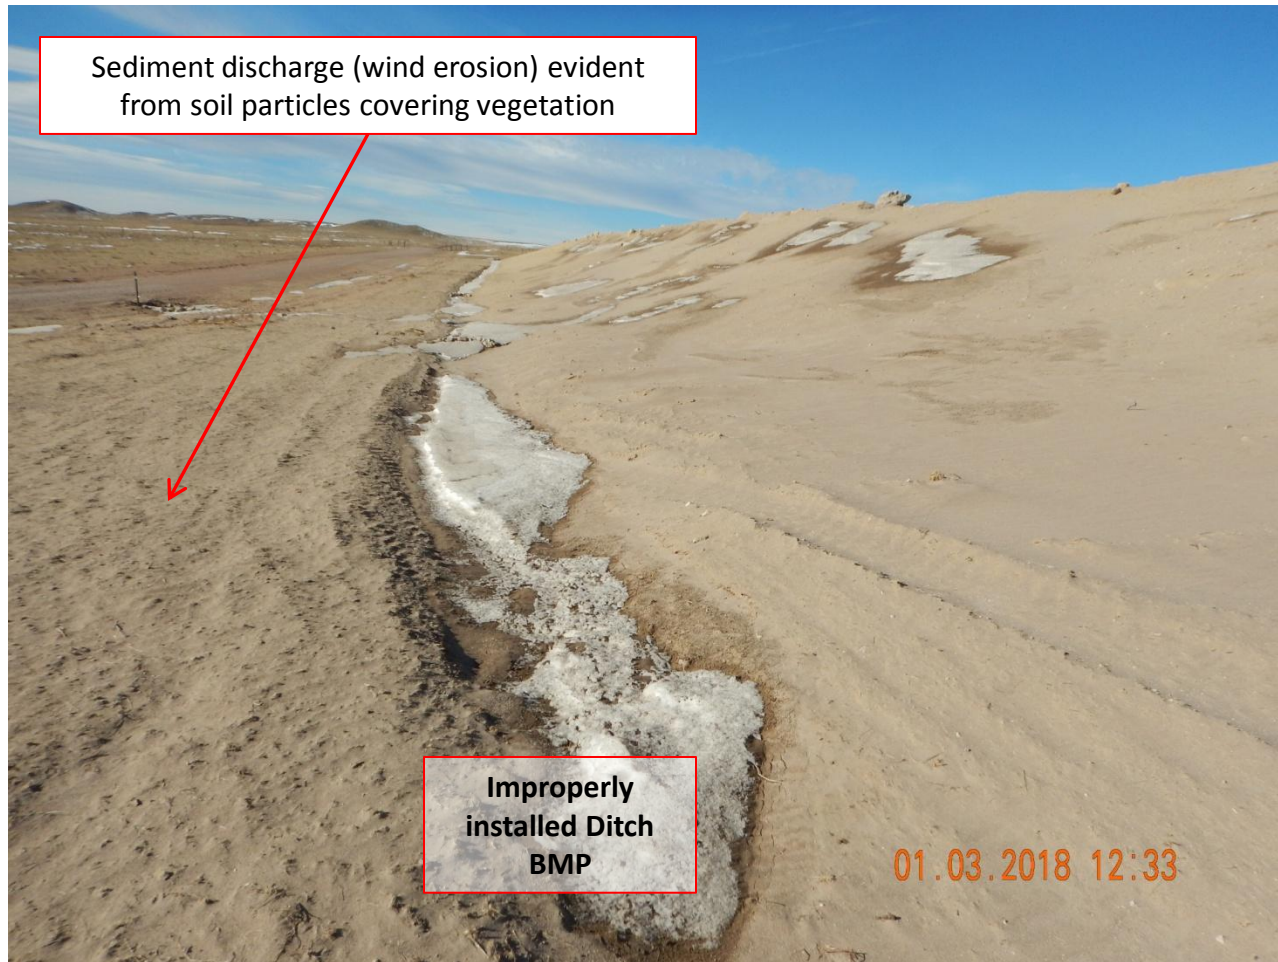
Sediment discharge (wind erosion) evident from soil particles covering vegetation

Improperly installed Ditch BMP

Photo 12. Photo taken from the southeast location, facing West on January 3, 2018. See comments under Photo 9.

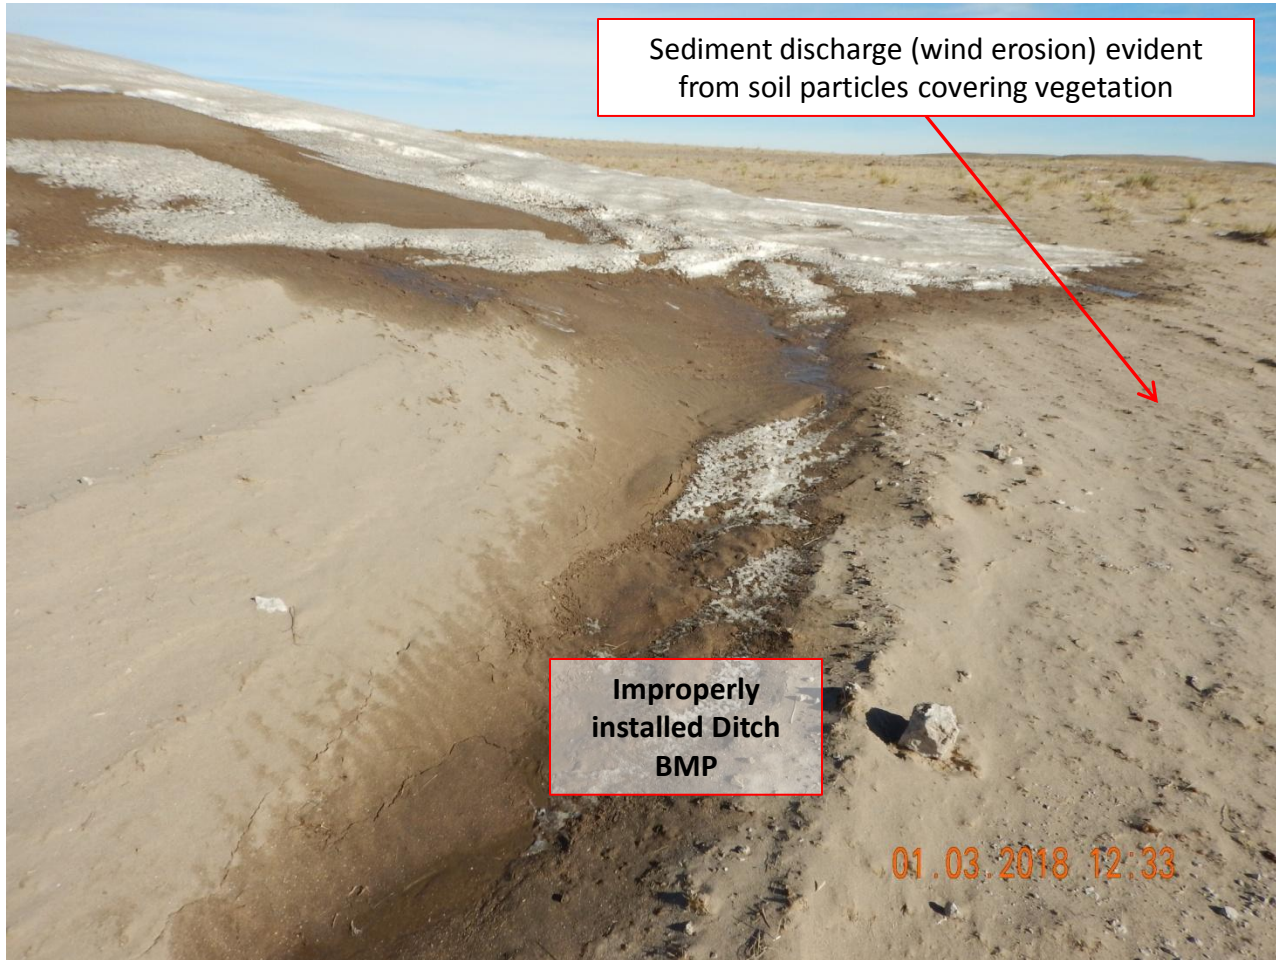
Photo 13. Photo taken from the southeast location, facing North on January 3, 2018. See comments under Photo 9.

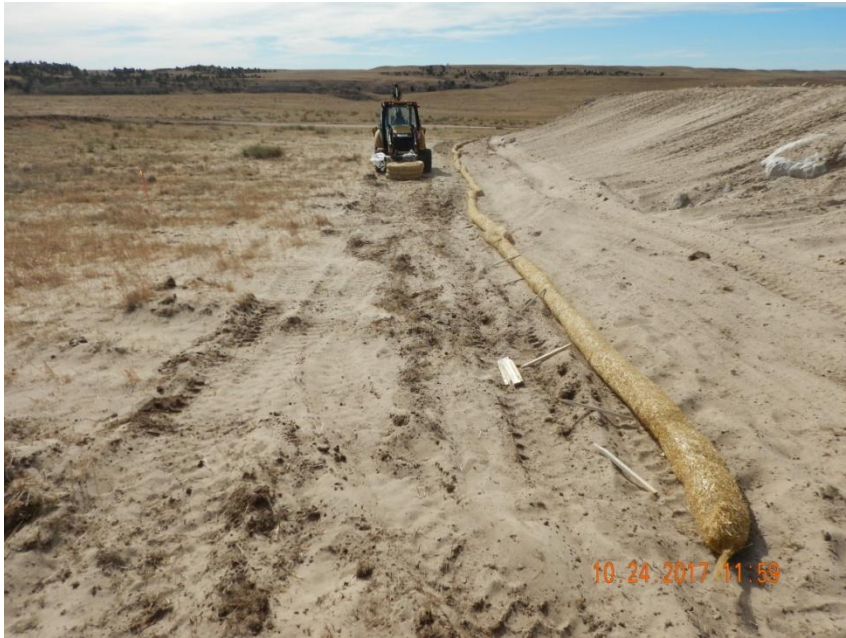
Photo 14. Photo taken from the eastern location on the fill slope, facing South on October 24, 2017.

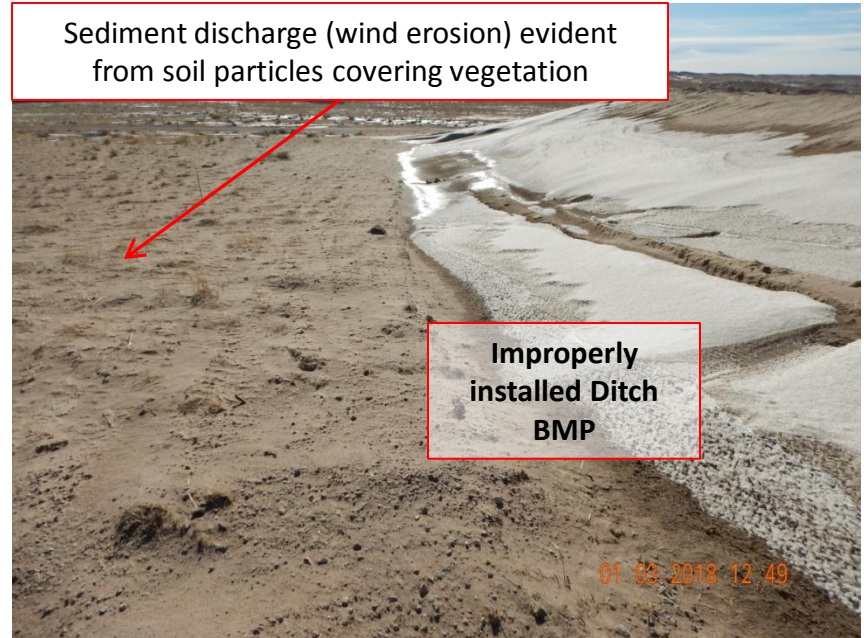
Photo 15. Photo taken from the eastern location on the fill slope, facing South on January 3, 2018. See comments under Photo 9.

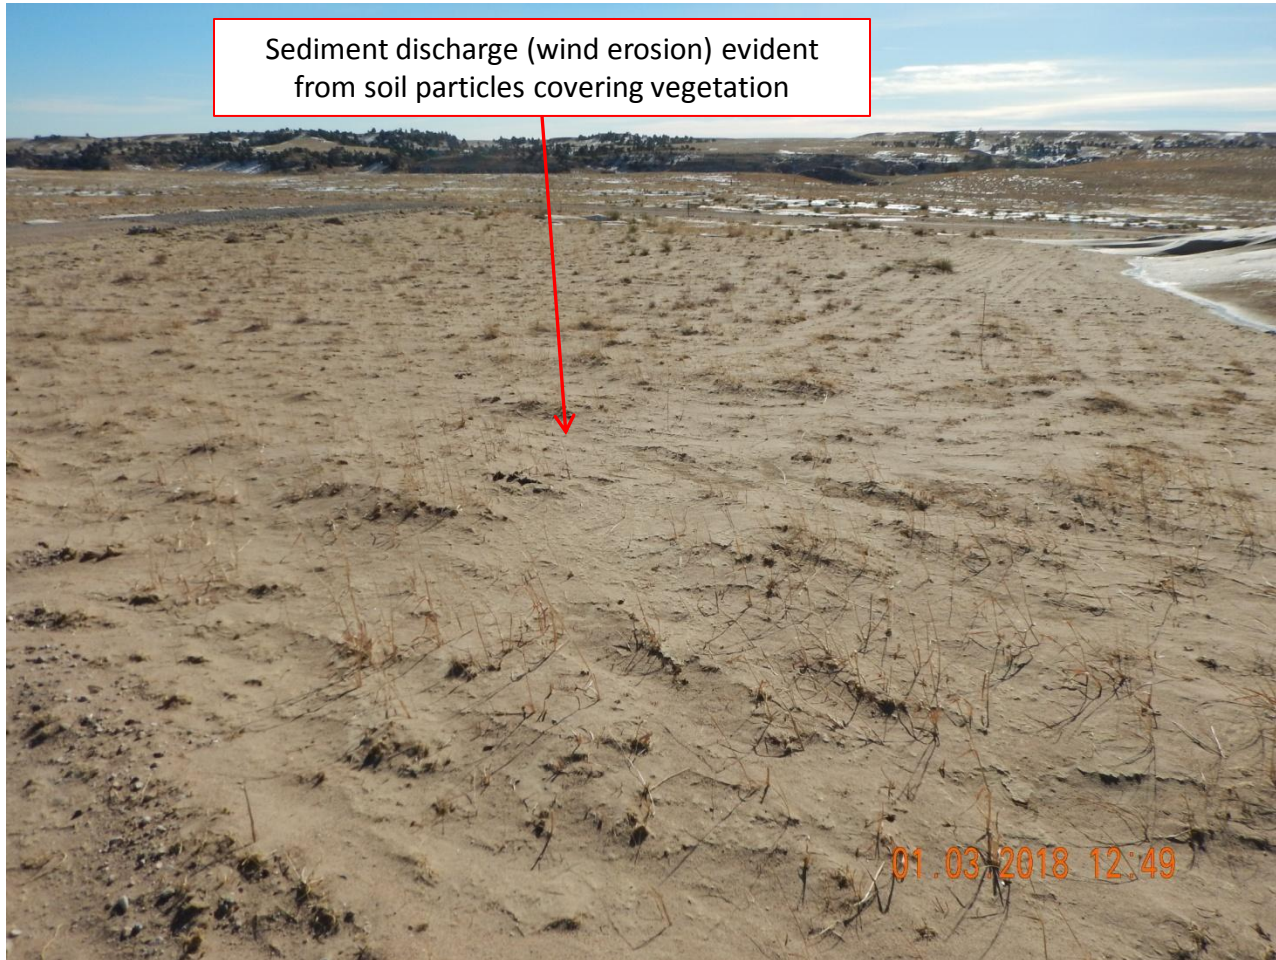
Photo 16. Photo taken from the eastern location on the fill slope, facing Southeast on January 3, 2018. See comments under Photo 9.

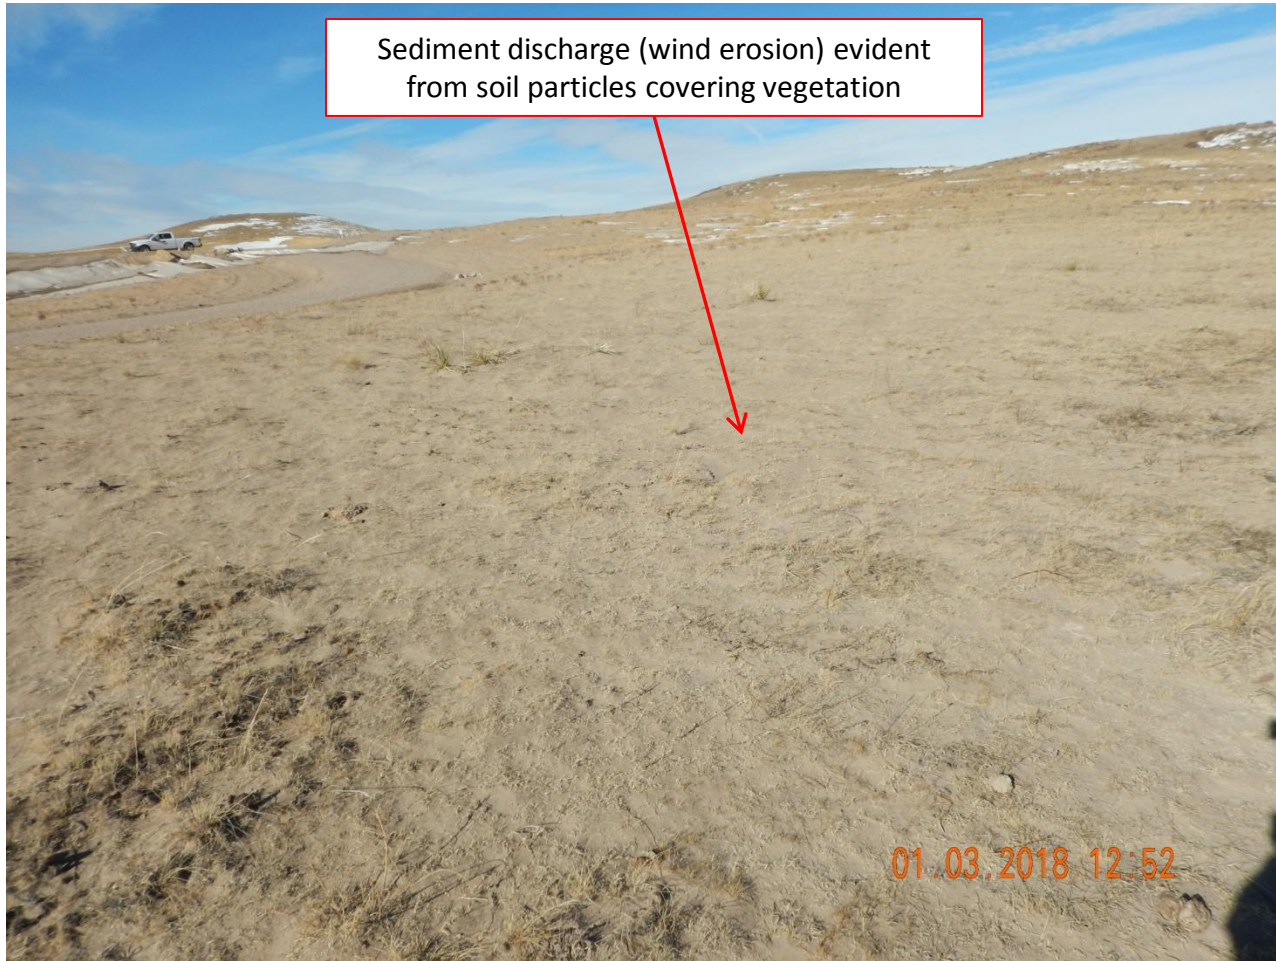
Photo 17. Photo taken from the east of the access road, facing Northwest on January 3, 2018. See comments under Photo 9.

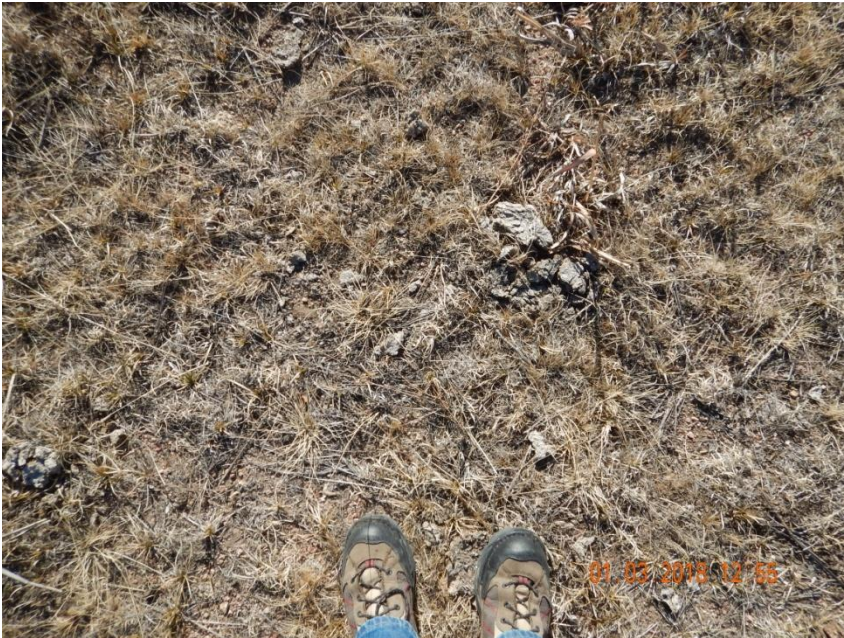
Photo 18. Close-up reference photo taken north of location where there have been no impacts to sediment discharge from the location.

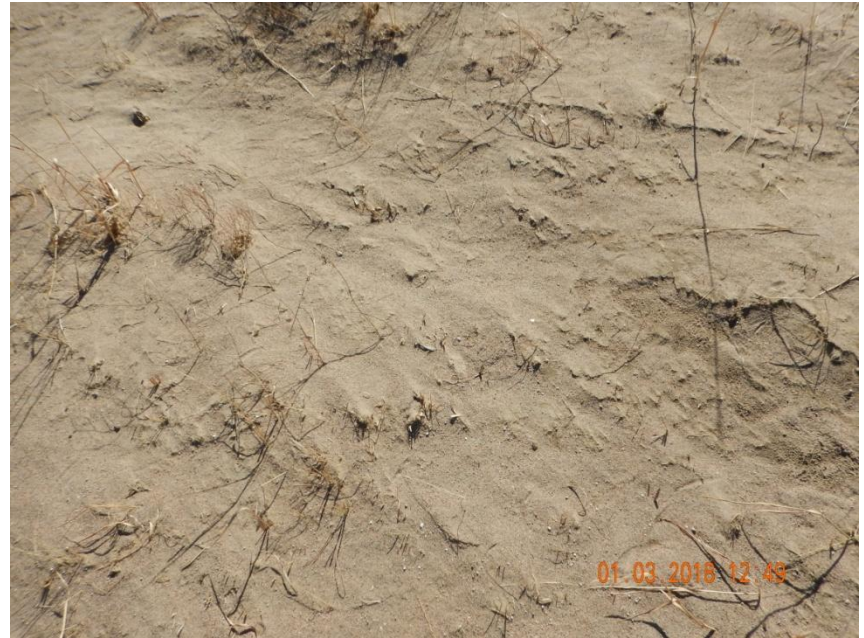
Photo 19. Close-up photo taken east of the location illustrating the evidence of sediment discharge off location.
