Inspection Photos
Location Name: Lark 33-5 #21-4
API: 05-007-06323

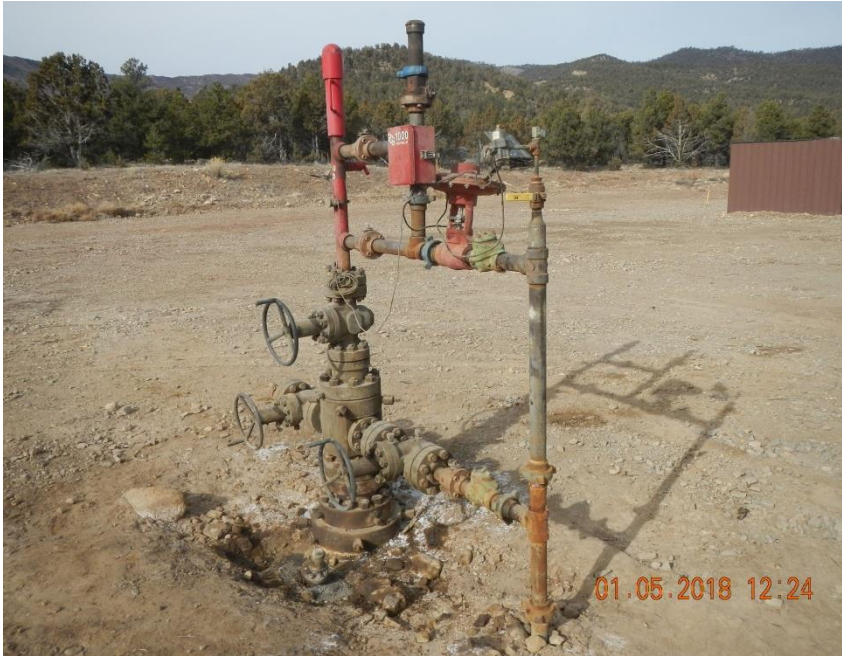
Lark 33-5 #21-4 well head.

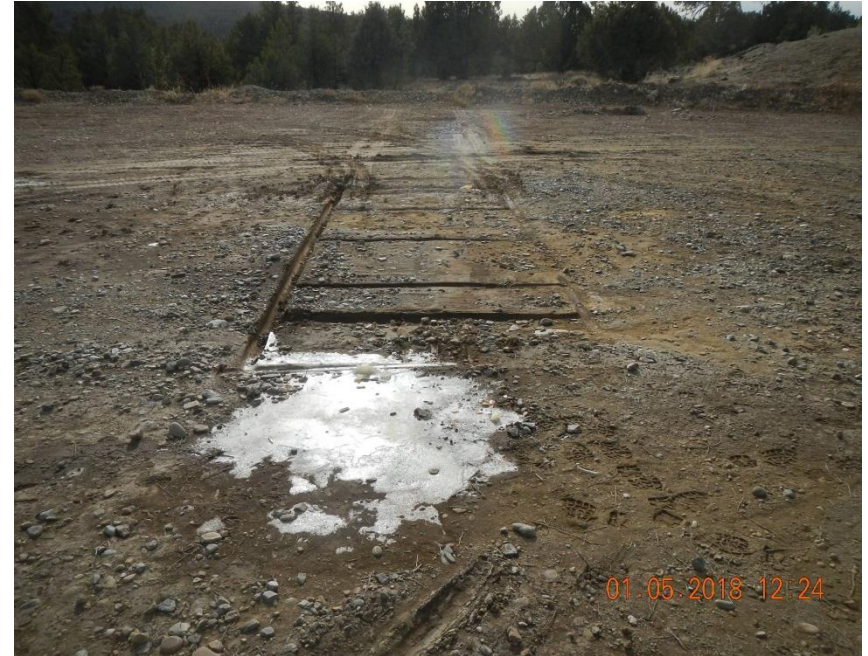
Mark left from horizontal tank skid.

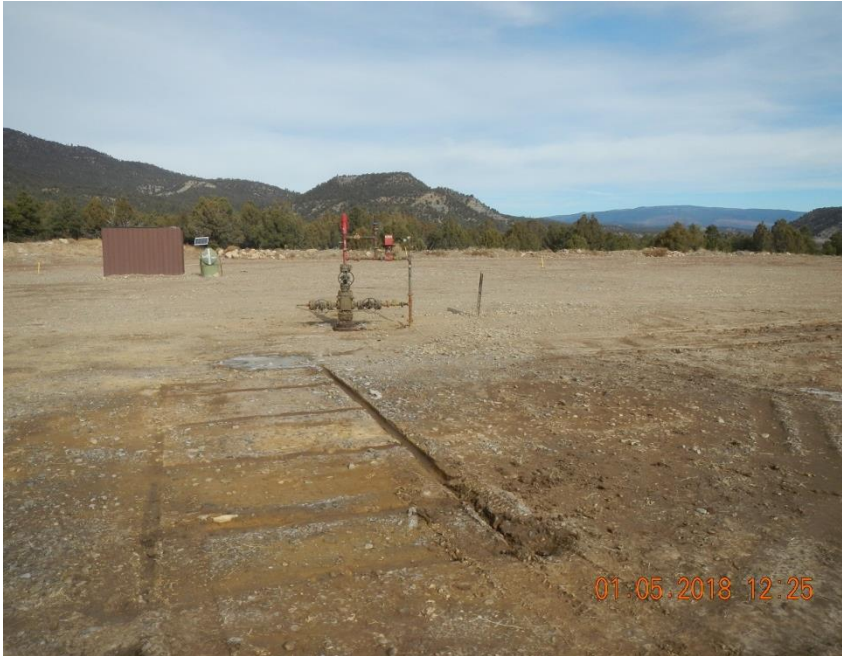
Proximity of release in relation to well head.

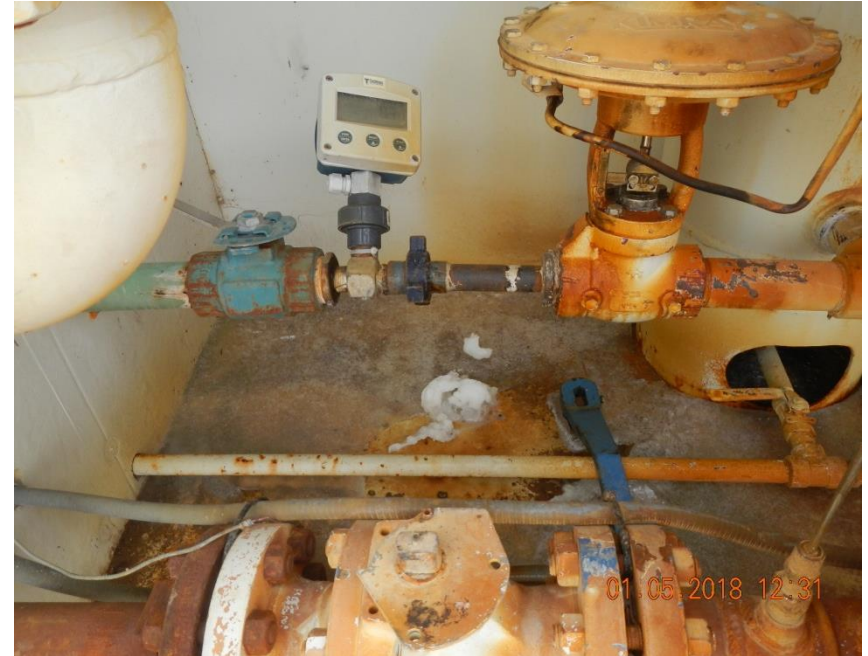
Produced water line leak observed in separator shack.

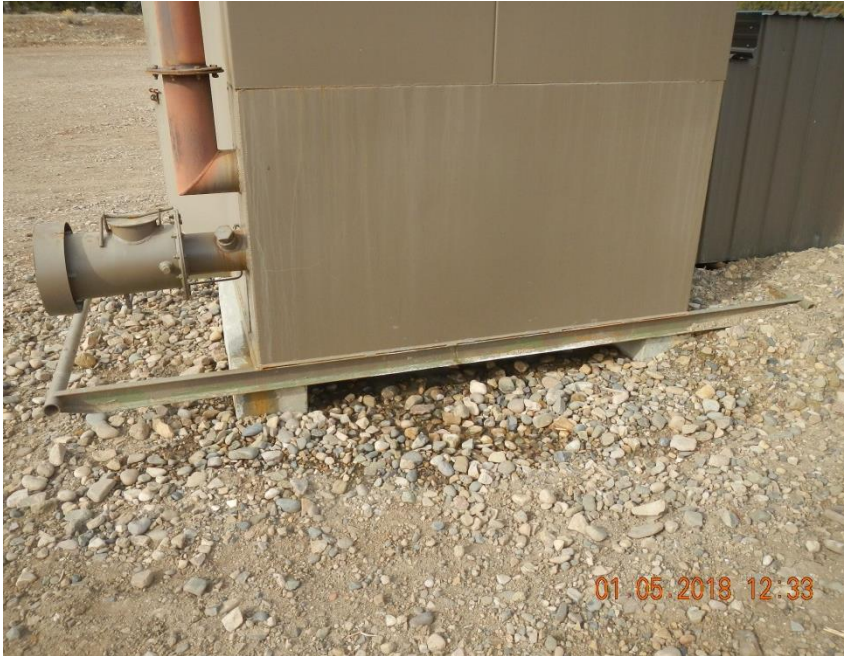
Produced water leaking from separator shack.

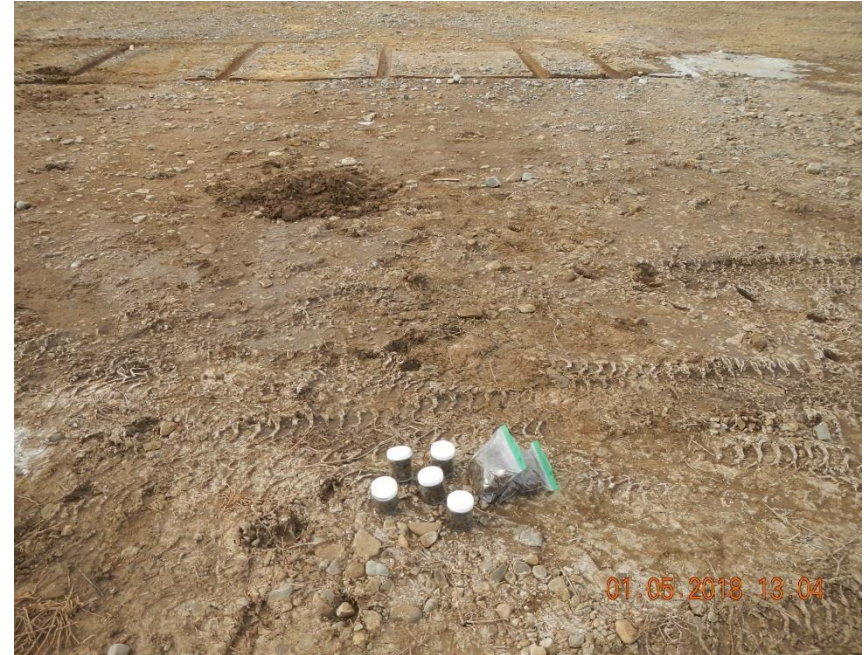
5 – 4 oz. jars and two ziploc bags of impacted material collected by Petrox representative.
