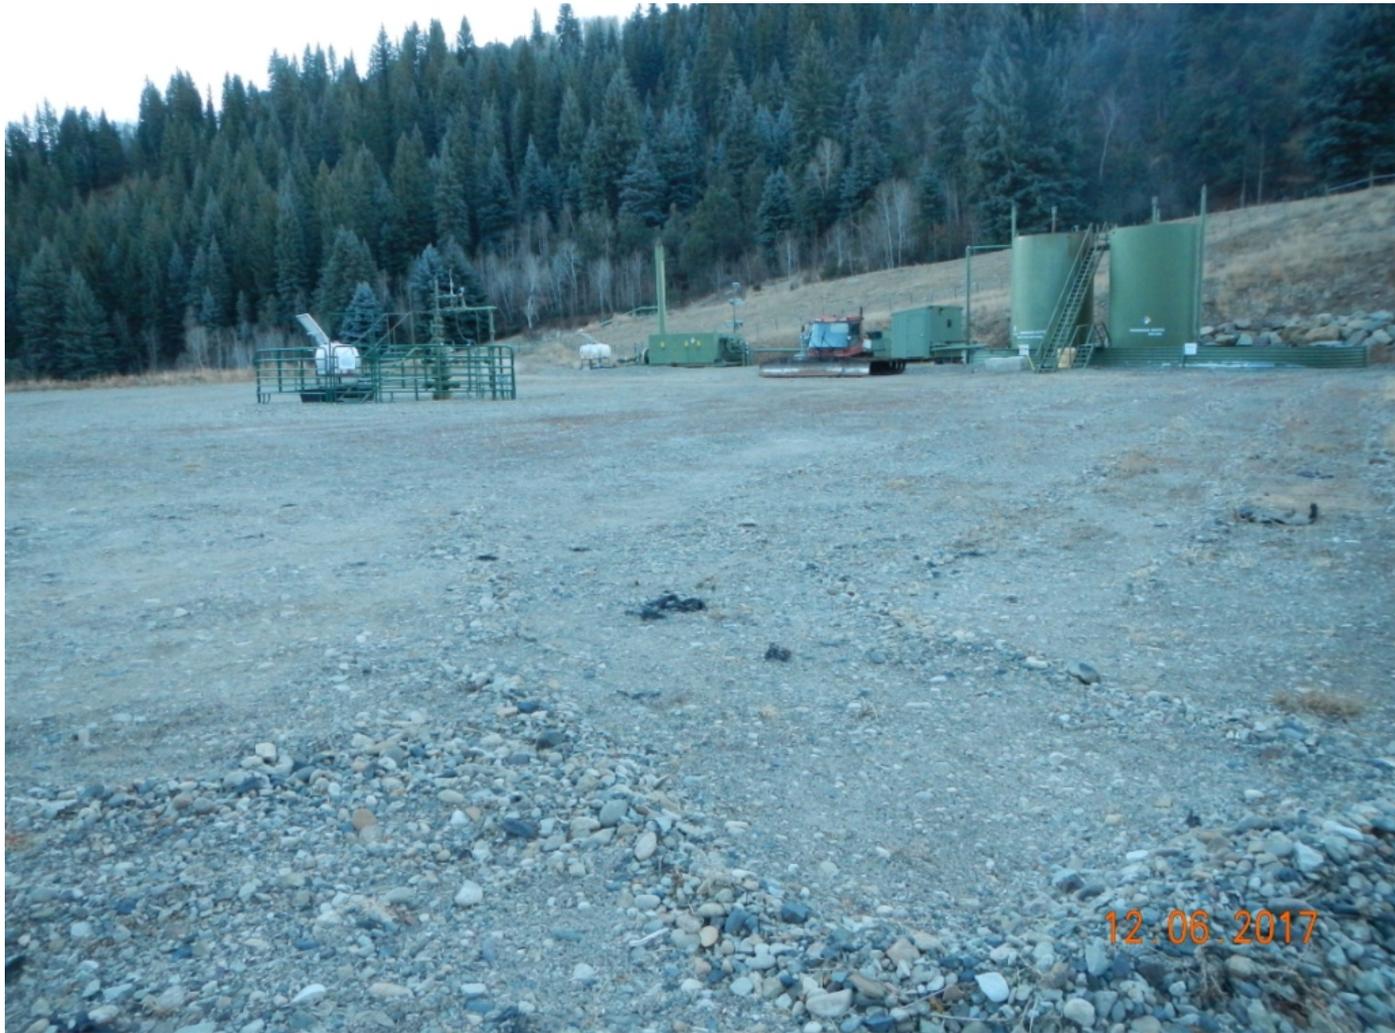
**Photo 1. View of the project area from the northwestern corner facing center.**

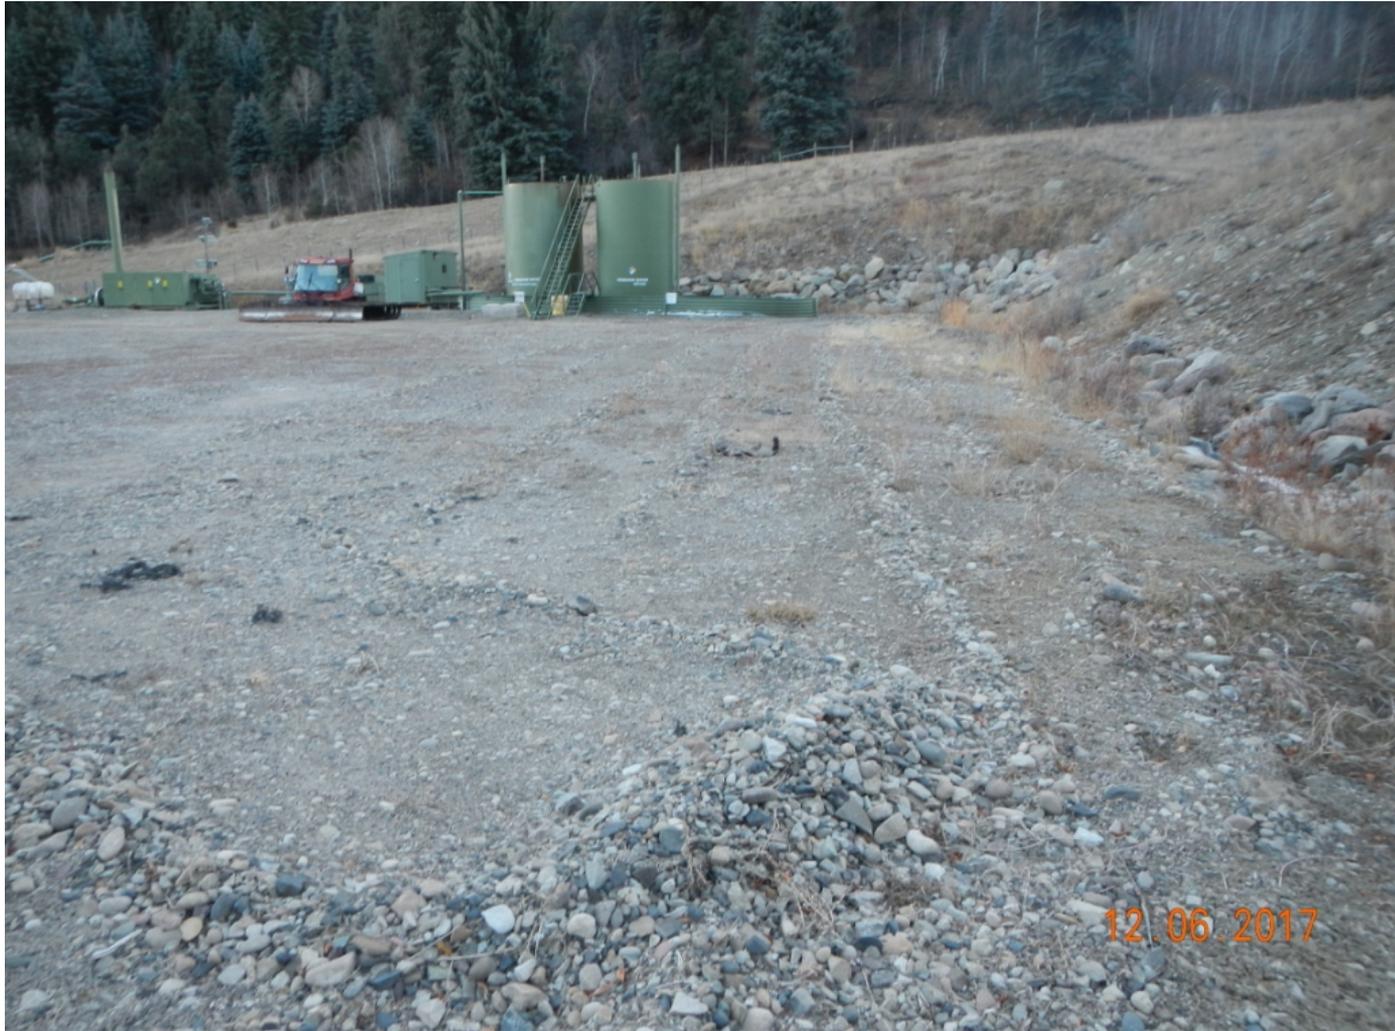
**Photo 2. View of the project area from the northwestern edge facing southward.**

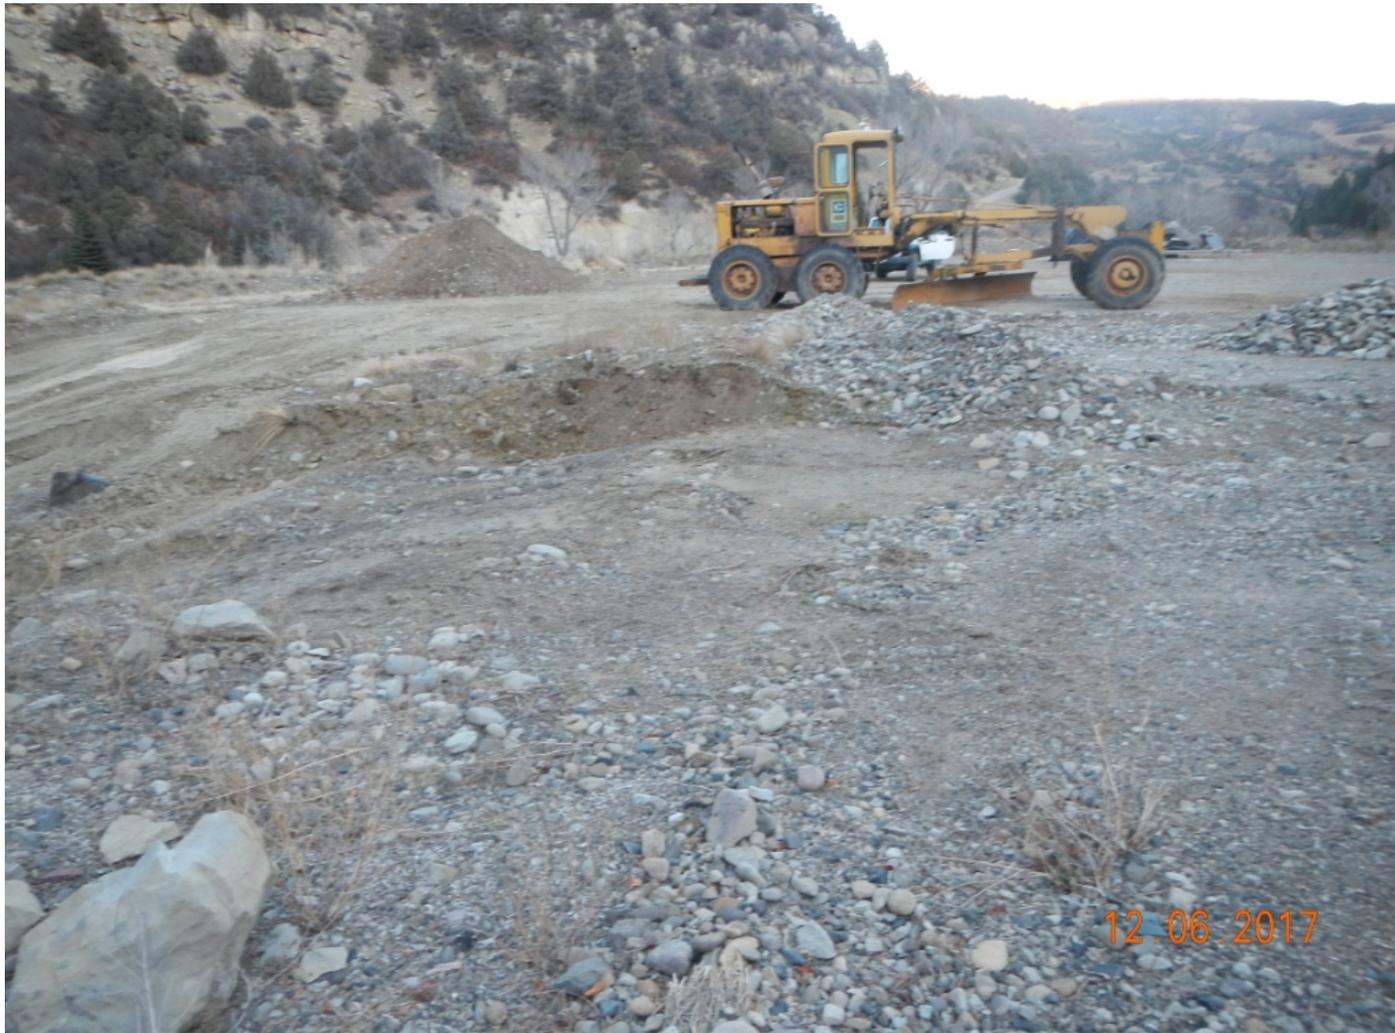
**Photo 3. View of equipment and soil/rock stockpiles where the former pit appears to be in the process of being filled. Interim reclamation has not been conducted.**

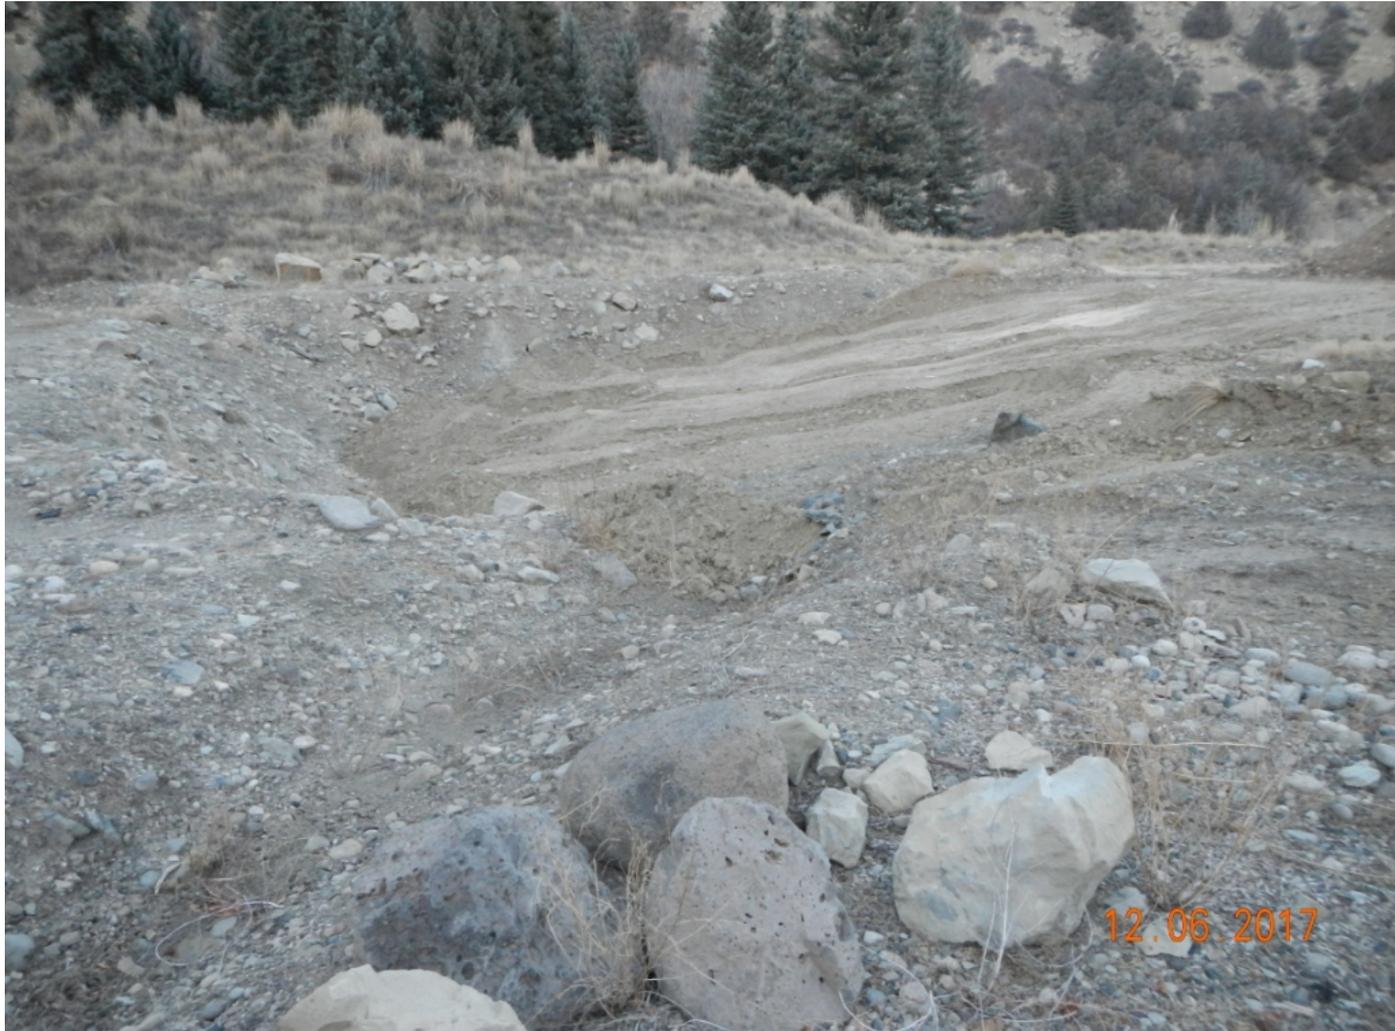
**Photo 4. View of area where old pit is being filled in the northwestern project area.**

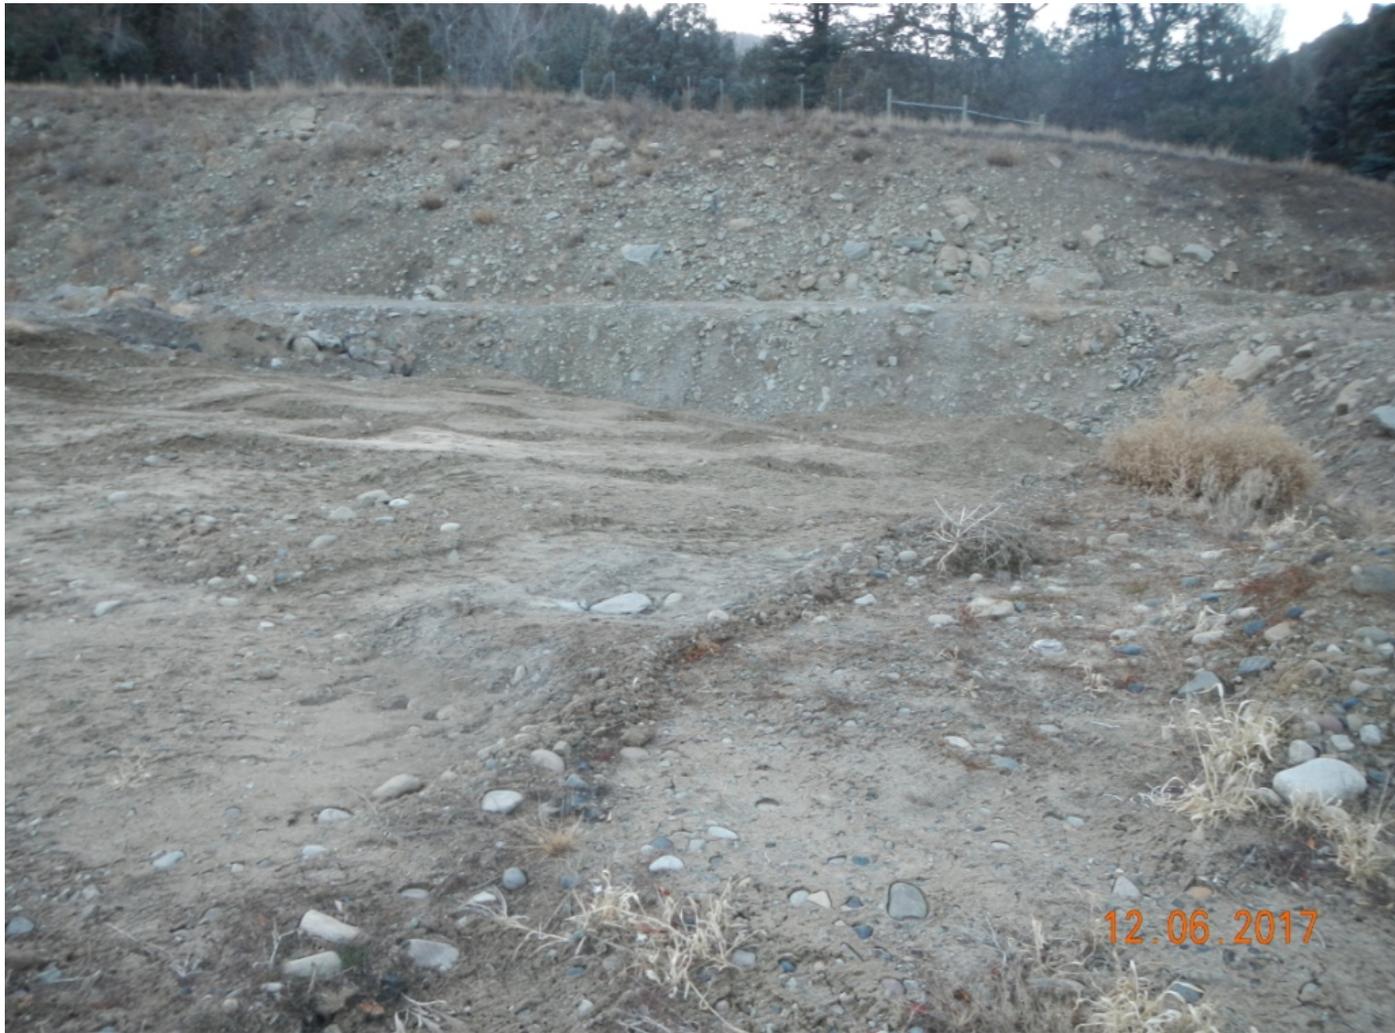
**Photo 5. Another view of pit area in the northwestern project area that appears to be in the process of being filled.**
