COLORADO
Oil & Gas Conservation
Commission
Department of Natural Resources

Inspection Photos: Encana PA Standard Shale API#045-06914

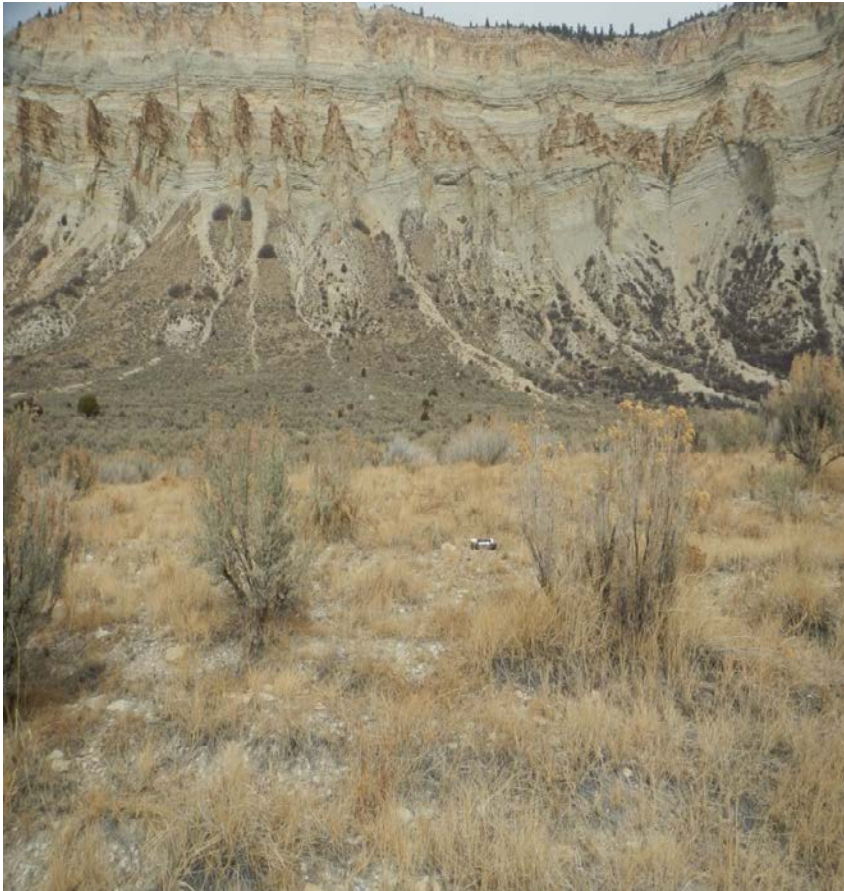
Photo#1:
View North over Location Center

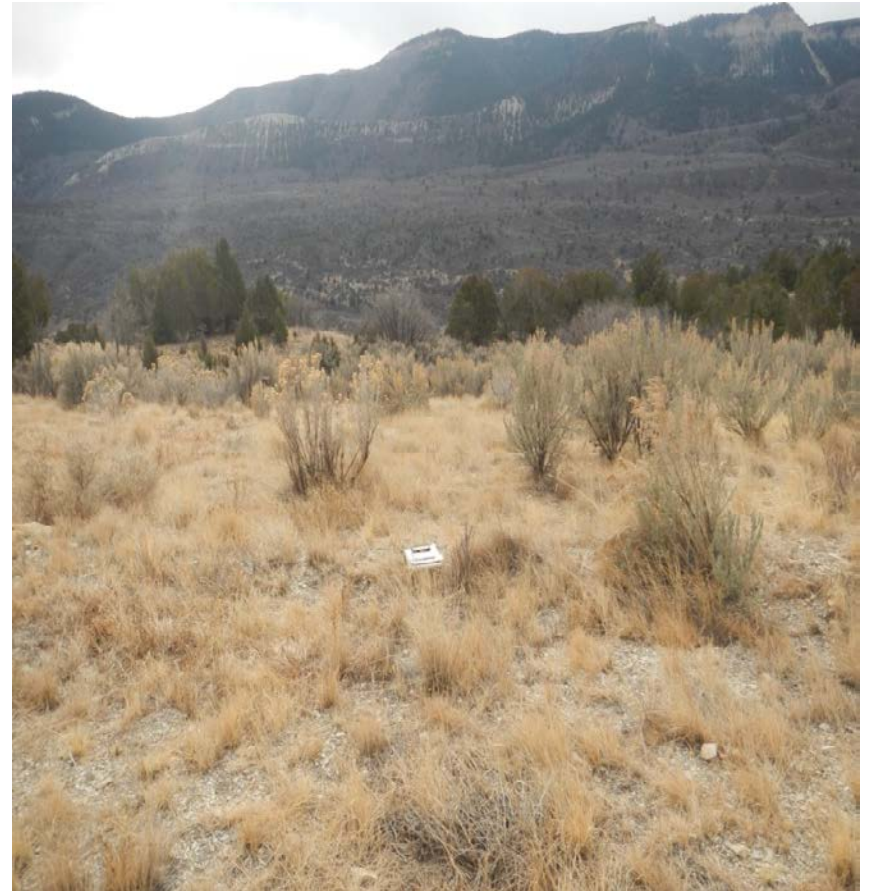
Photo#2:
View South over Location Center

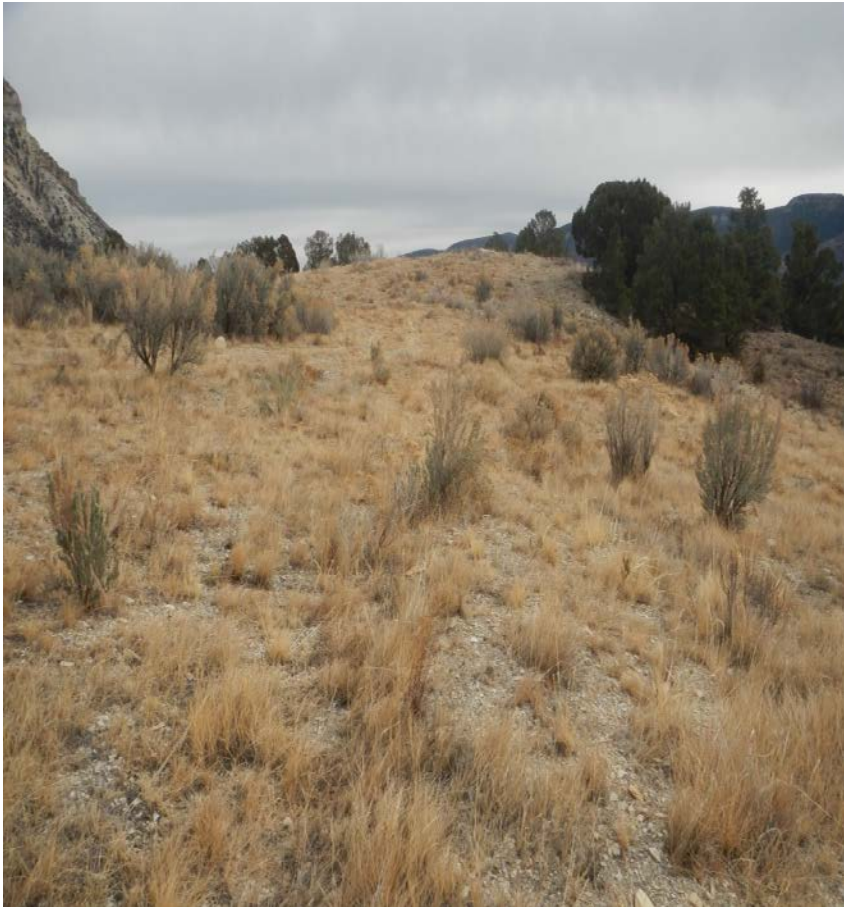
Photo#3:

View East over Location Center

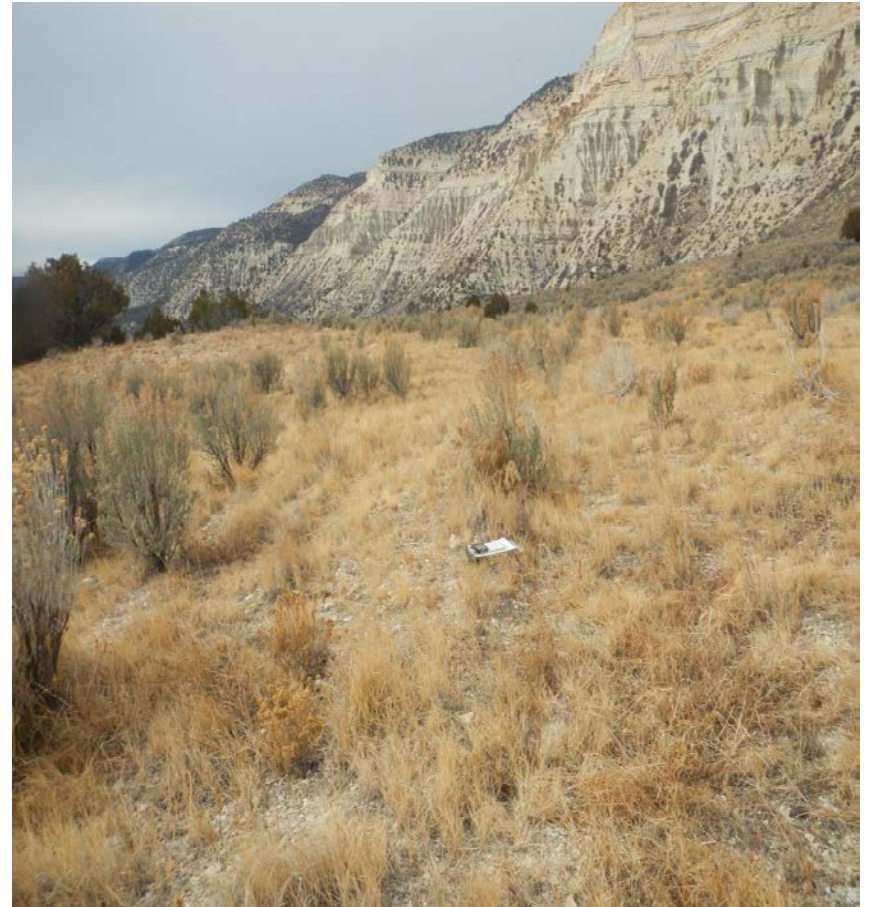
Photo#4:

View West over Location Center

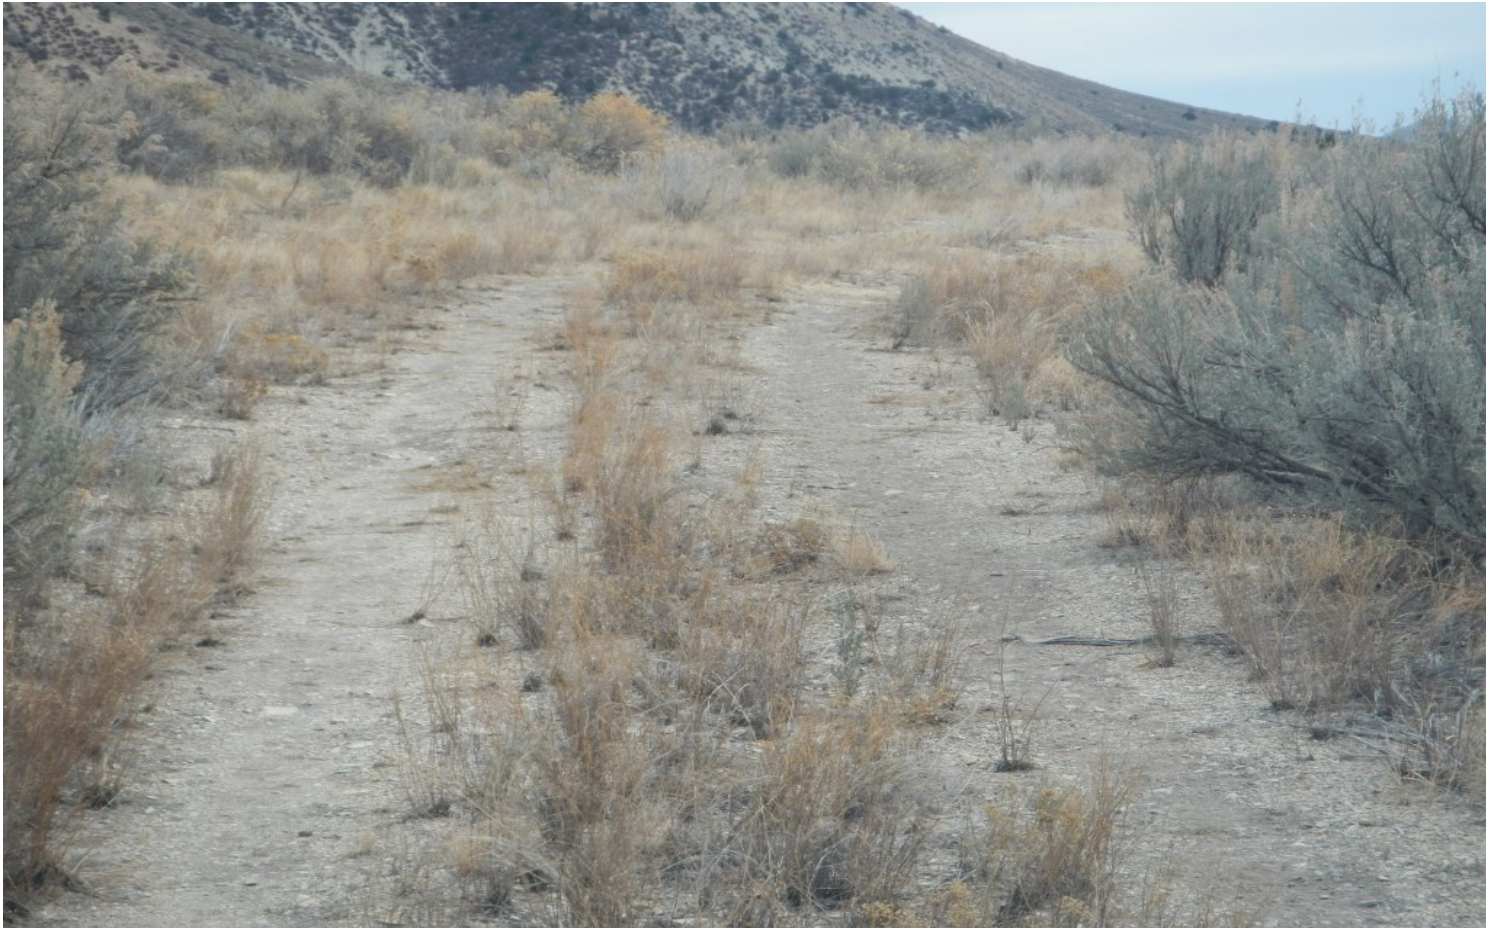
Photo#5:

Access Road into Location has Not been Reclaimed.

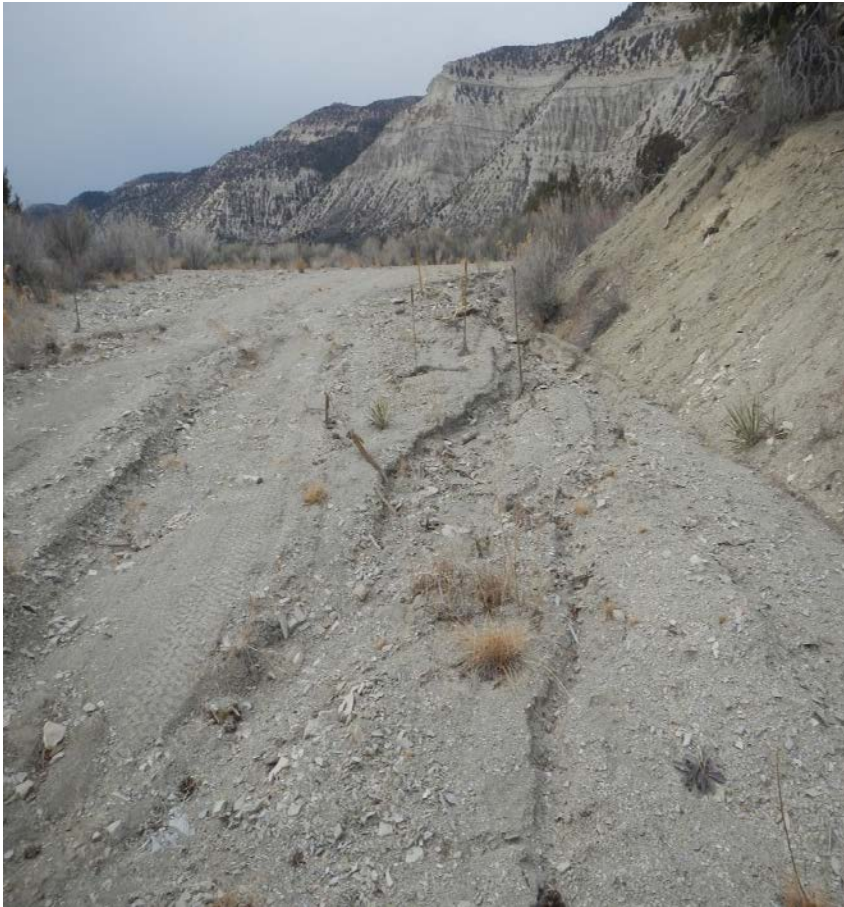
Photo#6:

Access Road into Location has Not been Reclaimed.

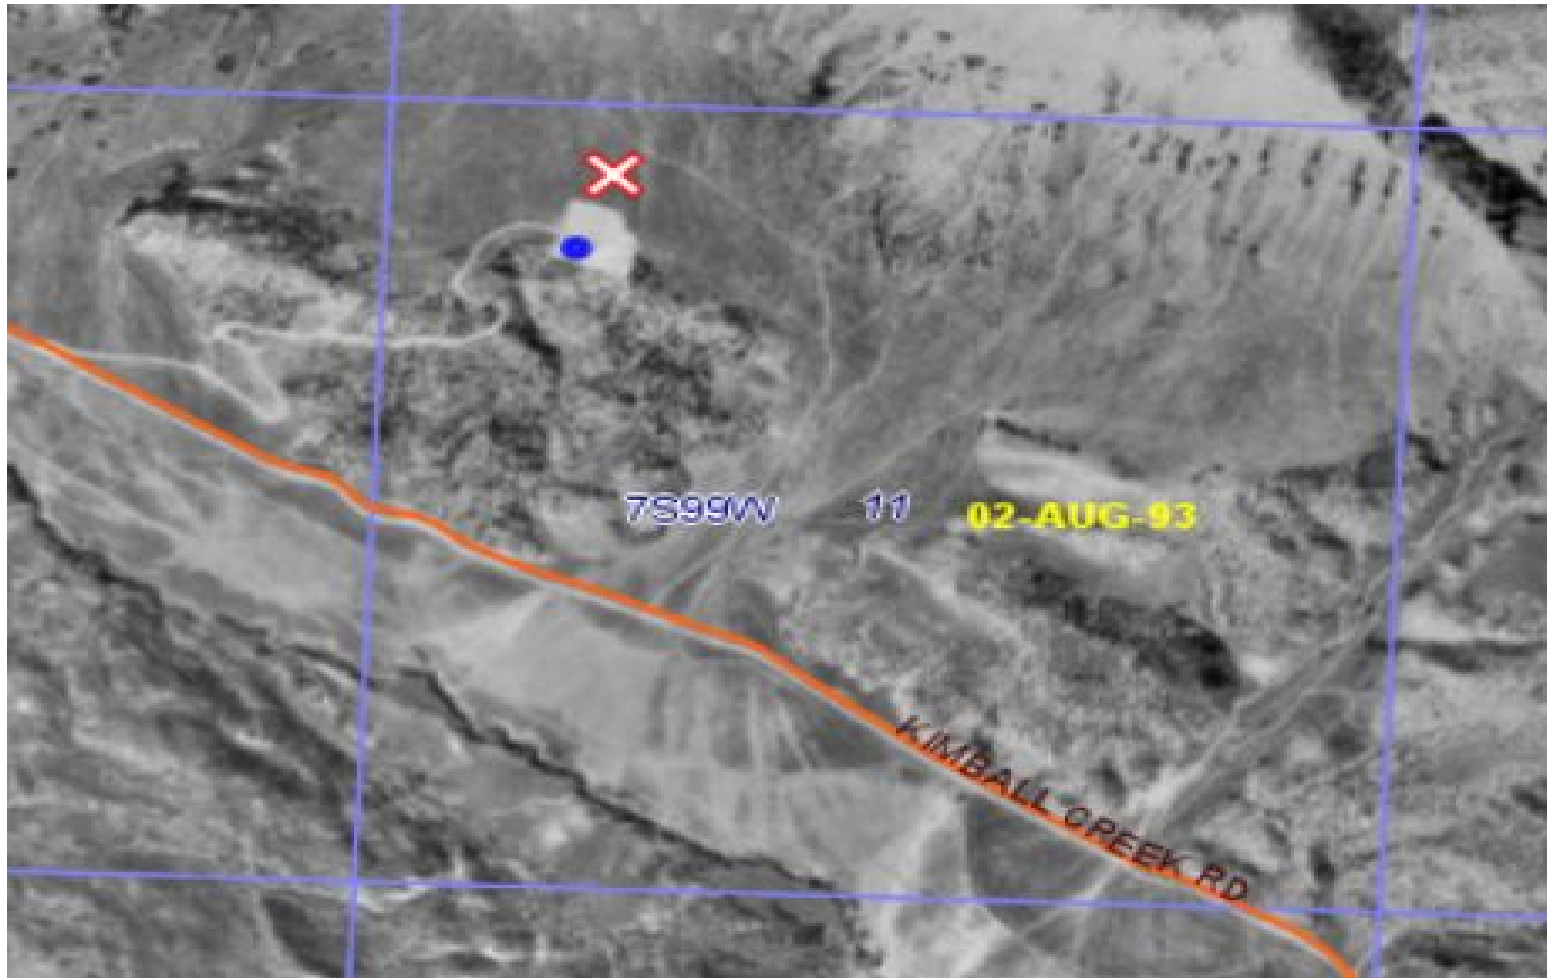
Photo#8:

From Aerial Photos it appears Road was built to Access Location.

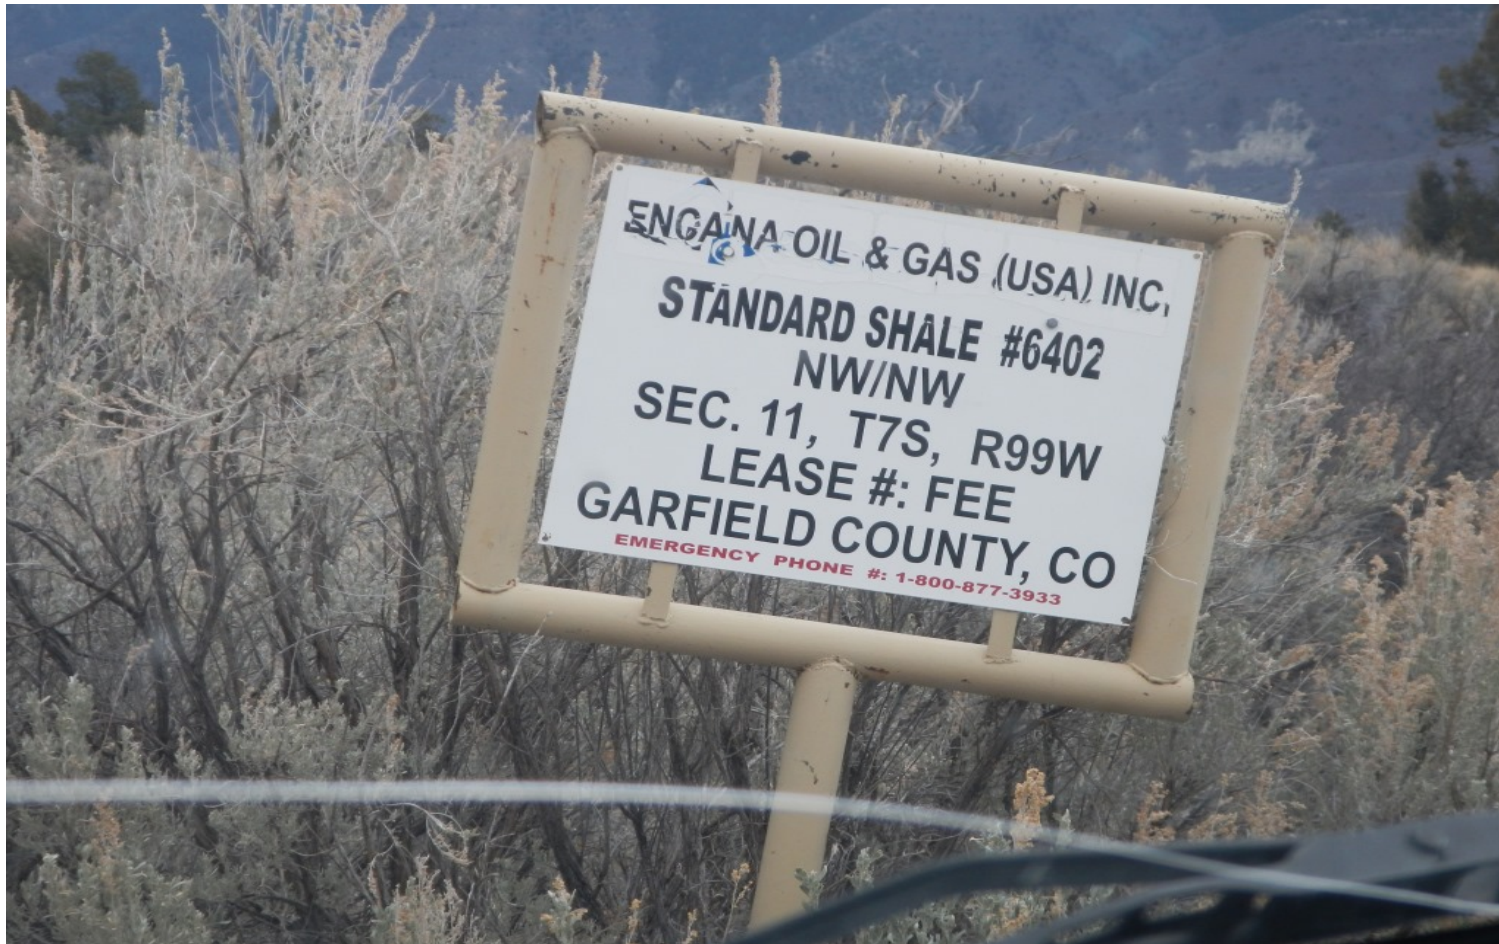
Photo#9:

Old sign is only Debris on Location & will need to be removed before Final Reclamation is Passed.
