Inspection Photos
Location Name: Iles Investment CO 1-23
API: 05-081-05136

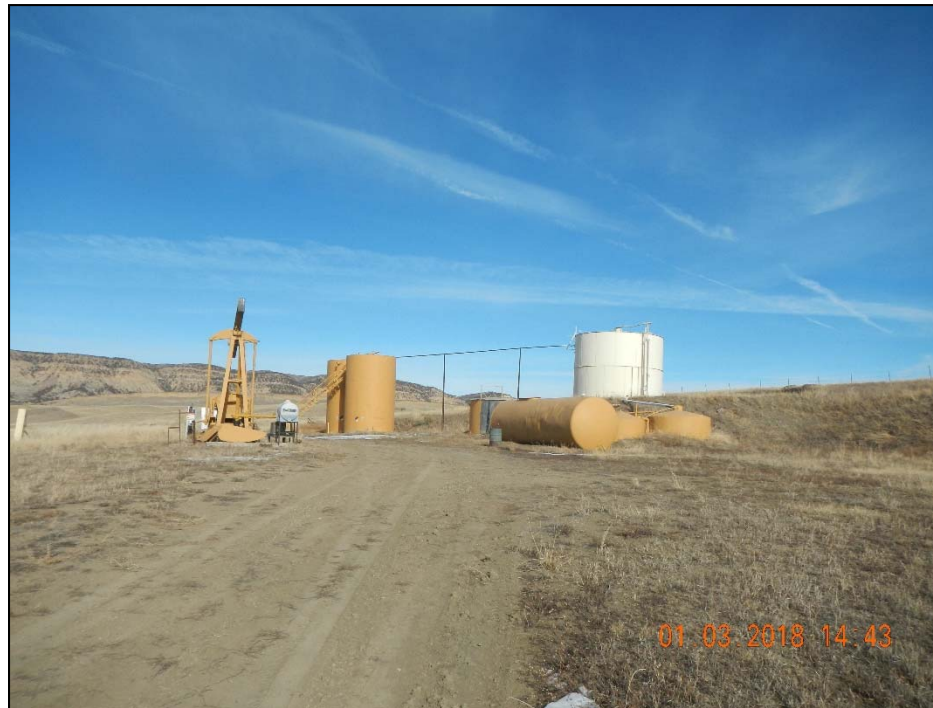
Photo 1. Overview of location taken at entrance facing northeast.

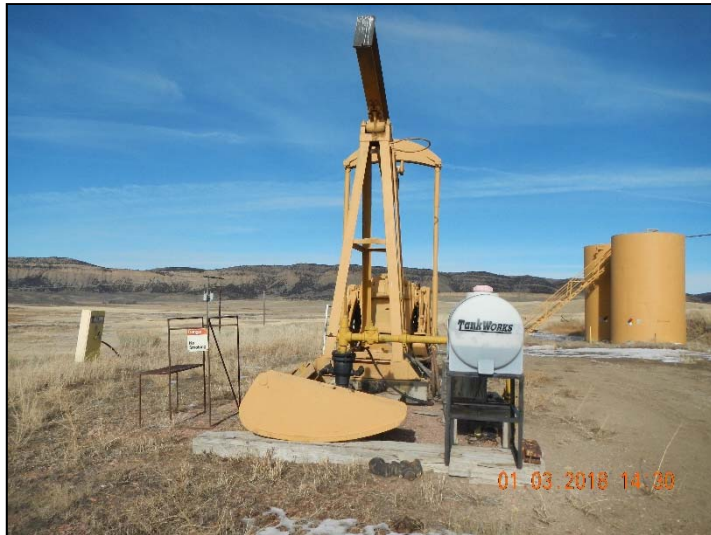
**Photo 2. No wellhead sign. Risers at wellhead.
1/3/2018**

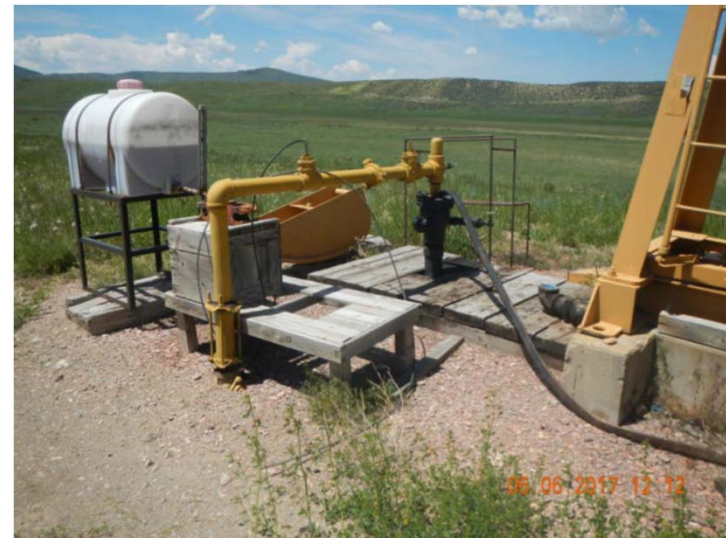
**Photo 3. No wellhead sign. Risers at wellhead.
6/6/2017**

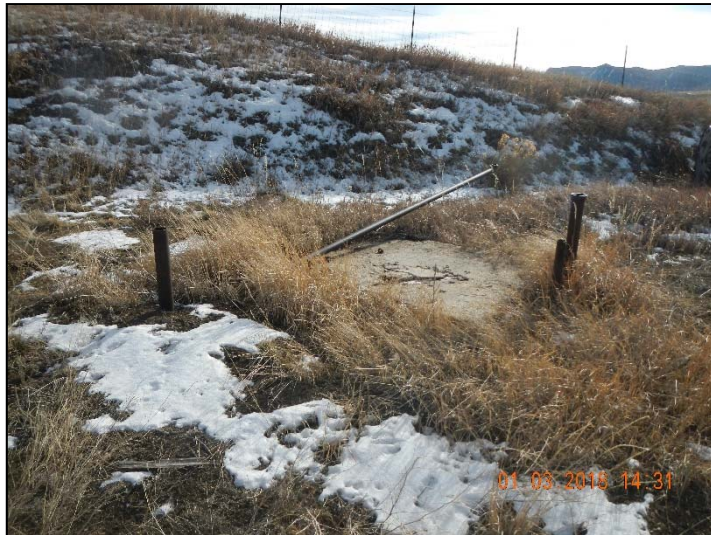
Photo 4. Risers at entrance.
1/3/2018

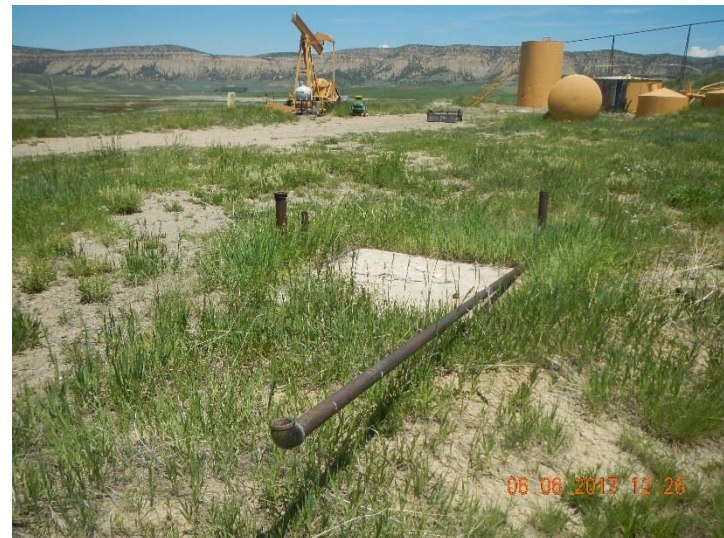
Photo 5. Risers at entrance.
6/6/2017

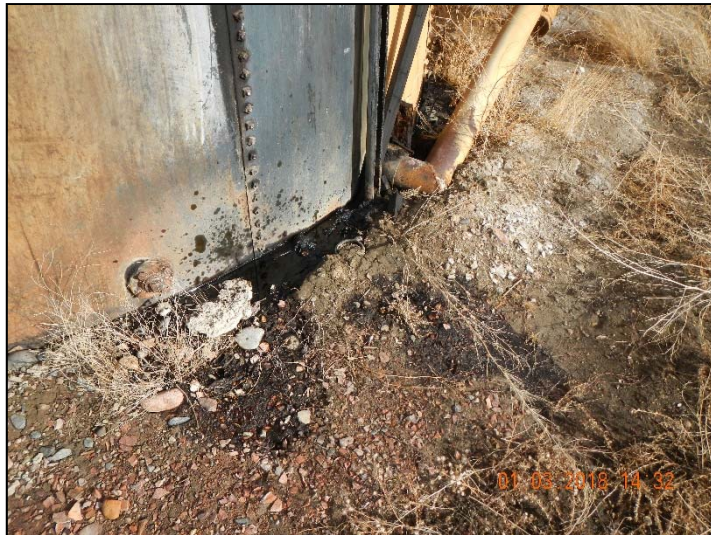
Photo 6. Free fluid at tank base.
1/3/2018

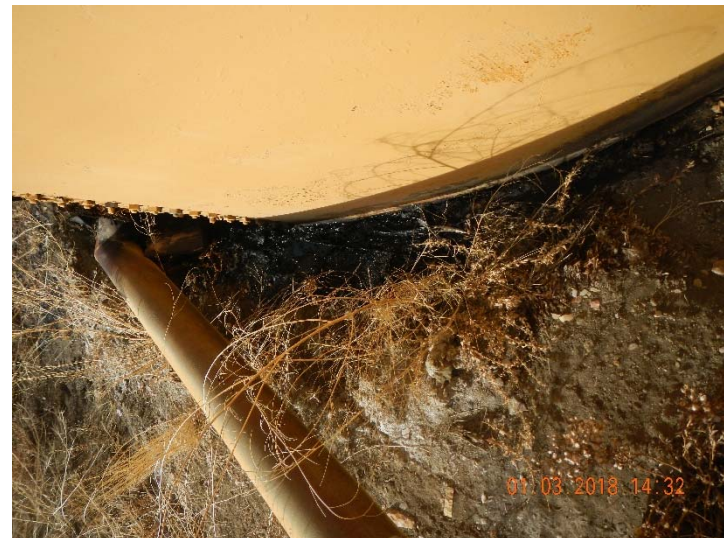
Photo 7. Free fluid at tank base.
1/3/2018

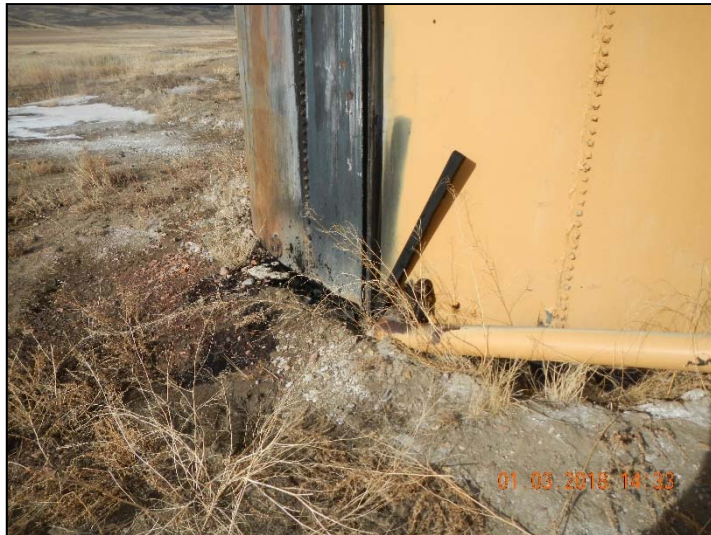
Photo 8. Free fluid and stained soil at tank base.
1/3/2018

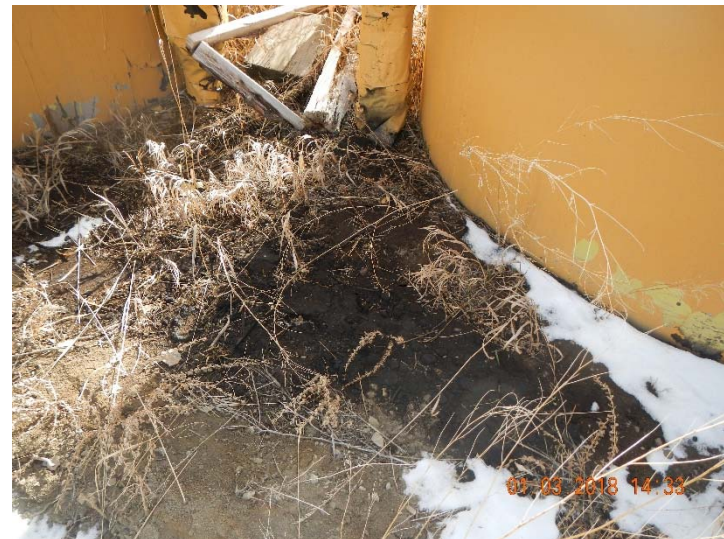
Photo 9. Stained soil at tank base.
1/3/2018

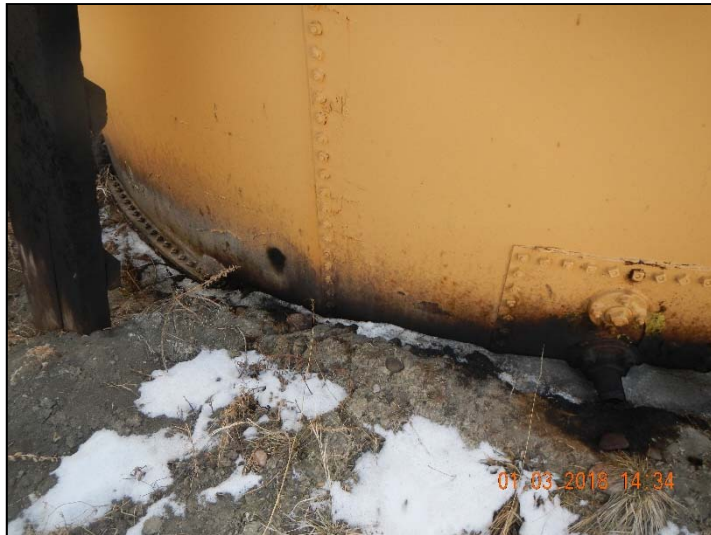
Photo 10. Hole in tank. Stained soil and free fluid at base.
1/3/2018

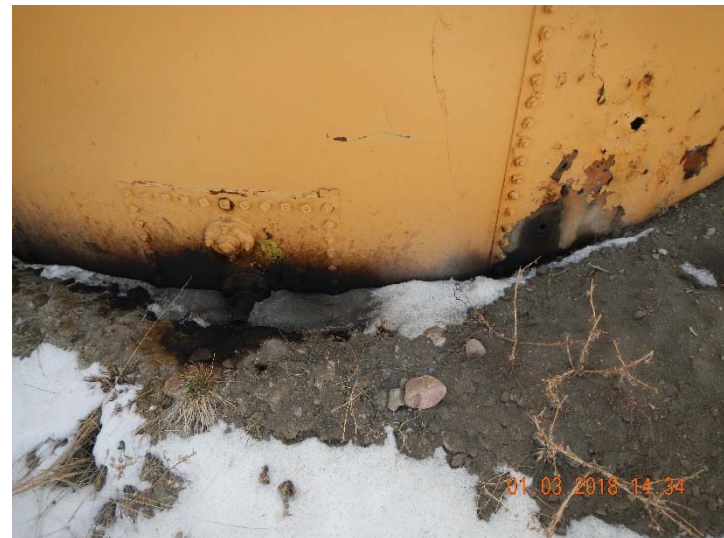
Photo 11. Hole in tank. Stained soil and free fluid at base.
1/3/2018

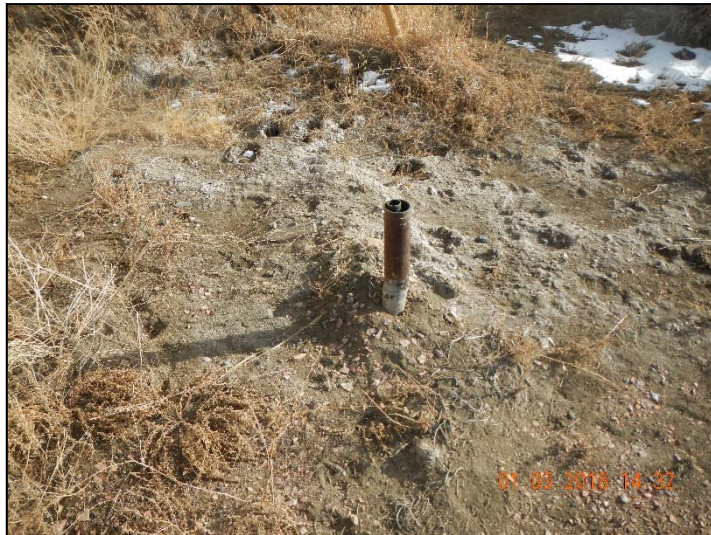
Photo 12. Unmarked riser.
1/3/2018

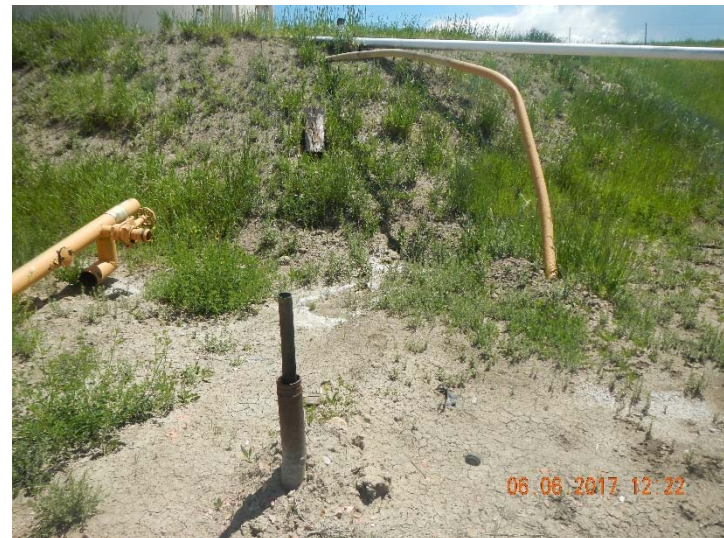
Photo 13. Unmarked riser.
6/6/2017

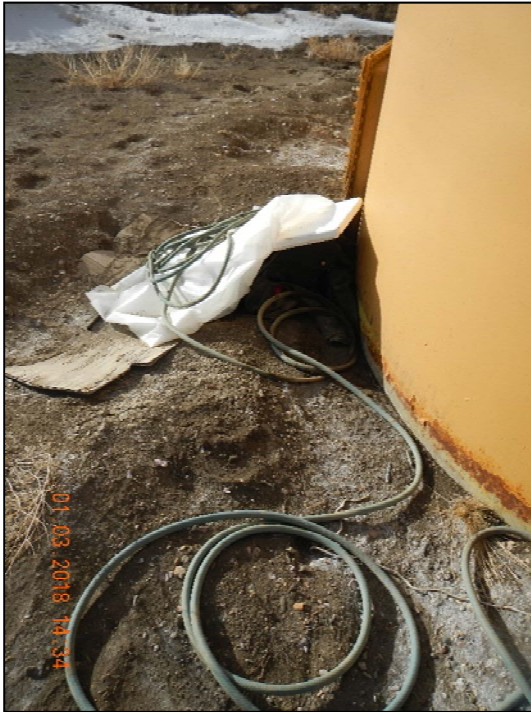
Photo 14. Stained soil and debris.
1/3/2018

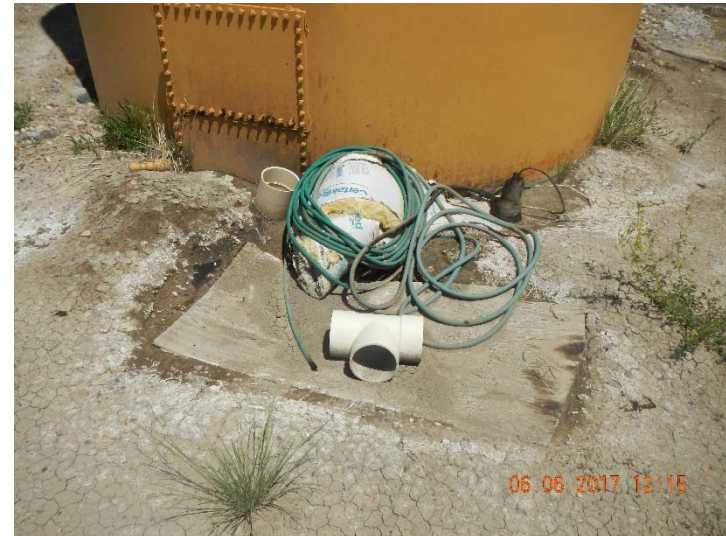
Photo 15. Stained soil and debris.
6/6/2017

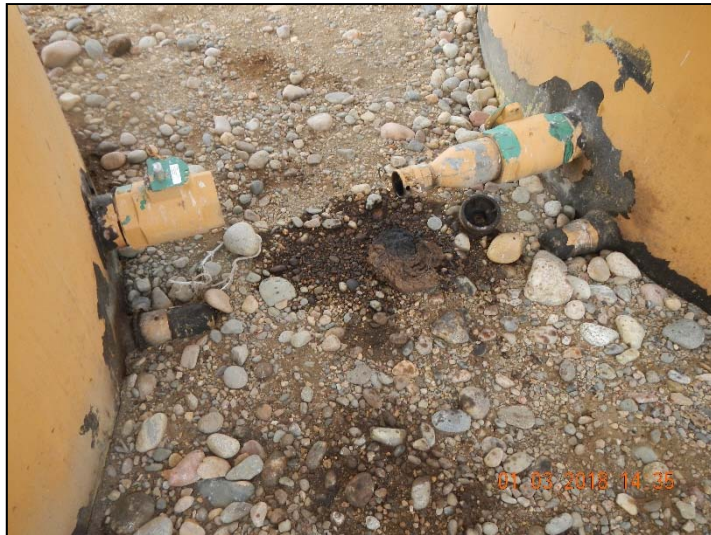
Photo 16. Stained soil at tank loadouts.
1/3/2018

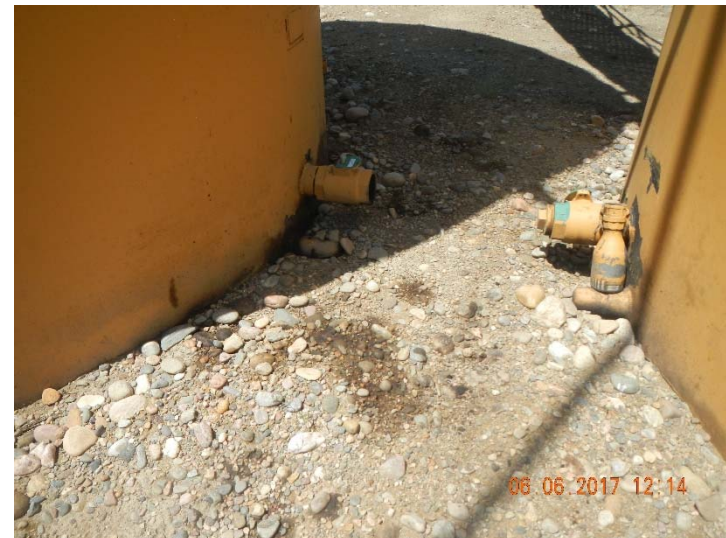
Photo 17. Stained soil at tank loadouts.
6/6/2017

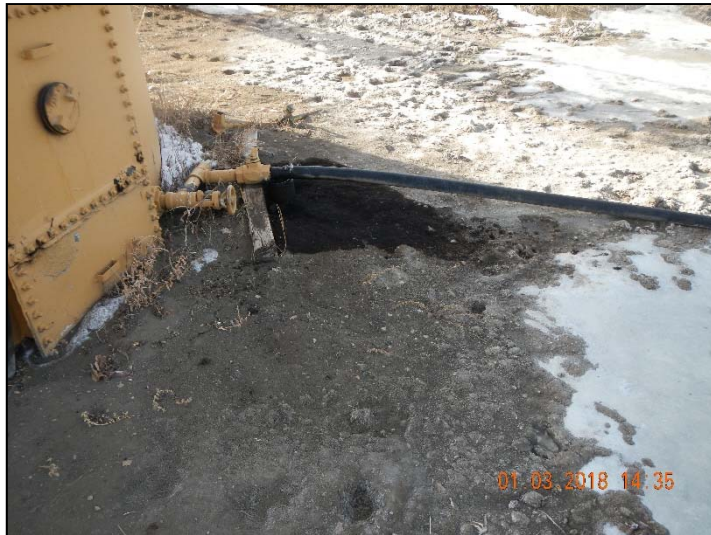
Photo 18. Stained soil at tank loadout.
1/3/2018

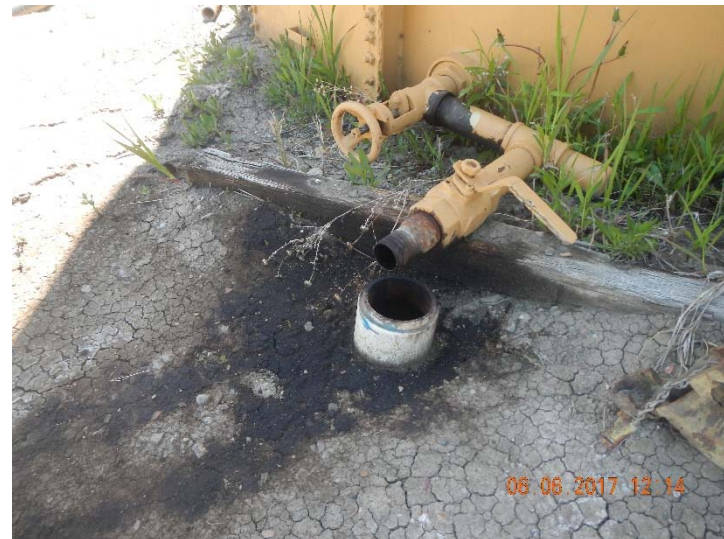
Photo 19. Stained soil at tank loadout.
6/6/2017

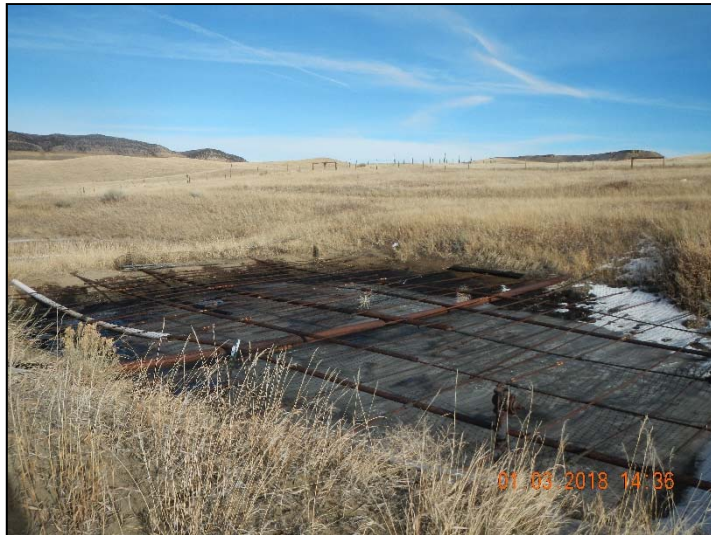
Photo 20. Pit. Unmarked riser in right foreground.
1/3/2018

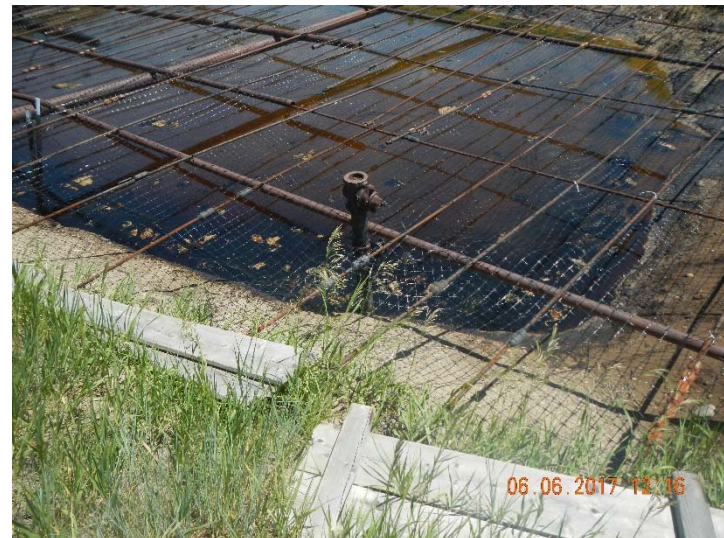
Photo 21. Pit. Unmarked riser.
6/6/2017

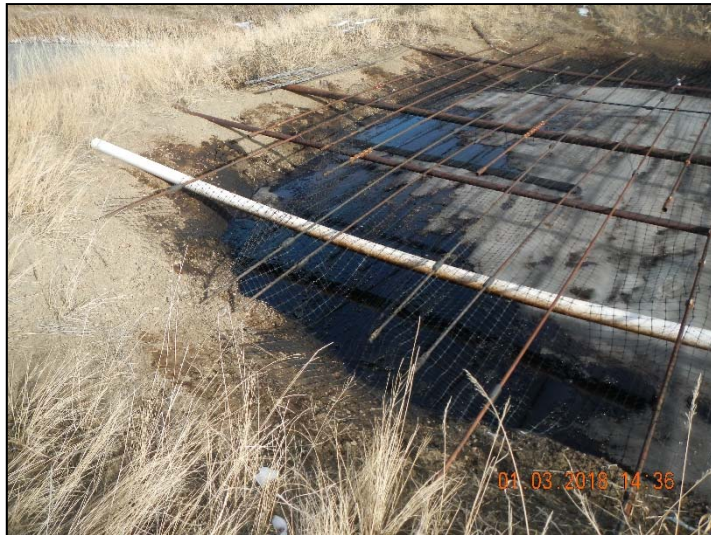
**Photo 22. Netting sagging into pit. Oil present.
Less than 2 feet of freeboard.
1/3/2018**

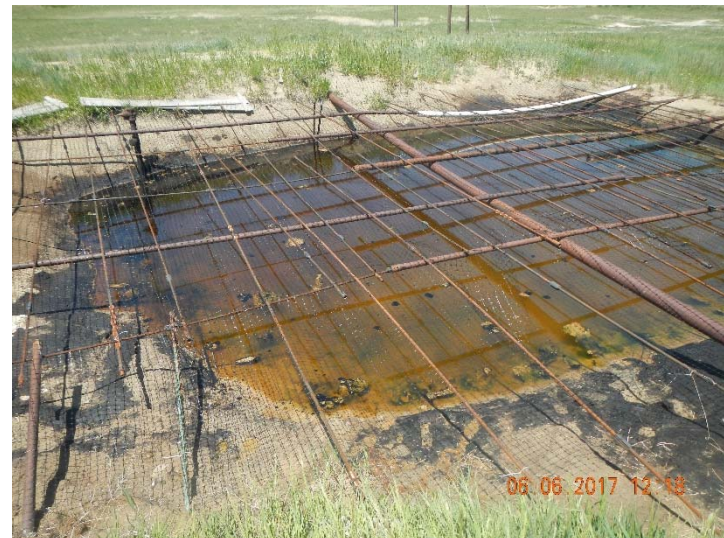
**Photo 23. Netting sagging into pit. Oil present. Less than
2 feet of freeboard.
6/6/2017**

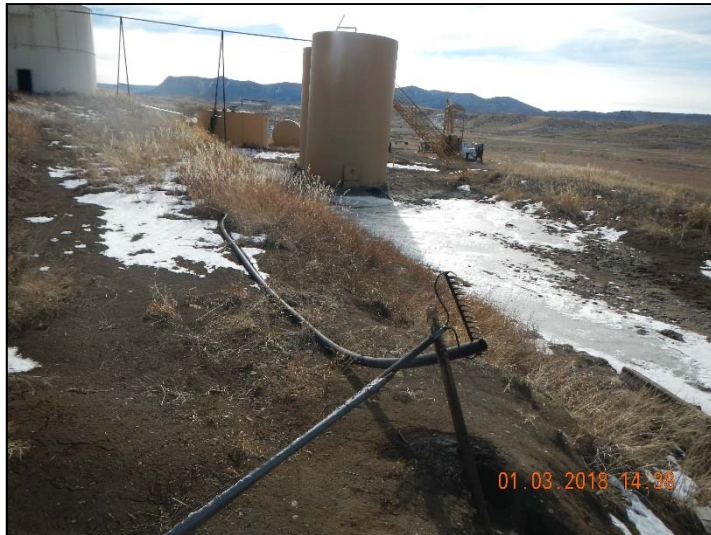
Photo 24. Stained soil on eastern side of pit.
1/3/2018

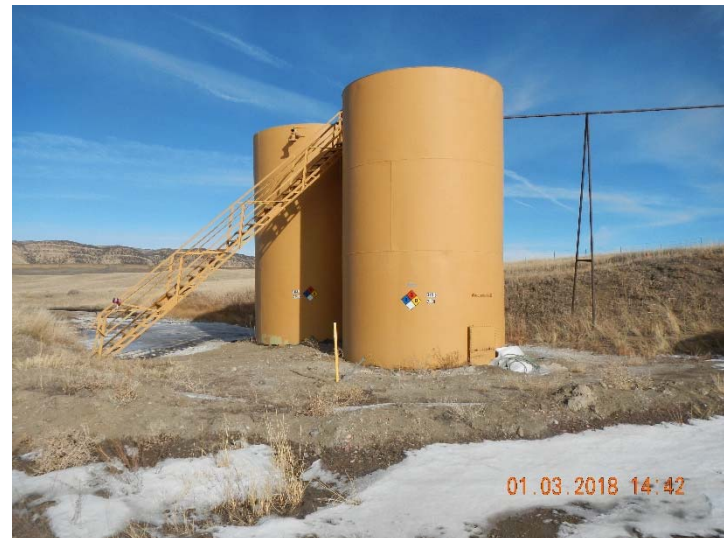
Photo 25. Incomplete tank labels.
1/3/2018

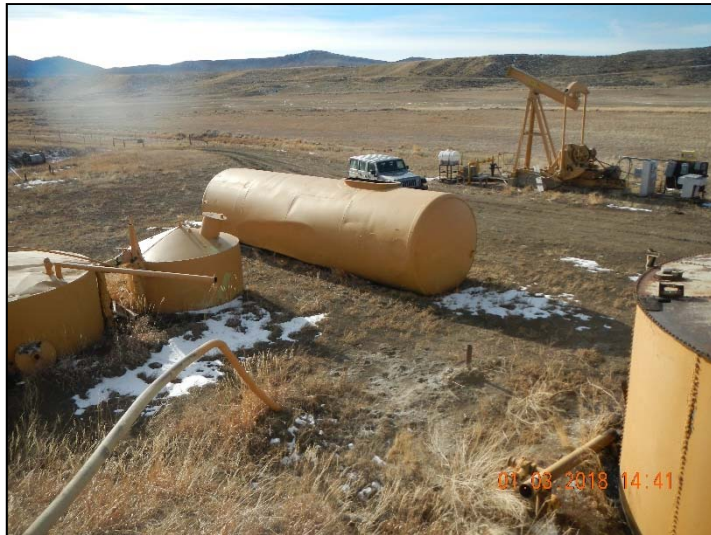
Photo 26. No tank labels. No berms.
1/3/2018

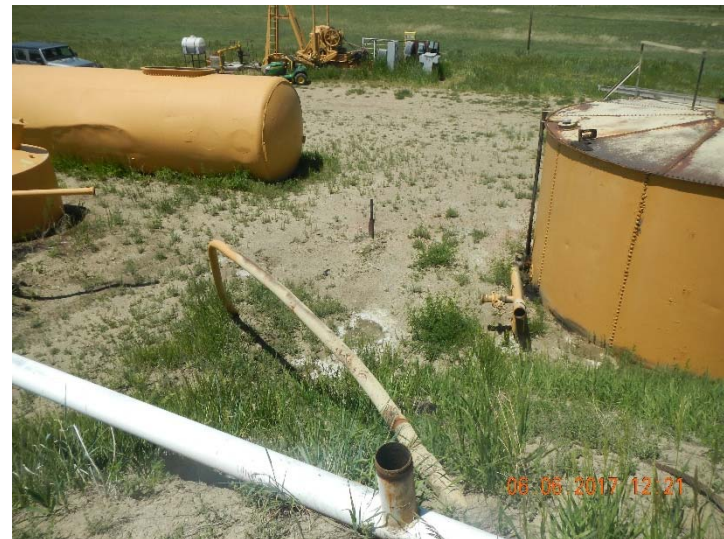
Photo 27. No tank labels. No berms.
6/6/2017
