Inspection Photos

API: 05-067-07003

Operator: BP AMERICA PRODUCTION COMPANY

Inspection Number: 680602402

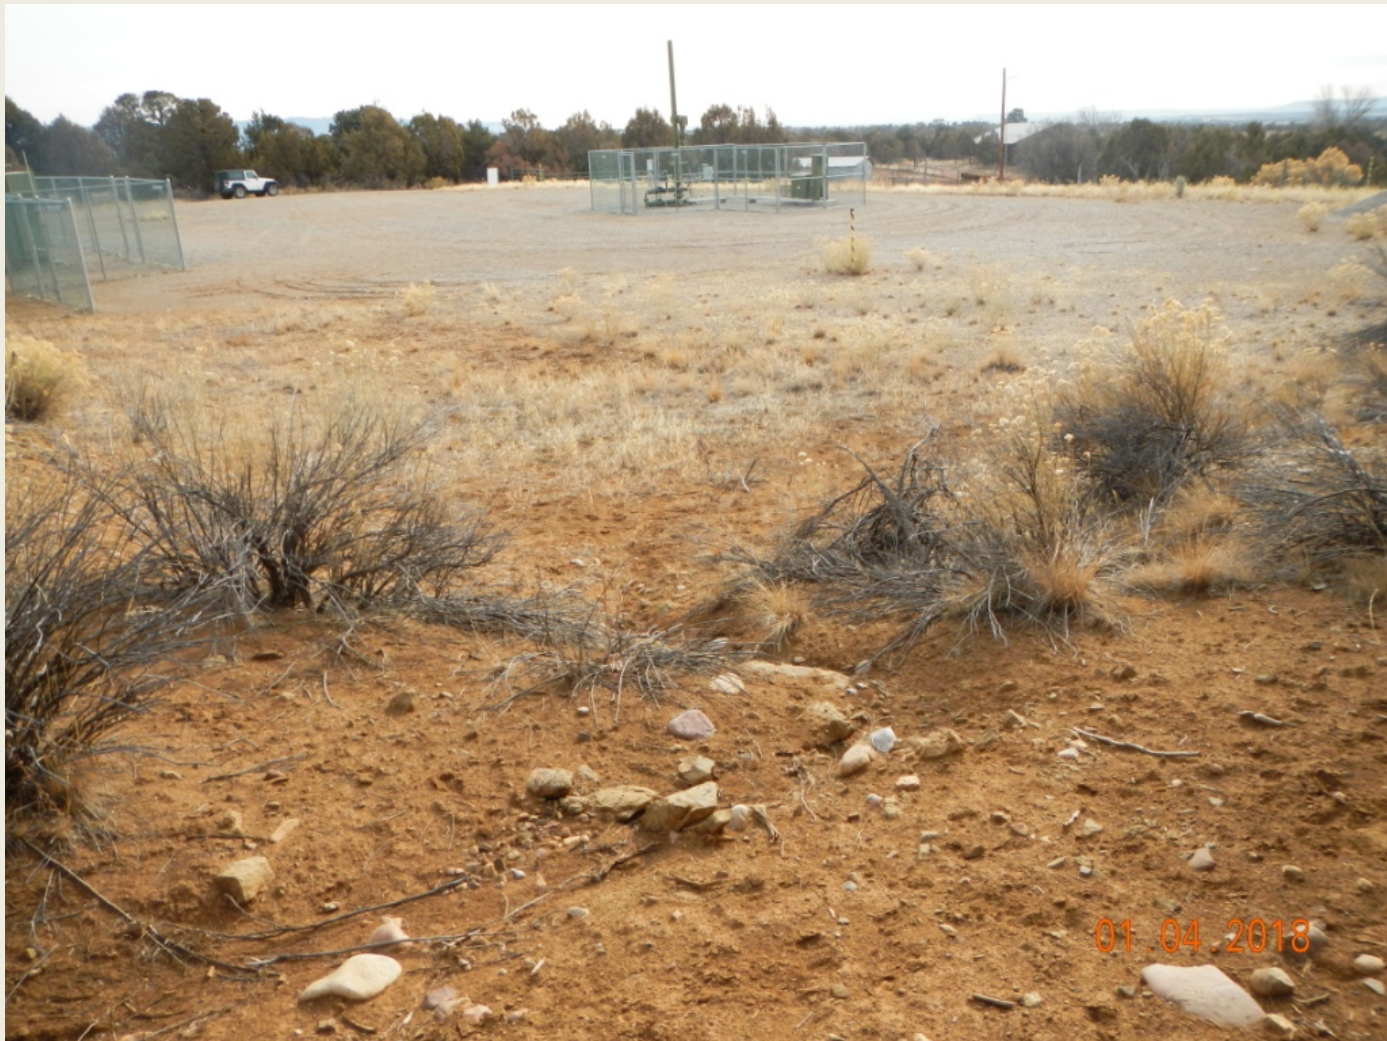
Photo 1. View of the project area from the northwestern corner facing center. Stormwater run-on is occurring here and needs to be monitored.

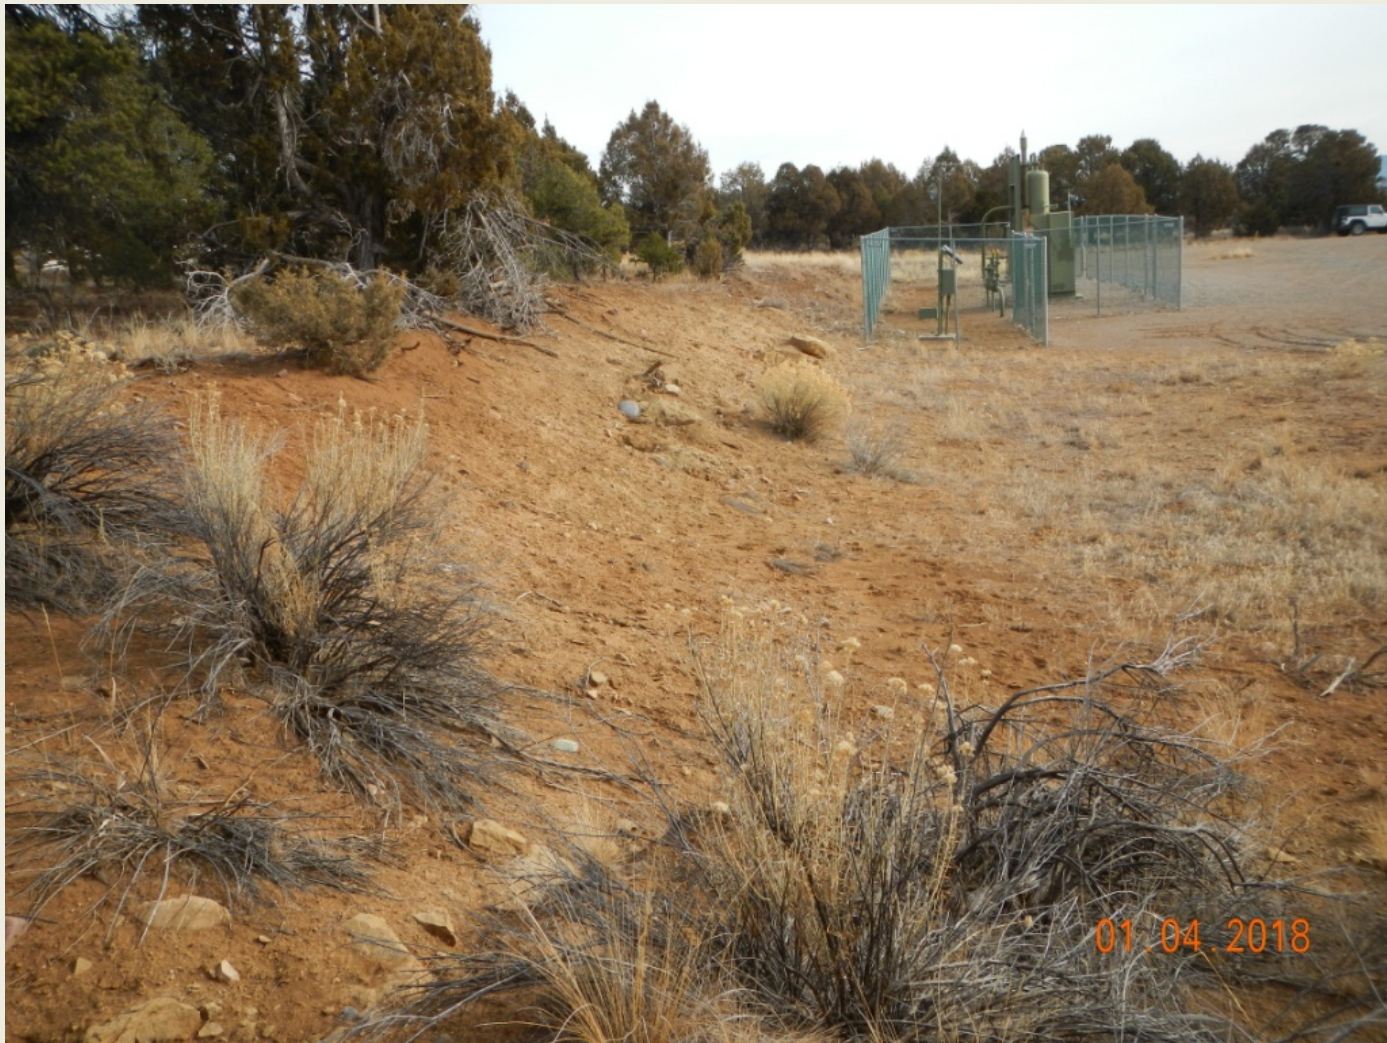
Photo 2. View of the northern portion of the project area from the northwestern corner facing eastward.

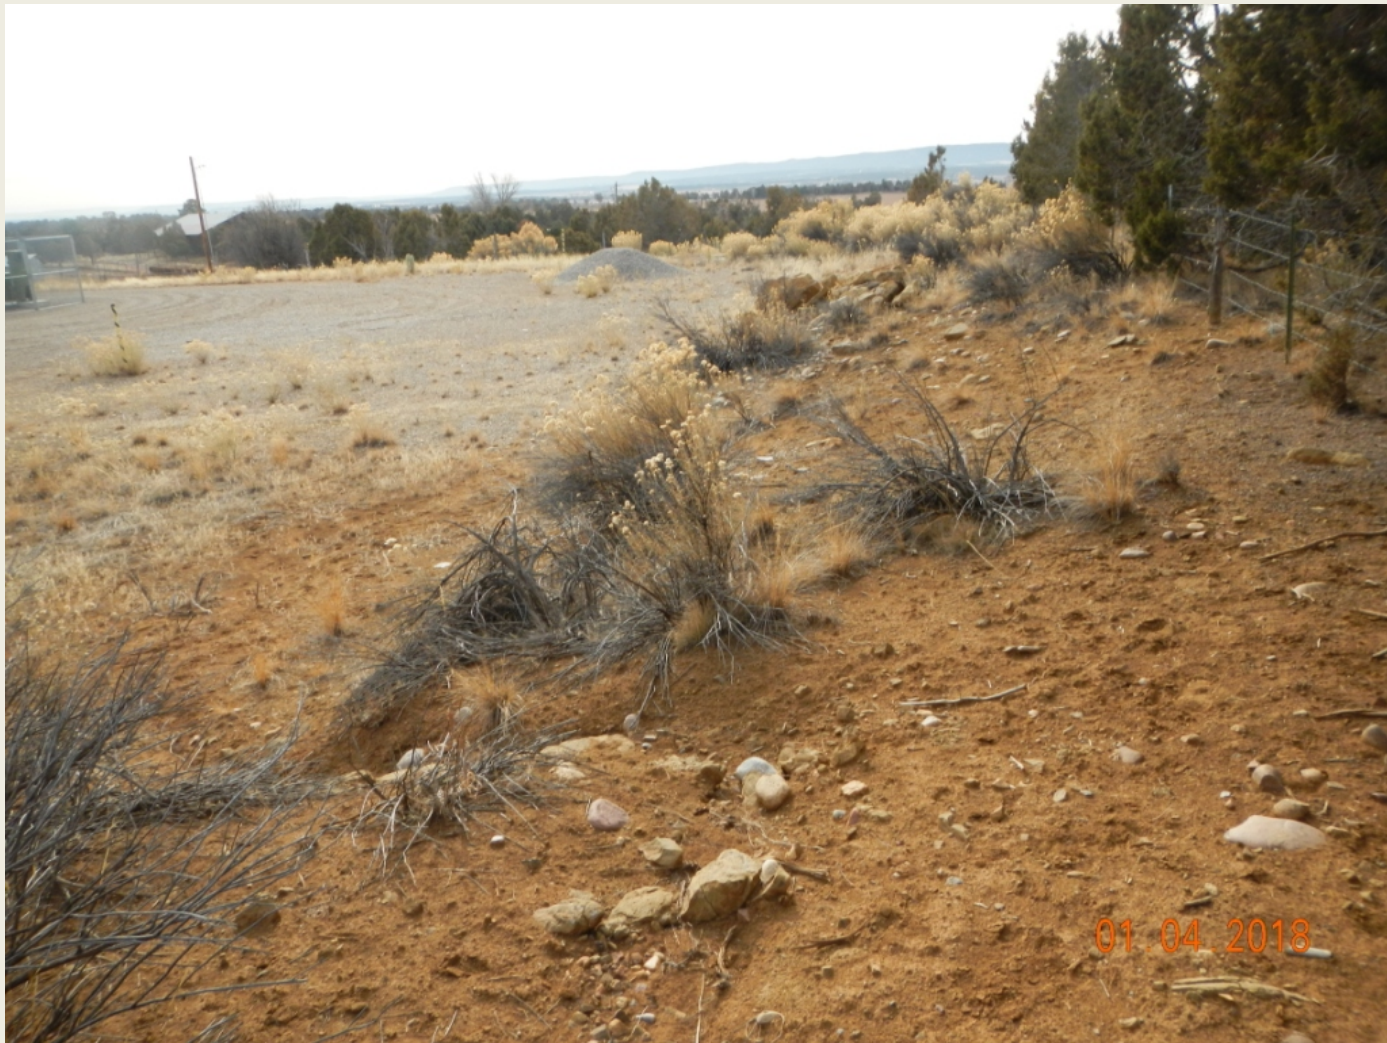
Photo 3. View of the western portion of the project area from northwestern corner facing southward. Revegetation is progressing with smooth brome (*Bromus inermis*), dropseed (*Sporobolus* sp.).

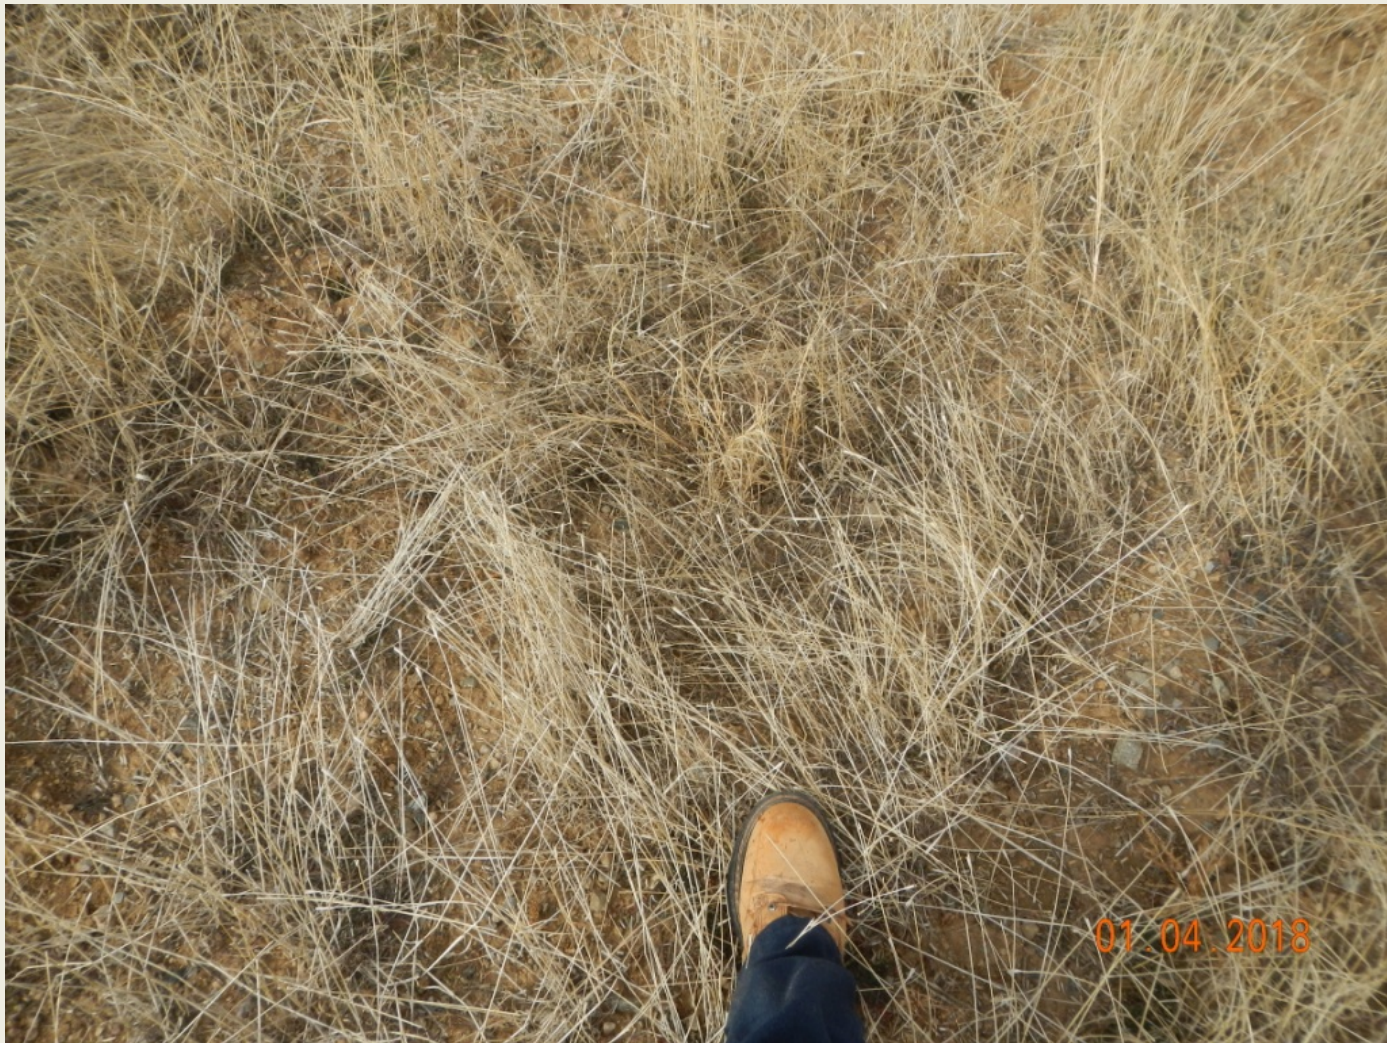
Photo 4. View of jointed goatgrass (*Aegilops cylindrica*) within the southern portion of the project area.
