Interim Reclamation and Stormwater Inspection

January 9, 2018

Operator: MALLARD EXPLORATION LLC - #10670

Location ID: 447898

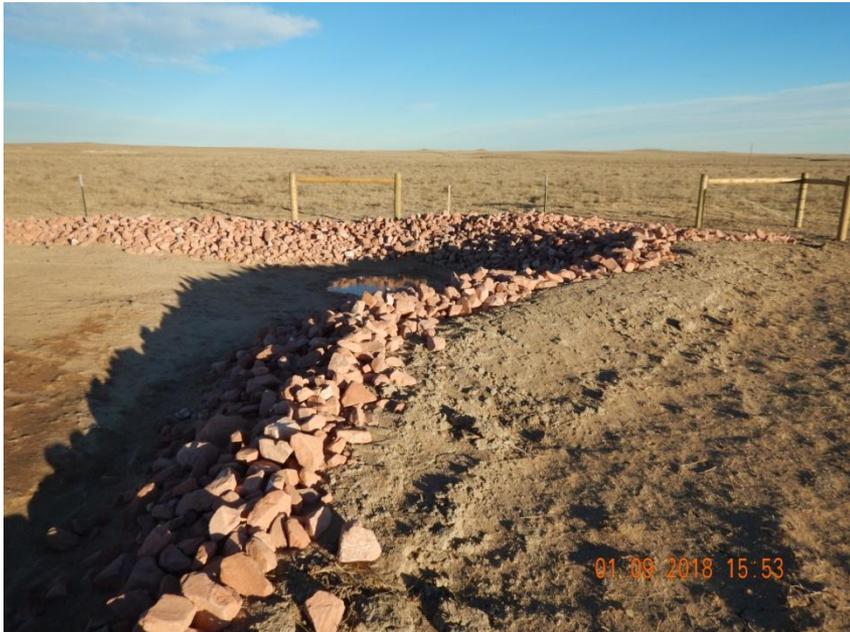
Photo 1. Photo taken from the southeast location, facing East. A sediment trap with a stabilized outlet has been installed. Operator may want to consider an additional sediment trap as this is the only sediment trap for a total disturbance of 19.17 acres which will not be reclaimed to reduce the total disturbance for interim reclamation.

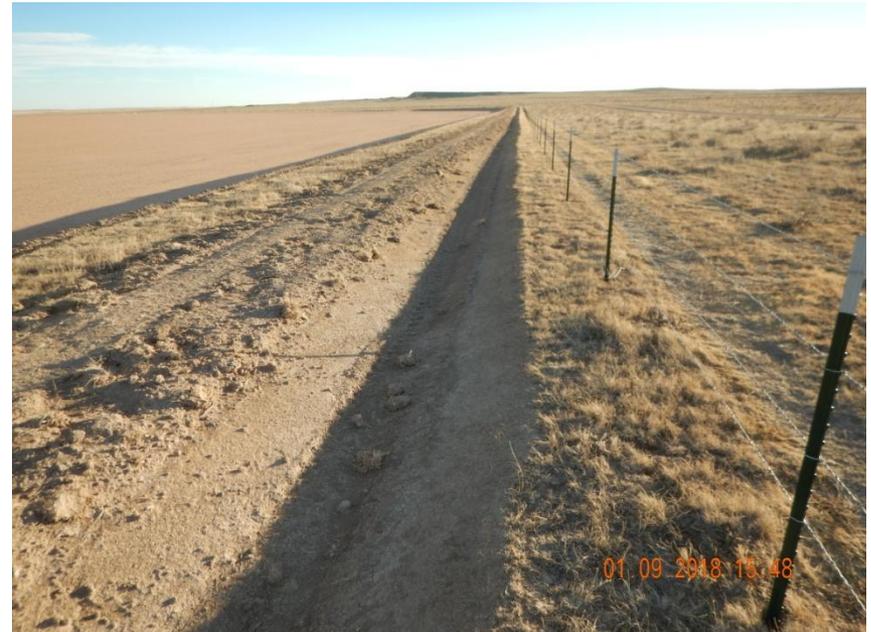
Photo 2. Photo taken from the western location, facing South. A ditch BMP has been installed along the perimeter location.

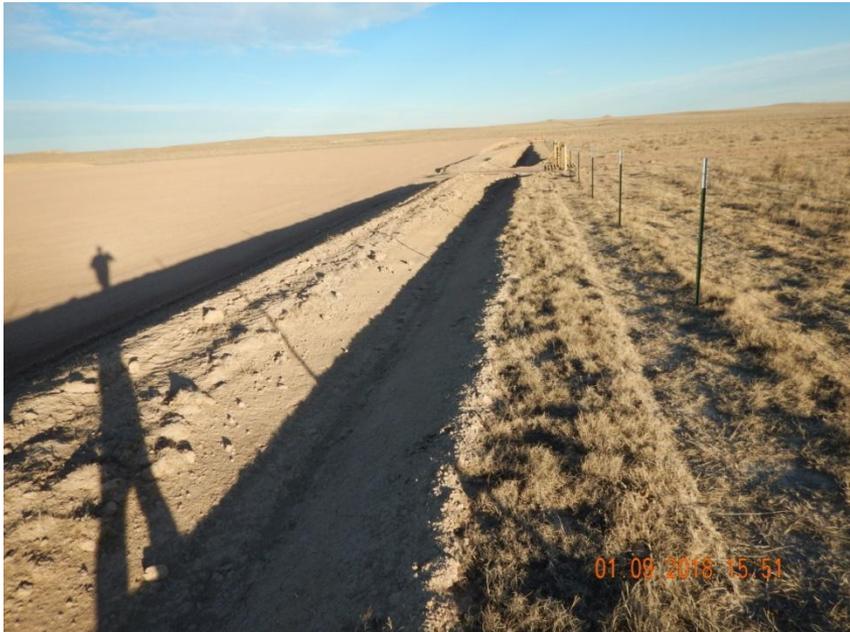
Photo 3. Photo taken from the southern location, facing East. See comments under Photo 2.

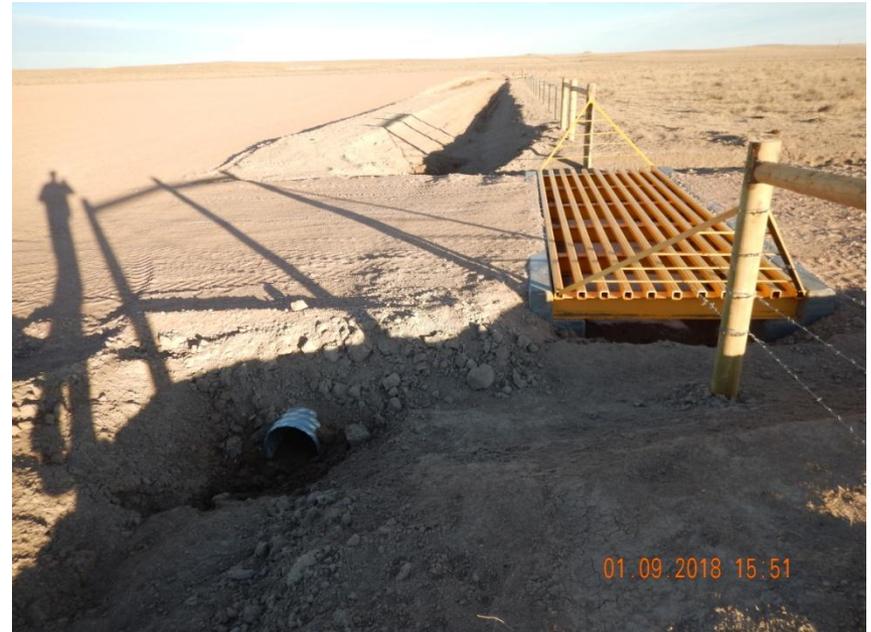
Photo 4. Photo taken from the southern location, facing East. Vehicle tracking device installed. Culvert installed in conjunction with the ditch BMP.

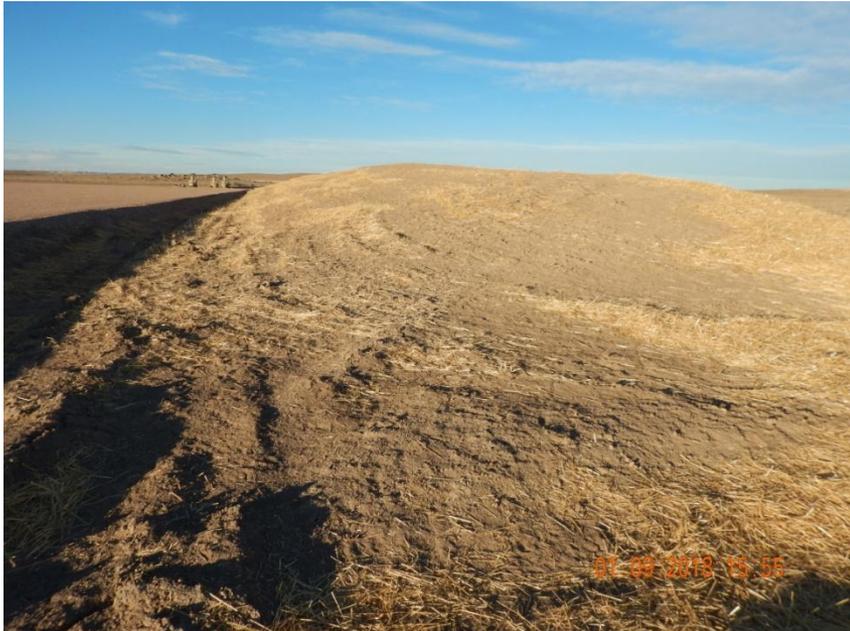
Photo 5. Photo taken from the eastern location, facing North toward the topsoil stockpile. Straw mulch is blowing off topsoil which may need maintenance.

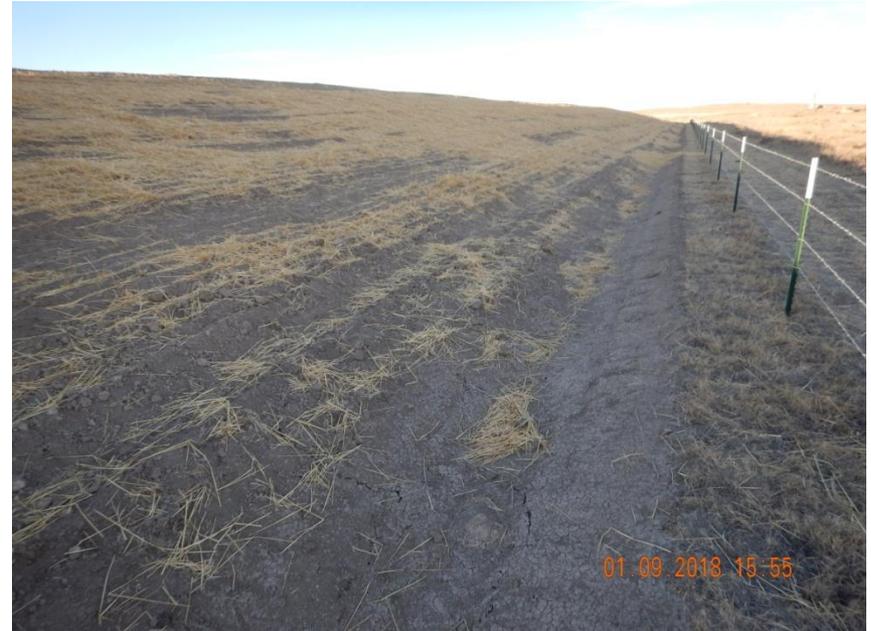
Photo 6. Photo taken from the eastern location, facing North. See comments under Photo 5.

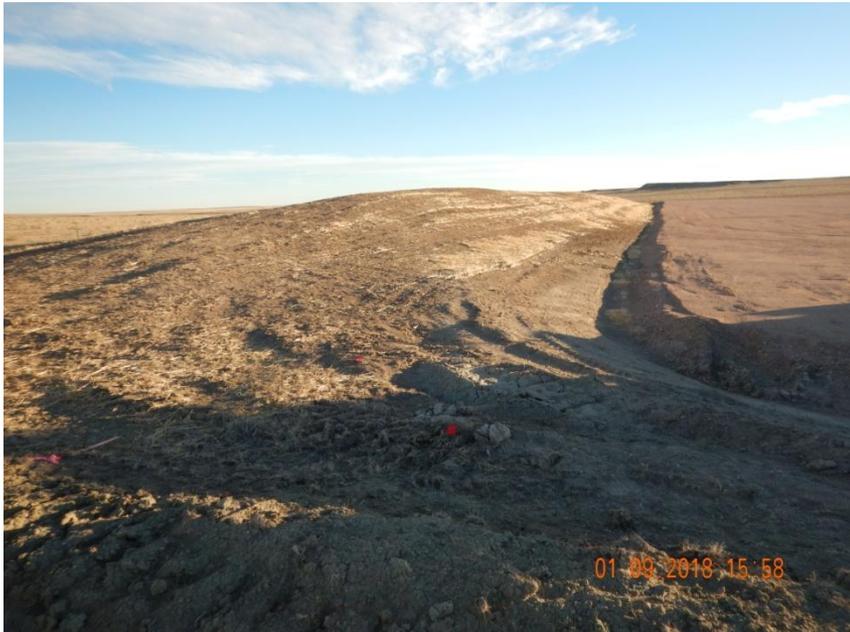
Photo 7. Photo taken from the northeast location, facing South towards the topsoil stockpile. Photo illustrates portions of the topsoil are bare and may require additional stabilization.

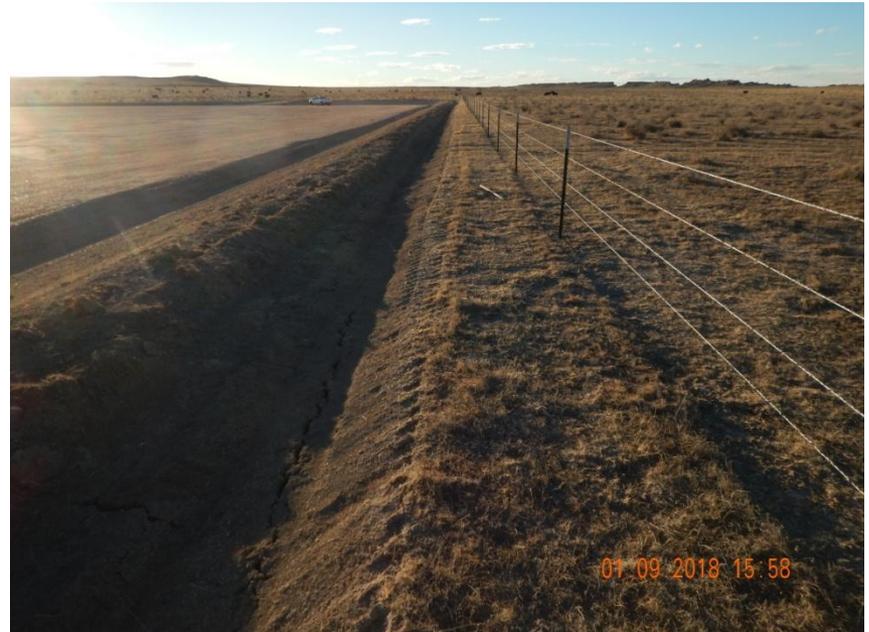
Photo 8. Photo taken from the northern location, facing West. See comments under Photo 2.
