# Inspection Photos

API: 05-067-09471

Operator: BP AMERICA PRODUCTION COMPANY

Inspection Number: 680602409

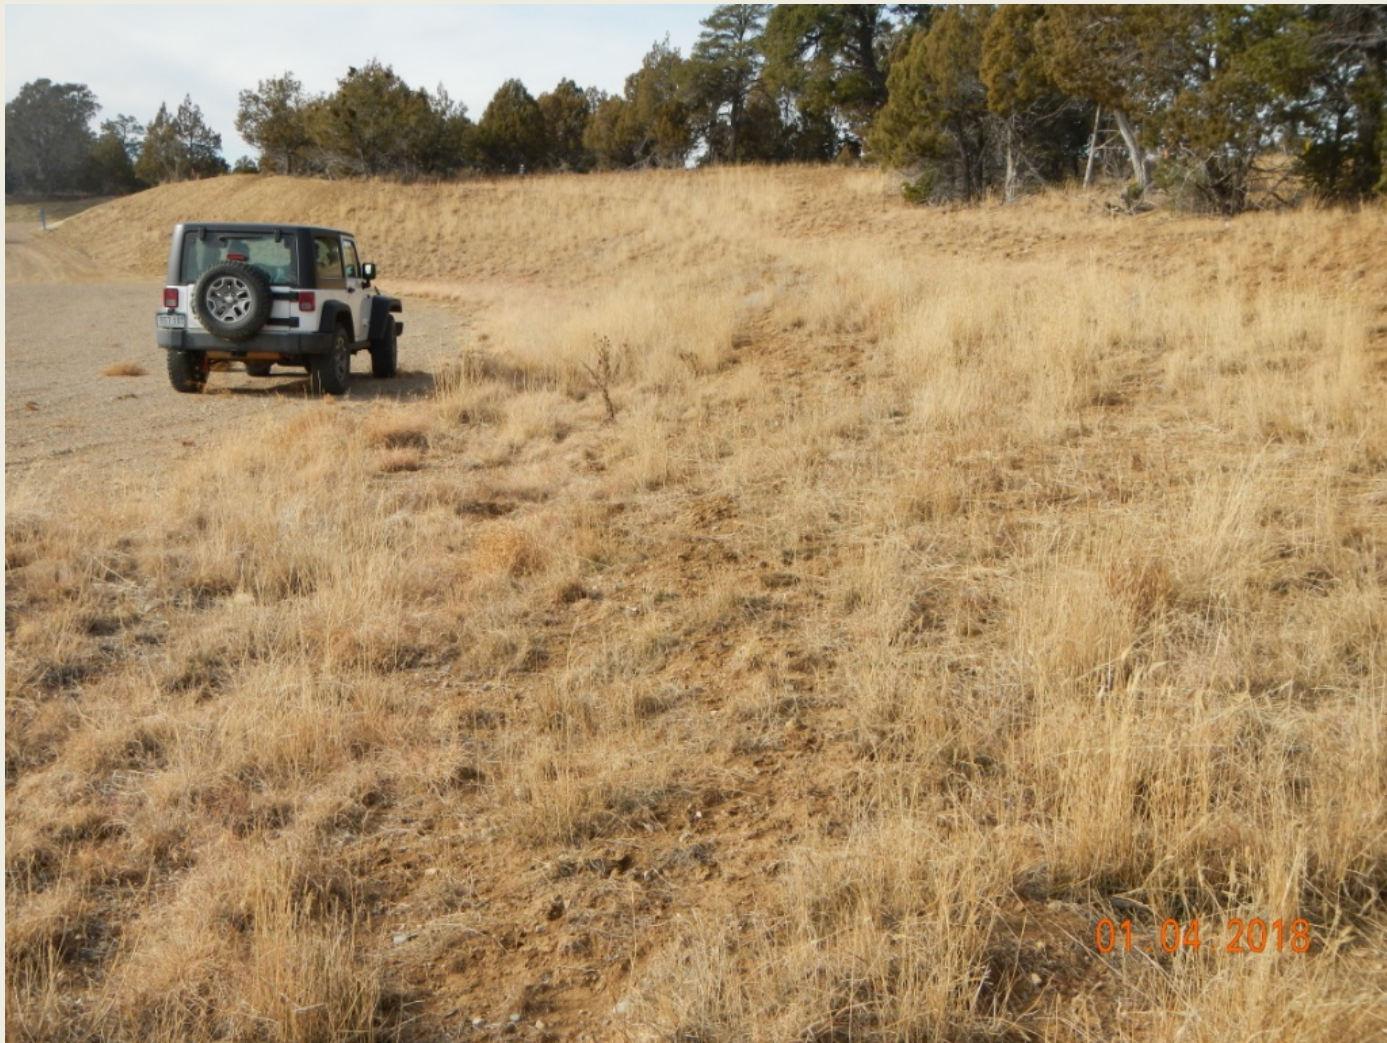
**Photo 2. View of the northern portion of the project area from the northeastern corner facing westward. Revegetation is progressing with crested wheatgrass (*Agropyron cristatum*) and blue grama (*Bouteloua gracilis*).**

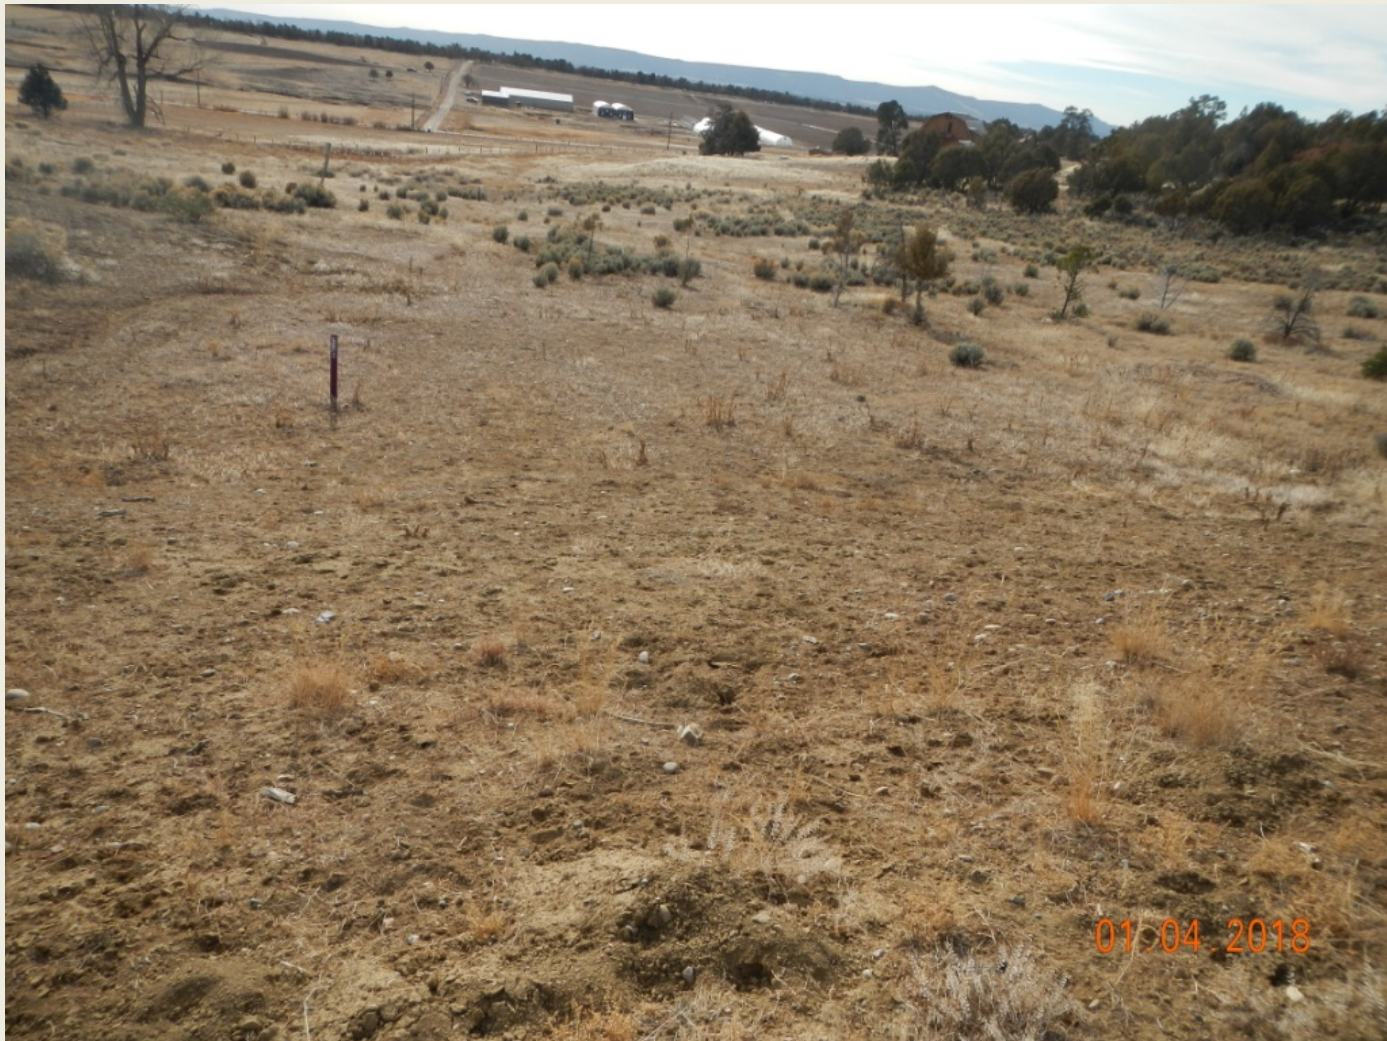
**Photo 4. View of area in the southern portion of the project are with sparse revegetation. Vegetation in this area is largely annual weeds. This needs to be evaluated during the 2018 growing season and re-seeded by November 1, 2018 if desirable cover is not established.**

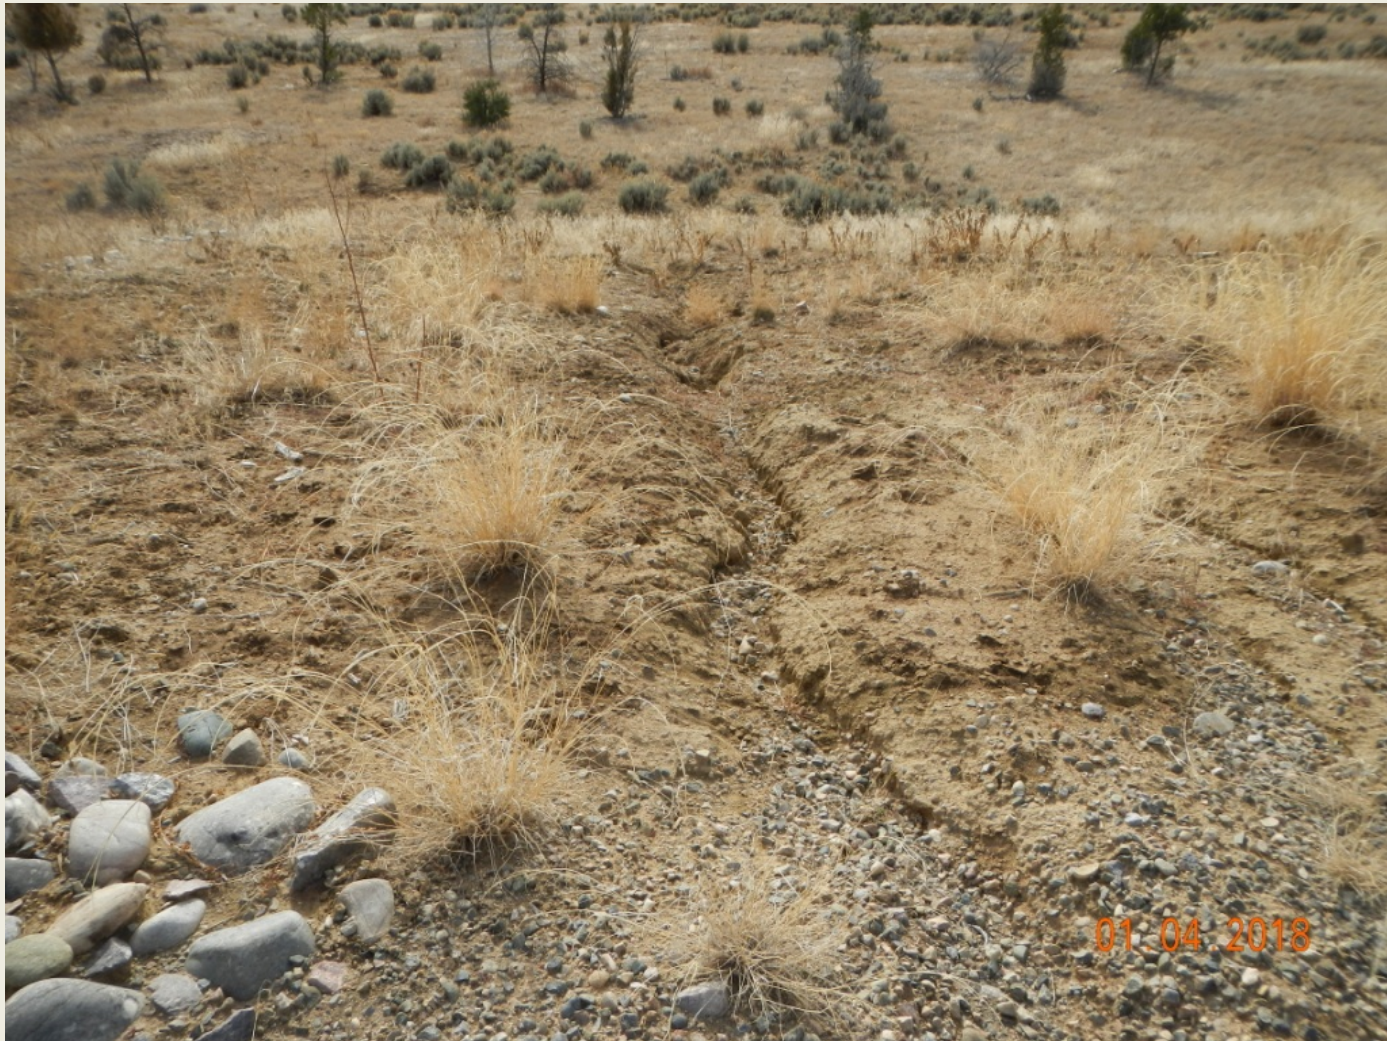
**Photo 5. View of erosional channels in the southern portion of the project area.**

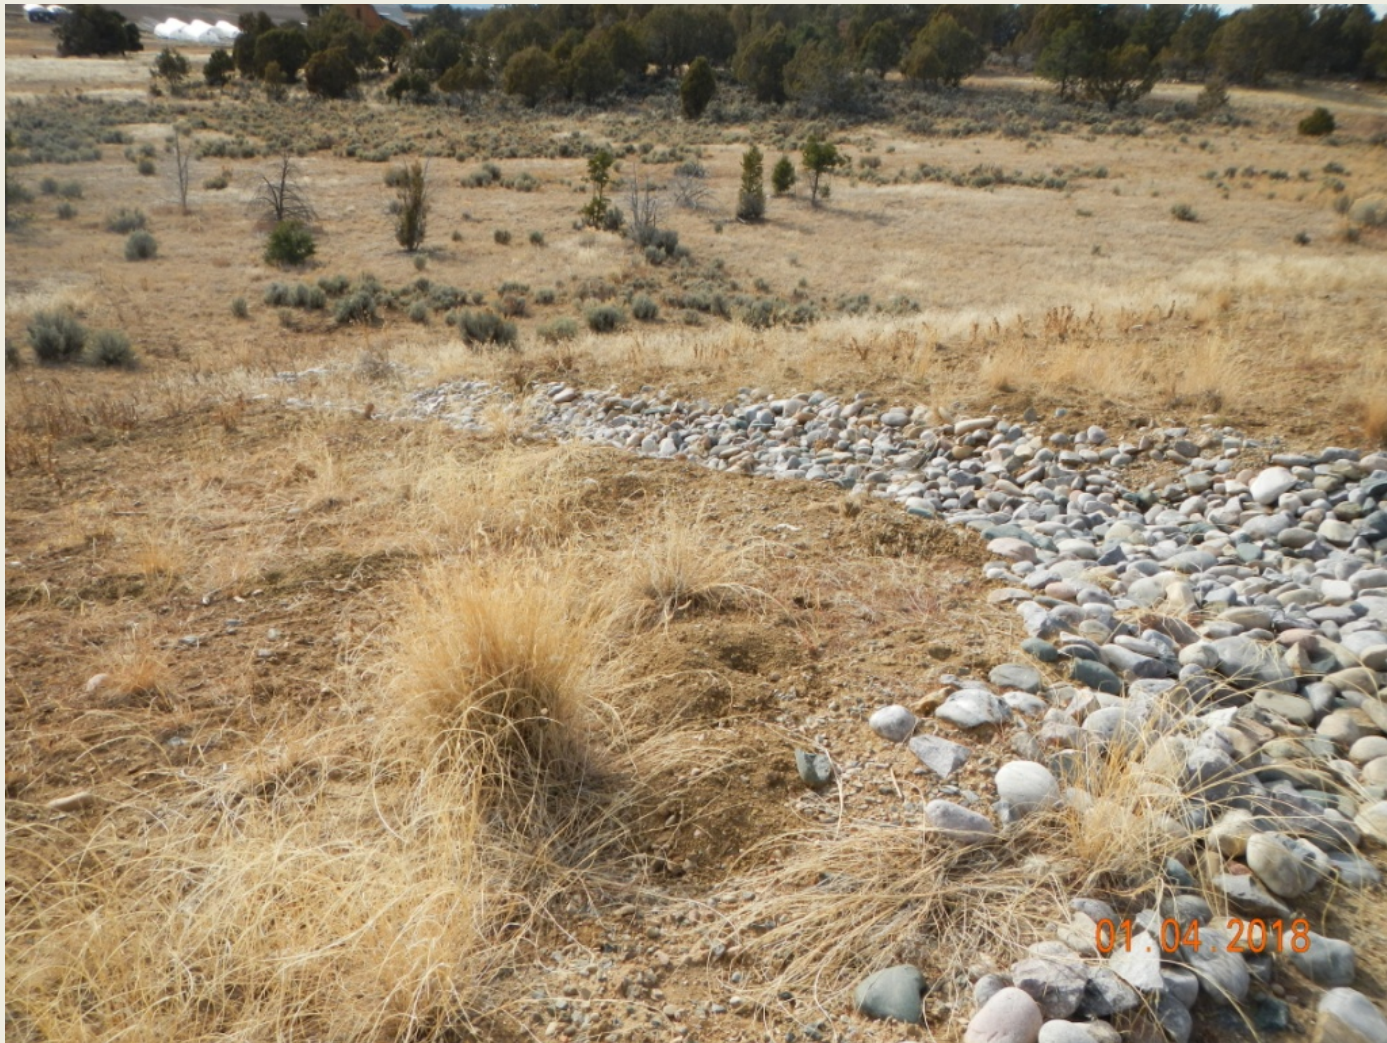
**Photo 6. View of cobble run-down in the southern portion of the project area.**

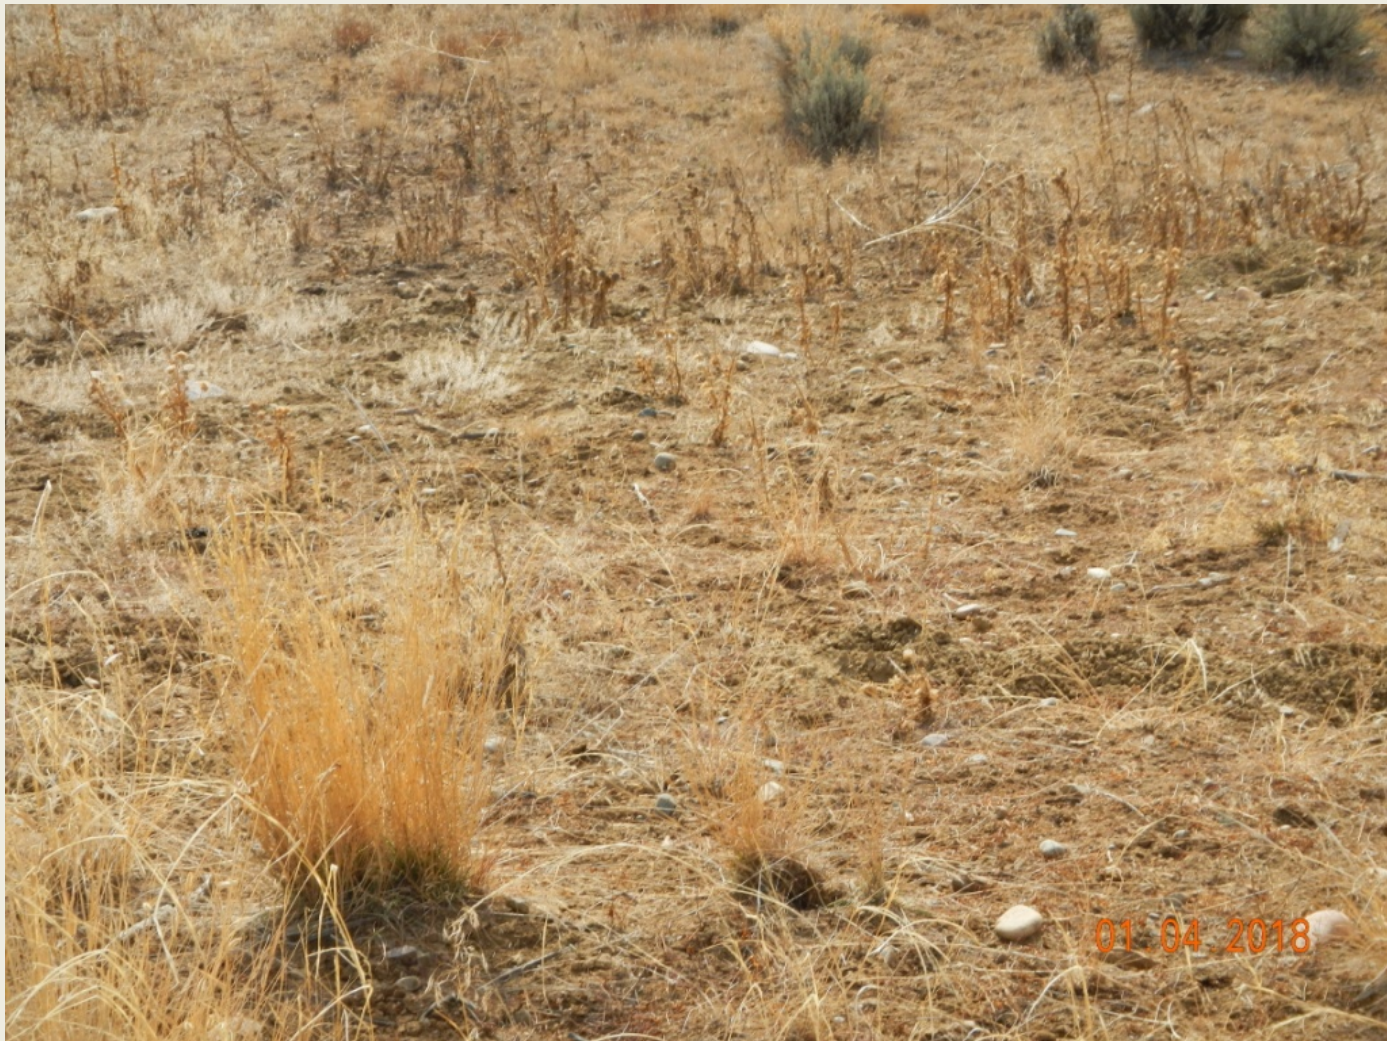
**Photo 7. View of musk thistles (*Carduus nutans*) in the southern portion of the project area.**
