Inspection Photos

Operator: NOBLE ENERGY INC - 100322

Location ID: 318182

Inspection Doc. Number: 682503068

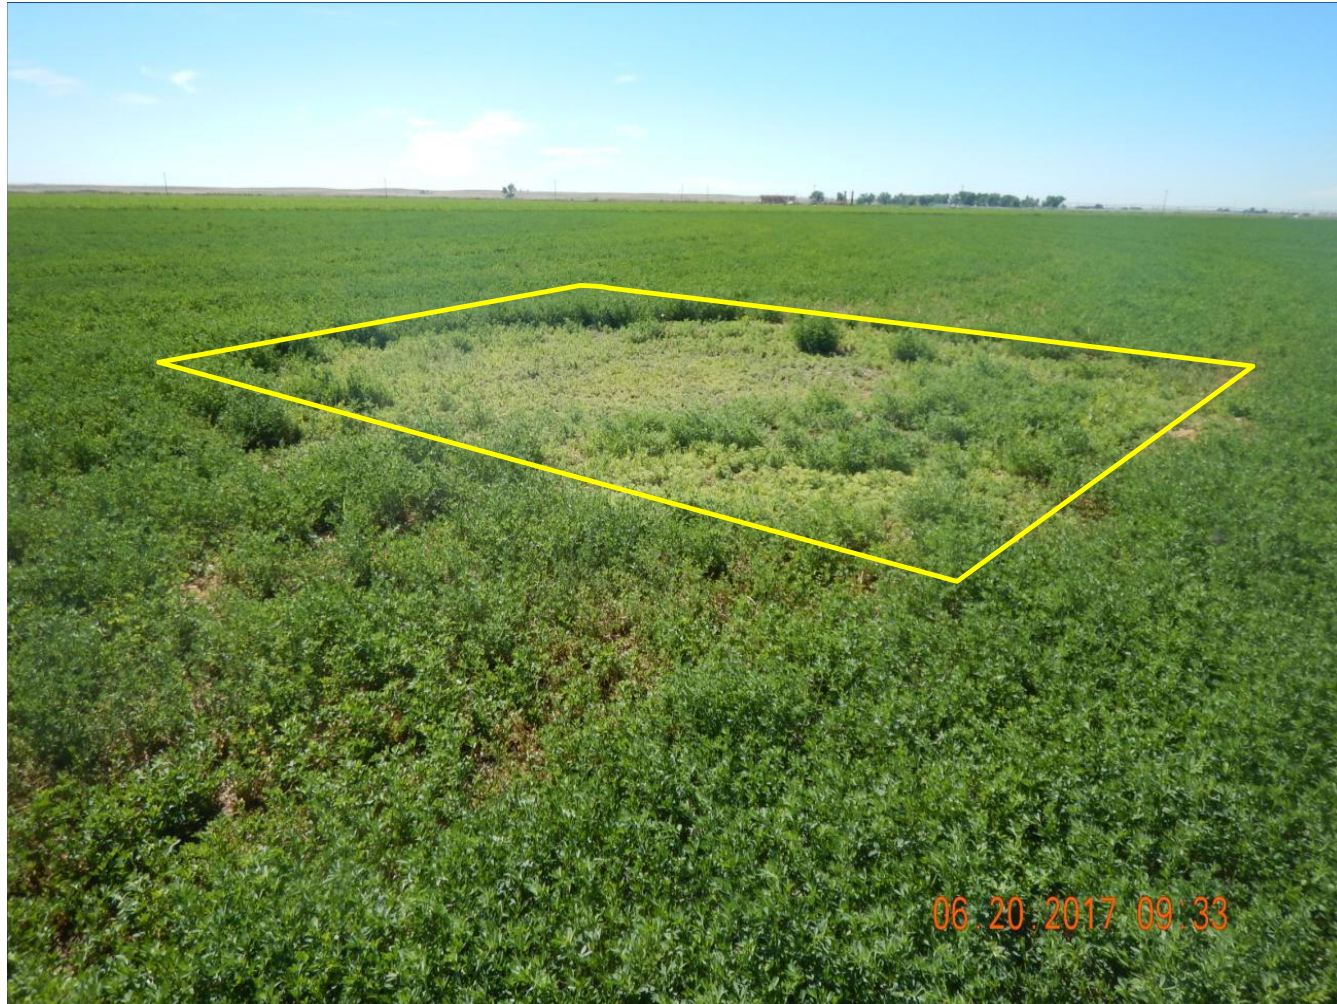
Photo 1: Photo from inspection dated 6/20/2017. Photo shows well location during the growing season is predominantly undesirable weedy plant species and not reflective of the adjacent perennial cropland

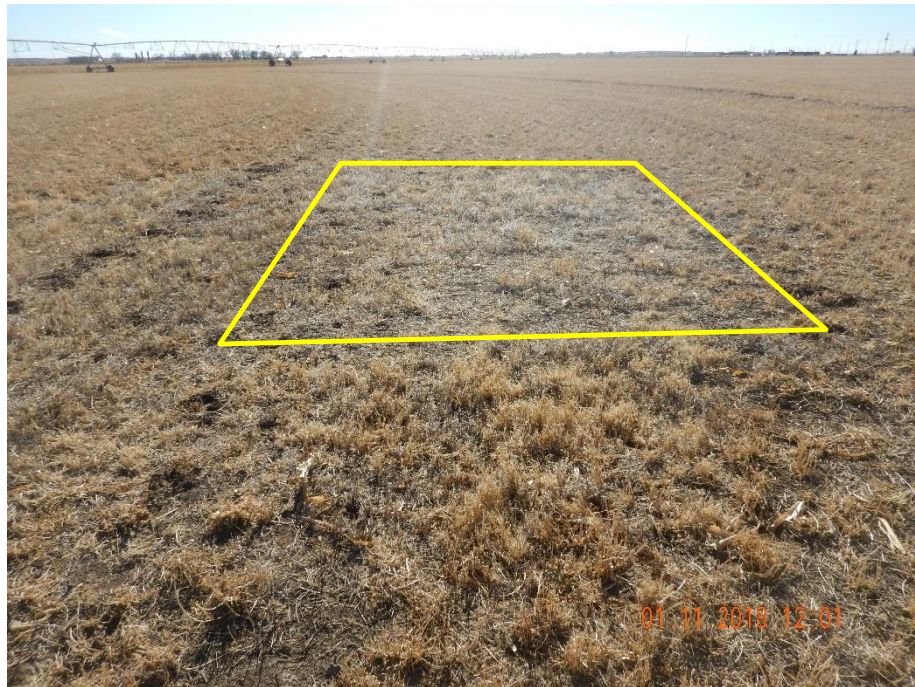
Photo 1b: Photo taken from the north end of the former well location. Photo shows no additional reclamation activities appear to have been conducted per corrective actions. Well location remains predominantly undesirable weedy plant species not reflective of the adjacent reference area.

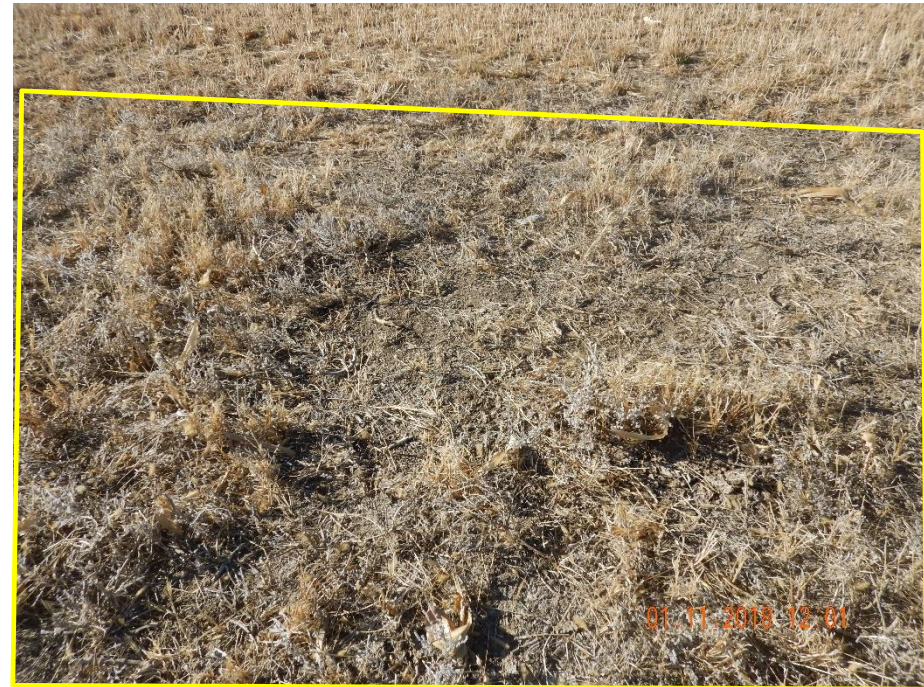
Photo 2: Photo taken from the well location. Photo shows vegetation at well remains predominantly undesirable weedy plant species such as kochia

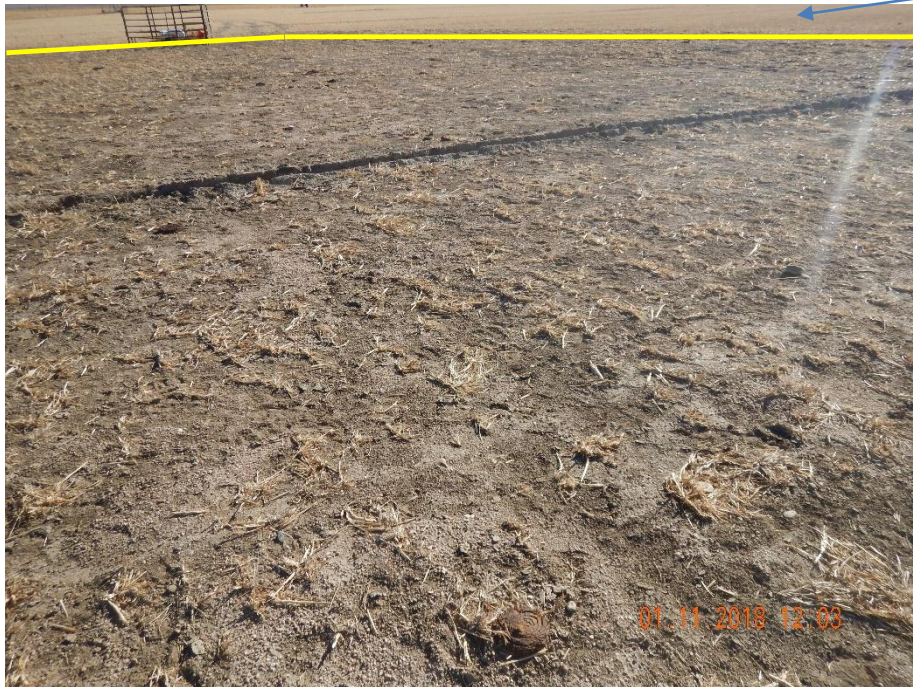
Photo 3: Photo taken from the north end of the former tank battery location, facing southeast. Photo shows battery location remains predominantly bare and exposed soil. Unable to find evidence that additional reclamation activities have been conducted per corrective actions.

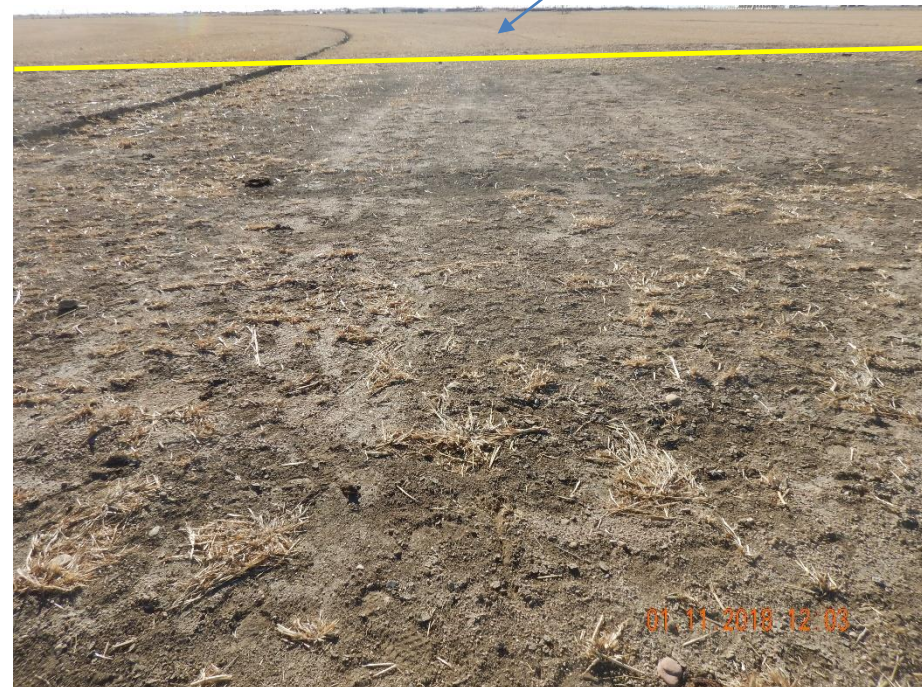
Photo 4: Photo taken from the north end of the former tank battery location, facing south. Photo shows battery location remains predominantly bare and exposed soil. Unable to find evidence that additional reclamation activities have been conducted per corrective actions.

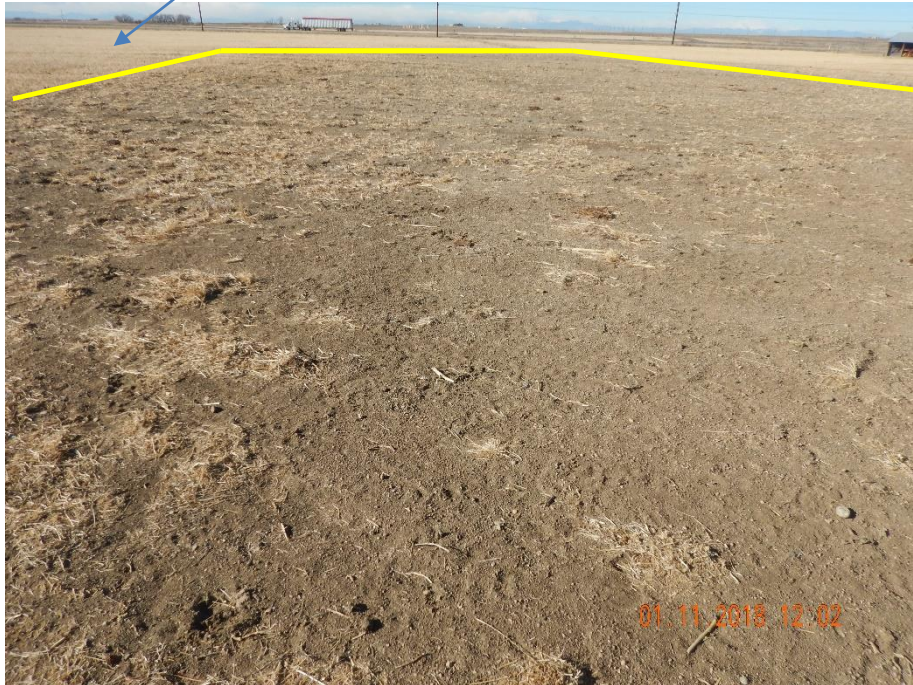
Photo 5: Photo taken from the east end of the former tank battery location, facing west. Photo shows battery location remains predominantly bare and exposed soil. Unable to find evidence that additional reclamation activities have been conducted per corrective actions.

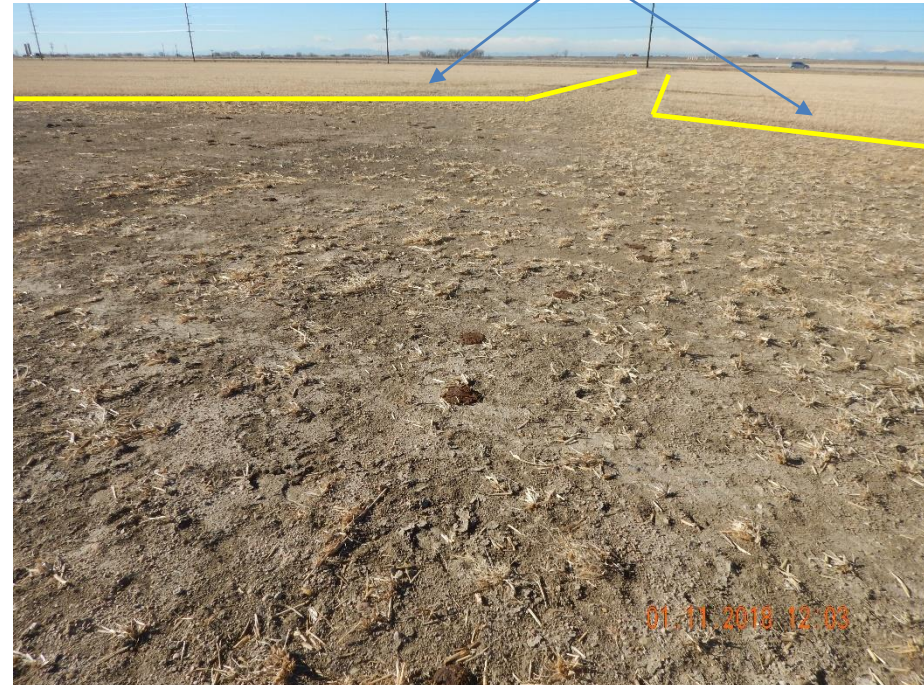
Photo 6: Photo taken from the north end of the former tank battery location, facing west. Photo shows battery location and access road remains predominantly bare and exposed soil. Unable to find evidence that additional reclamation activities have been conducted per corrective actions.

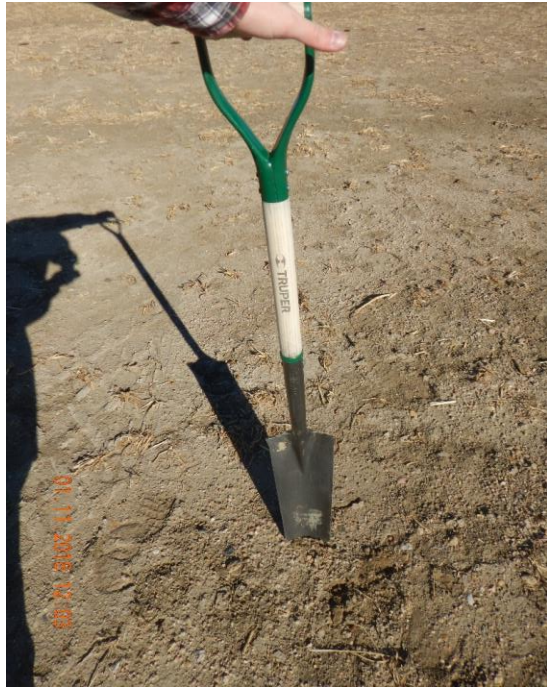
Photo 7: Photo taken from the battery location. Photo shows inspector was unable to penetrate surface of the soil with a shovel. Compaction concerns remain evidence.

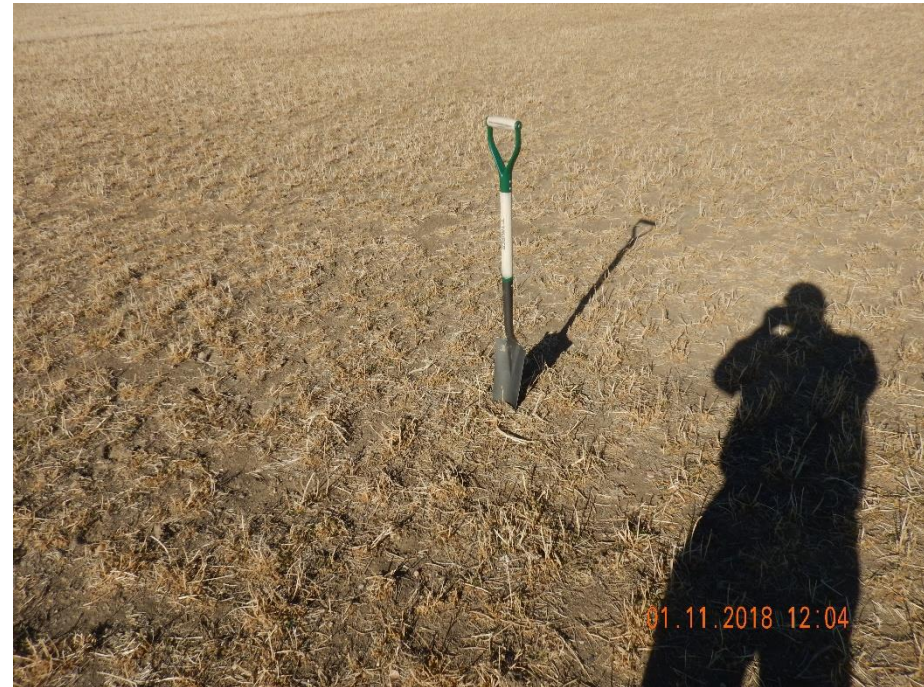
Photo 8: Photo taken from the adjacent reference area. For comparison with the disturbance areas (photo 7), photo shows inspector was able to penetrate the top 6 inches of soil with relative ease.
