Inspection Photos
Location Name: [Champlin 485 Amoco #1]
API: 05-001-07900

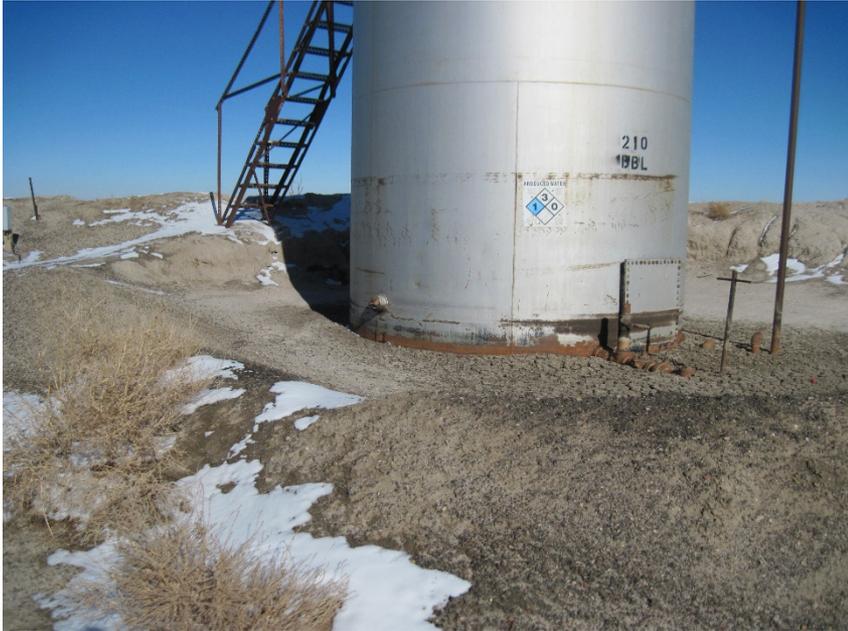
Berms will not hold capacity of water tank

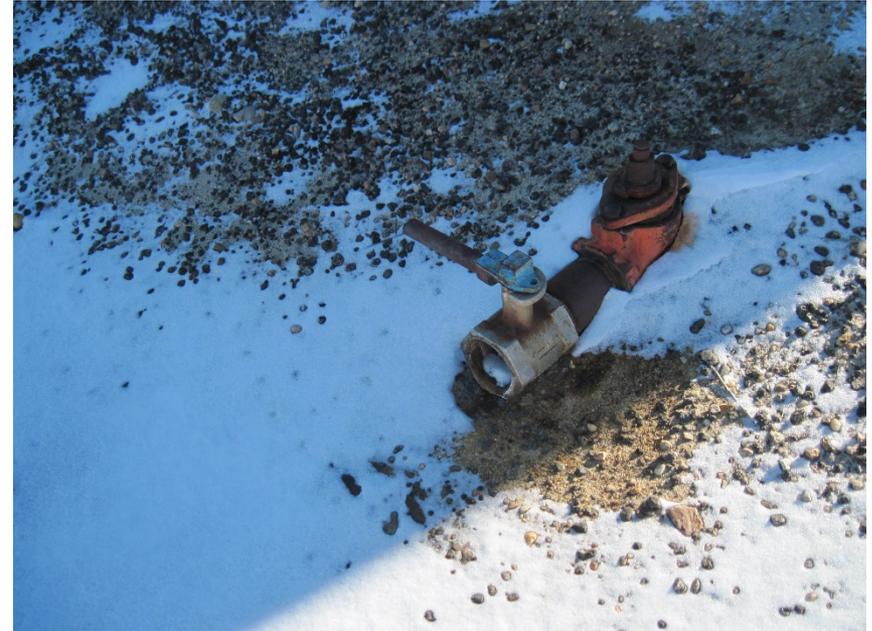
Need Cap on load line
