Well Name : Herrera 3

API # : 067-06526

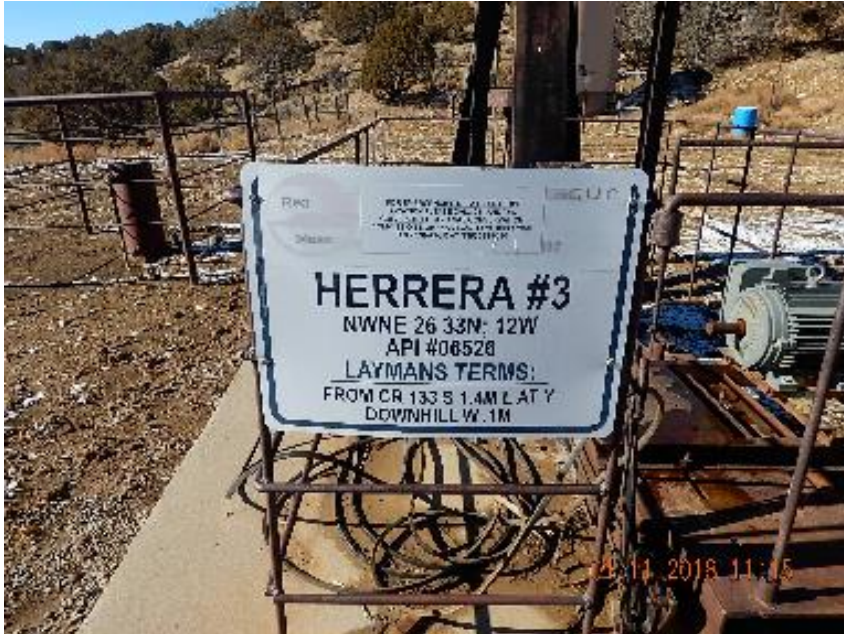
Photo 1: Wellhead sign.

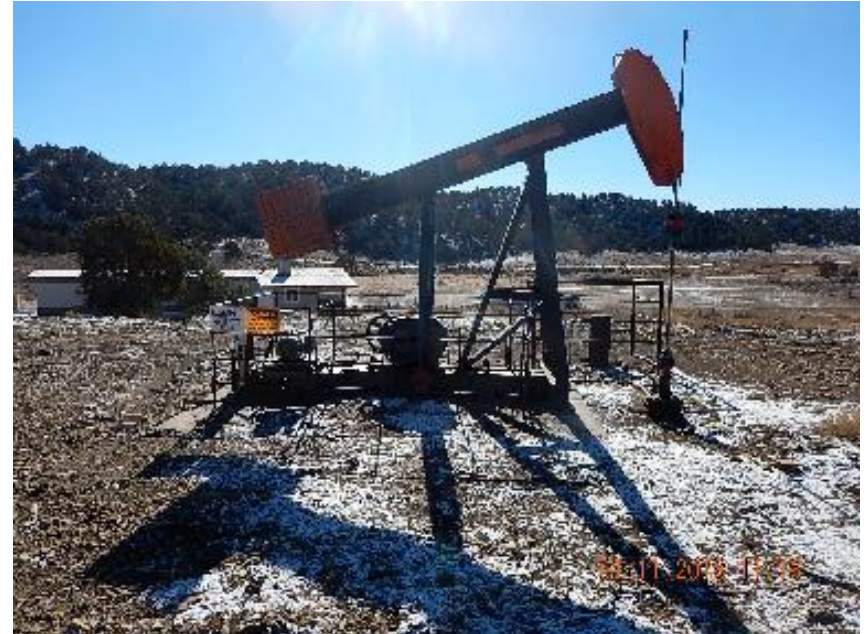
Photo 2: Pump jack, wellhead, and electric motor.

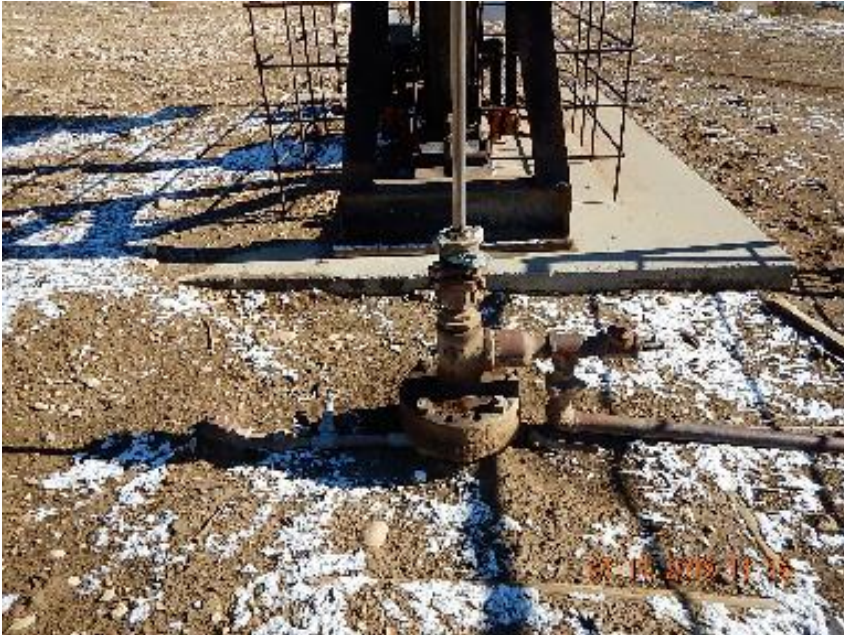
Photo 3: Wellhead.

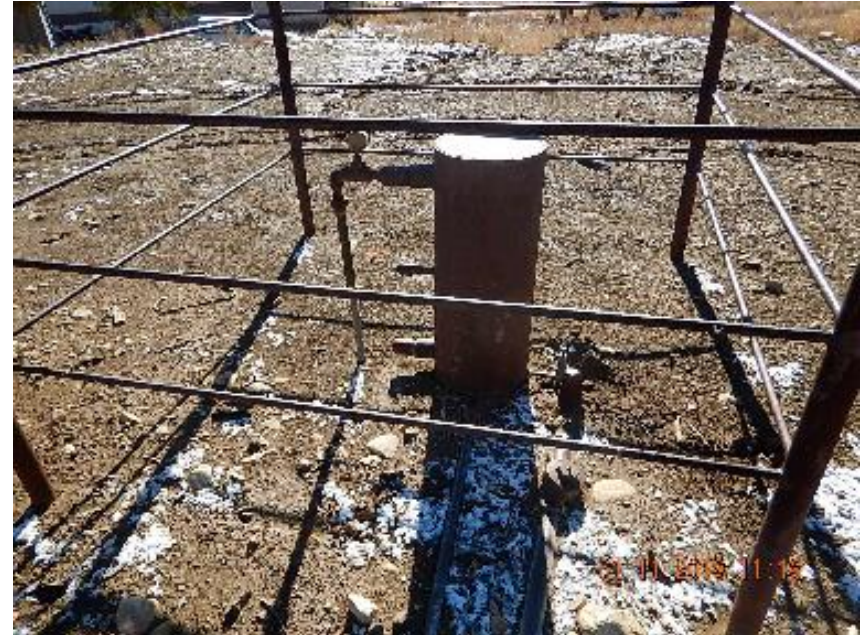
Photo 4: Domestic tap.

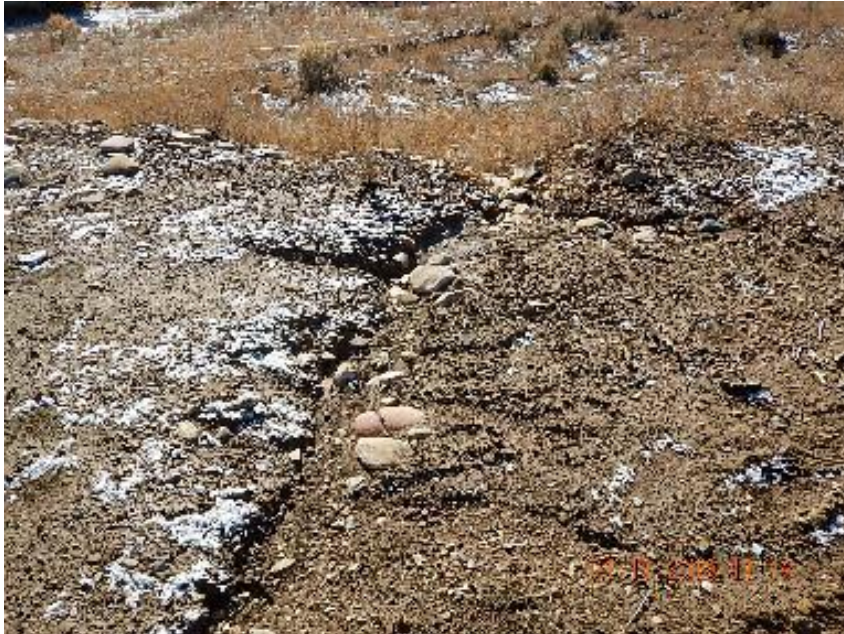
Photo 5: Erosion channel on S perimeter.

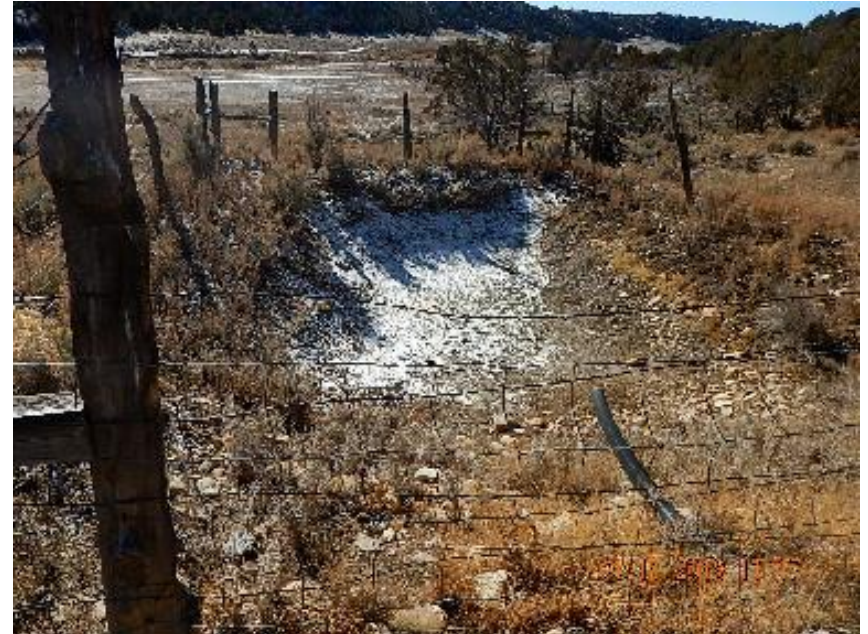
Photo 6: Open pit on W perimeter.

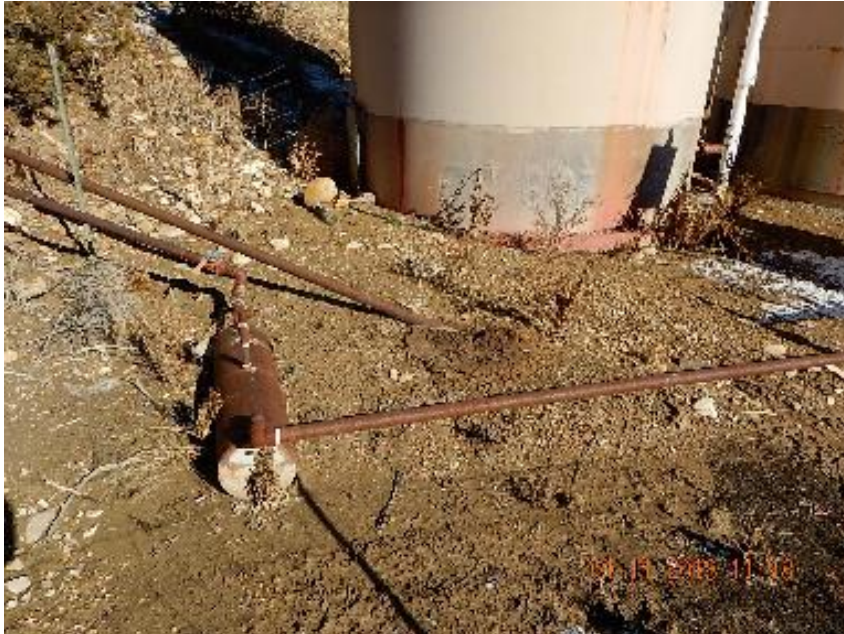
Photo 7: Flowlines at bottom of slope into tank battery. 4" line closest to tank goes into ground but has dried crude oil at surface.

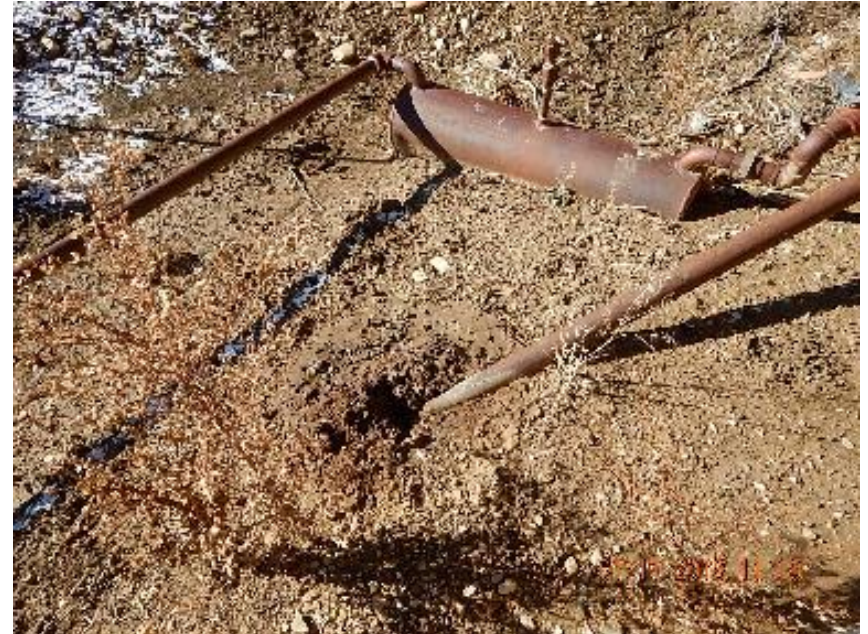
Photo 8: Closer view of 4" line with impacted soil at surface.

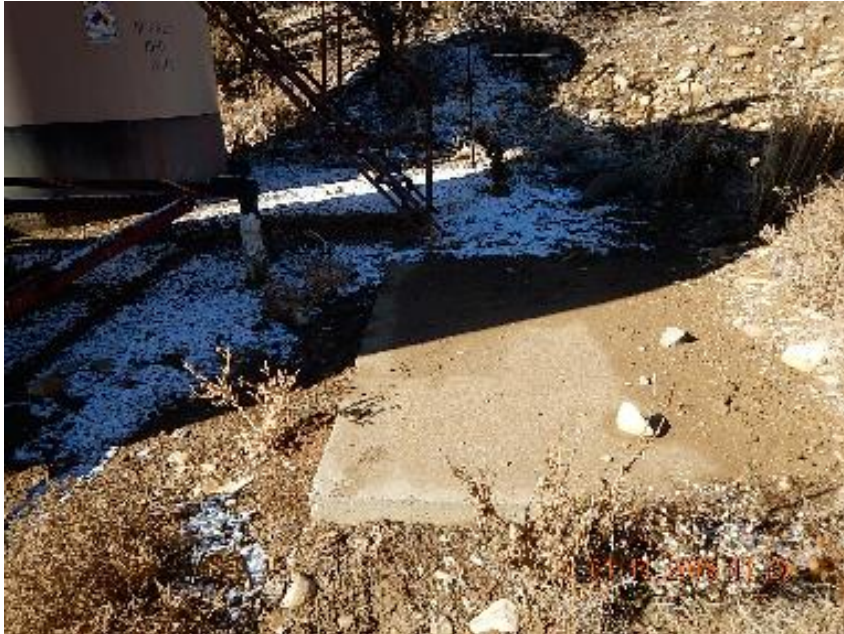
Photo 9: Unused concrete pad.

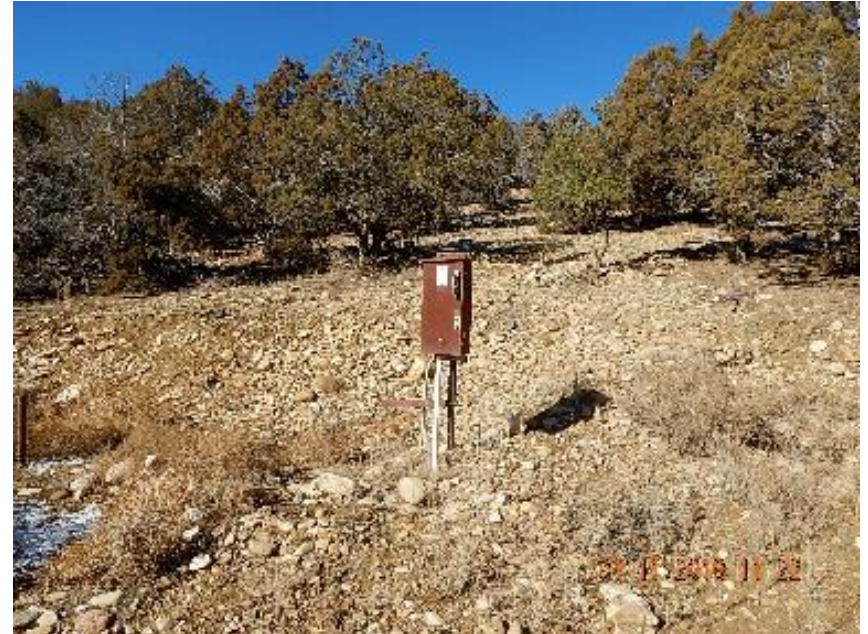
Photo 10: Power panel.

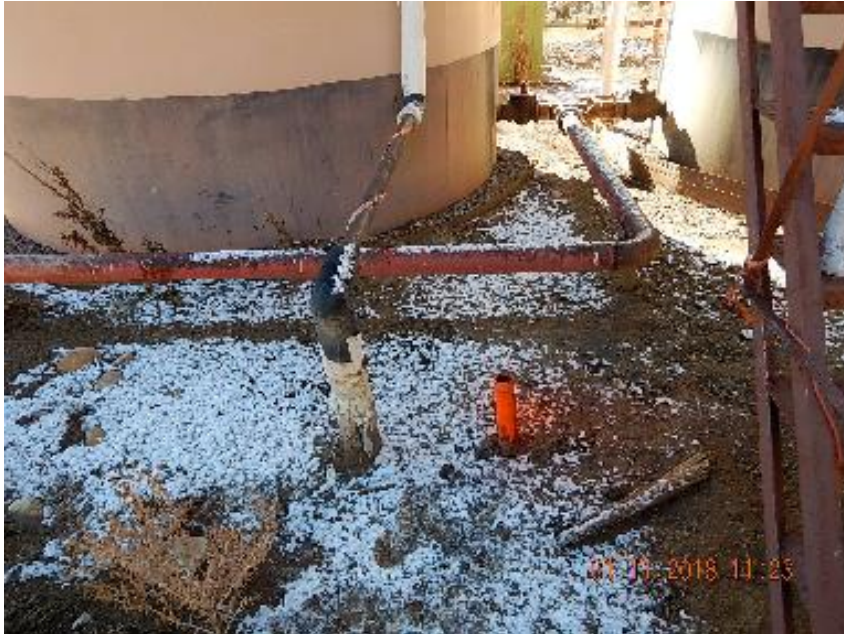
Photo 11: Open ended unused 3" steel riser on E side of tanks.

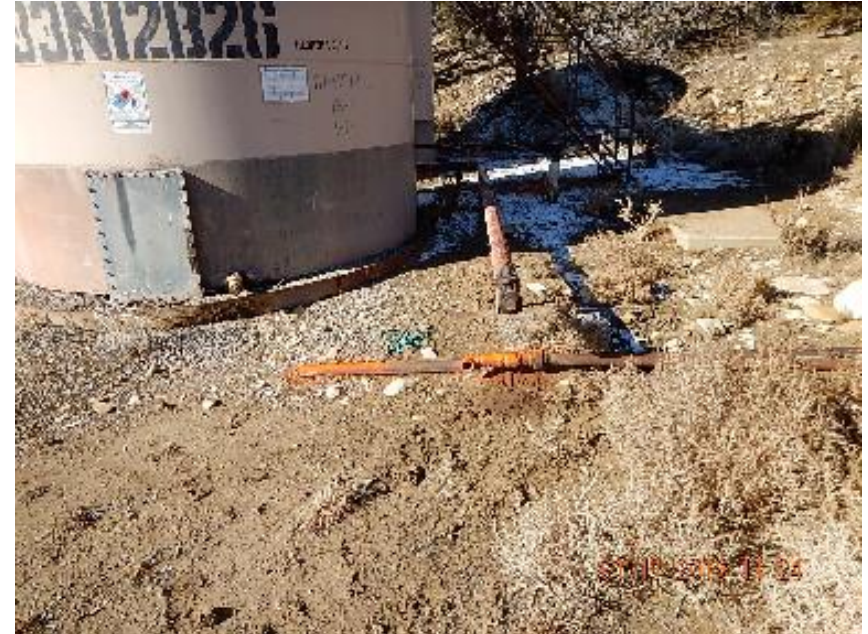
Photo 12: Open ended 3" steel flowline off front of tanks below tank loadout.

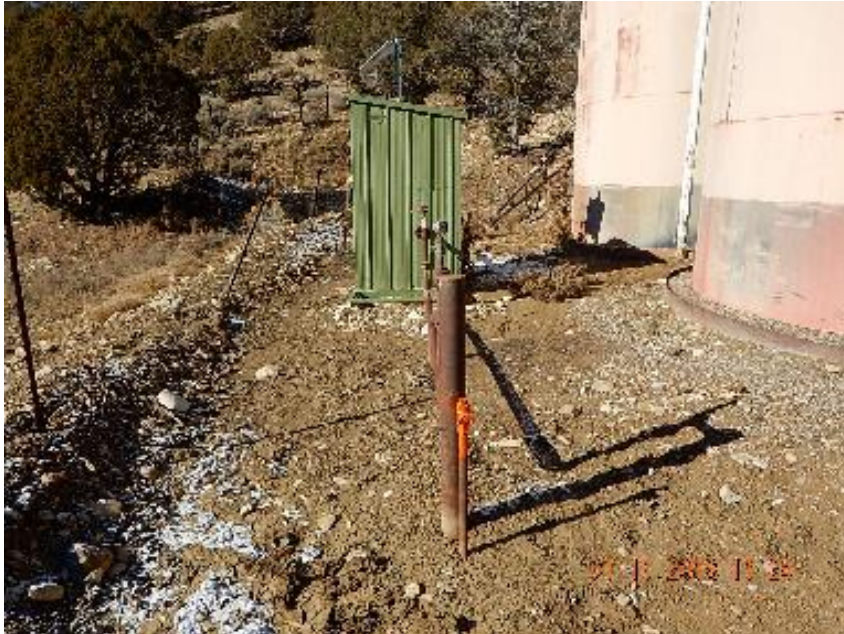
Photo 13: 1" steel riser on W side of tanks out from gas meter run.

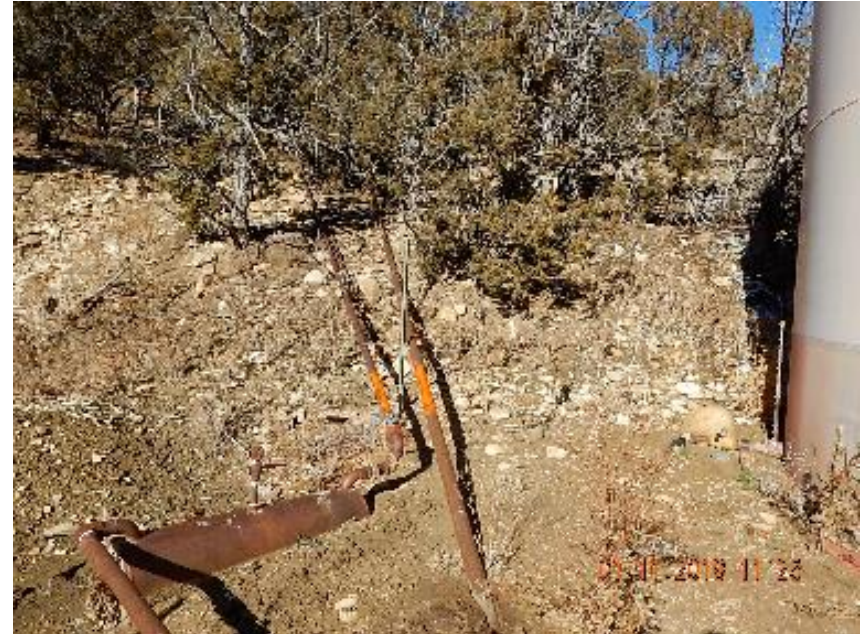
Photo 14: Steel flowlines on W side of tanks coming off slope.

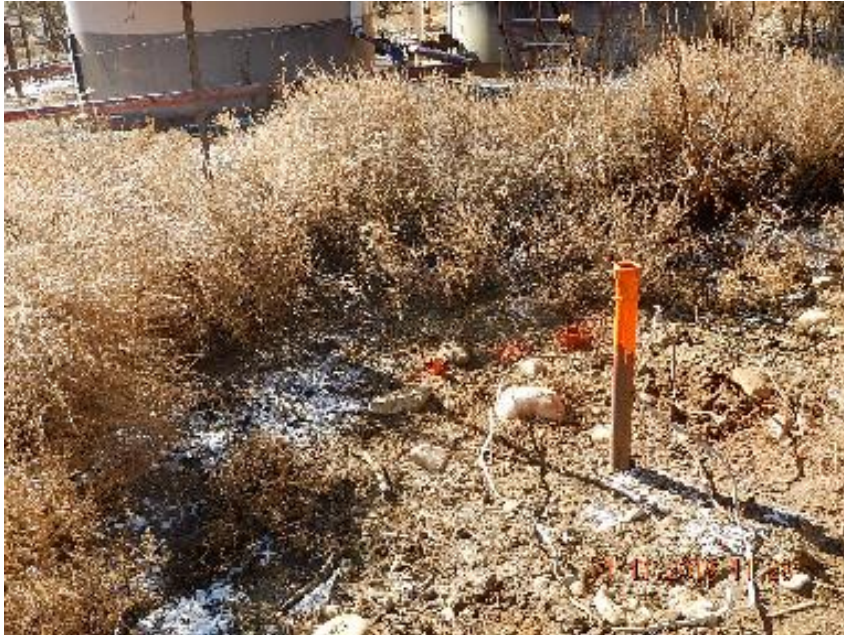
Photo 15: Unused riser and unused flowlines/risers behind it on E side of tanks outside fencing.

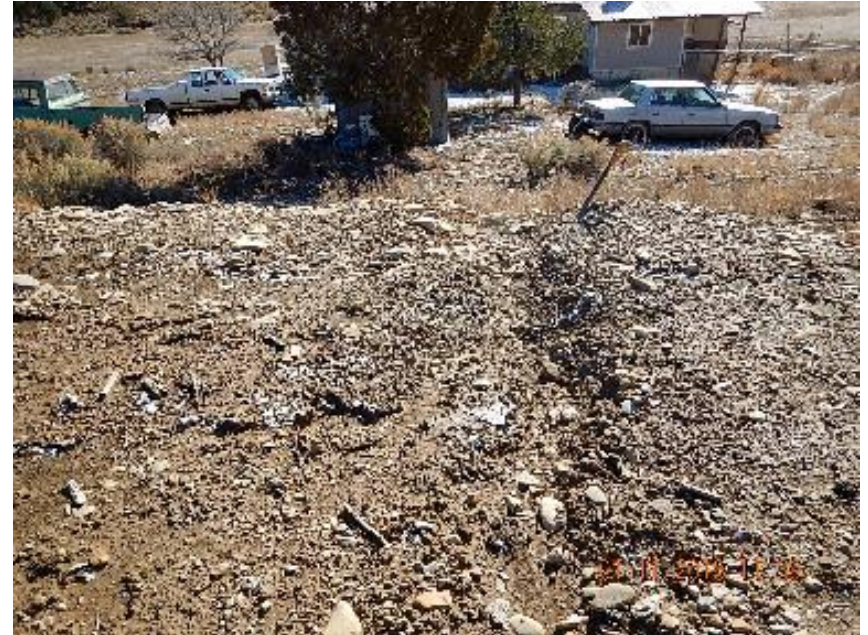
Photo 16: Erosion channel off S side of location.

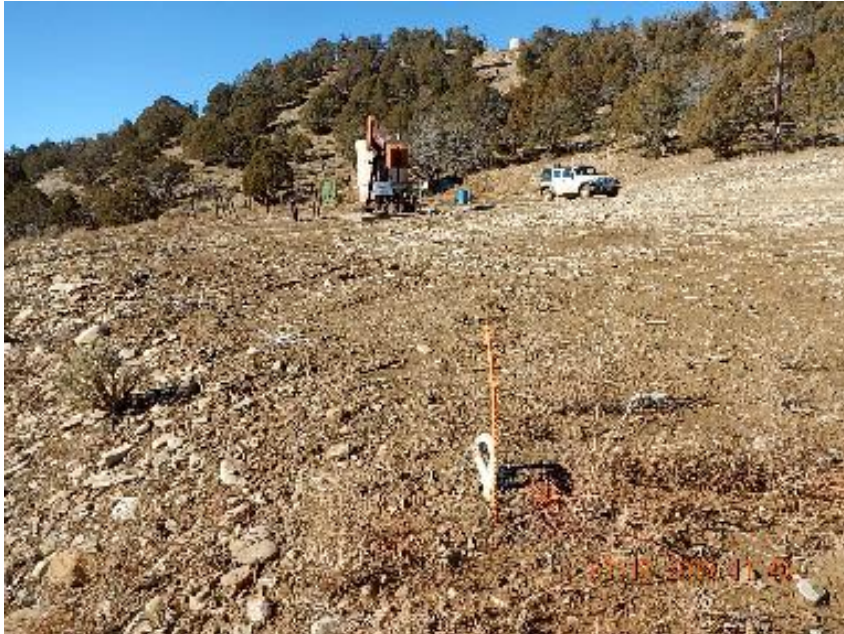
Photo 17: Anchor and location overview.

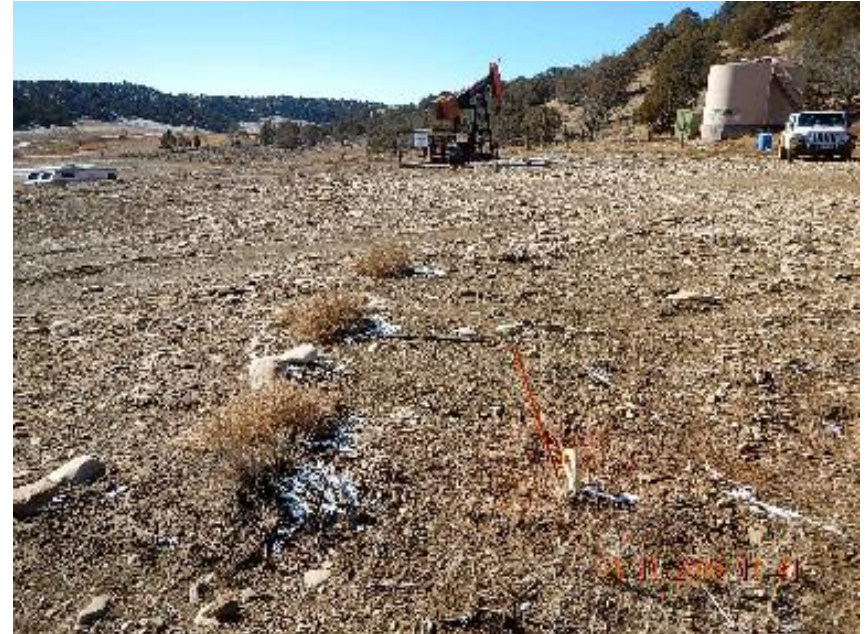
Photo 18: Anchor and location overview.

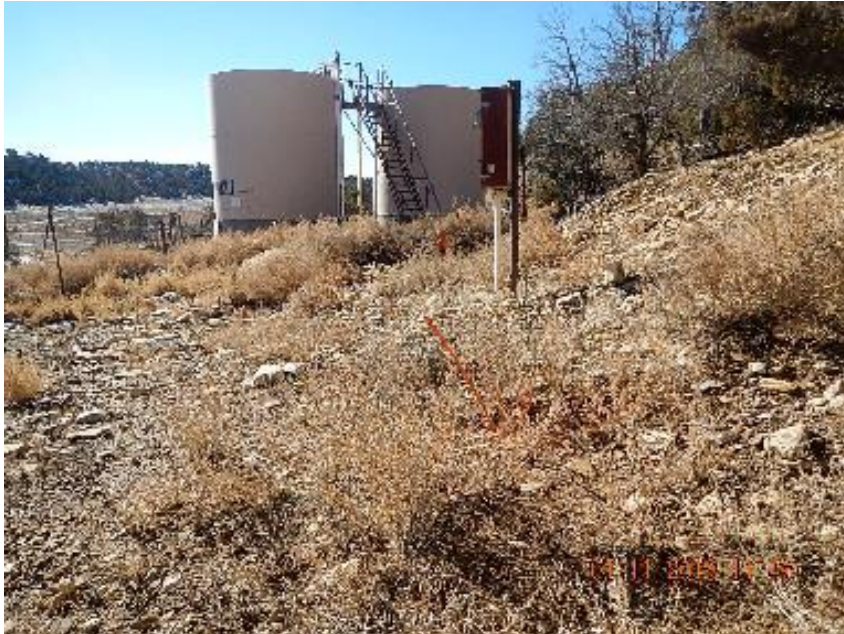
Photo 19: Anchor and location overview.

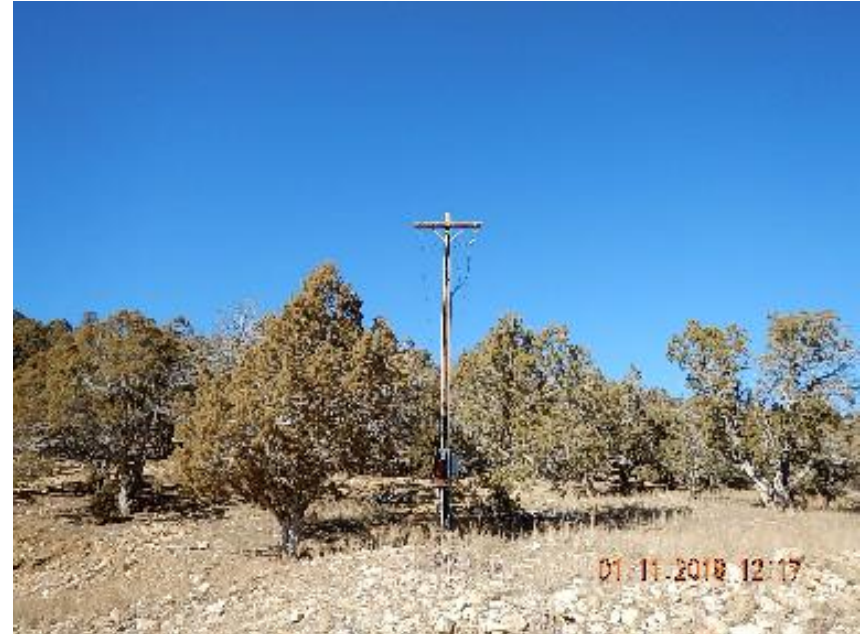
Photo 20: Power coming onto location.
