Inspection Photos

01/17/2018

Operator: MAGPIE OPERATING, INC - 52530

Location ID: 401718

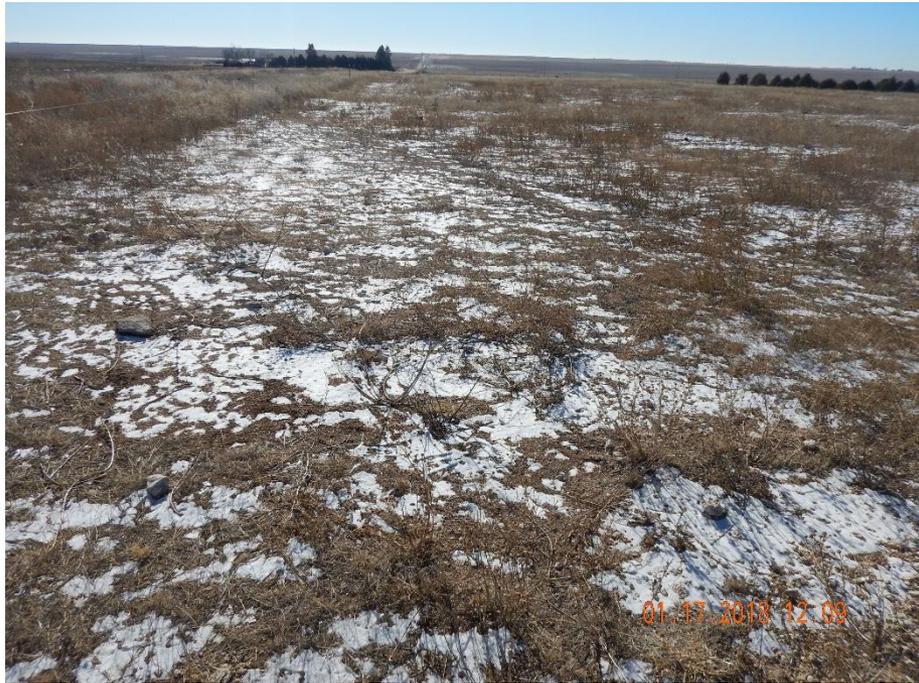
Photo 1: Photo taken from the north end of the former pit and facilities location, facing south. Photo shows large areas of the location remain predominantly bare and exposed soil. Unable to find evidence that additional reclamation activities have been conducted per corrective actions.

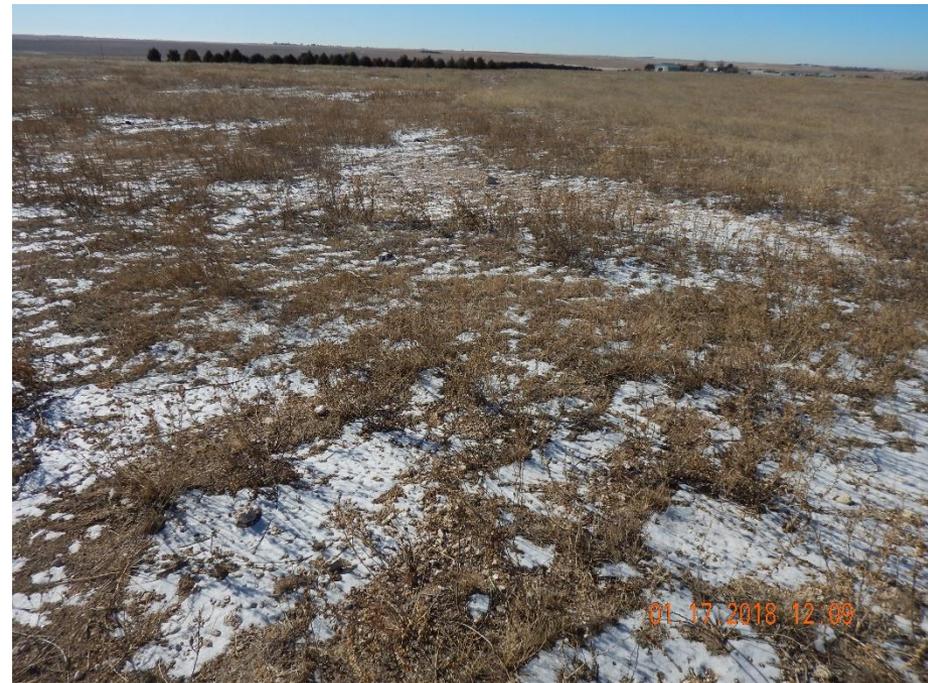
Photo 2: Photo taken from the north end of the former pit and facilities location, facing southwest. Photo shows large areas of the location remain predominantly bare and exposed soil. Unable to find evidence that additional reclamation activities have been conducted per corrective actions.

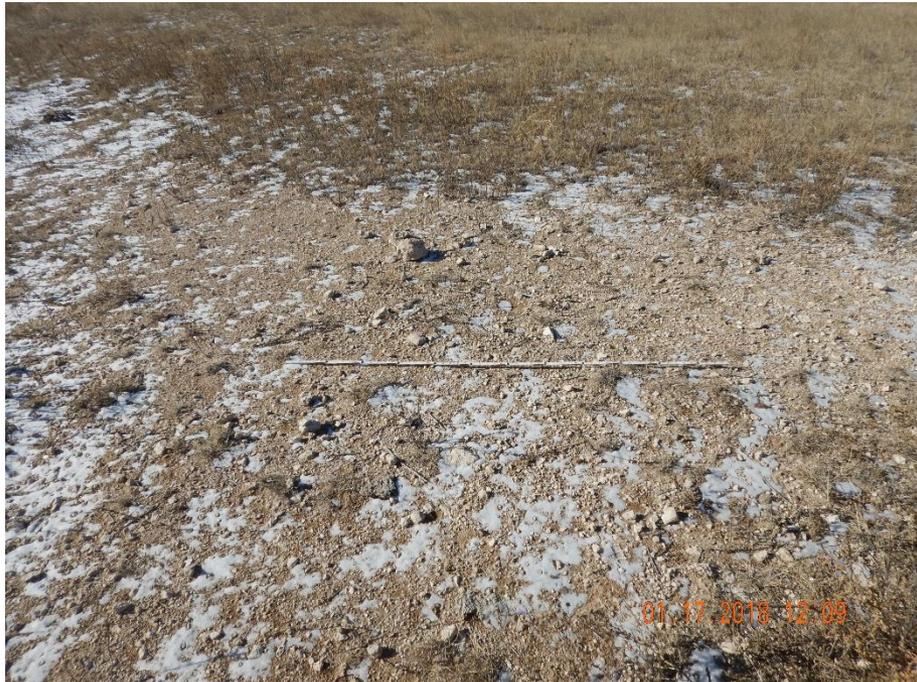
Photo 3: Photo taken from the east end of the former pit/facilities location. Photo shows large areas of the location remain predominantly bare and exposed soil. Unable to find evidence that additional reclamation activities have been conducted per corrective actions. 6 foot measuring stick for reference.

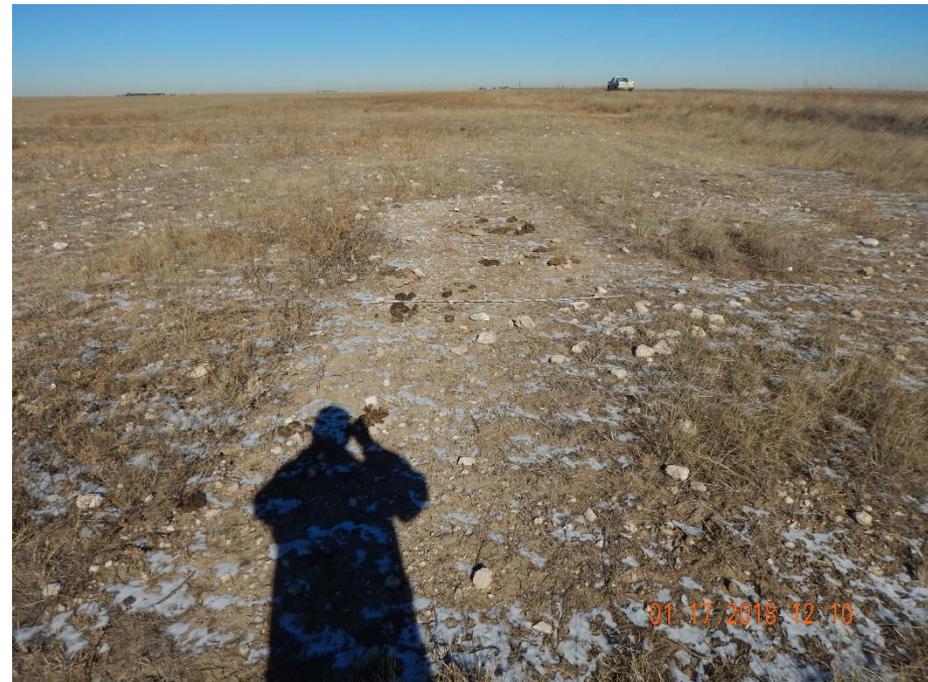
Photo 4: Photo taken from the southeast end of the former pit/facilities location. Photo shows large areas of the location remain predominantly bare and exposed soil. Unable to find evidence that additional reclamation activities have been conducted per corrective actions.

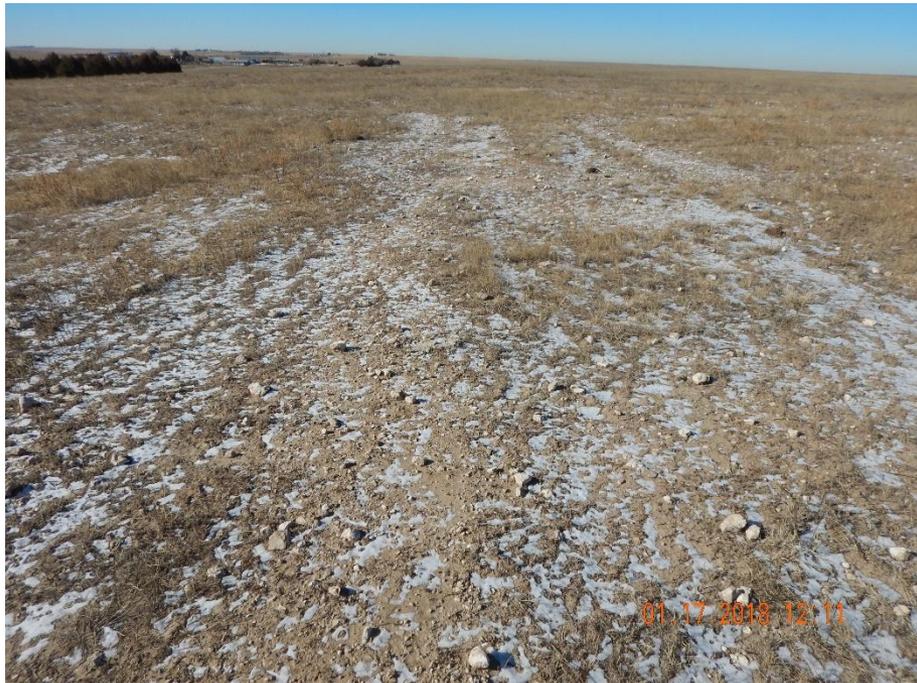
Photo 5: Photo taken from the southeast end of the former pit/facilities location, facing west. Photo shows large areas of the location remain predominantly bare and exposed soil. Unable to find evidence that additional reclamation activities have been conducted per corrective actions.

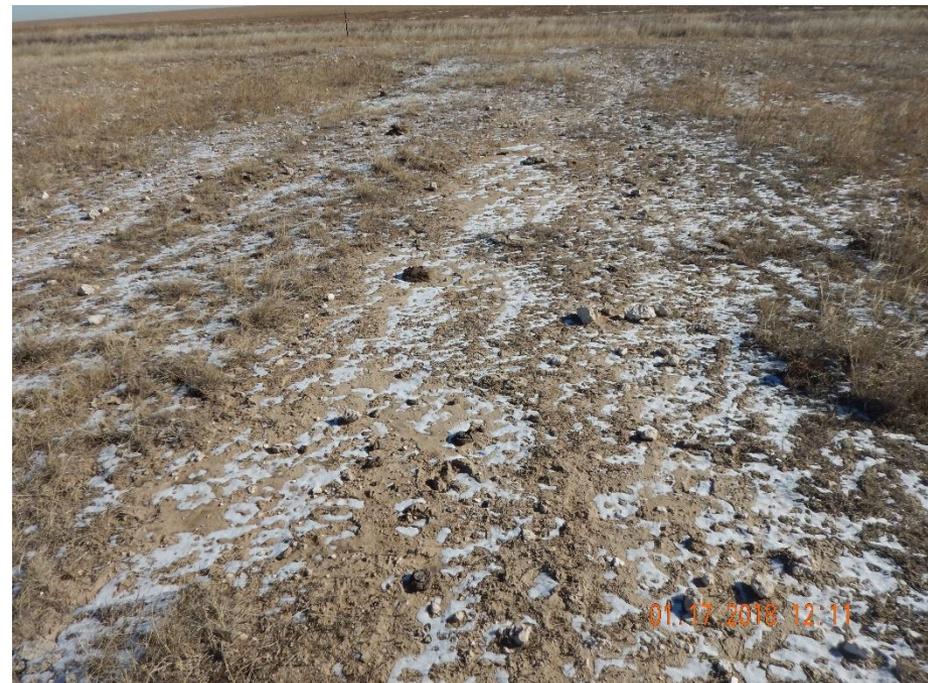
Photo 6: Photo taken from the west end of the former pit/facilities location, facing east. Photo shows large areas of the location remain predominantly bare and exposed soil. Unable to find evidence that additional reclamation activities have been conducted per corrective actions.

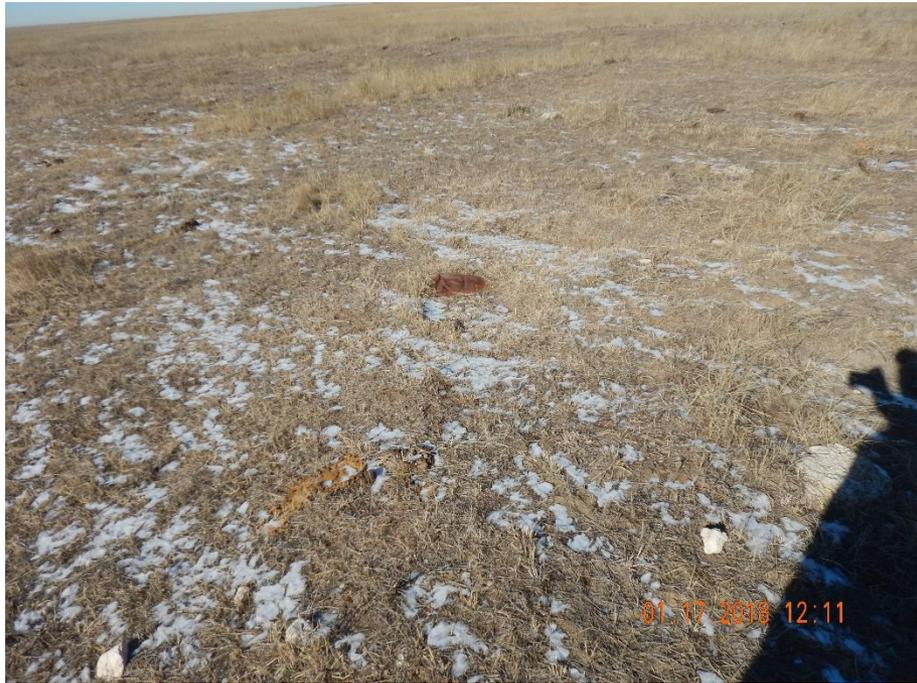
Photo 7: Previous inspection documented debris remaining on the location. Photo shows debris identified in previous inspection has not been removed. Debris appears to be a partially buried barrel.

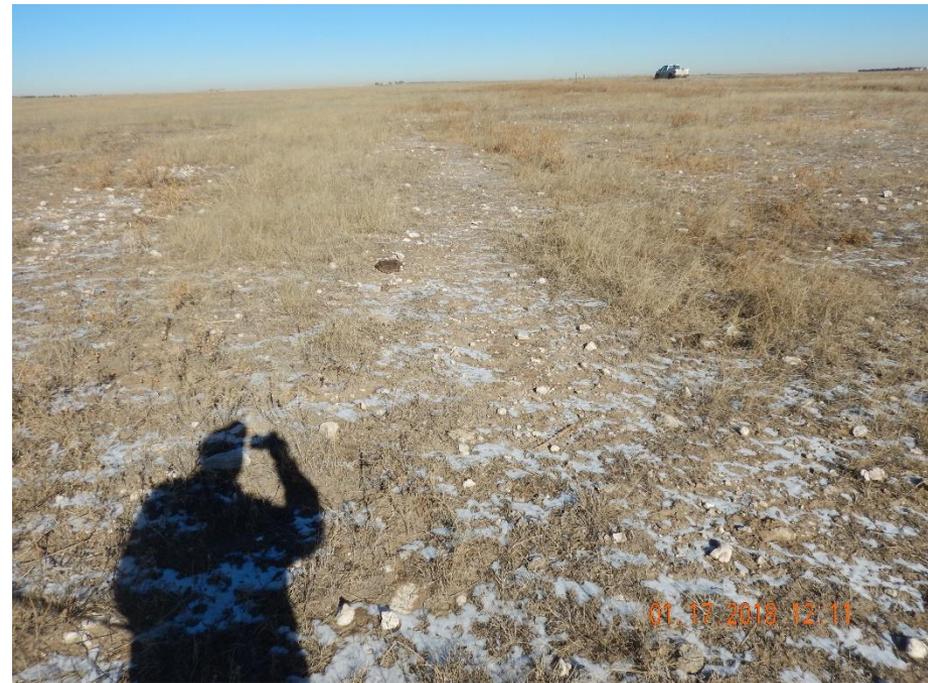
Photo 8: Photo taken from the southwest end of the former pit and facilities location, facing north. Photo shows large areas of the location remain predominantly bare and exposed soil. Unable to find evidence that additional reclamation activities have been conducted per corrective actions.

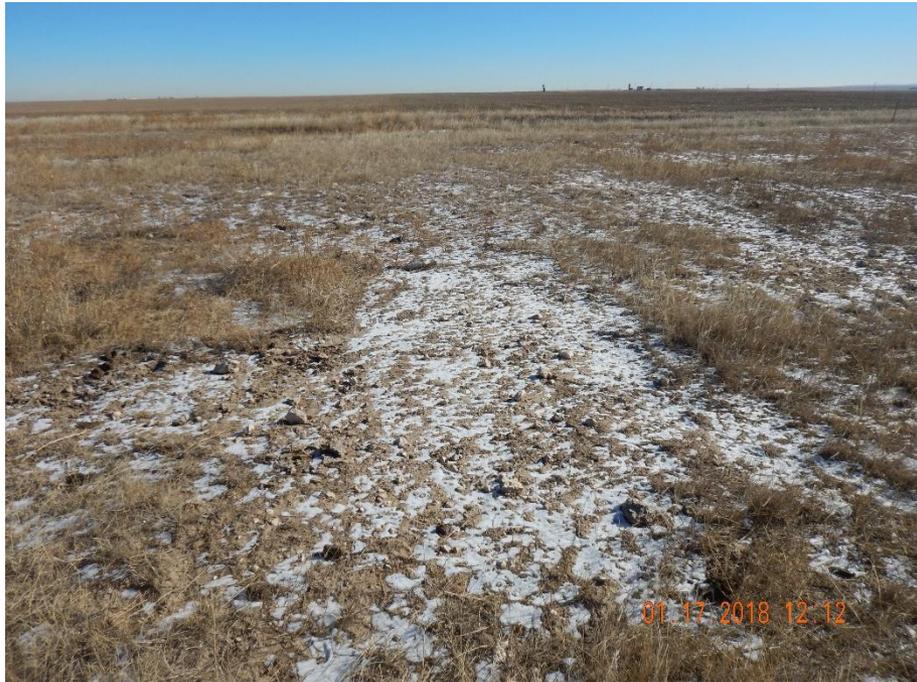
Photo 9: Photo taken from the west end of the former pit and facilities location, facing east. Photo shows large areas of the location remain predominantly bare and exposed soil. Unable to find evidence that additional reclamation activities have been conducted per corrective actions.

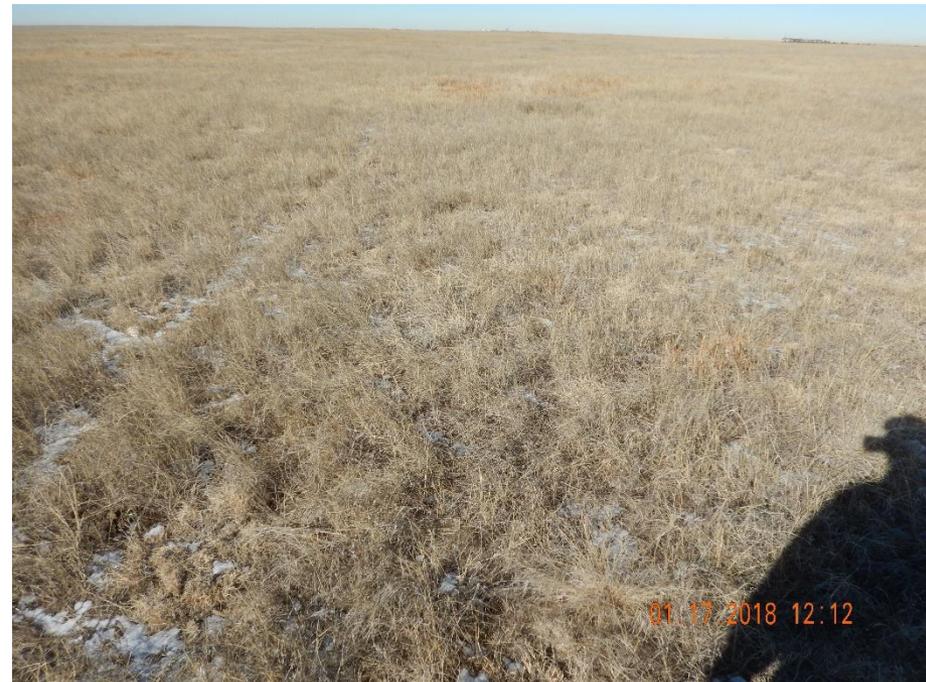
Photo 10: Photo taken from the adjacent reference area to compare vegetative growth and establishment to the disturbance area. Vegetation seen here predominantly sand dropseed, sideoats and blue grama, western wheatgrass, etc...
