Inspection Photos

01/17/2018

Operator: BEREN CORPORATION - 7800

Location ID: 317052

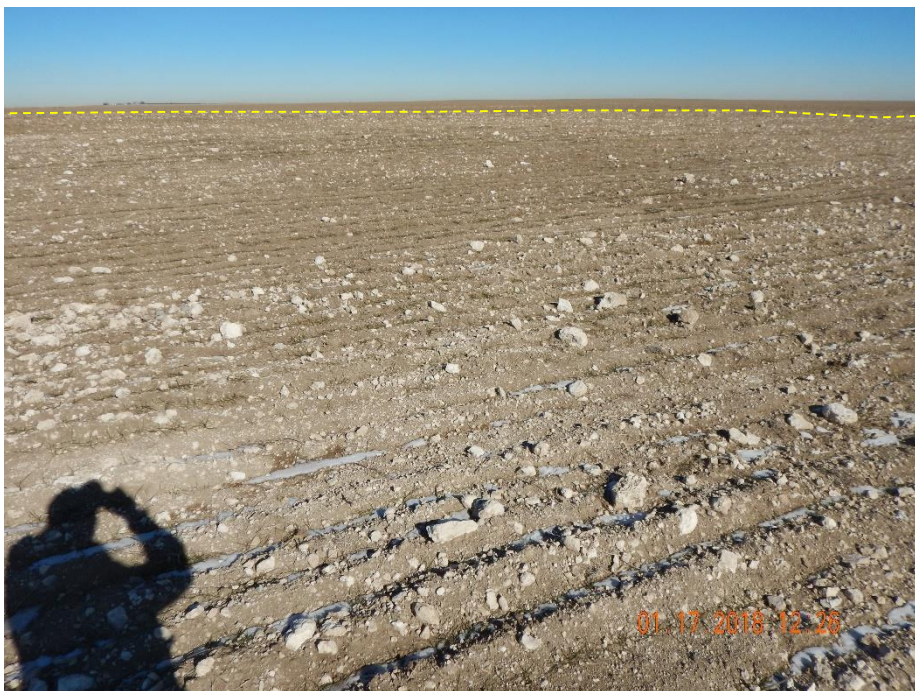
Photo 1: Photo taken from the southwest end of the location, facing north. Photos 1-3 provide overview of the reclamation area. Yellow-dotted line represents the perimeter of the location, with the location in the foreground, and the reference areas in the background.

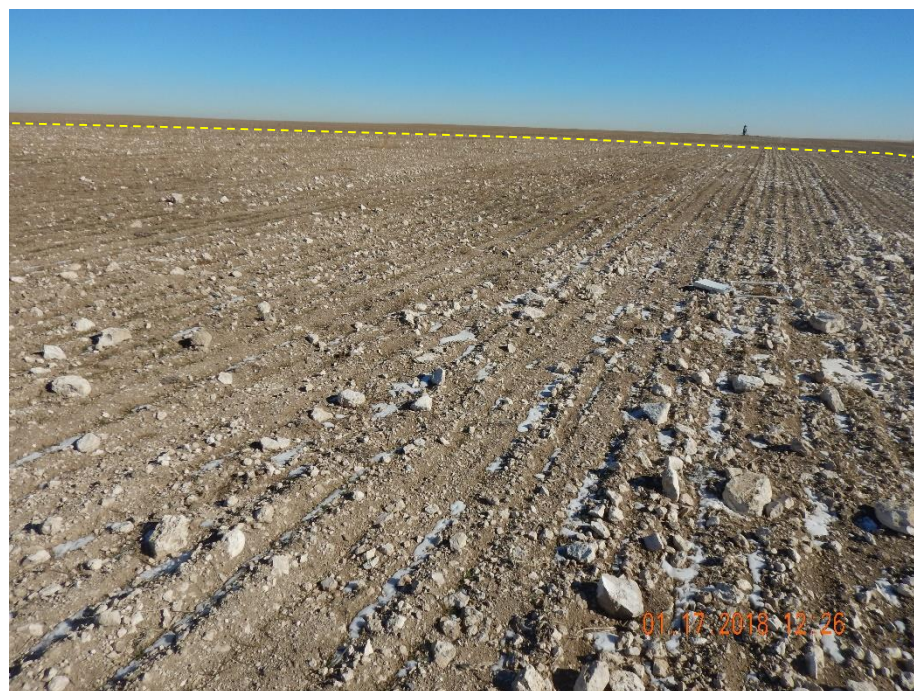
Photo 2: Photo taken from the southwest end of the location, facing northeast.

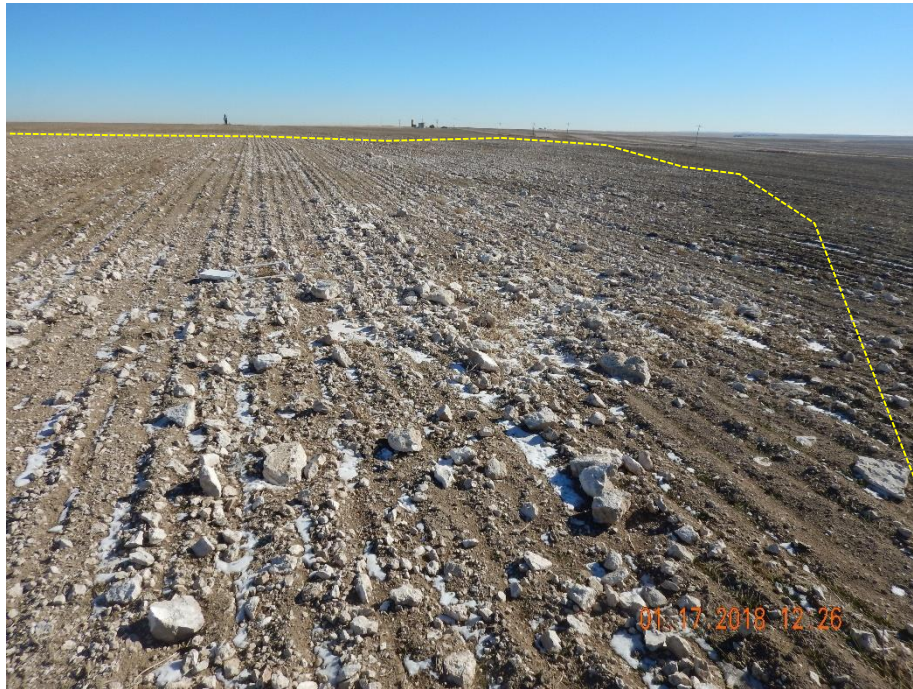
Photo 3: Photo taken from the southwest end of the location, facing east. There is an abundance of rocky material densely, and uniformly distributed throughout the location. Rock material in the reference area is extremely minimal when compared to the disturbance. Yellow-dotted line represents the perimeter of the location, with the location in the foreground, and the reference areas in the background.

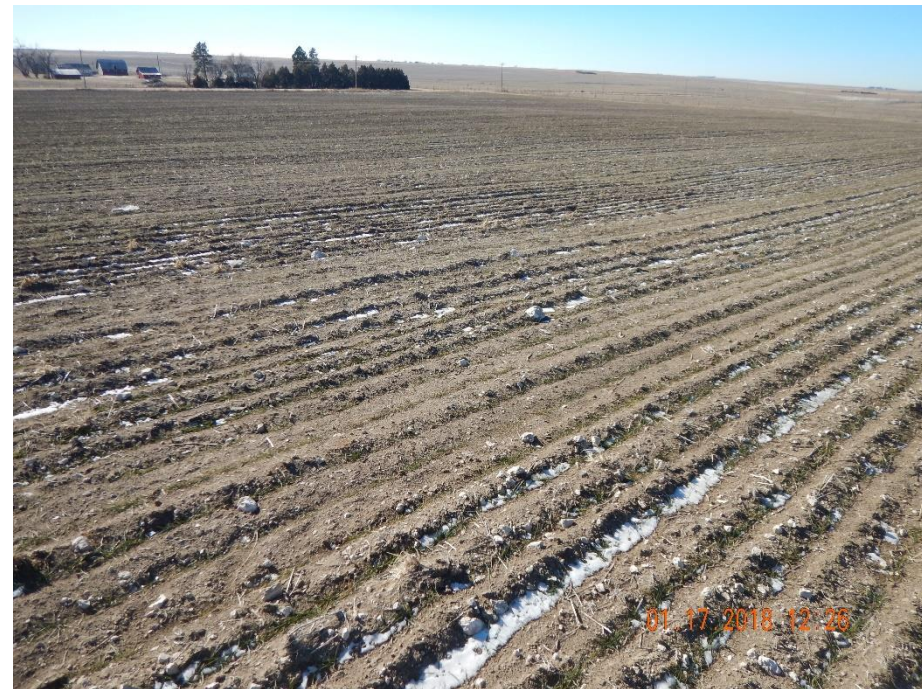
Photo 4: Photo taken from the southwest end of the location, facing southwest. Photo shows the adjacent reference areas. Note that though similar rock material is evident in the reference areas, it is not nearly as abundant, or as densely concentrated as it is on the location; the abundance of rocks is immediately evident upon accessing the location, is uniform throughout, and does not appear to be a natural when compared to the adjacent reference areas.

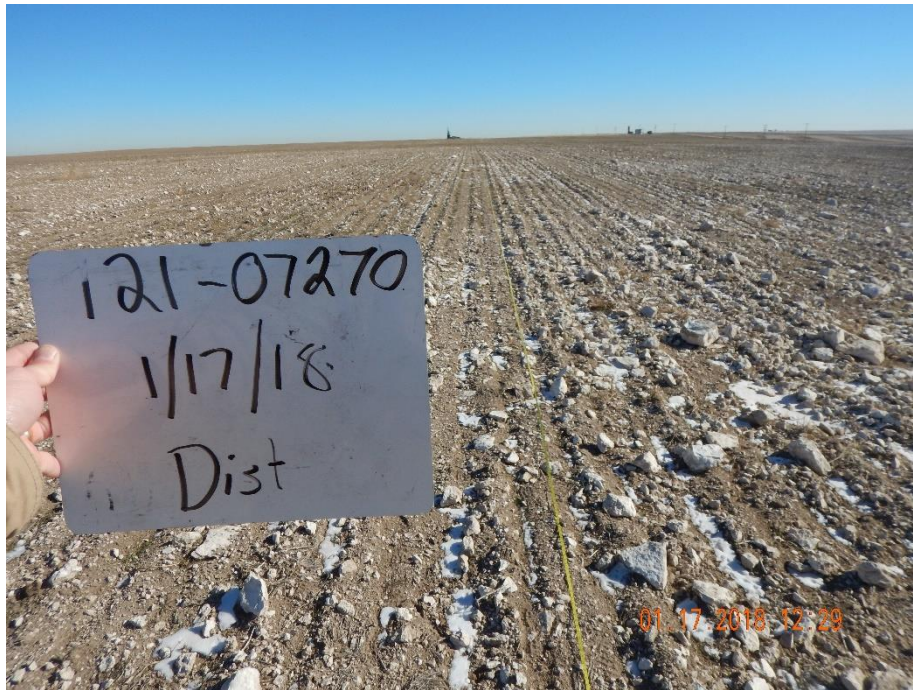
Photo 5: Photo taken from the location, facing east. Photo of the start point for the disturbance area germination quadrat survey.

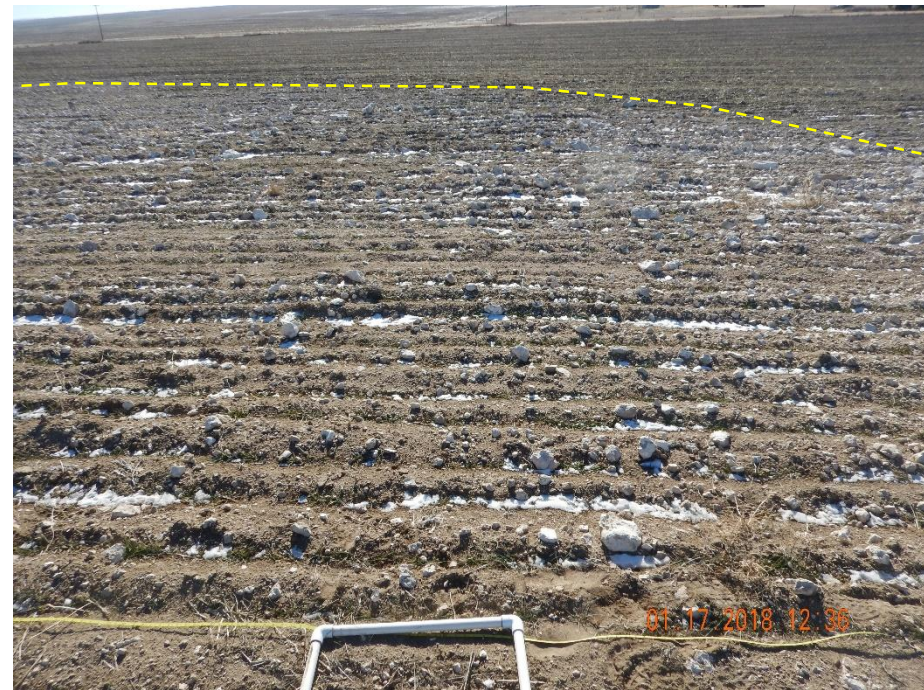
Photo 6: Photo taken from the 50th point of the disturbance area germination quadrat survey, facing south. Yellow-dotted line represents the perimeter of the location, with the location in the foreground, and the reference areas in the background.

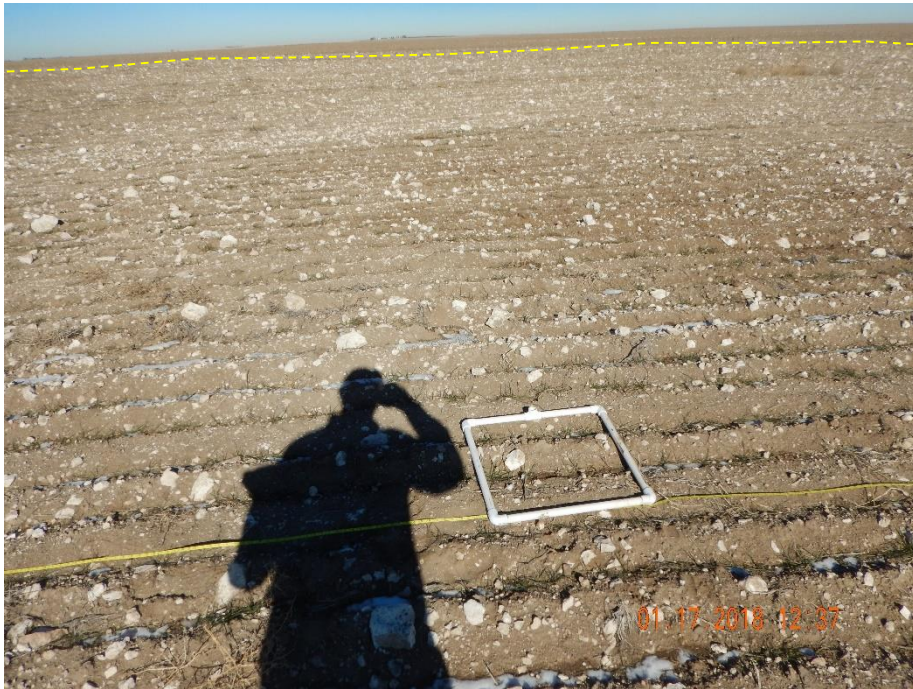
Photo 7: Photo taken from the 50th, point of the disturbance area germination quadrat survey, facing south. Yellow-dotted line represents the perimeter of the location, with the location in the foreground, and the reference areas in the background.

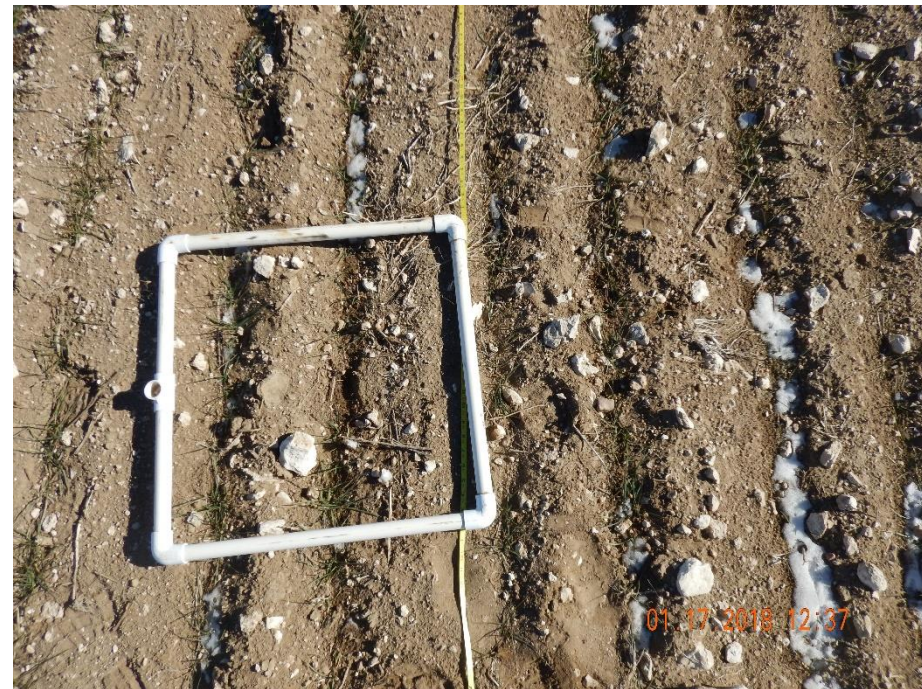
Photo 8: Photo of the 50th, point of the disturbance area germination quadrat survey.

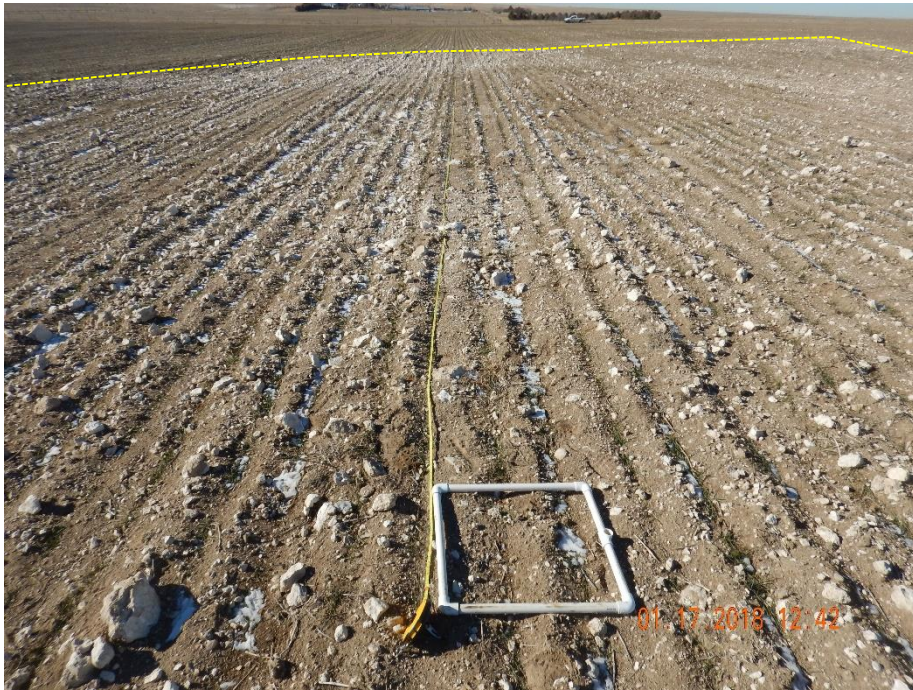
Photo 9: Photo taken from the location, facing east. Photo of the end point for the disturbance area germination quadrat survey. Yellow-dotted line represents the perimeter of the location, with the location in the foreground, and the reference areas in the background.

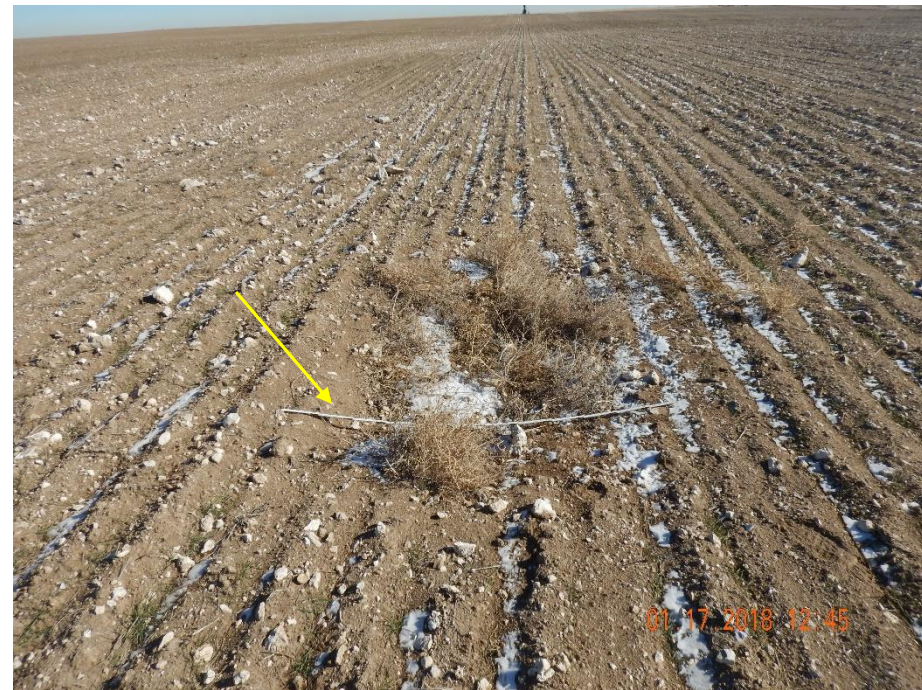
Photo 10: Photo taken from the well on location. Photo shows subsidence concerns remain evident. 6 foot measuring stick (arrow) for reference. Subsidence will need to be repaired.

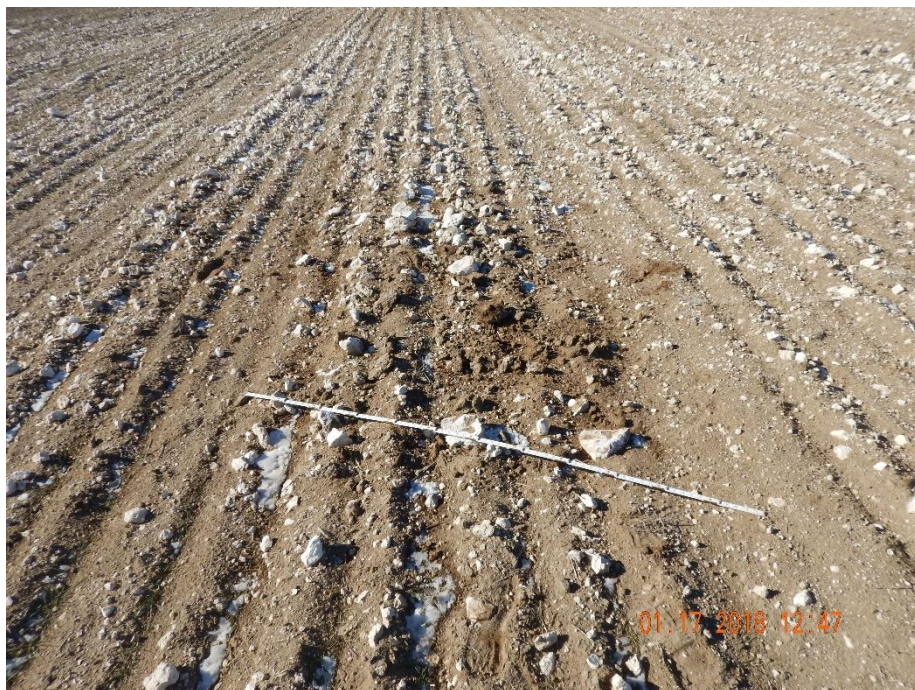
Photo 11: Photo taken from the southeast end of the location. Photos shows area of oil-stained soils observed on location.

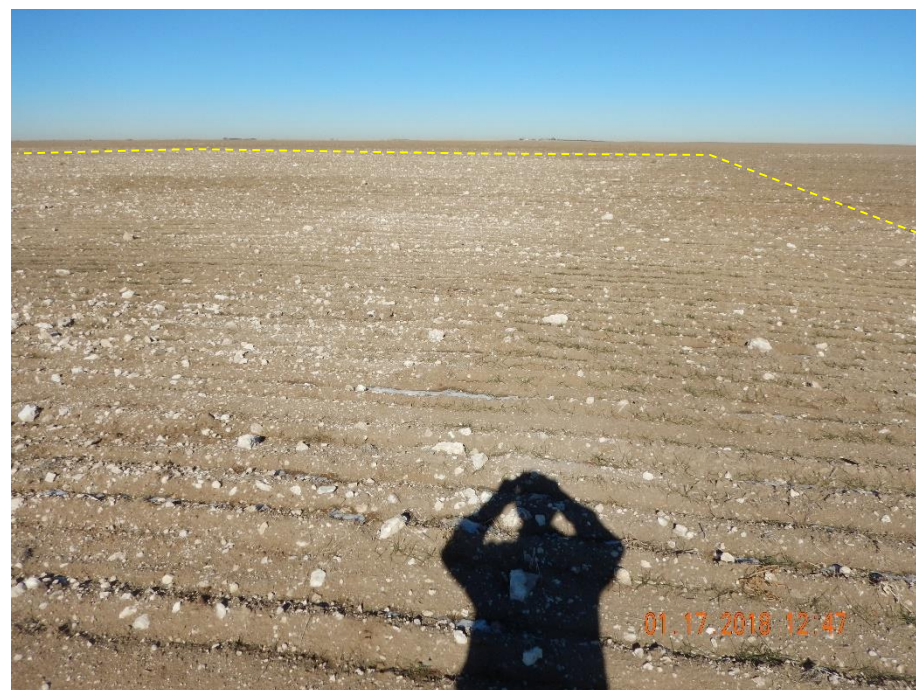
Photo 12: Photo taken from the east end of the location, facing north. Yellow-dotted line represents the perimeter of the location, with the location in the foreground, and the reference areas in the background.

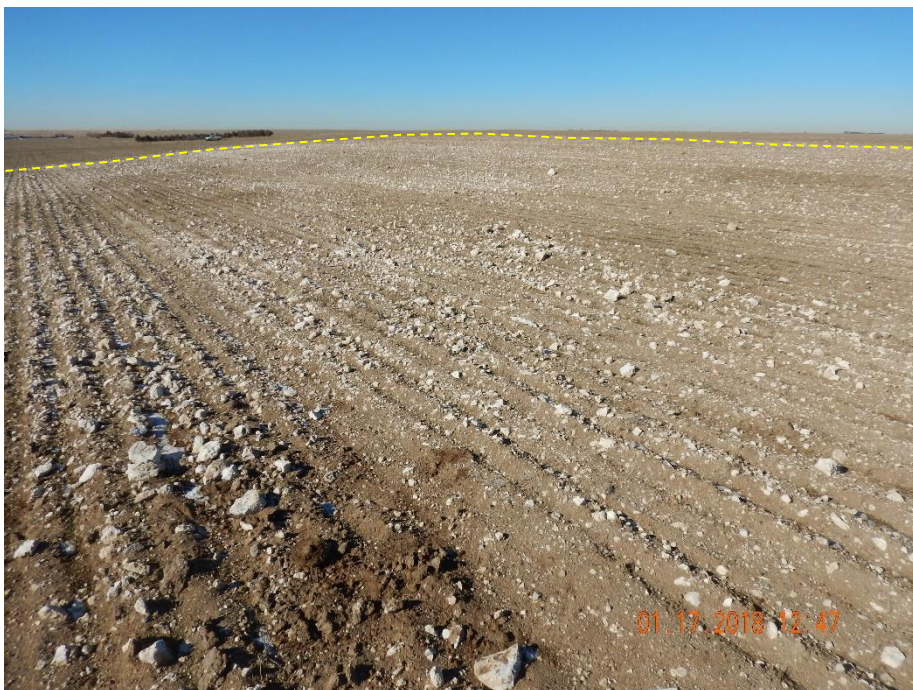
Photo 13: Photo taken from the east end of the location, facing northwest. Yellow-dotted line represents the perimeter of the location, with the location in the foreground, and the reference areas in the background.

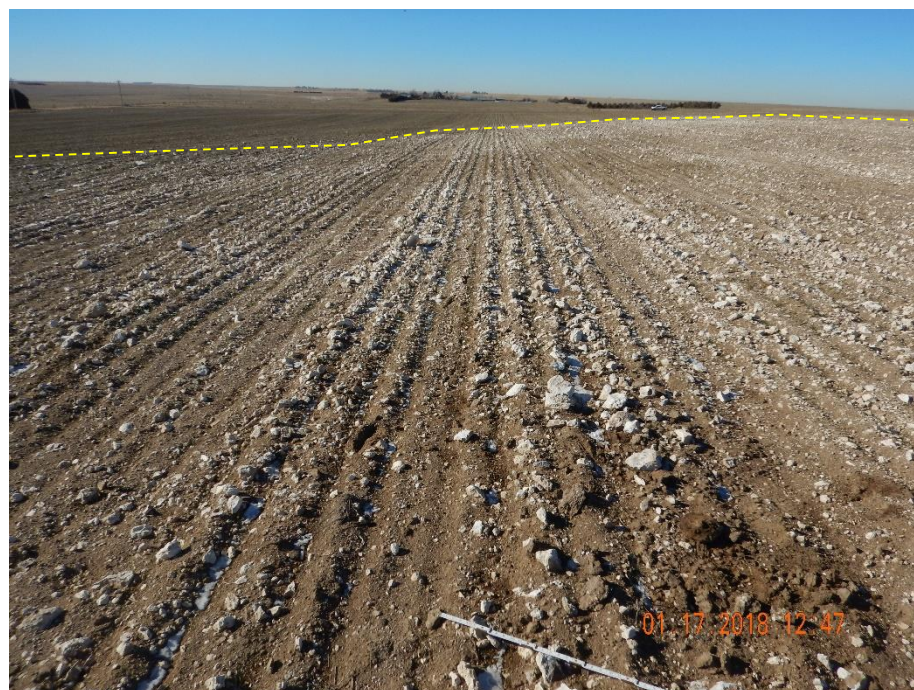
Photo 14: Photo taken from the southeast end of the location, facing west. Yellow-dotted line represents the perimeter of the location, with the location in the foreground, and the reference areas in the background.

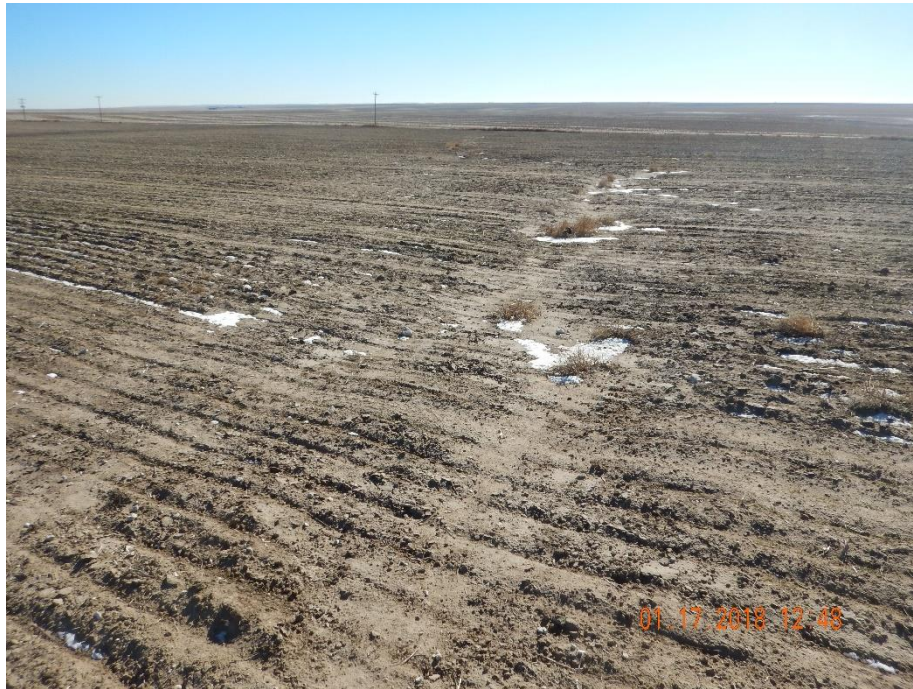
Photo 15: Photo taken from the east end of the location, facing southeast. Photo shows possible erosion concerns from the location.

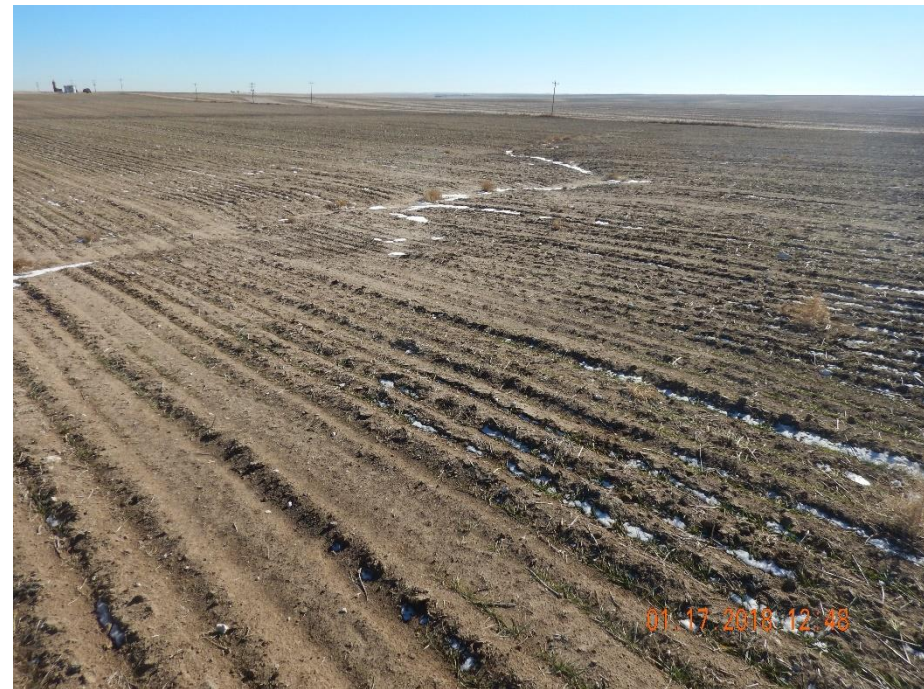
Photo 16: Photo taken from the east end of the location, facing southeast. Photo shows possible erosion concerns from the location.

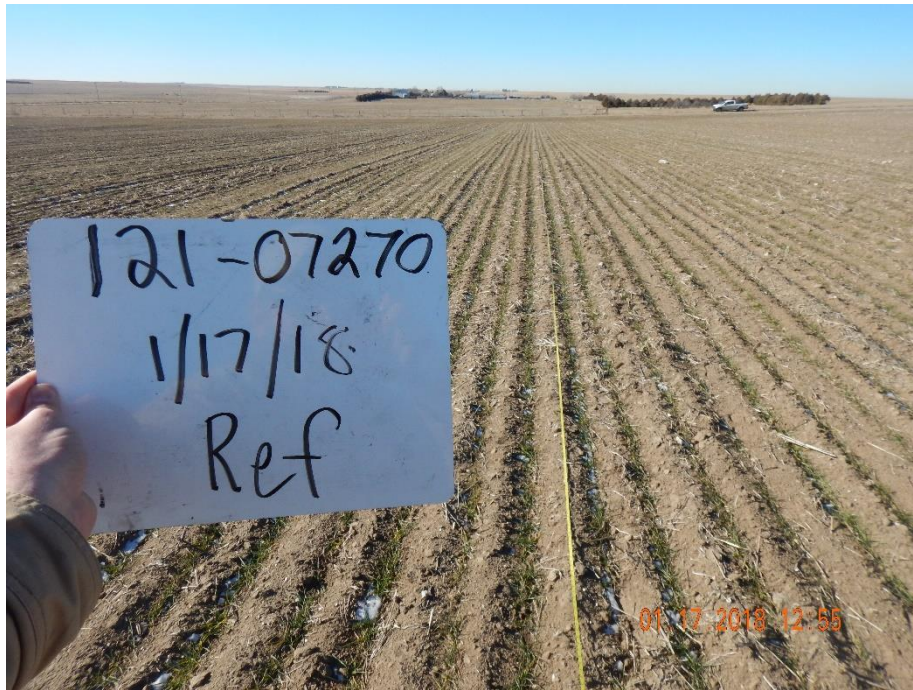
Photo 17: Photo taken from the reference area, facing west. Photo of the start point for the reference area germination quadrat survey. Note that though similar rock material is evident in the reference areas, it is not nearly as abundant, or as densely concentrated as it is on the location; the density of rocks is immediately evident upon accessing the location, is uniform throughout, and does not appear to be a natural occurrence.

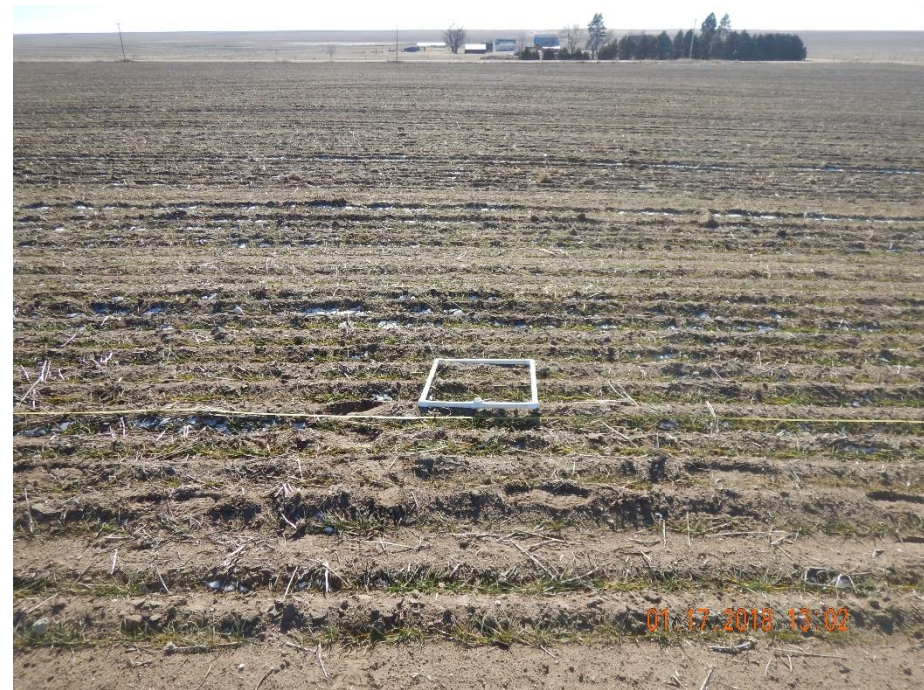
Photo 18: Photo taken from the 50th, point of the reference area germination quadrat survey, facing south.

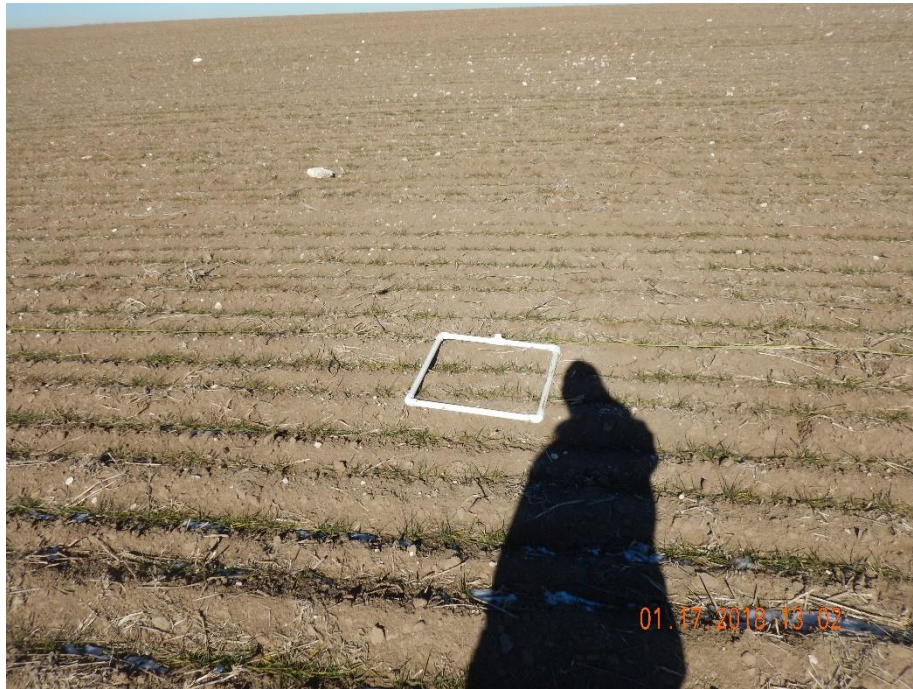
Photo 19: Photo taken from the 50th point of the reference area germination quadrat survey, facing north.

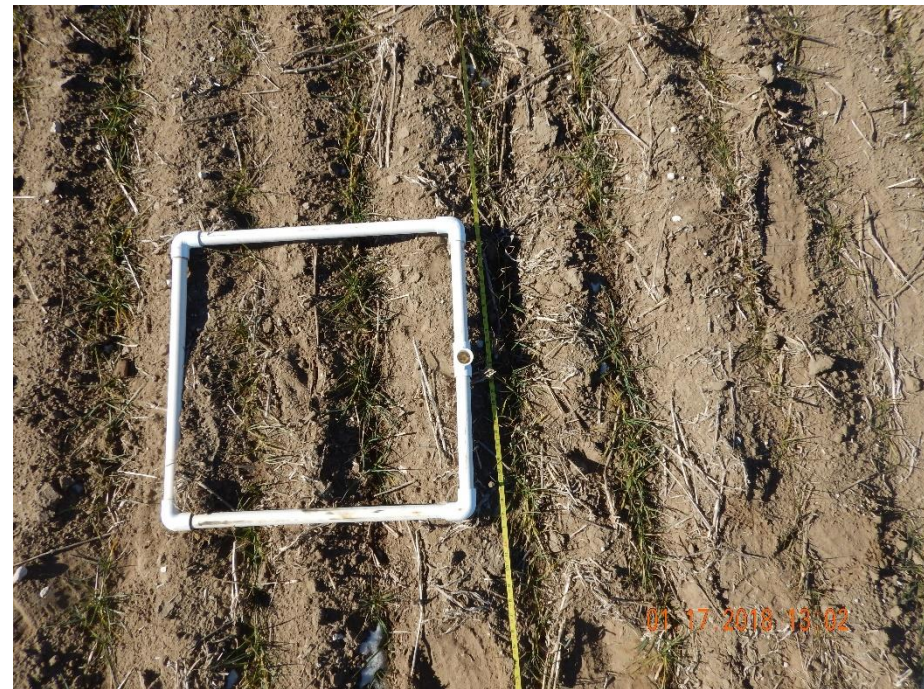
Photo 20: Photo taken from the 50th point of the reference area germination quadrat survey

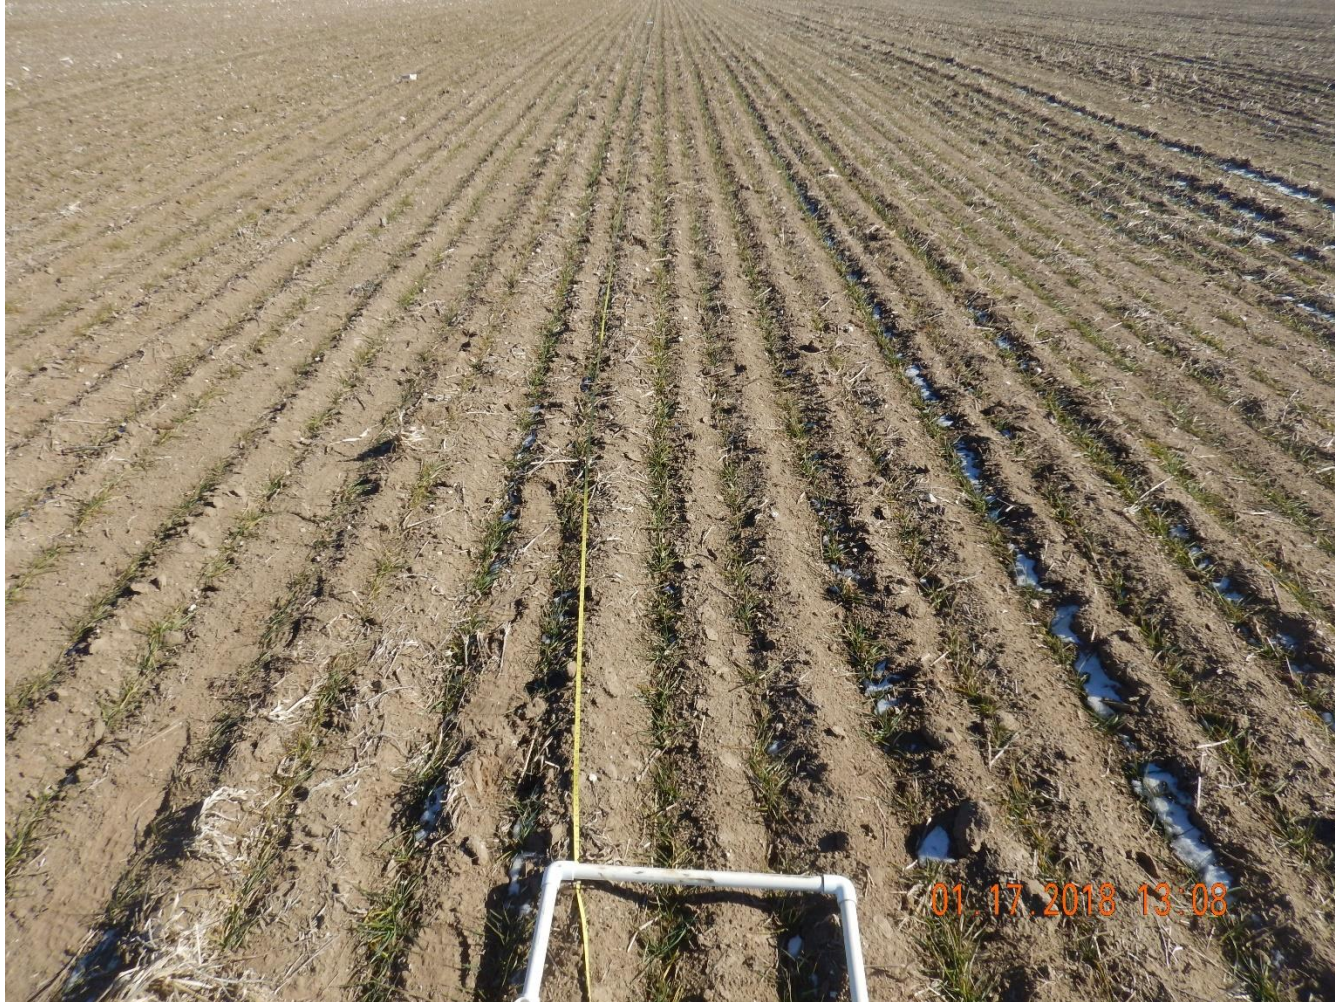
Photo 21: Photo taken from the reference area, facing east. Photo of the end point for the reference area germination quadrat survey.

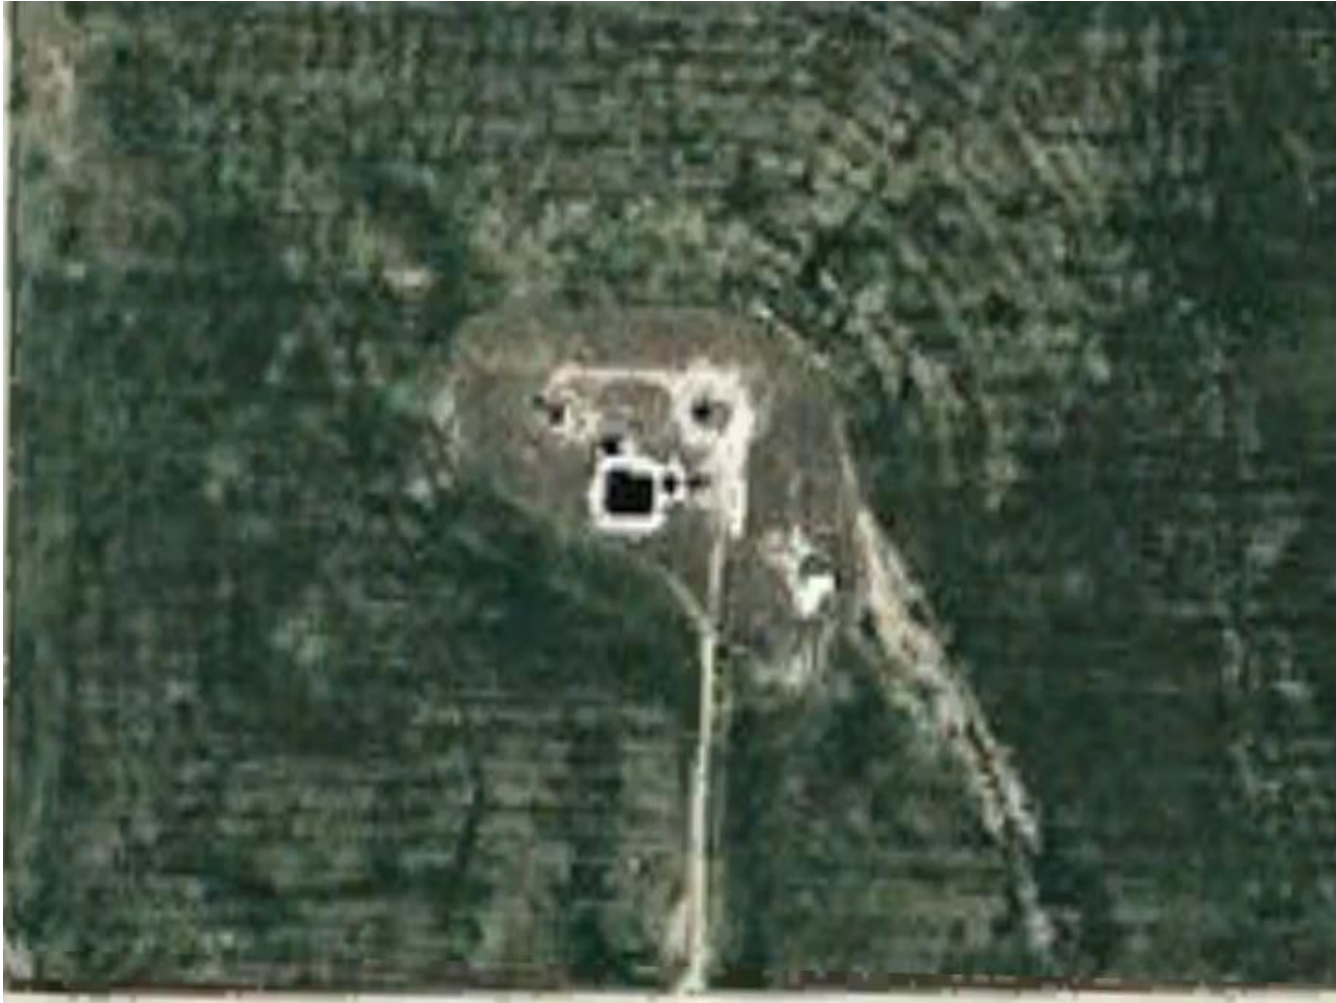
Photo 22: 2006 aerial imagery. Photo shows over-view of the location prior to the plugging and abandonment. Photo also shows areas to the east of the location where erosion concerns were noted.

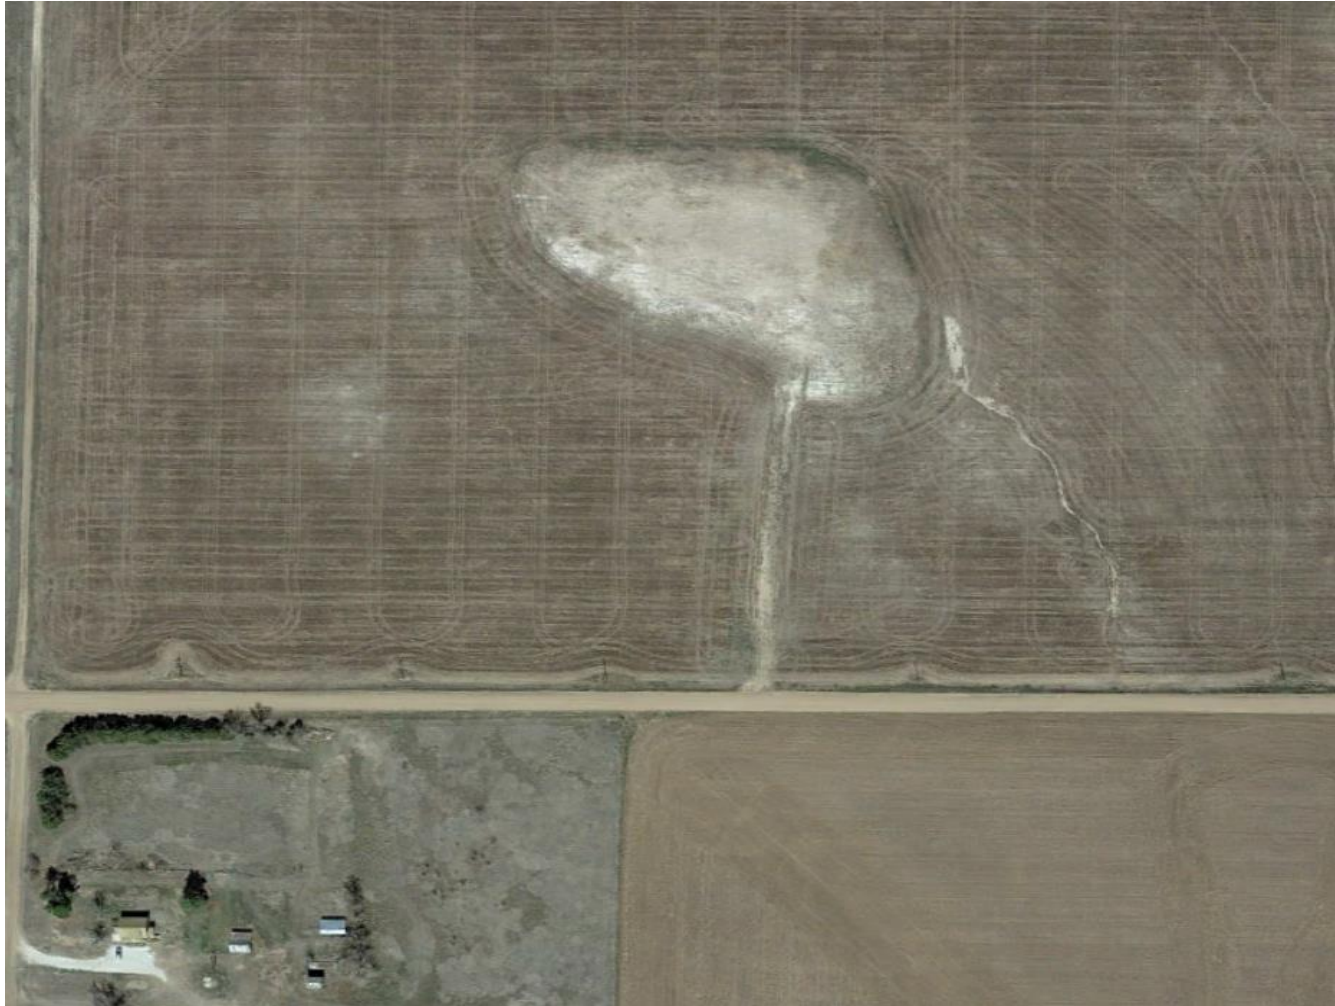
Photo 23: Current available aerial imager (2016) showing the location after plugging and abandonment. Disturbance area is ~2.24 acres in size. Note the lighter coloration of the location is due to the abundance of rocky material observed on site.

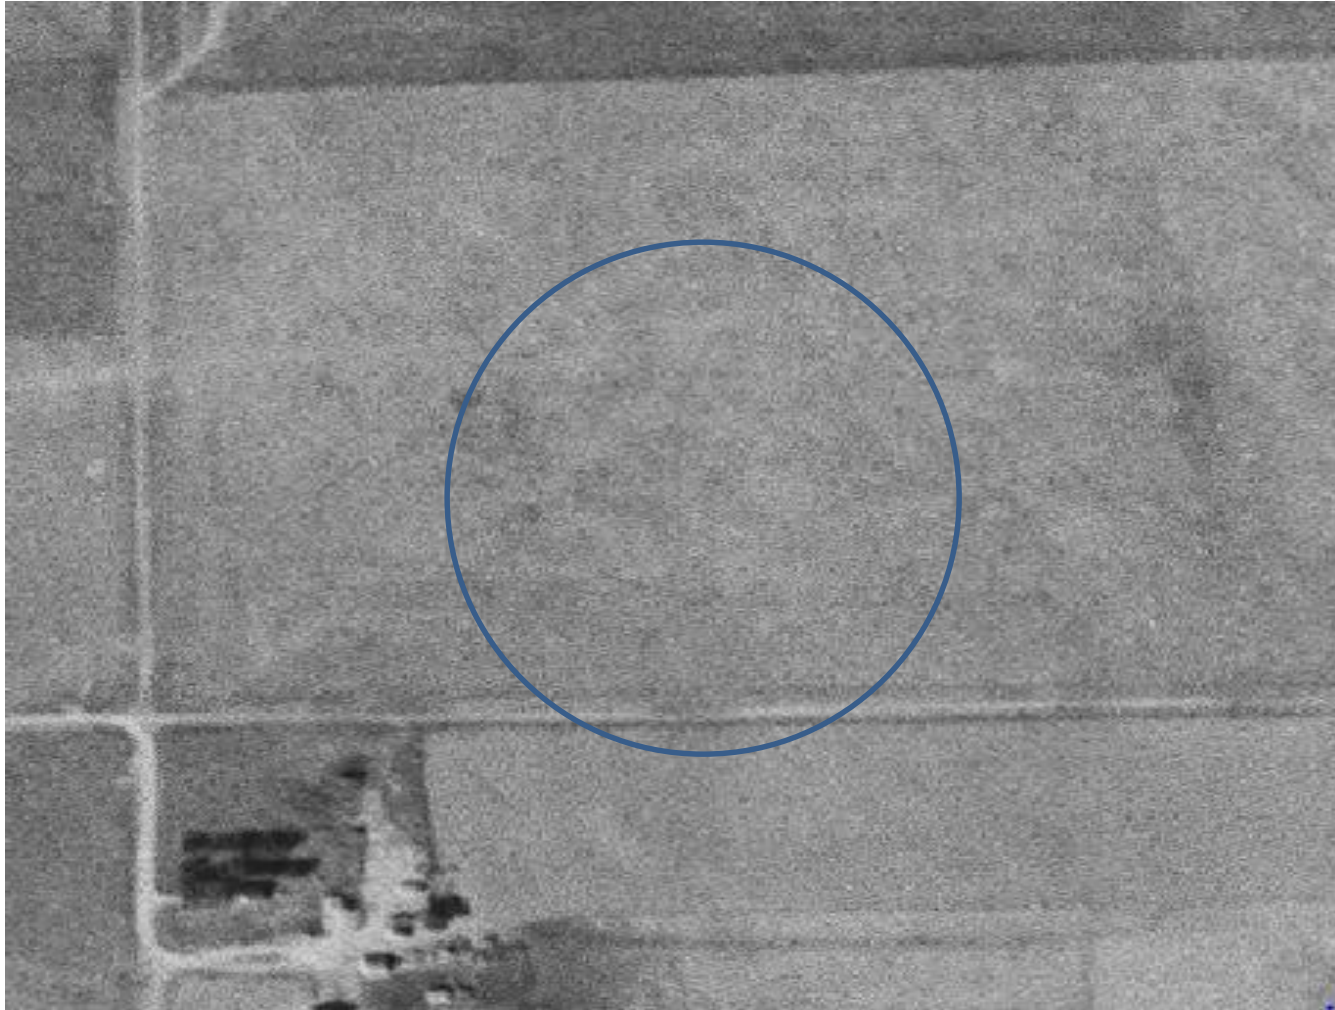
Photo 24: 1953 aerial imagery. Well was spud 1955. Photo shows area of the location prior to oil and gas activities. Note the heavy concentrations of rock material observed on site and in previous photos are not evident.
