# Inspection Photos

API: 05-067-08228

Operator: XTO ENERGY INC.

Inspection Number: 680602429

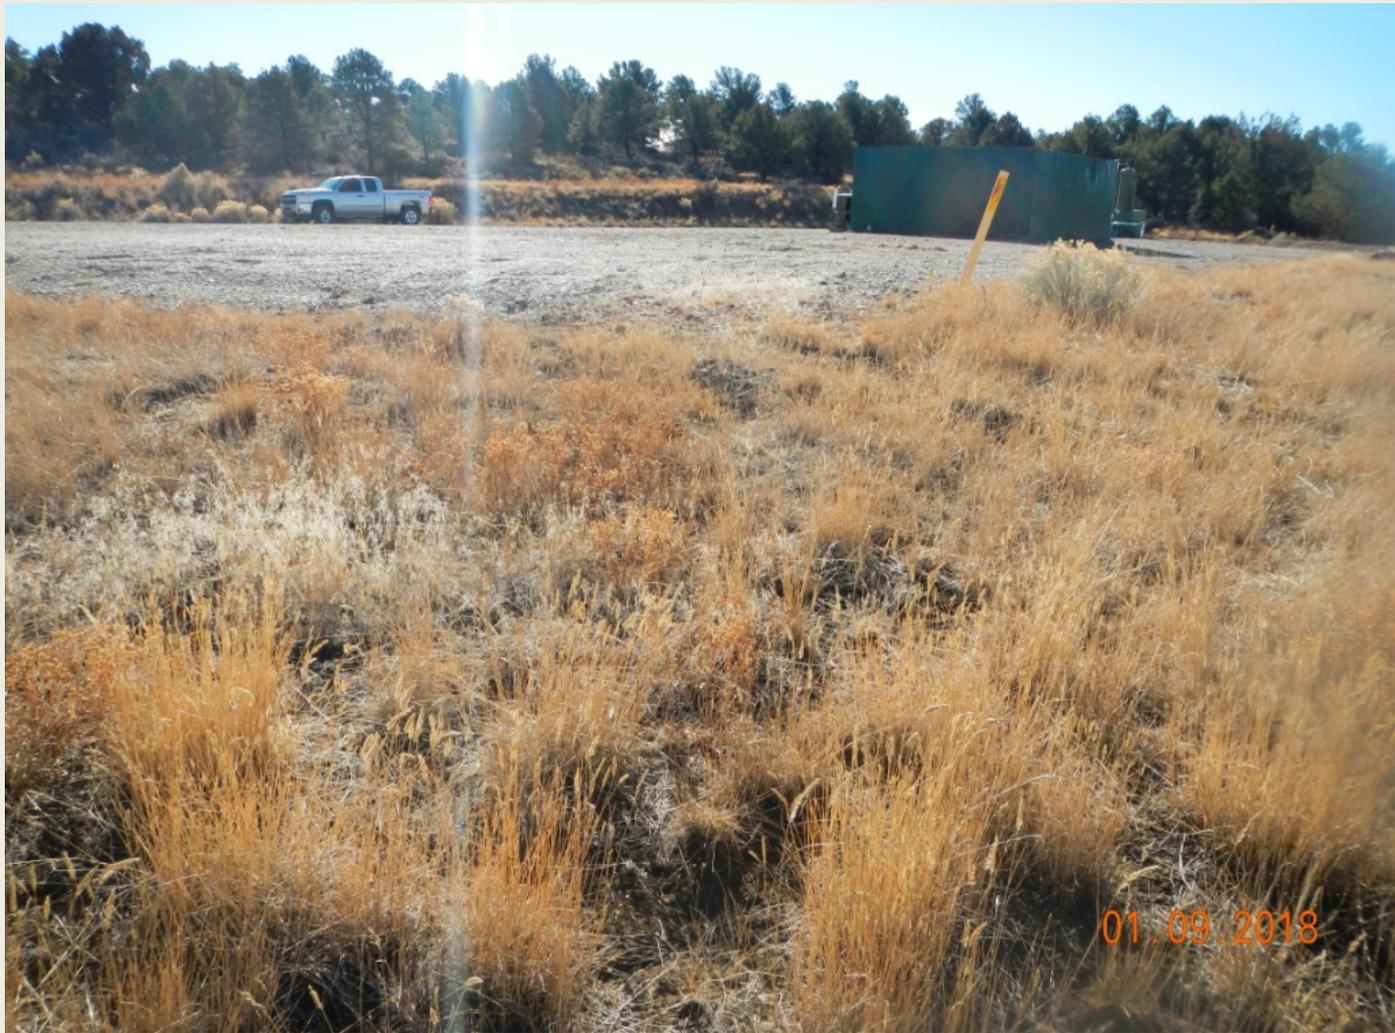
**Photo 1. View of the project area from the northwestern corner facing center.**

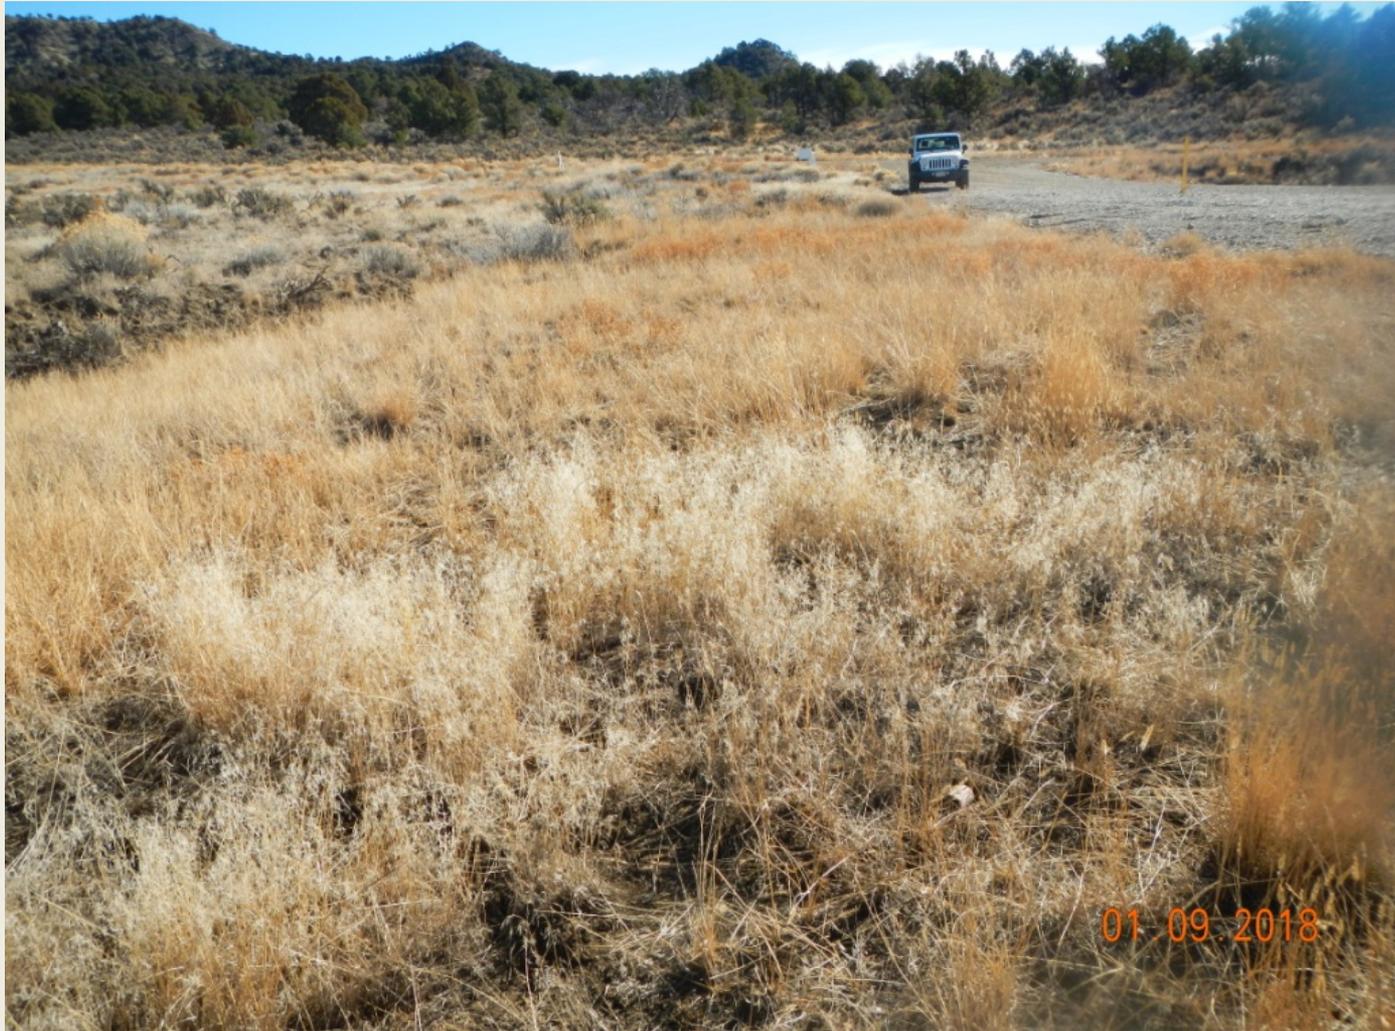
**Photo 2. View of the northern portion of the project area from the northwestern corner facing eastward.**

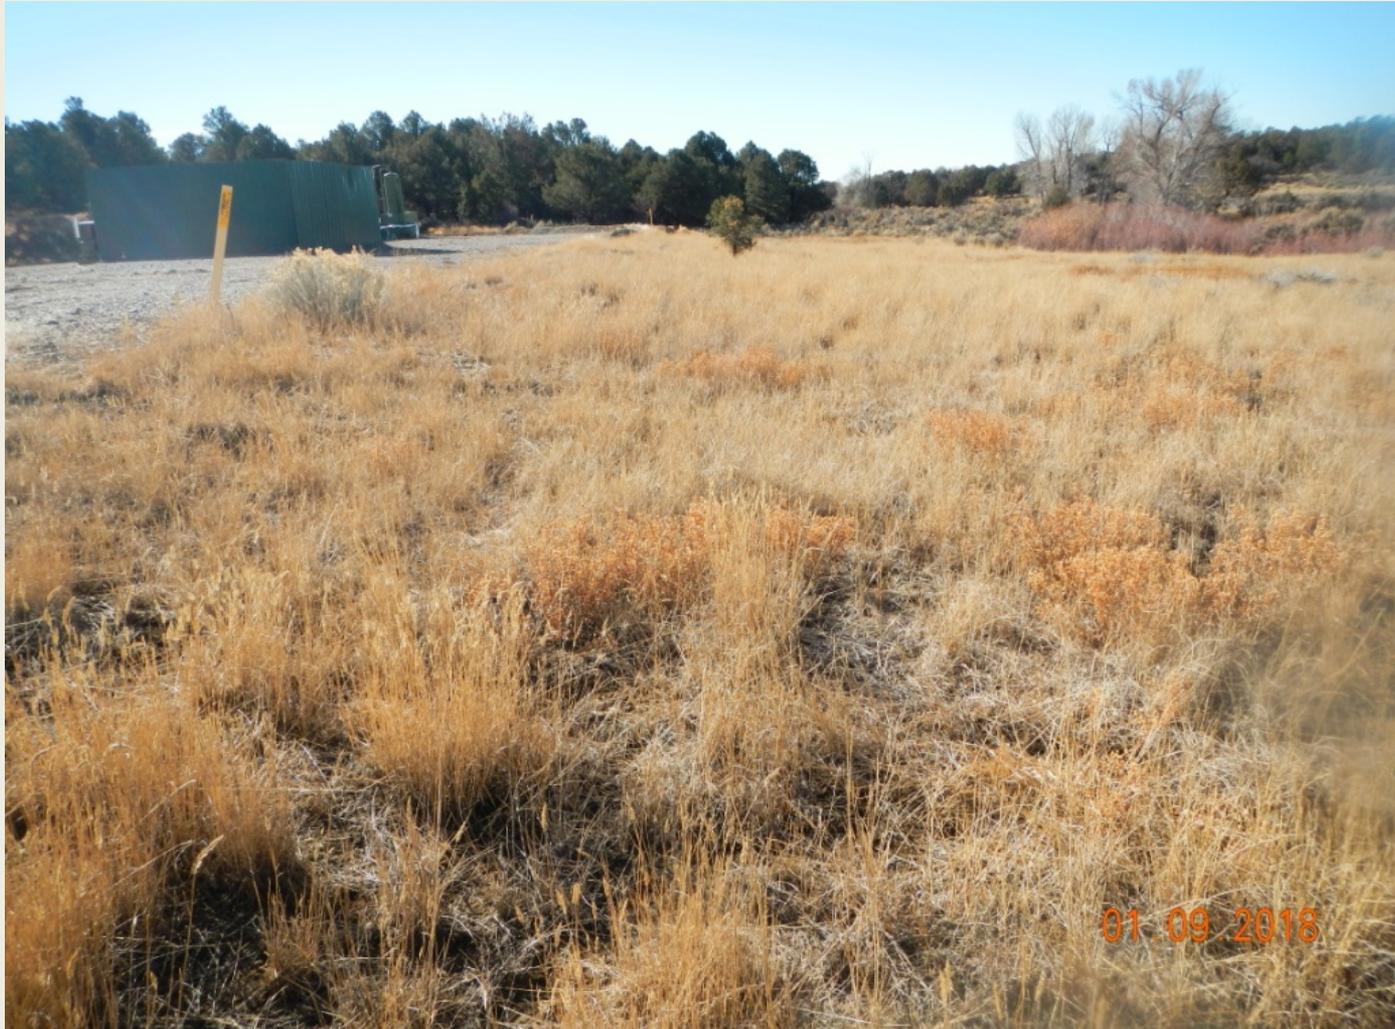
**Photo 3. View of the western portion of the project area from northwestern corner facing southward. Revegetation is progressing, with grasses such as crested wheatgrass (*Agropyron cristatum*), smooth brome (*Bromus inermis*) and western wheatgrass (*Pascopyrum smithii*) as well as sagebrush (*Artemisia tridentata*).**

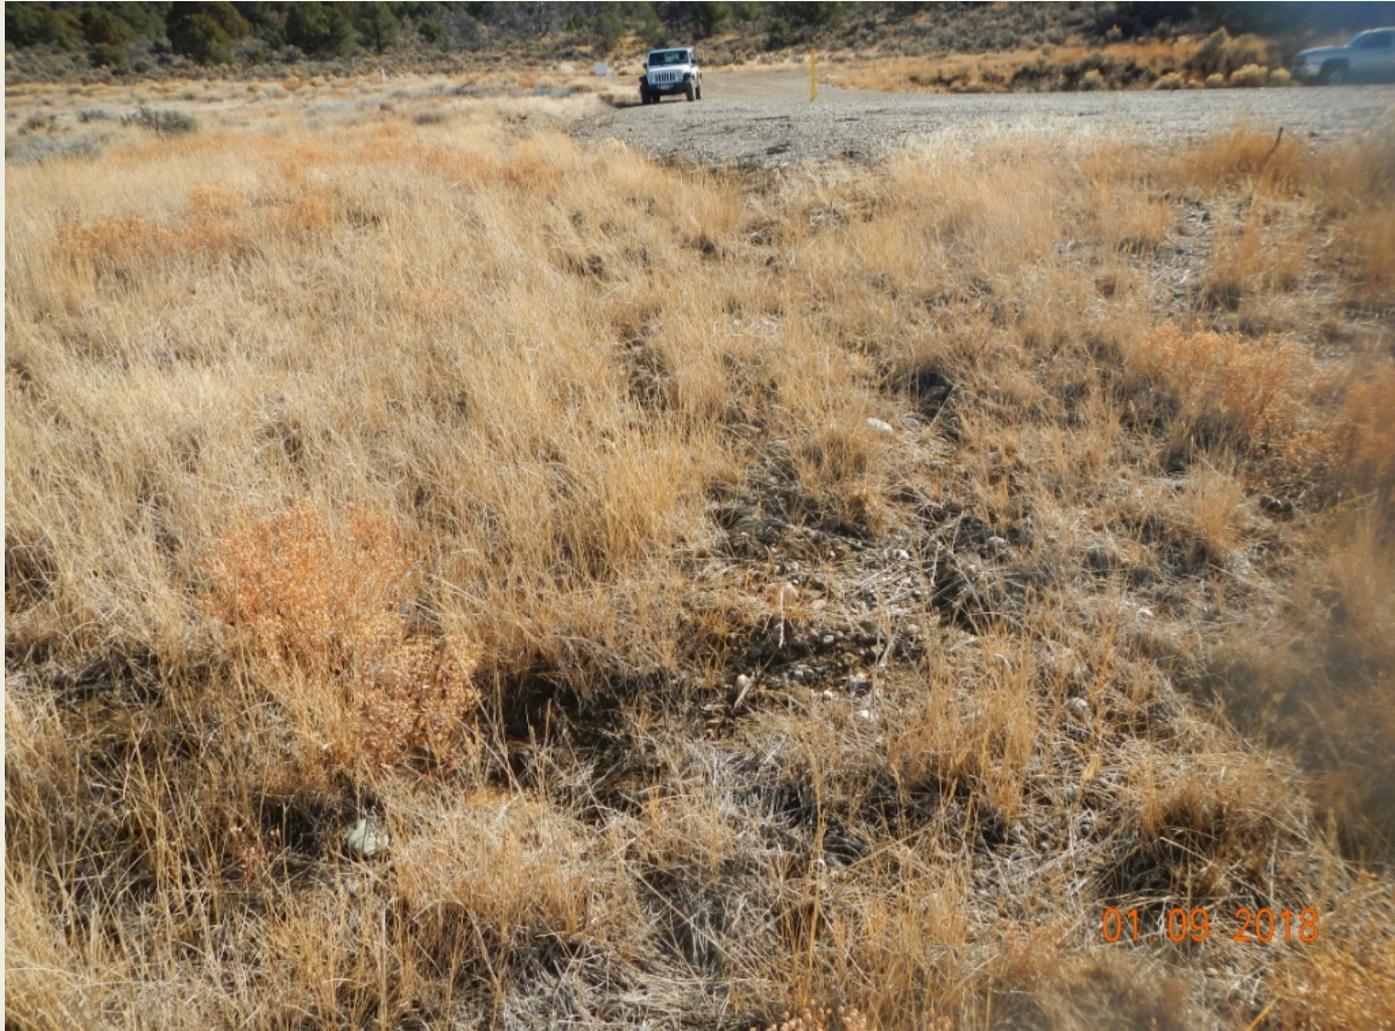
**Photo 4. View of area in the northwestern portion of the interim reclamation area where concentrated stormwater is starting to erode the interim reclamation area.**

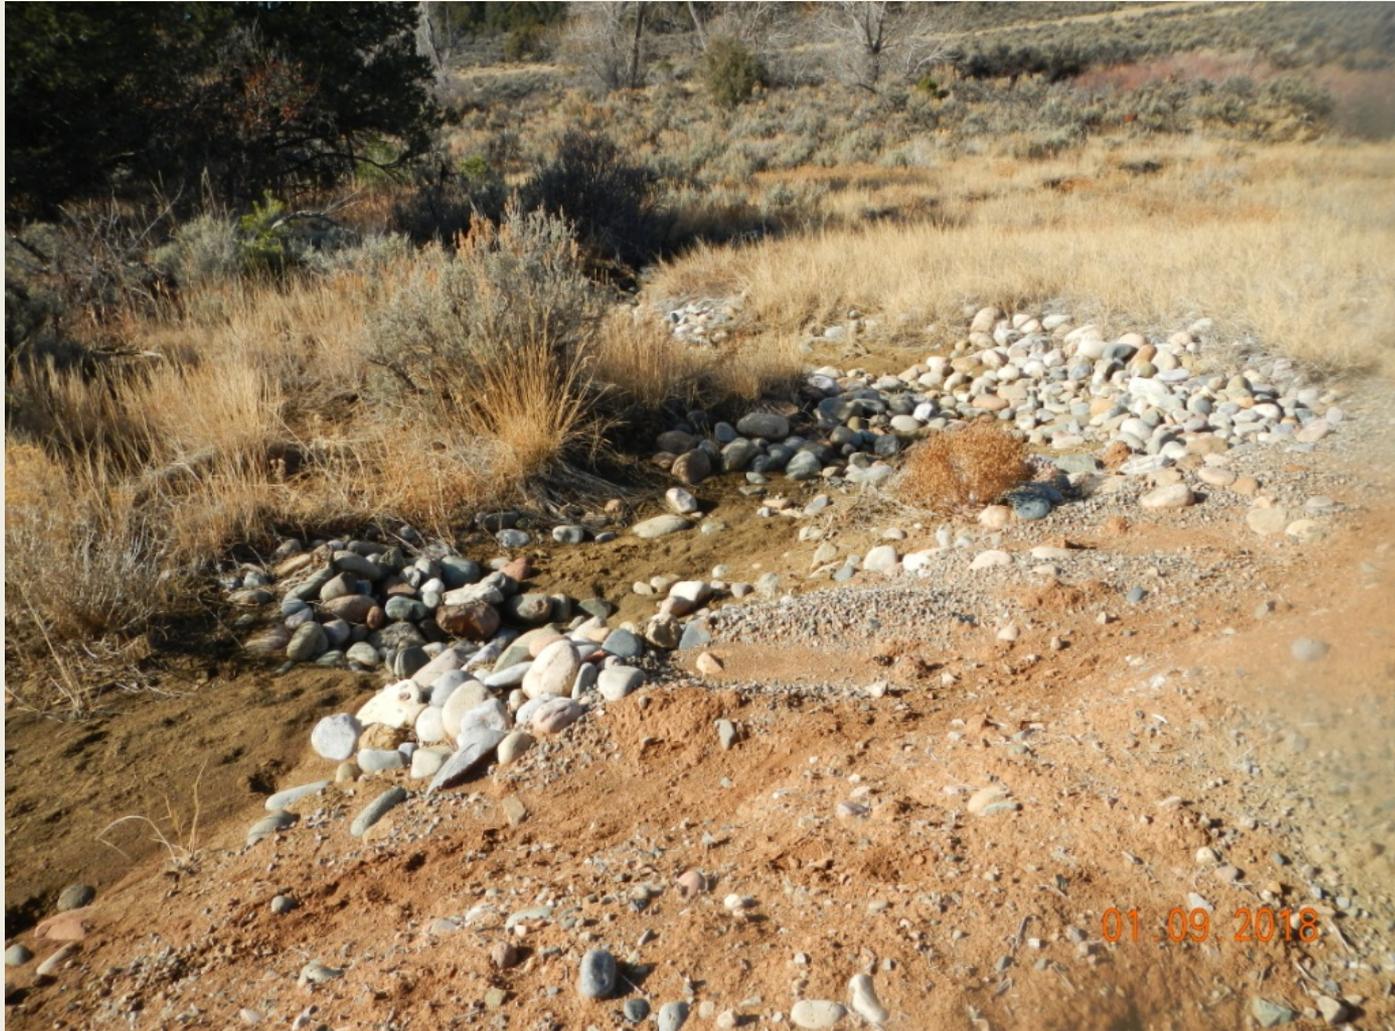
**Photo 5. View cobble run-down in the southern portion of the project area. This is filling with sediment and soon require maintenance.**

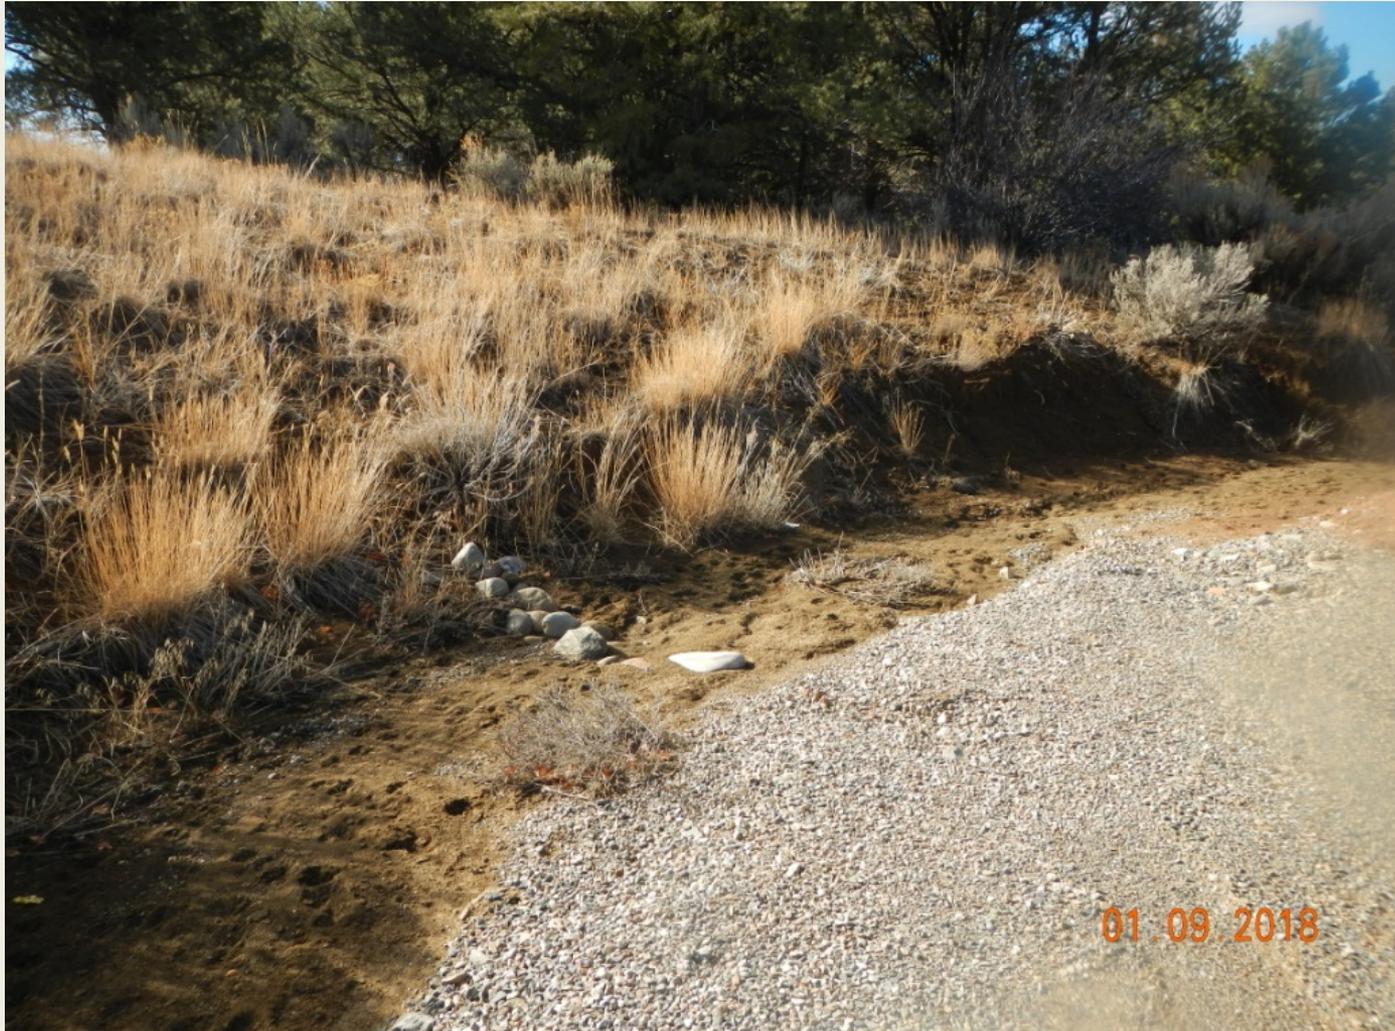
**Photo 6. View of cobble check dam and diversion in the southeastern portion of the project area. This is full of sediment and needs maintenance.**

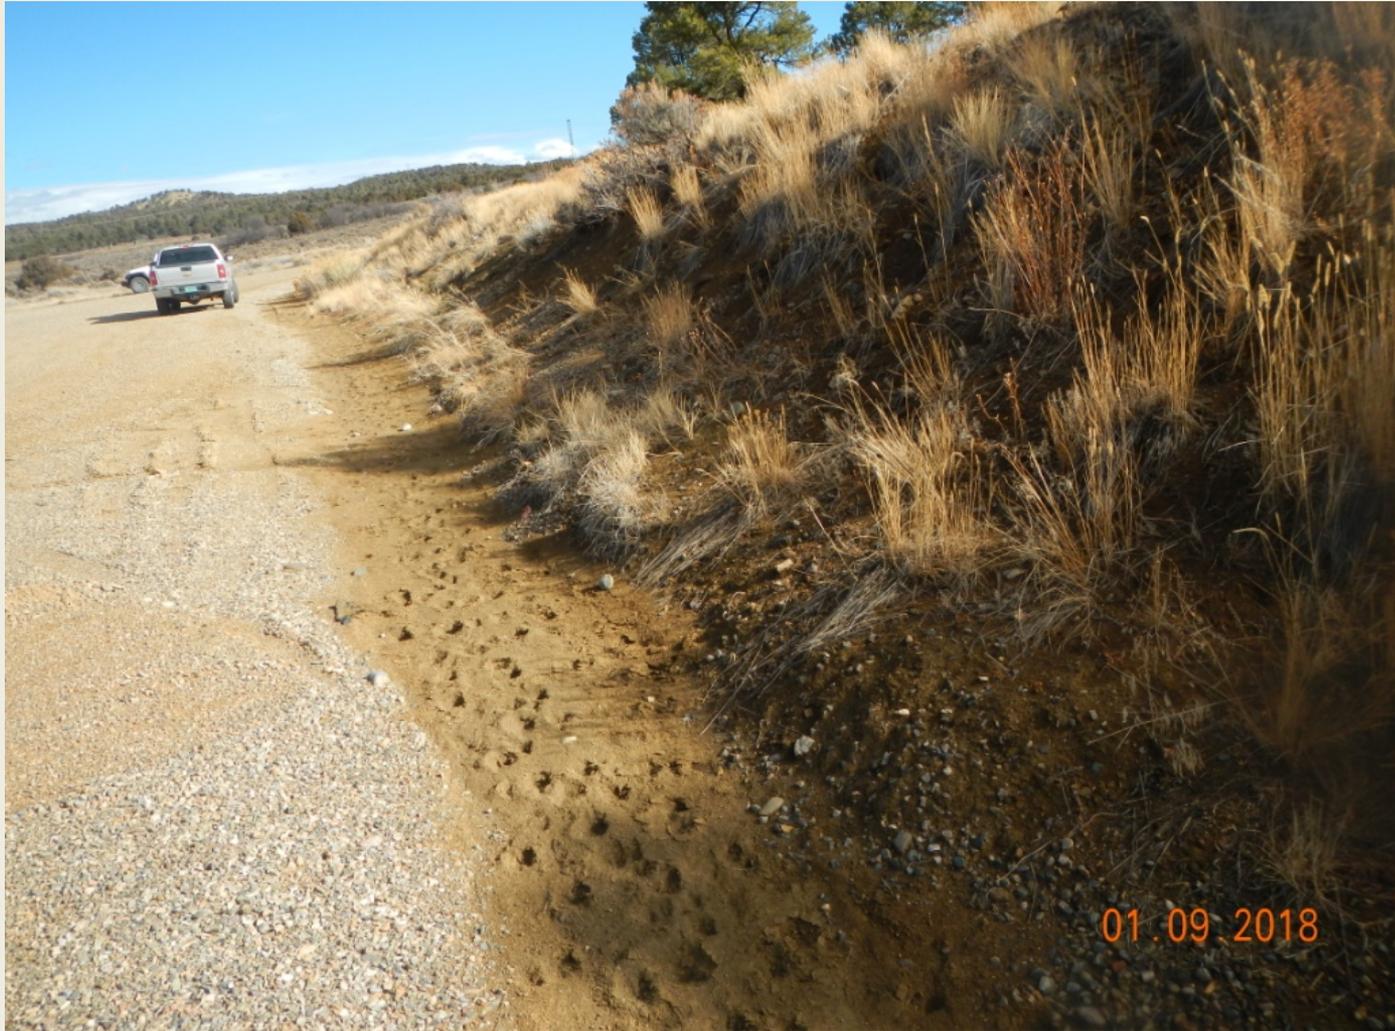
**Photo 7. View of diversion in the eastern portion of the project area facing northward. Diversion is full of sediment and needs maintenance.**

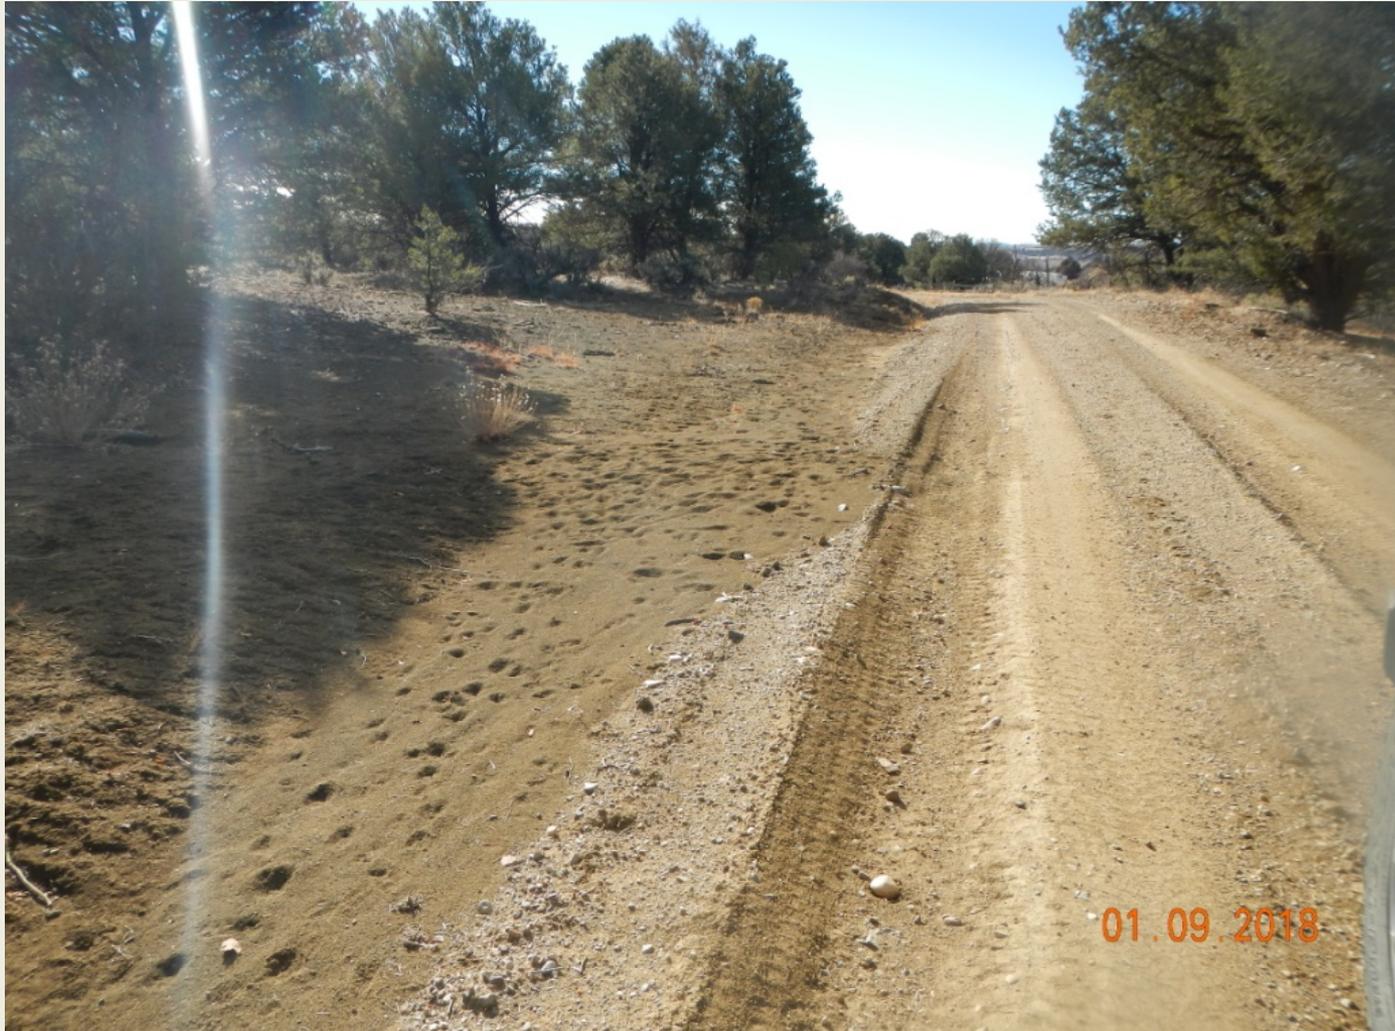
**Photo 8. View of roadside drainage full of sediment that needs maintenance.**
