Inspection Photos
Location Name: Extraction Windsor LV2
Location # 449441

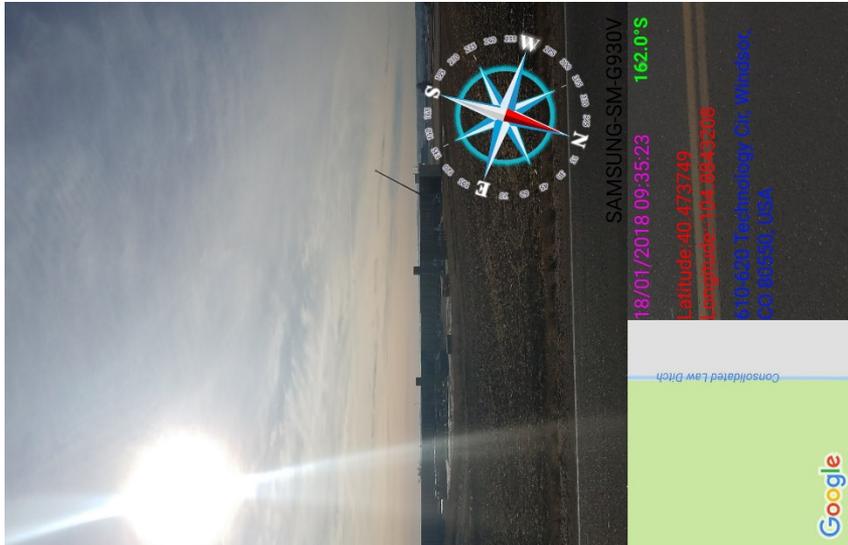
AWI Enclosed ECD in operation on location sound walls on west side removed

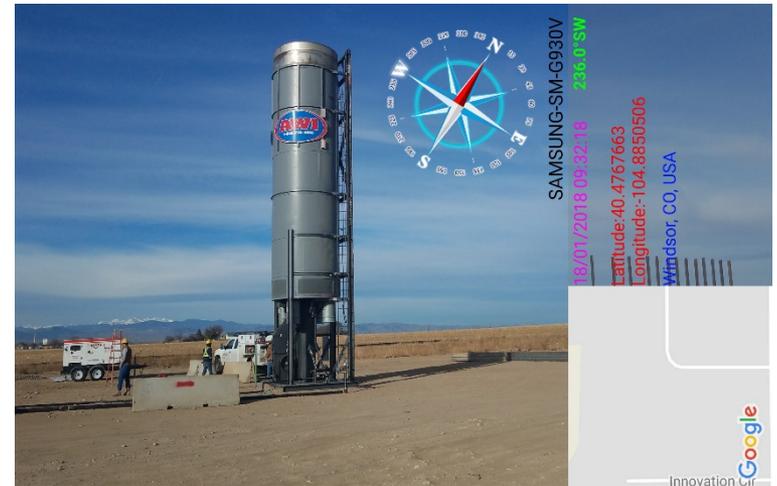
AWI Enclosed ECD
