Inspection Photos

API: 05-067-06545

Operator: HOLCOMB OIL & GAS INC

Inspection Number: 680602431

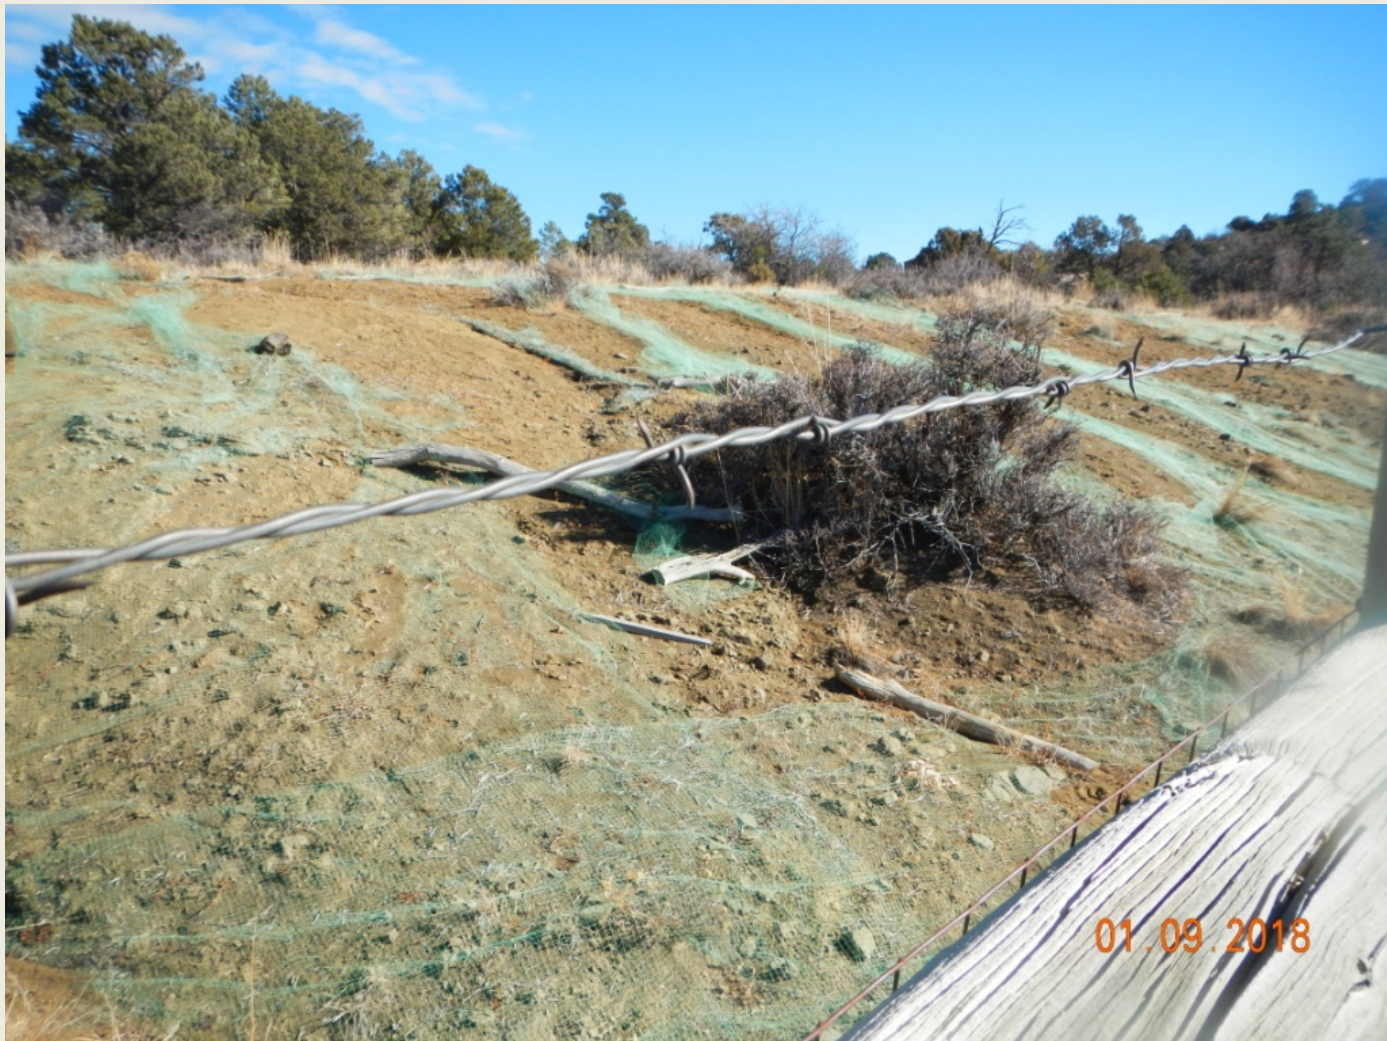
Photo 1. View of the northeastern portion of the project area (cut-slope). Straw blanket for erosion control is no longer functioning. Netting debris needs to be removed and erosion stabilized.

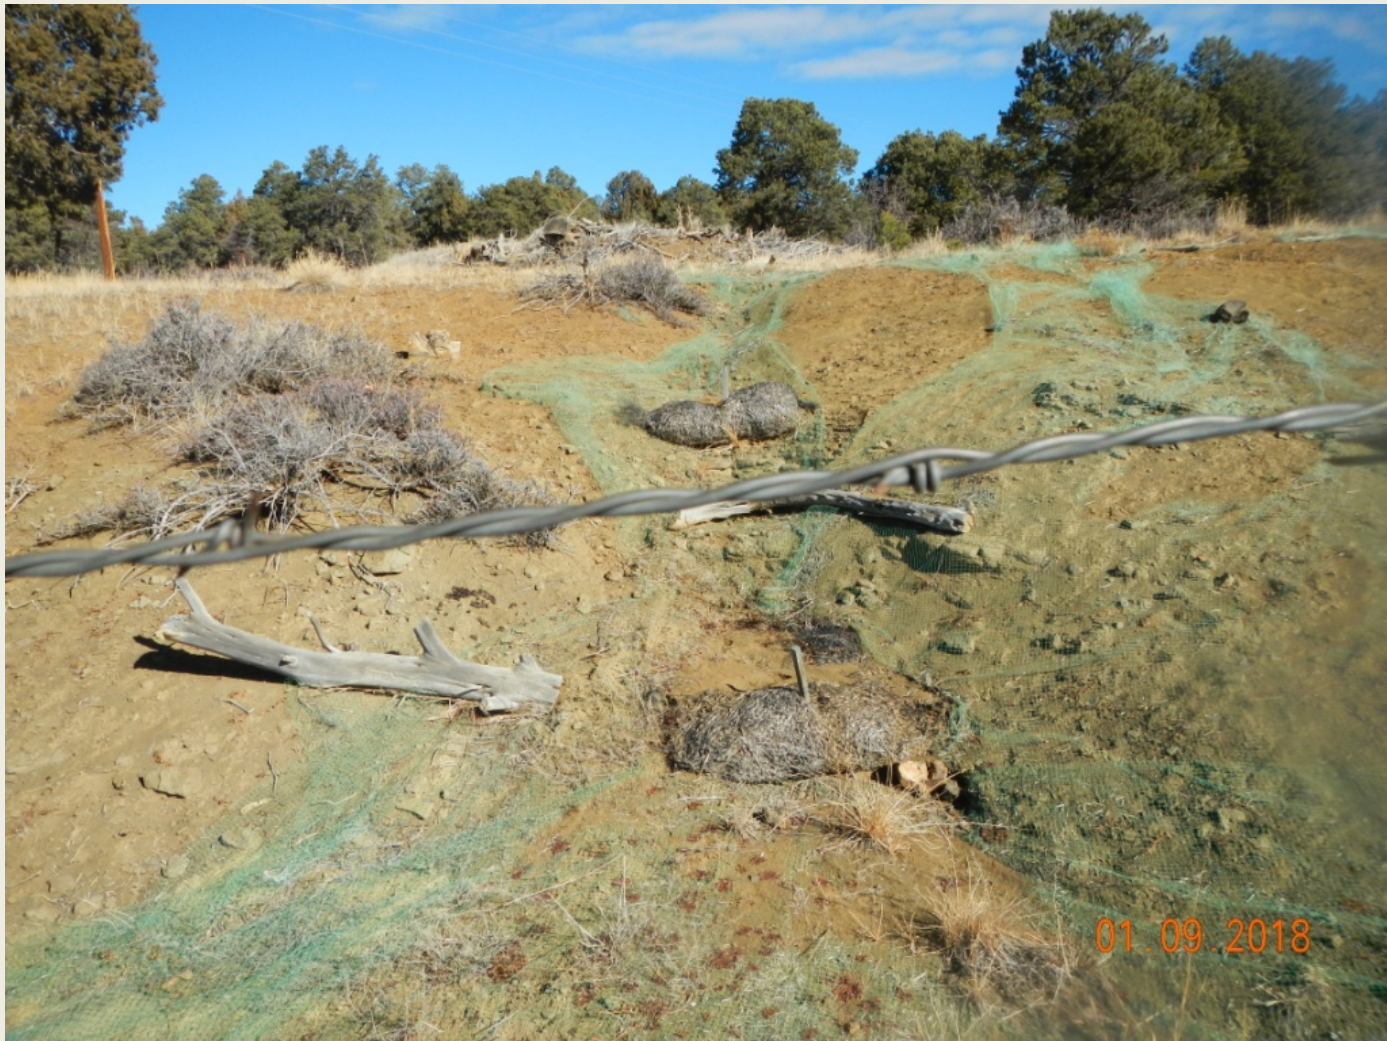
Photo 2. Another view of the northeastern portion of the project area. Wattles are full of sediment and need maintenance. Run-on controls appear needed.

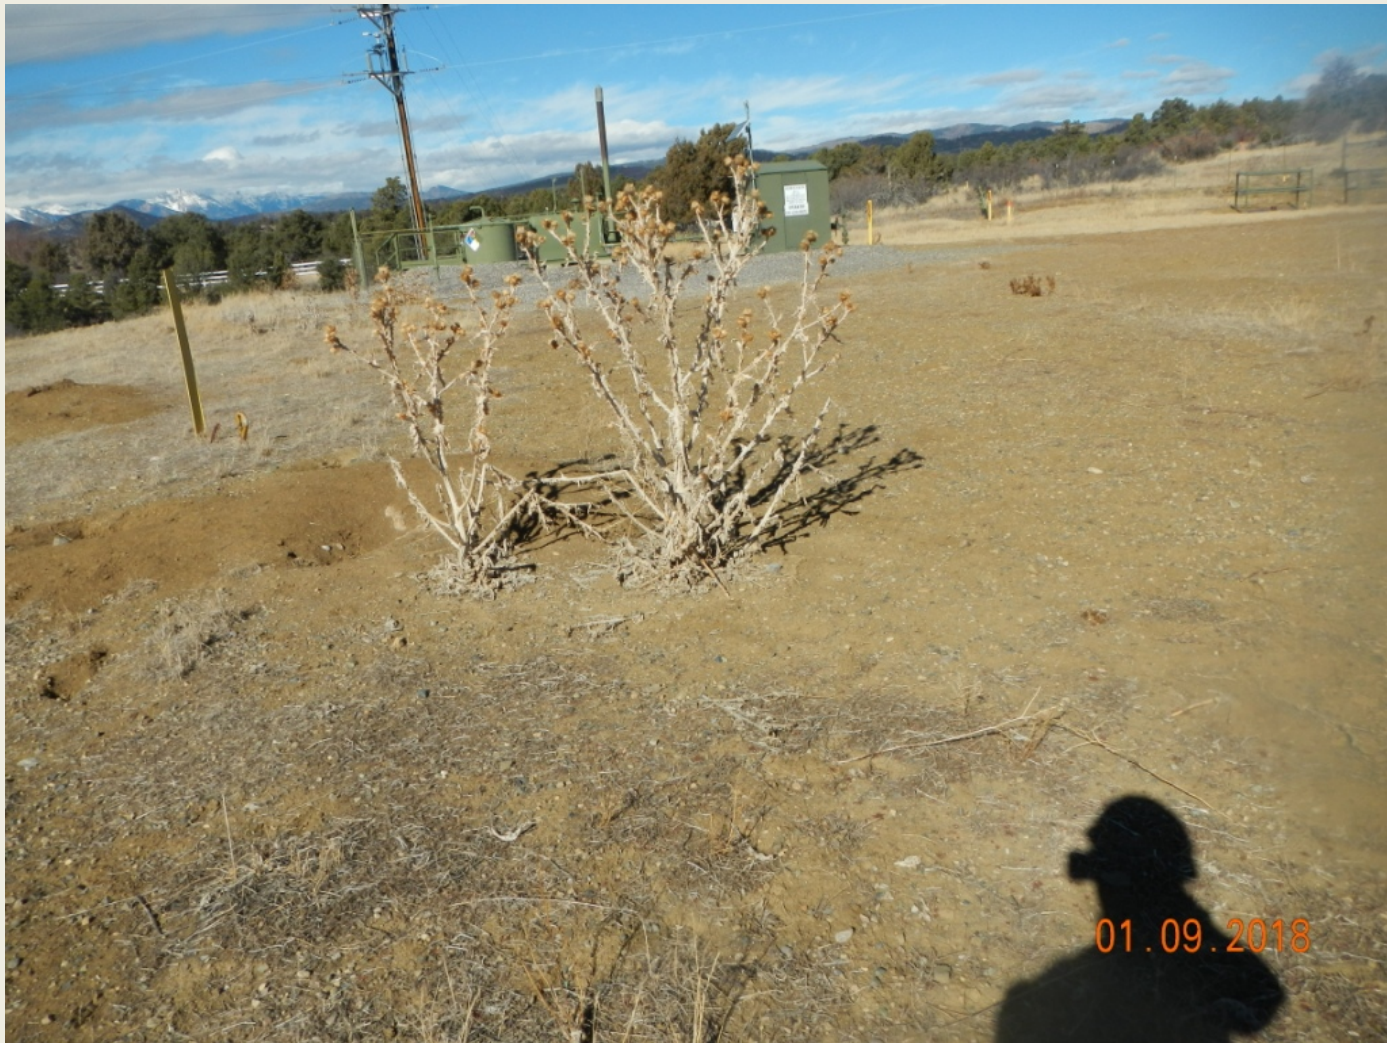
Photo 3. View of Scotch thistle (*Onopordum acanthium*) growing on the well pad.

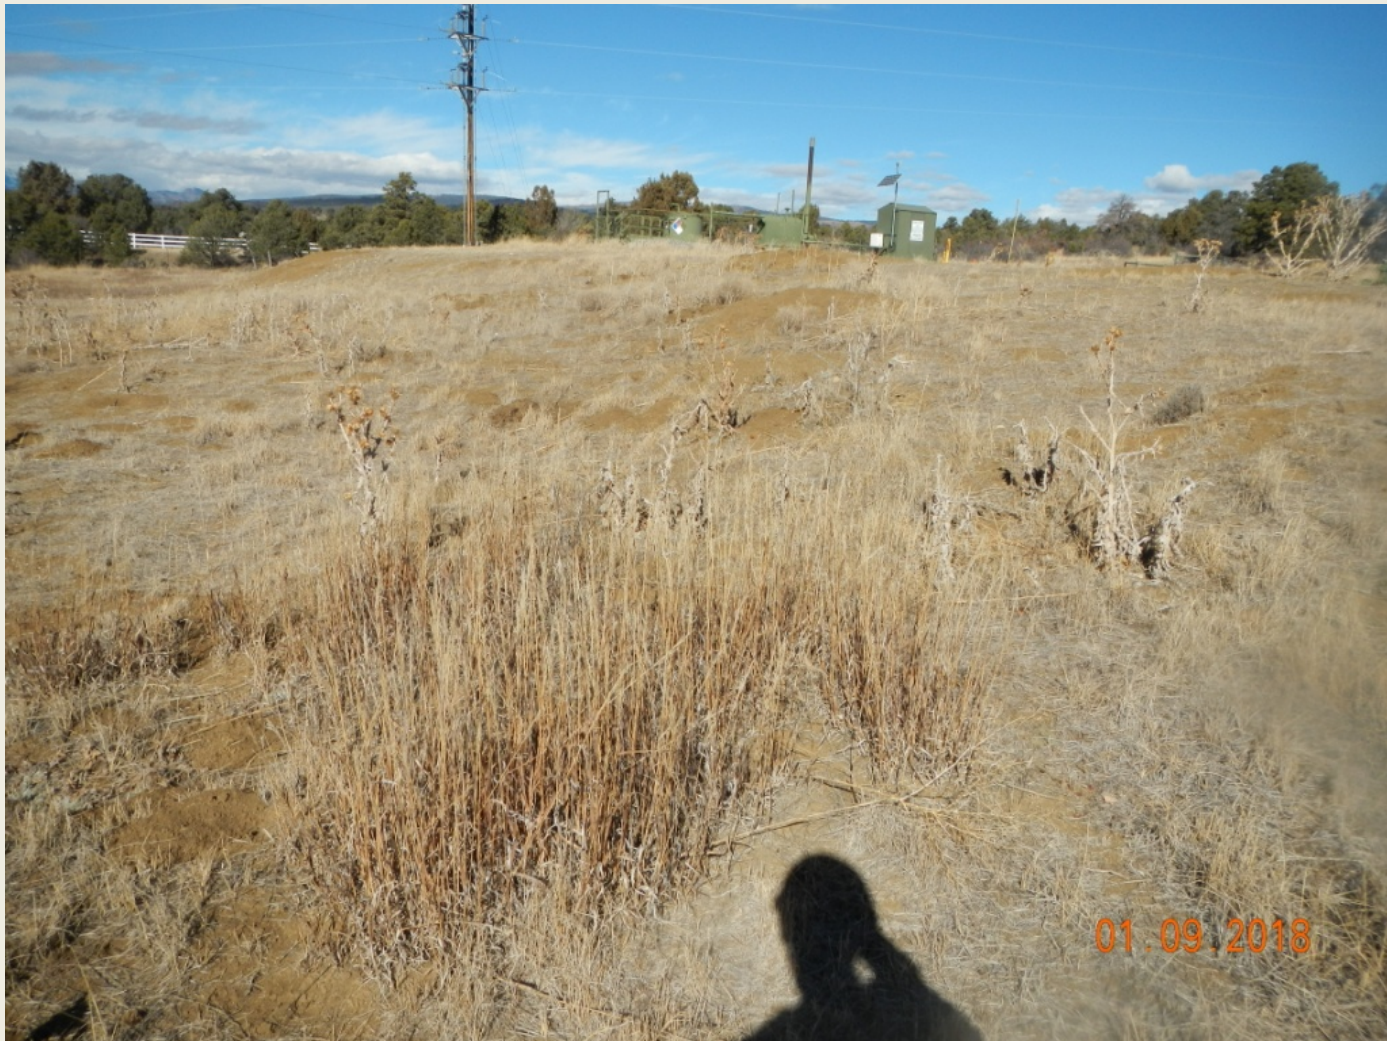
Photo 4. View of Scotch thistles within the southern portion of the interim reclamation area.
