Interim Reclamation and Stormwater Inspection

January 12, 2018

Operator: BONANZA CREEK ENERGY OPERATING COMPANY LLC - #8960

Location ID: 441121

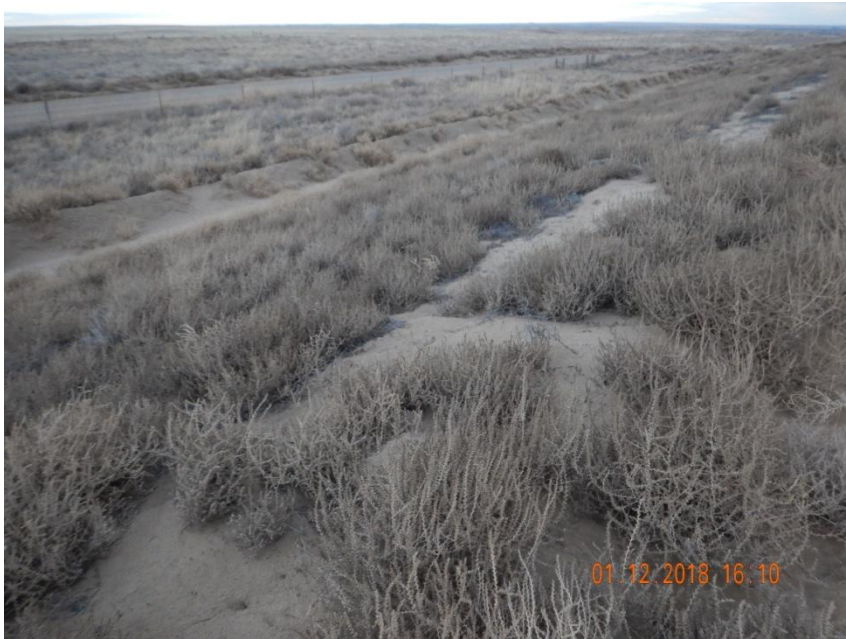
Photo 1. Photo taken from the eastern location , facing South. Photo indicates unmanaged Russian thistle (*Salsola tragus*-tumbleweed) throughout the perimeter and interim areas which is considered weed debris.

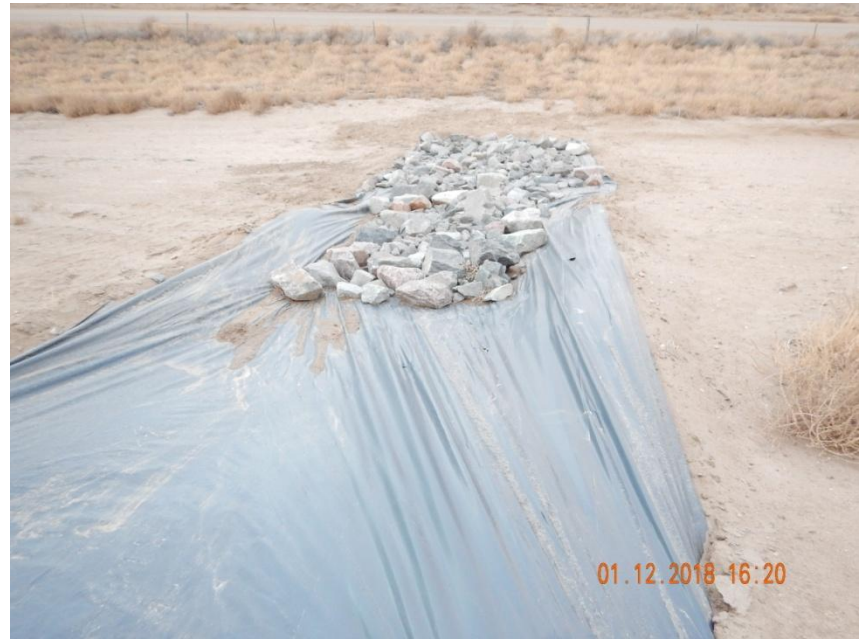
Photo 2. Photo taken from the eastern location, facing East. Unconsolidated soil material along the eastern fill slope. Operator needs to stabilize all unconsolidated soil material.

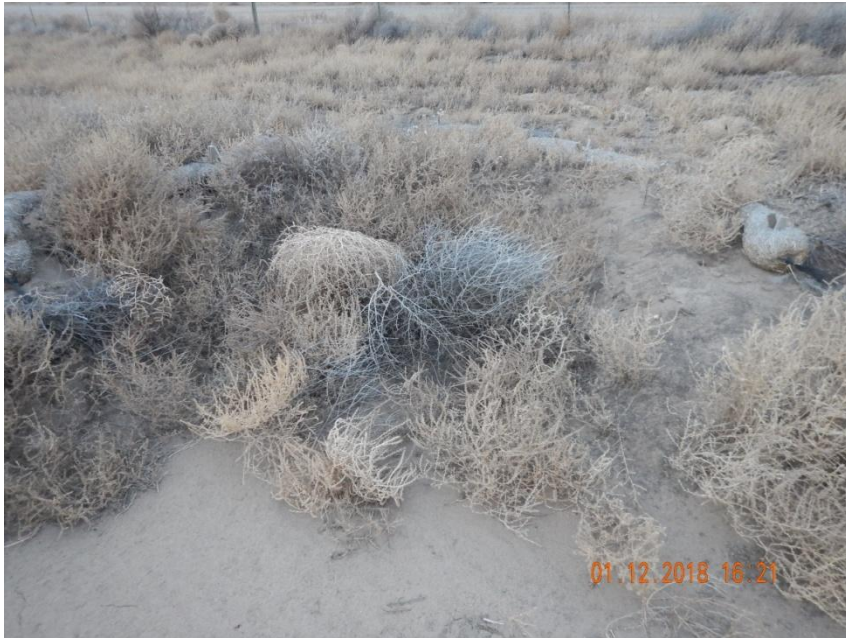
Photo 3. Photo taken from the eastern location, facing East. Sediment trap in need of maintenance. See comments under Photo 1.

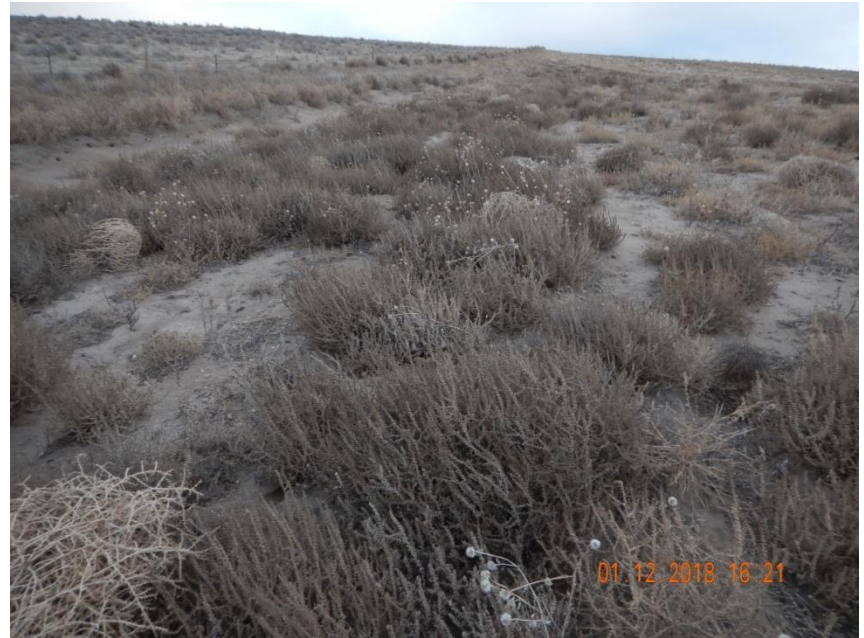
Photo 4. Photo taken from the southern location, facing East. See comments under Photo 1.

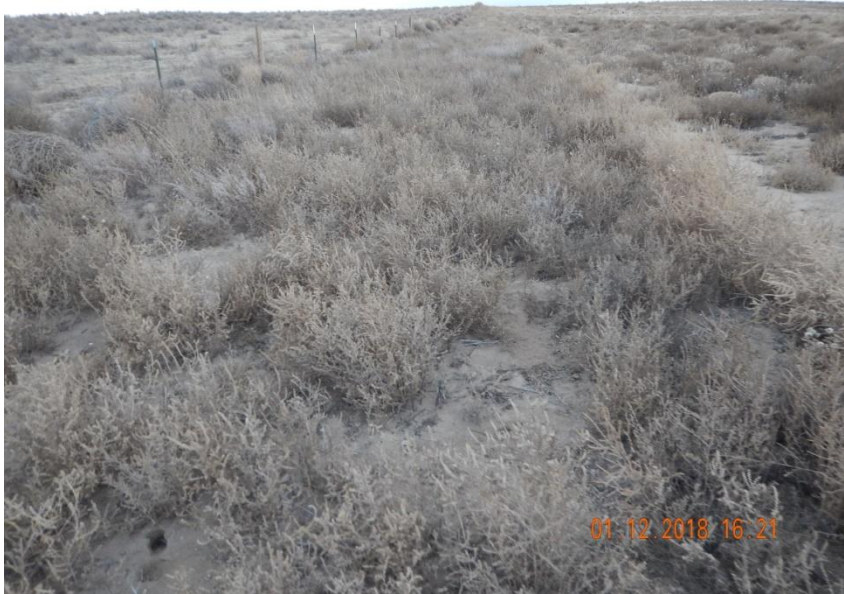
Photo 5. Photo taken from the southwestern location, facing North. See comments under Photo 1.

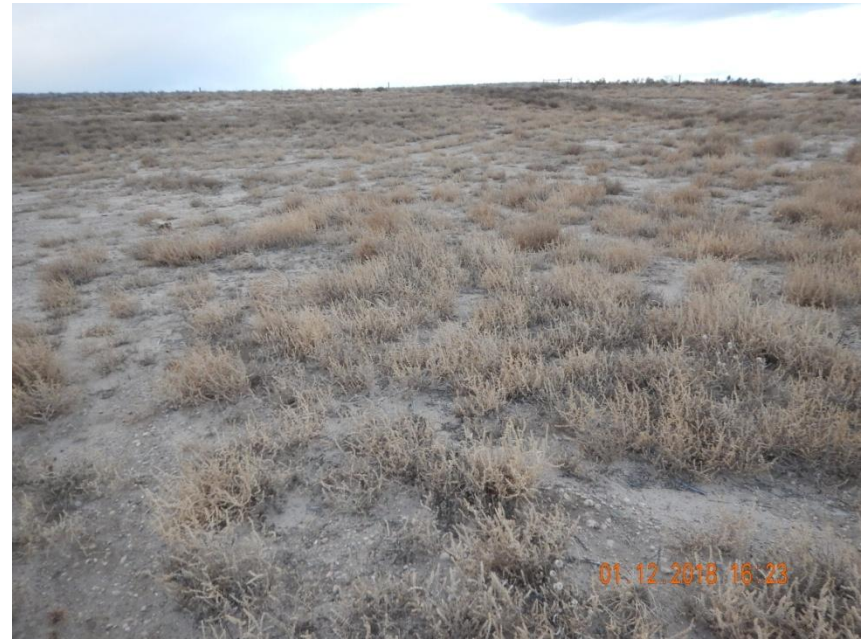
Photo 6. Photo taken from the northwestern location, facing West. See comments under Photo 1.

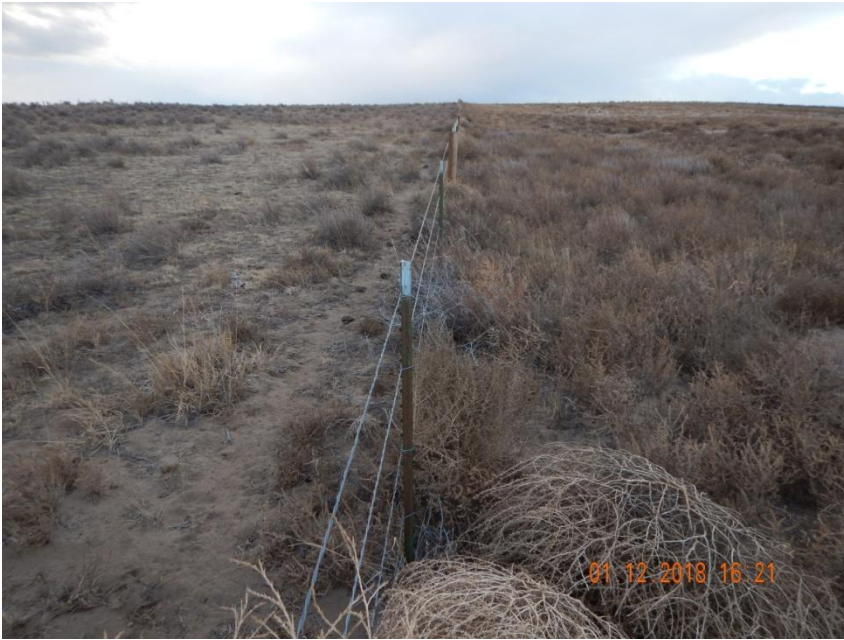
Photo 7. Photo taken from the southern perimeter of location, facing West. Interim areas are not reflective of reference area vegetative levels.

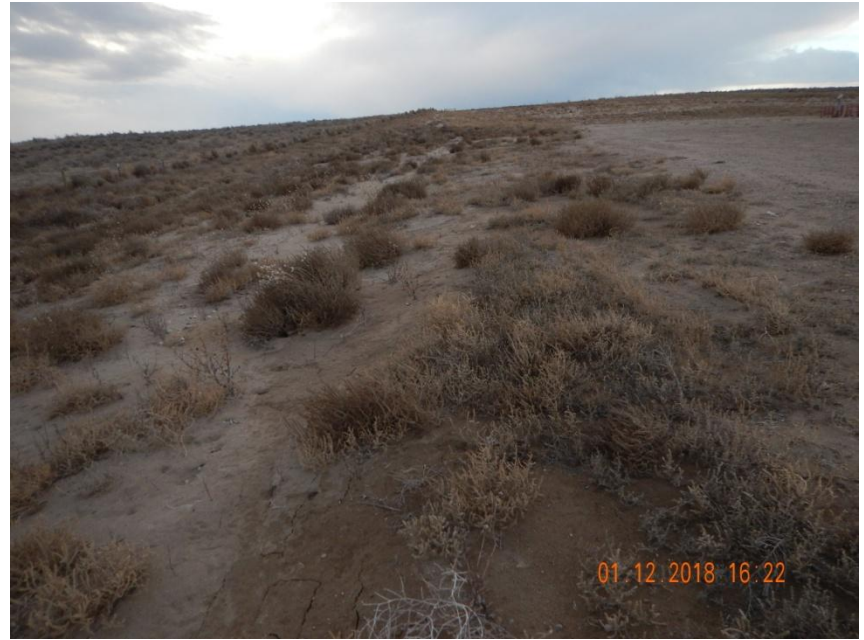
Photo 8. Photo taken from the southern location, facing West. See comments under Photo 1.

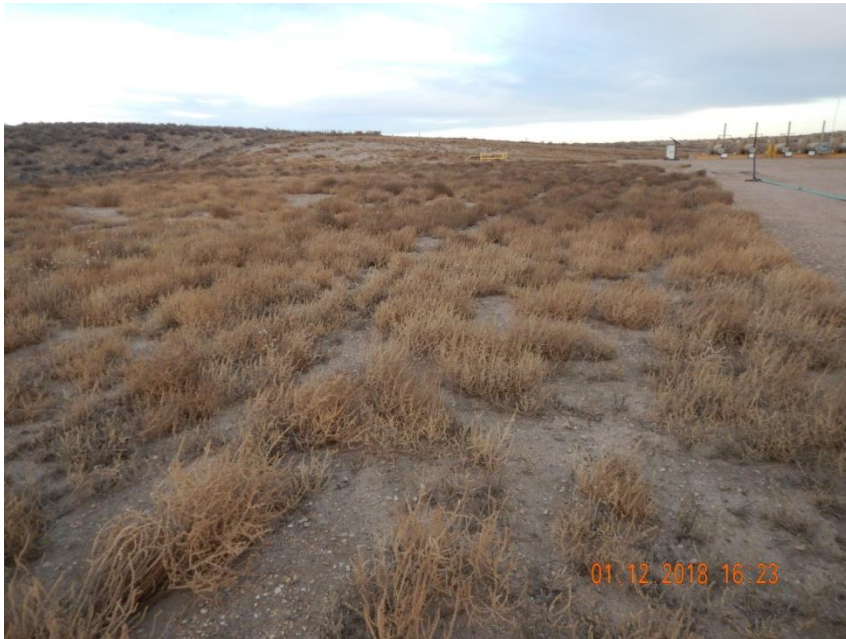
Photo 9. Photo taken from the northern location, facing East. See comments under Photo 1.
