Inspection Photos

API: 05-067-07674

Operator: XTO ENERGY INC

Inspection Number: 680602433

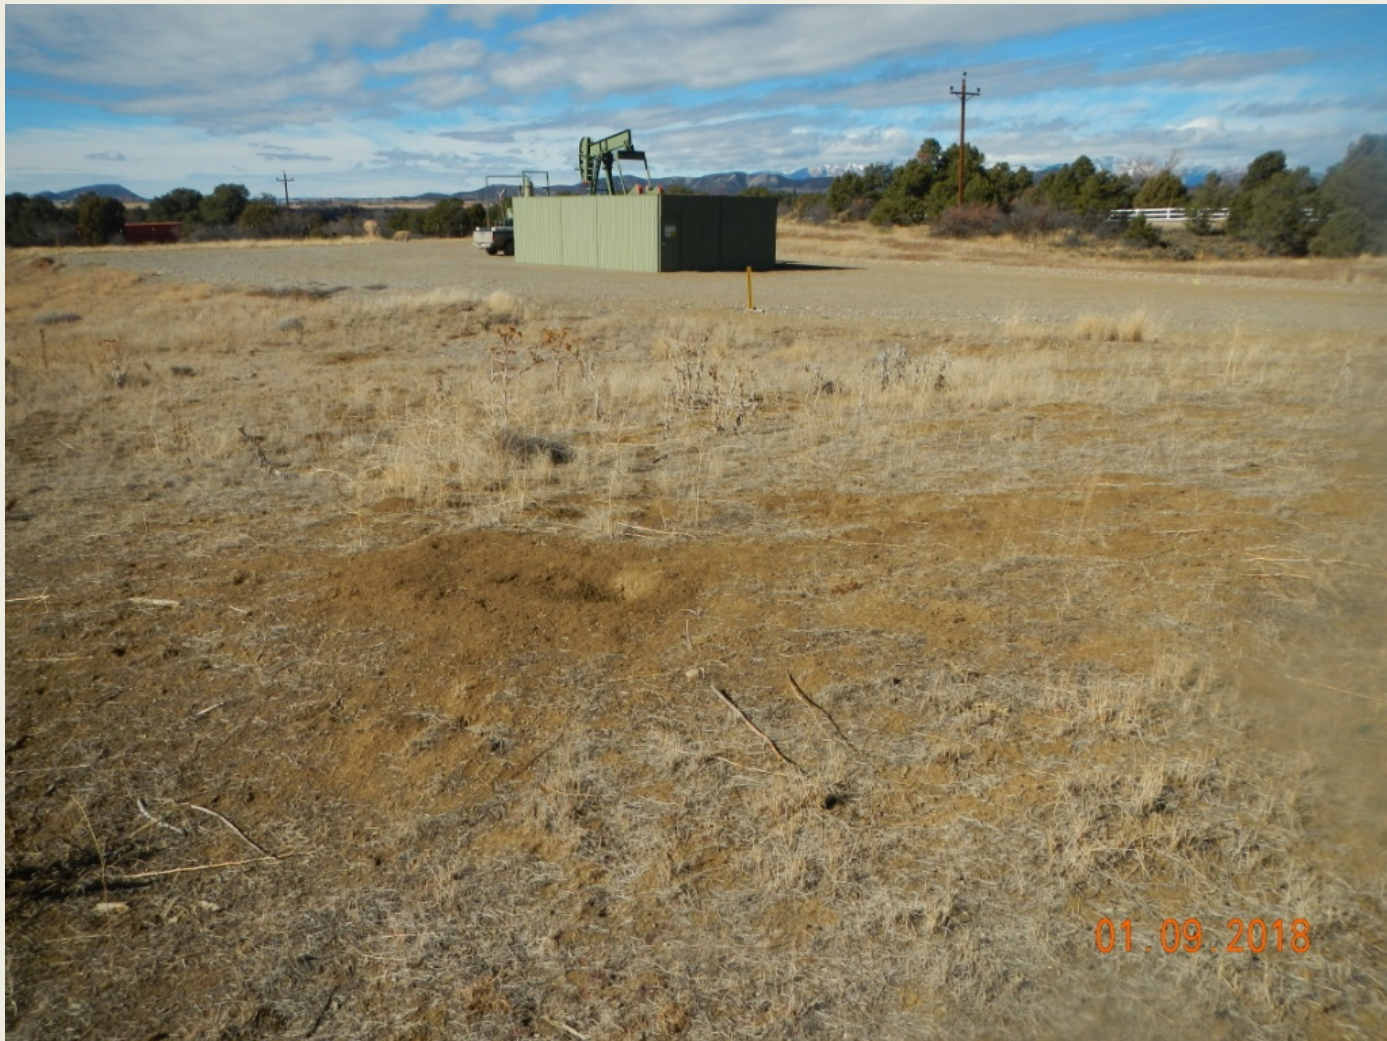
Photo 1. View of project area from the southeastern corner facing center.

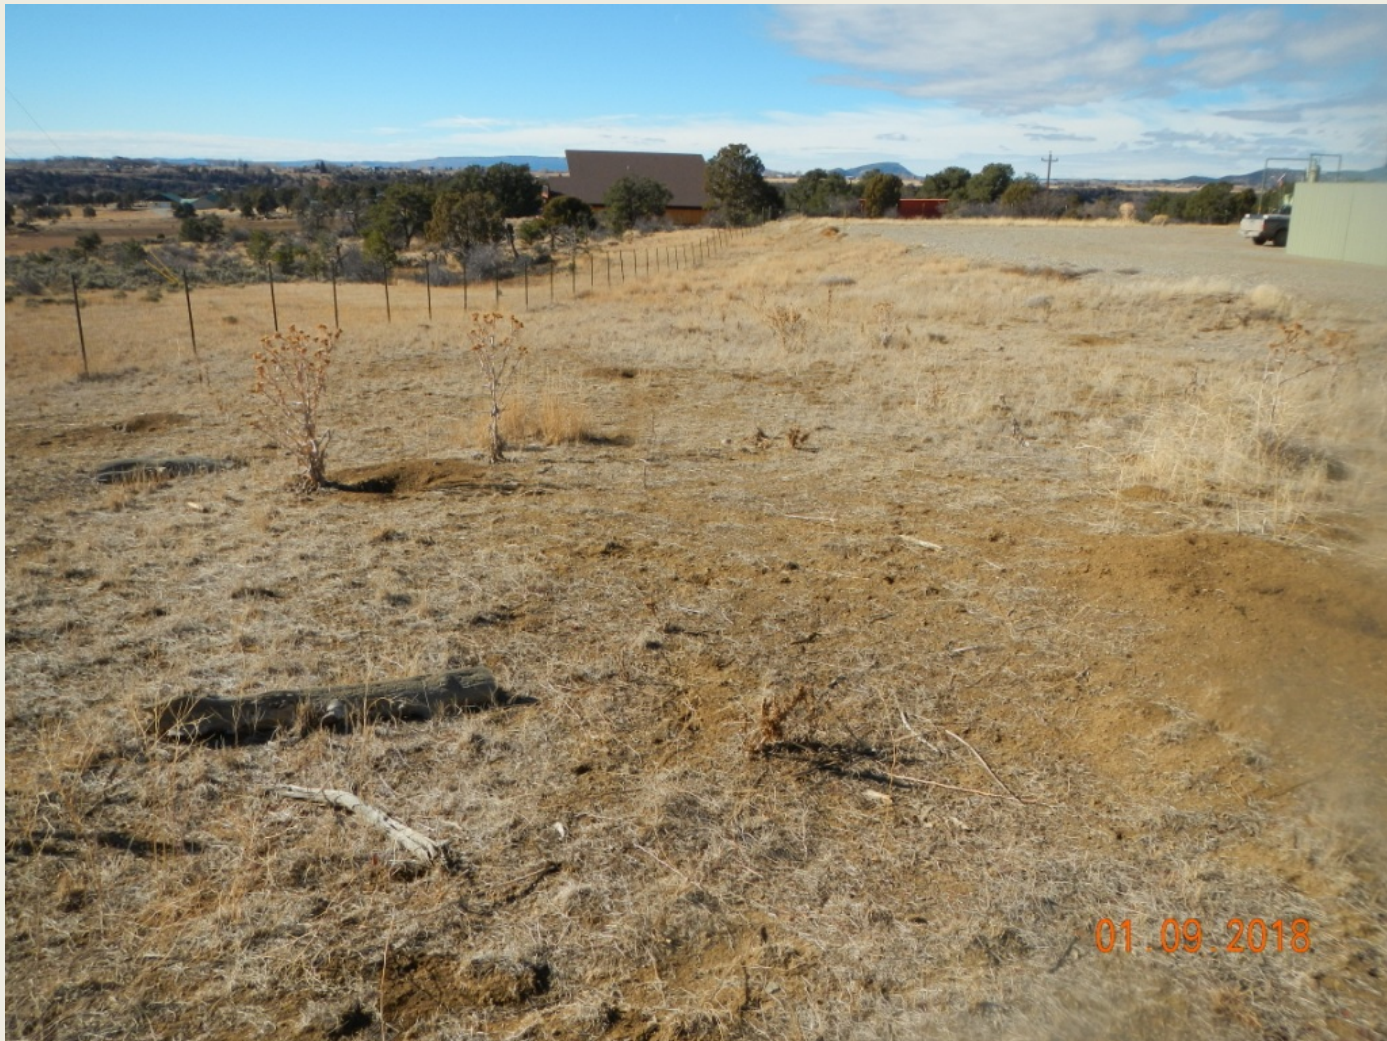
Photo 2. View of the southern portion of the project area from the southeastern corner facing westward. Approximately 100 Scotch thistles are present within the interim reclamation areas.

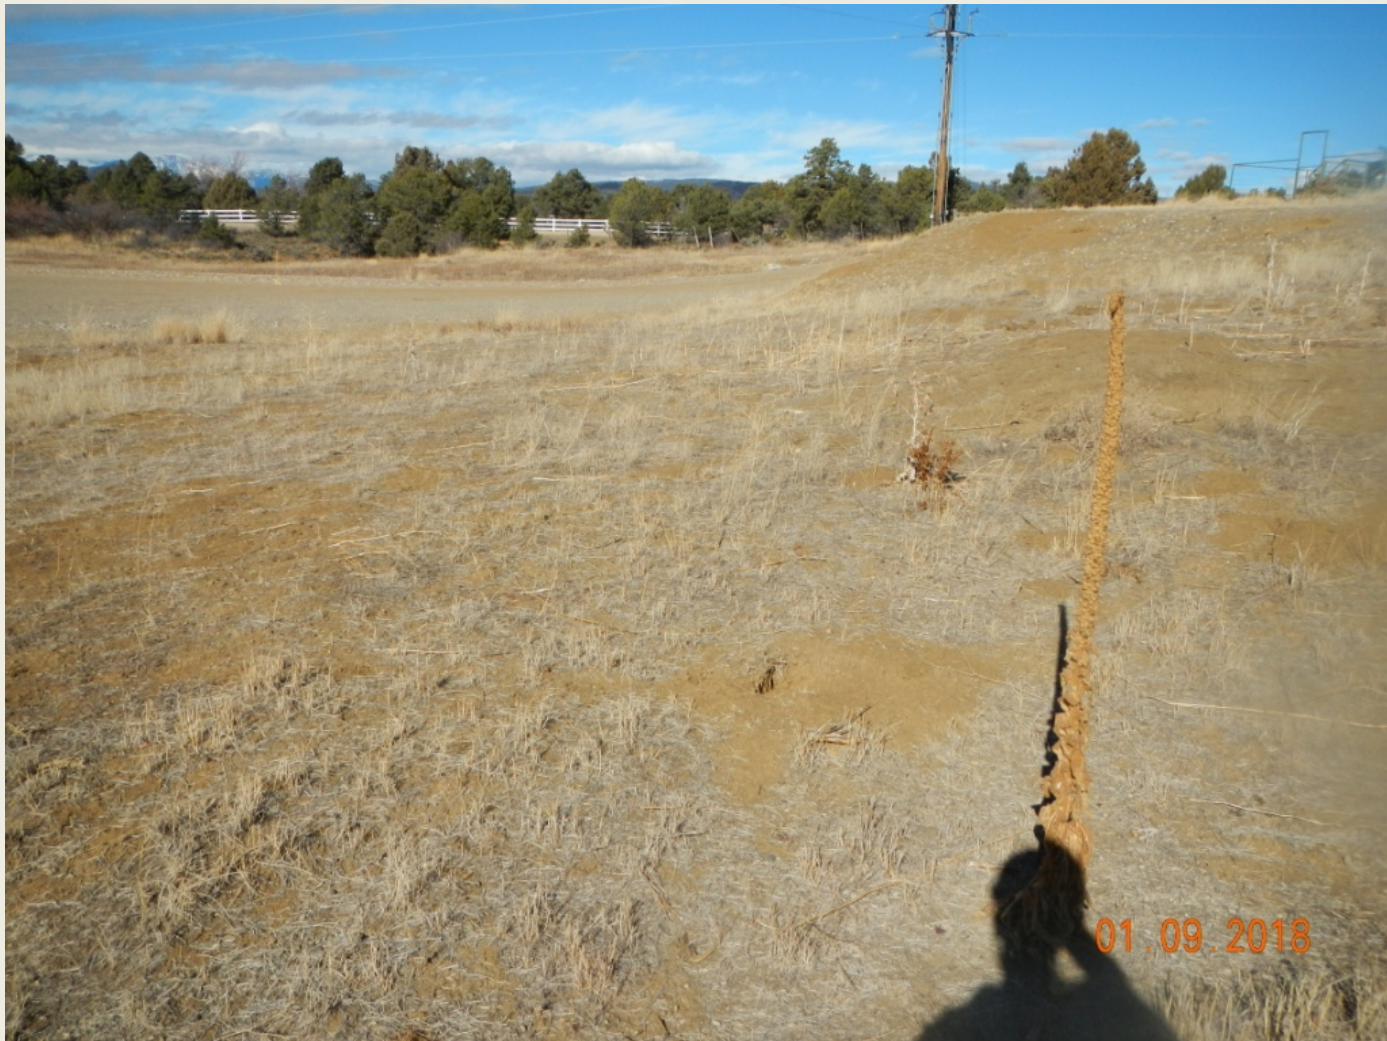
Photo 3. View of the eastern portion of the project area from the southeastern corner facing northward.

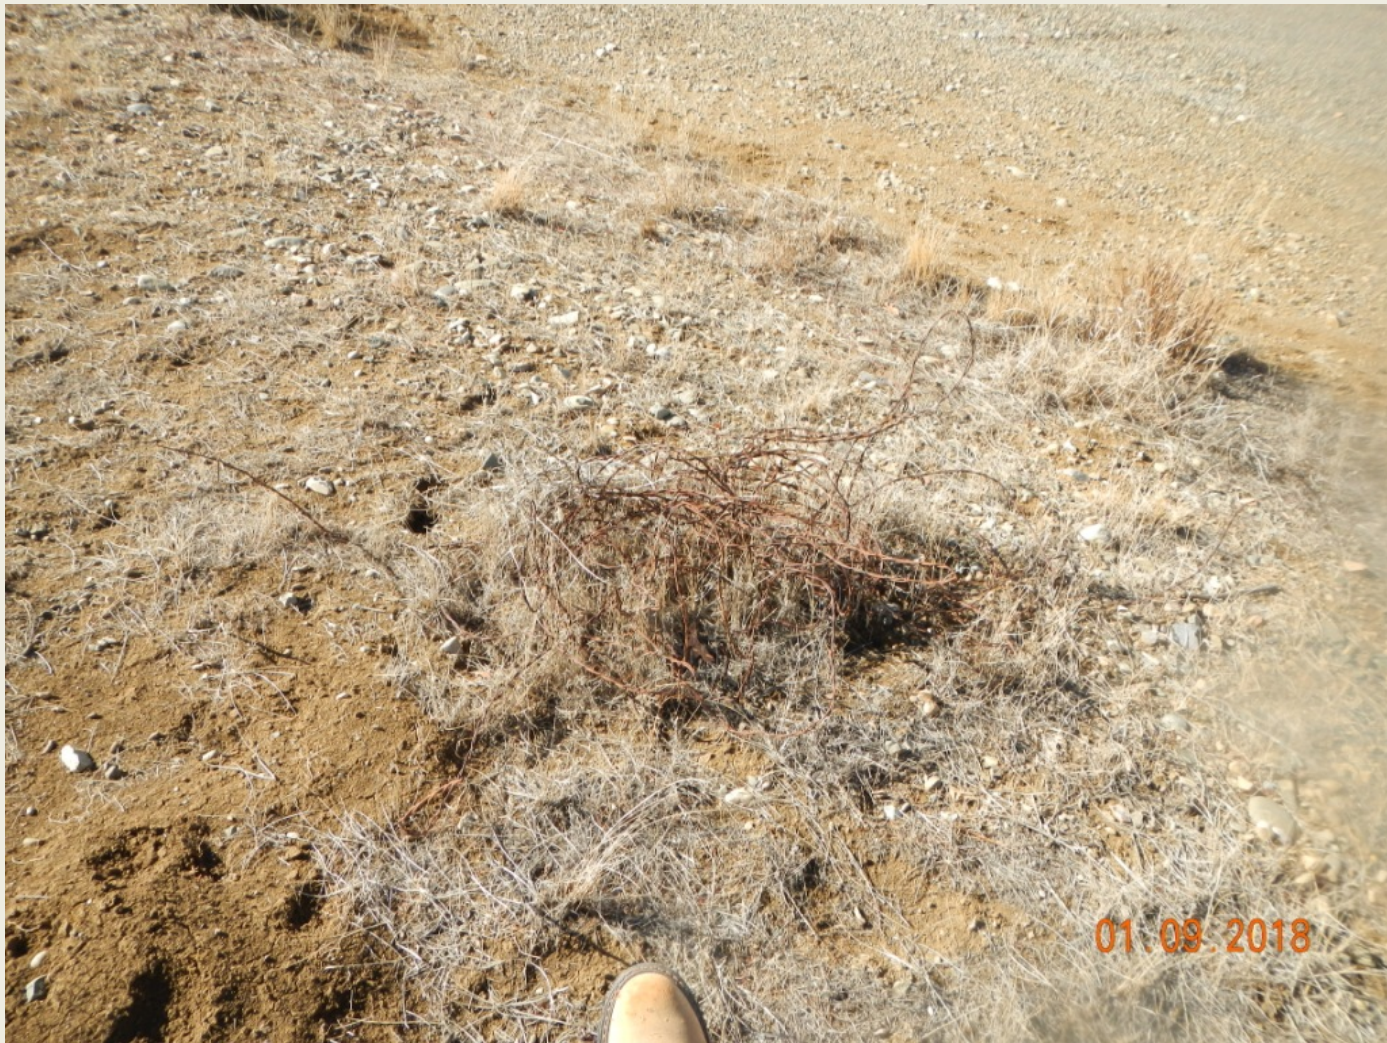
Photo 4. View of barbed wire within the southern portion of the project area.

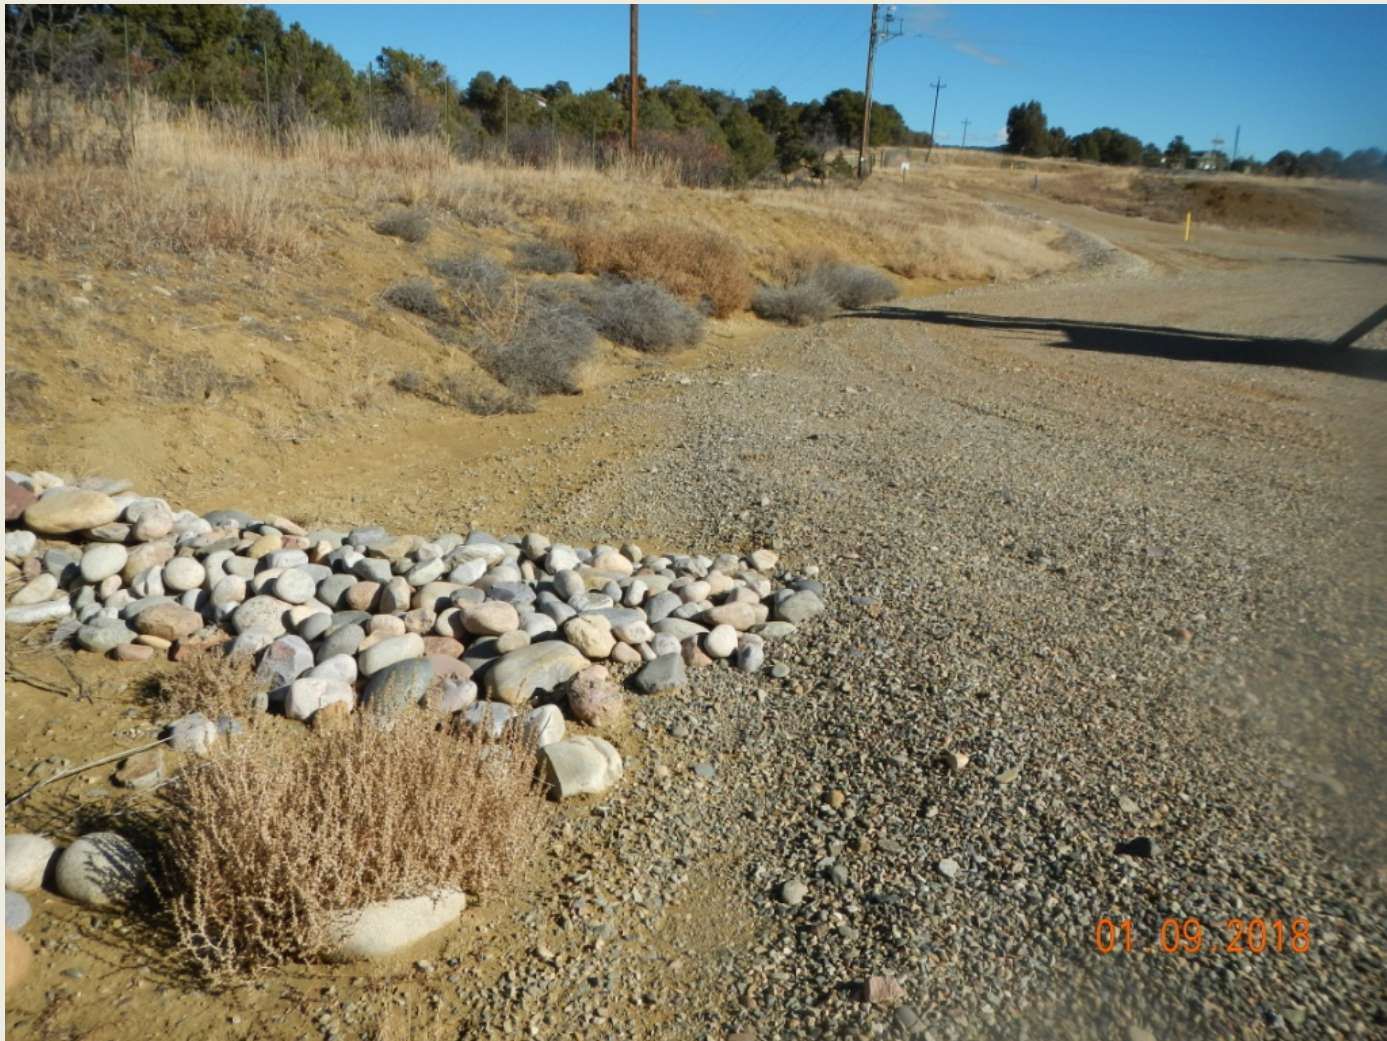
Photo 5. View of the northern portion of the project area from the northwestern portion of the project area facing eastward.
