Inspection Photos

API: 05-067-08149

Operator: XTO ENERGY INC

Inspection Number: 680602441

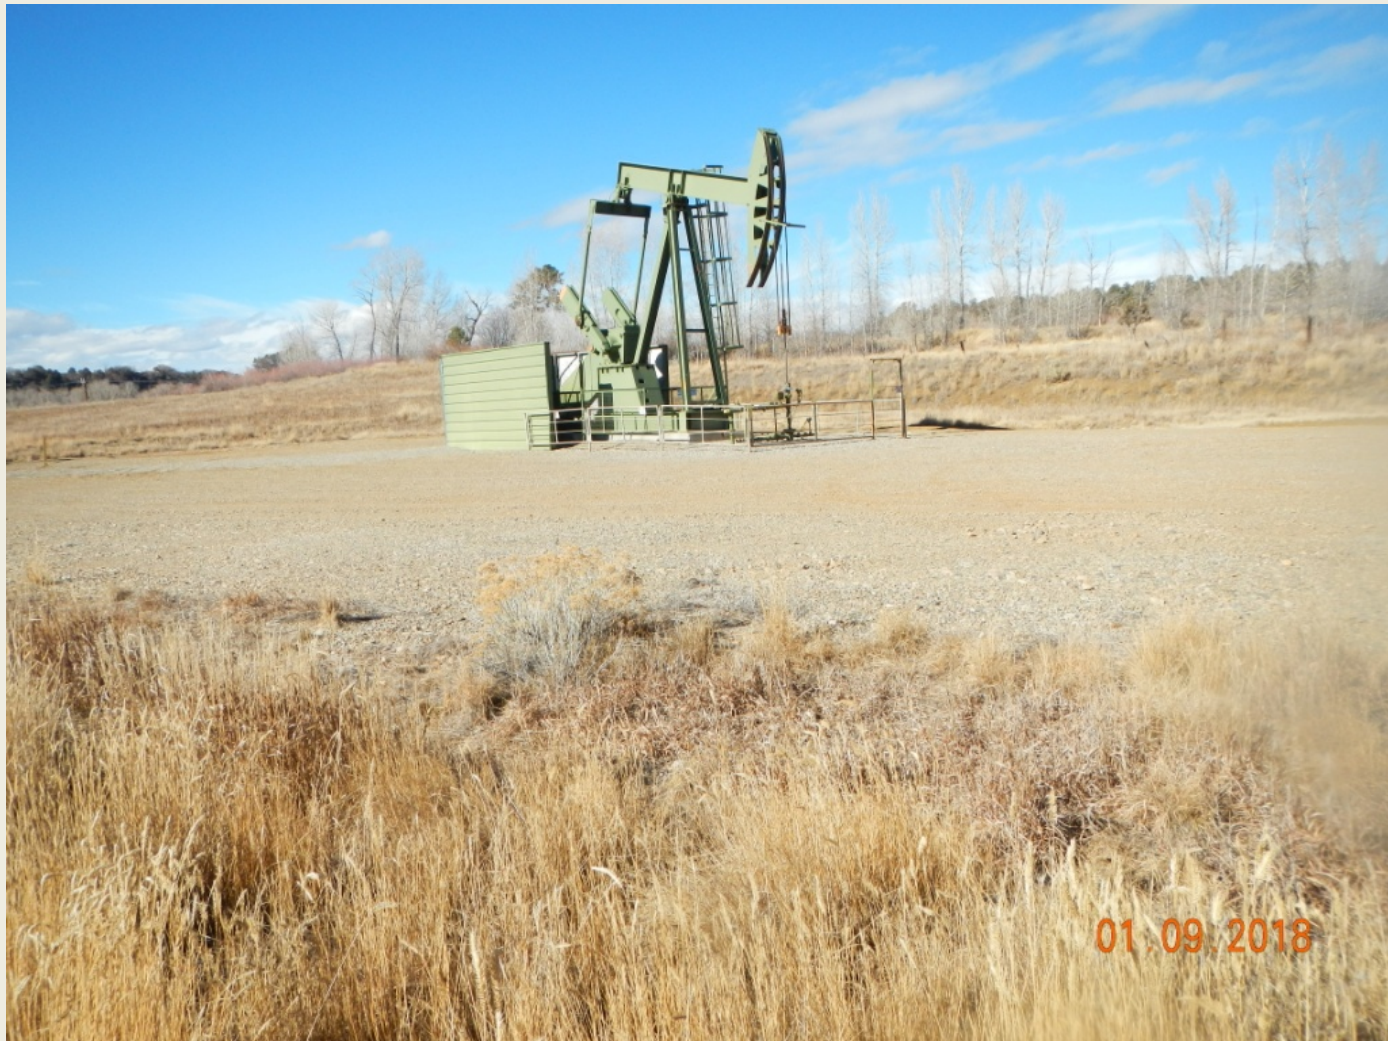
Photo 1. View of project area from the southeastern corner facing center.

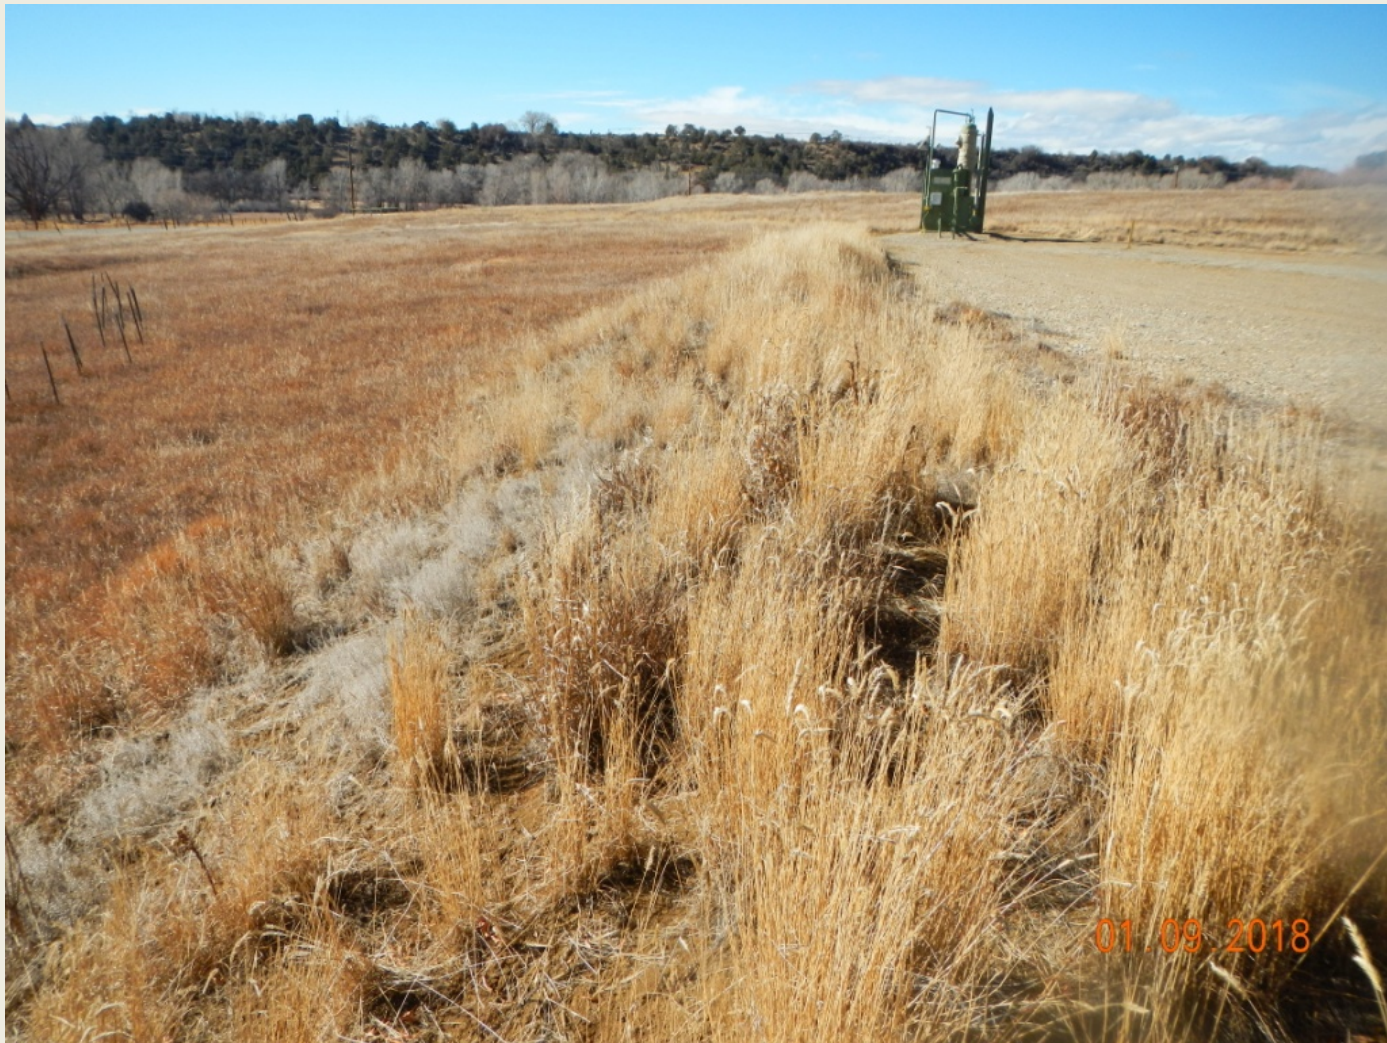
Photo 2. View of the southern portion of the project area from the southeastern corner facing westward. Revegetation is progressing with grasses such as crested wheatgrass (*Agropyron cristatum*) and smooth brome (*Bromus inermis*).

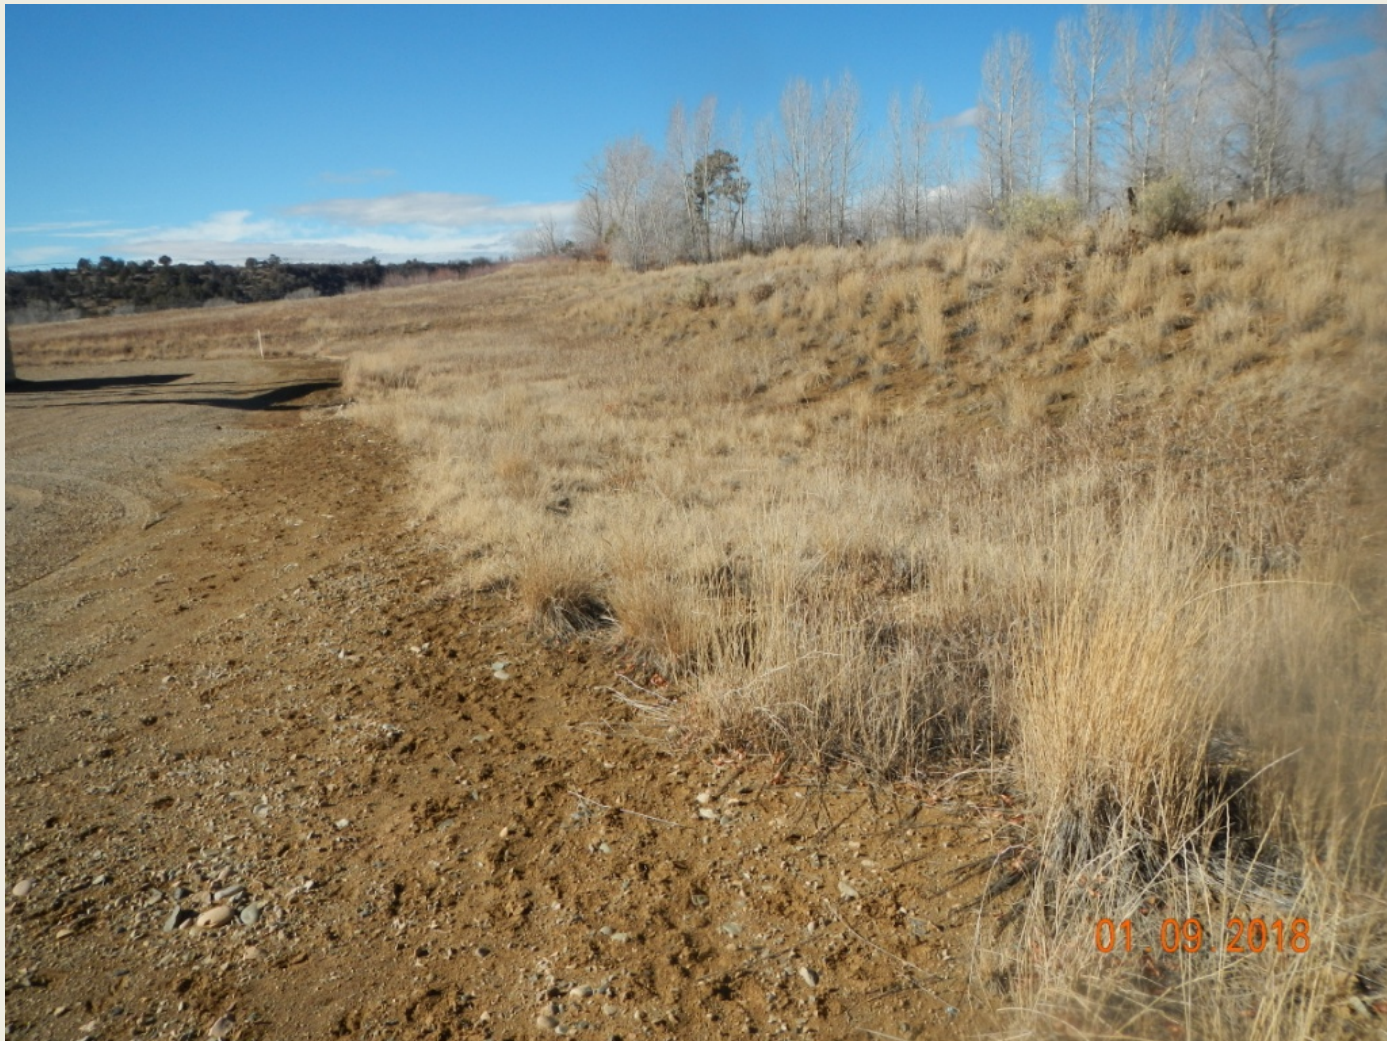
Photo 3. View of the northern portion of the project area from the northeastern corner facing westward.
