Inspection Photos

API: 05-067-07554

Operator: XTO ENERGY INC

Inspection Number: 680602446

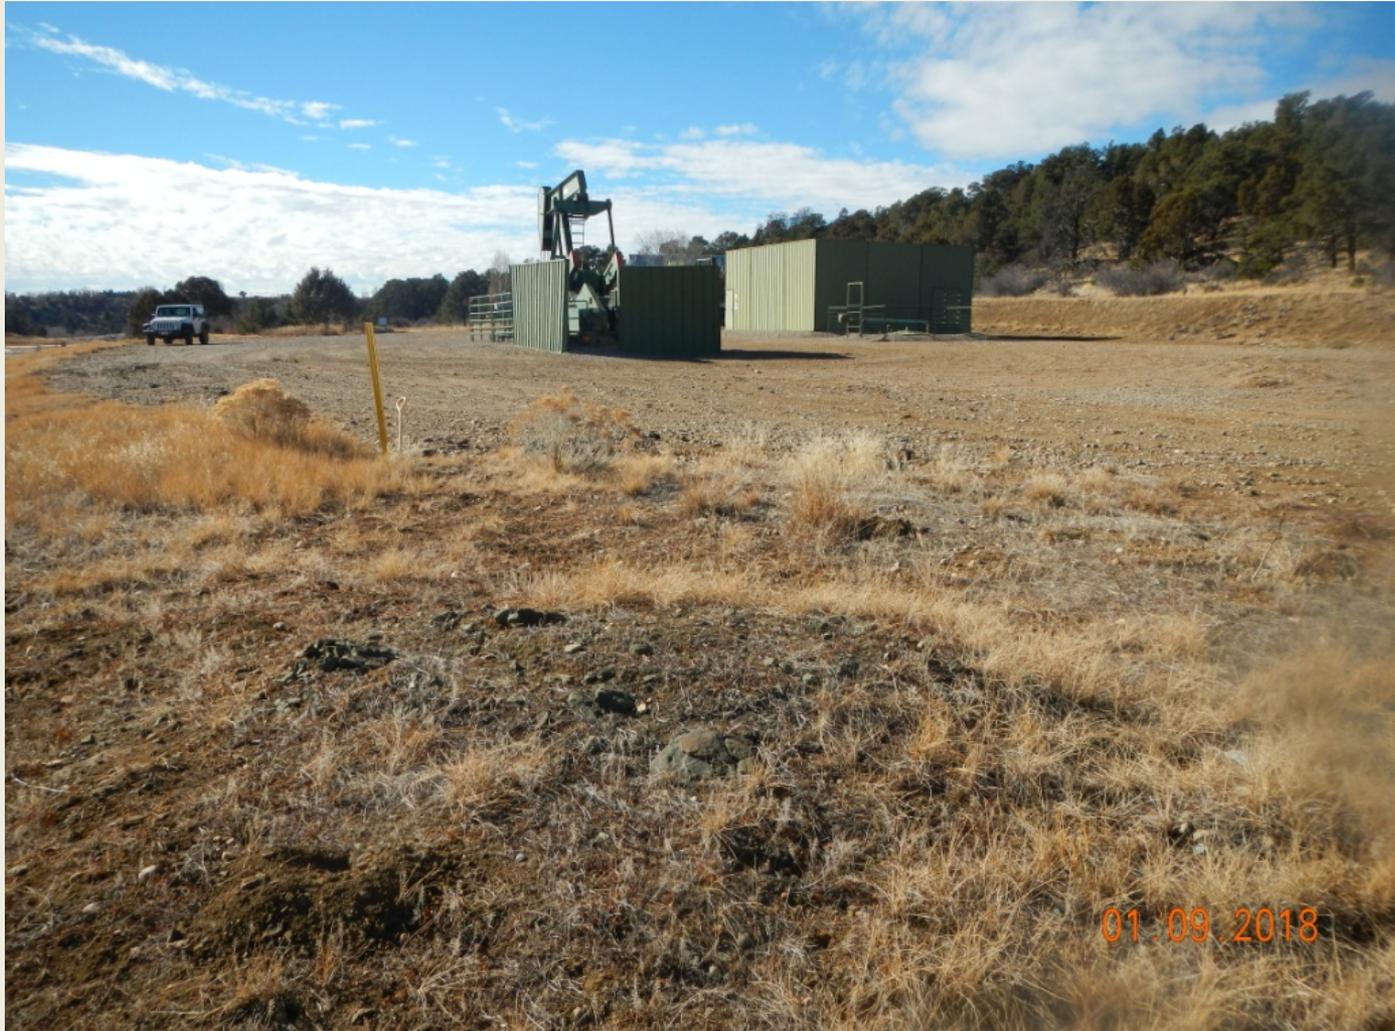
Photo 1. View of project area from the eastern corner facing center.

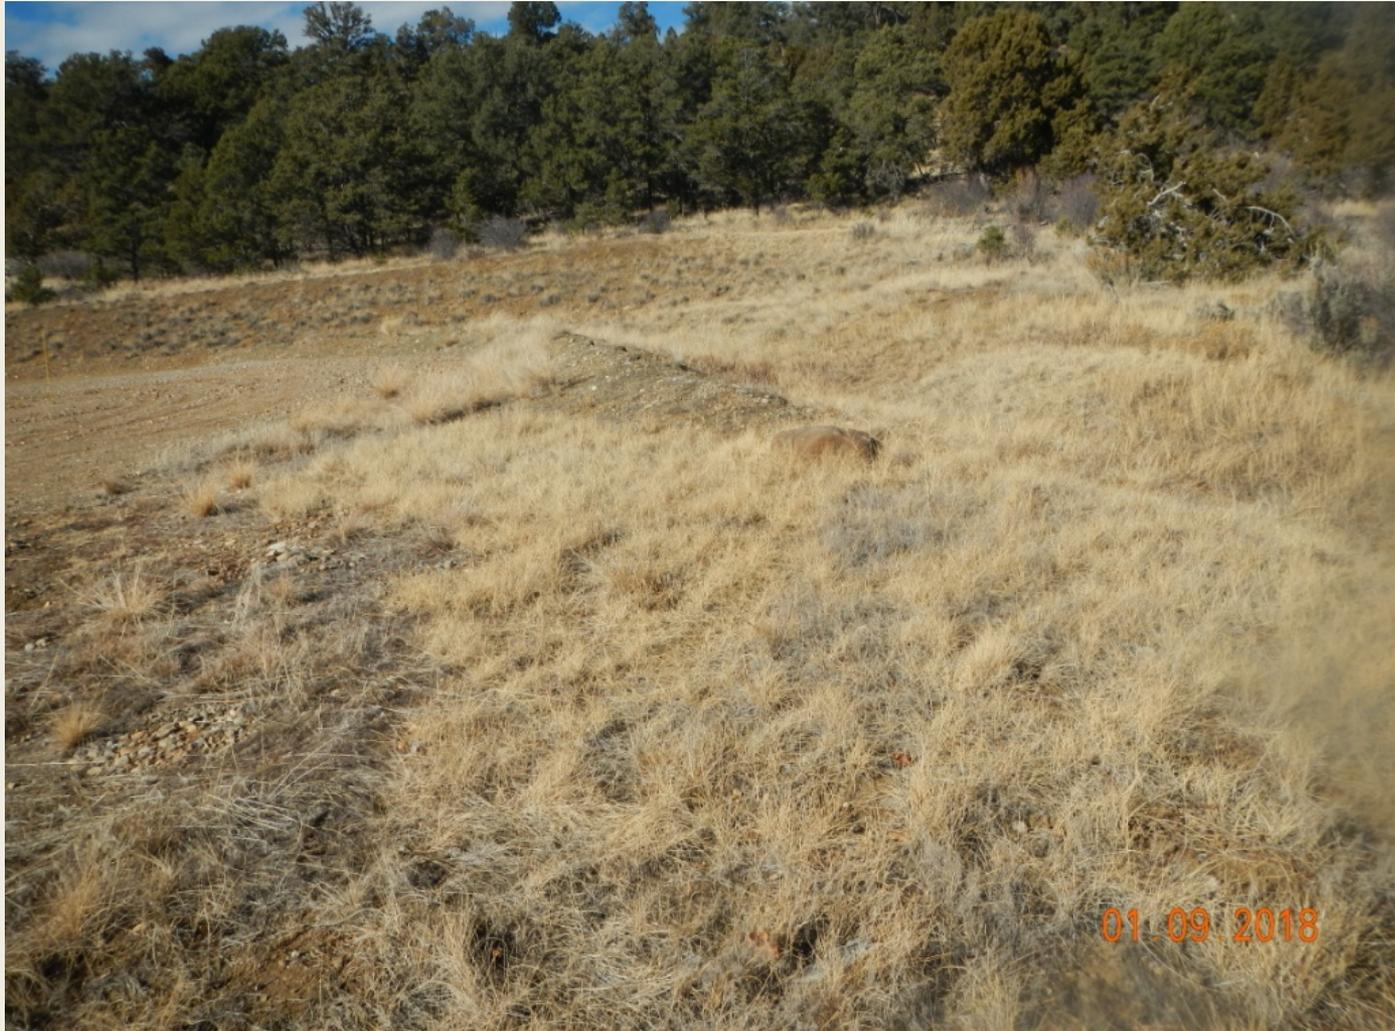
Photo 2. View of the eastern portion of the project area from the eastern corner facing northward.

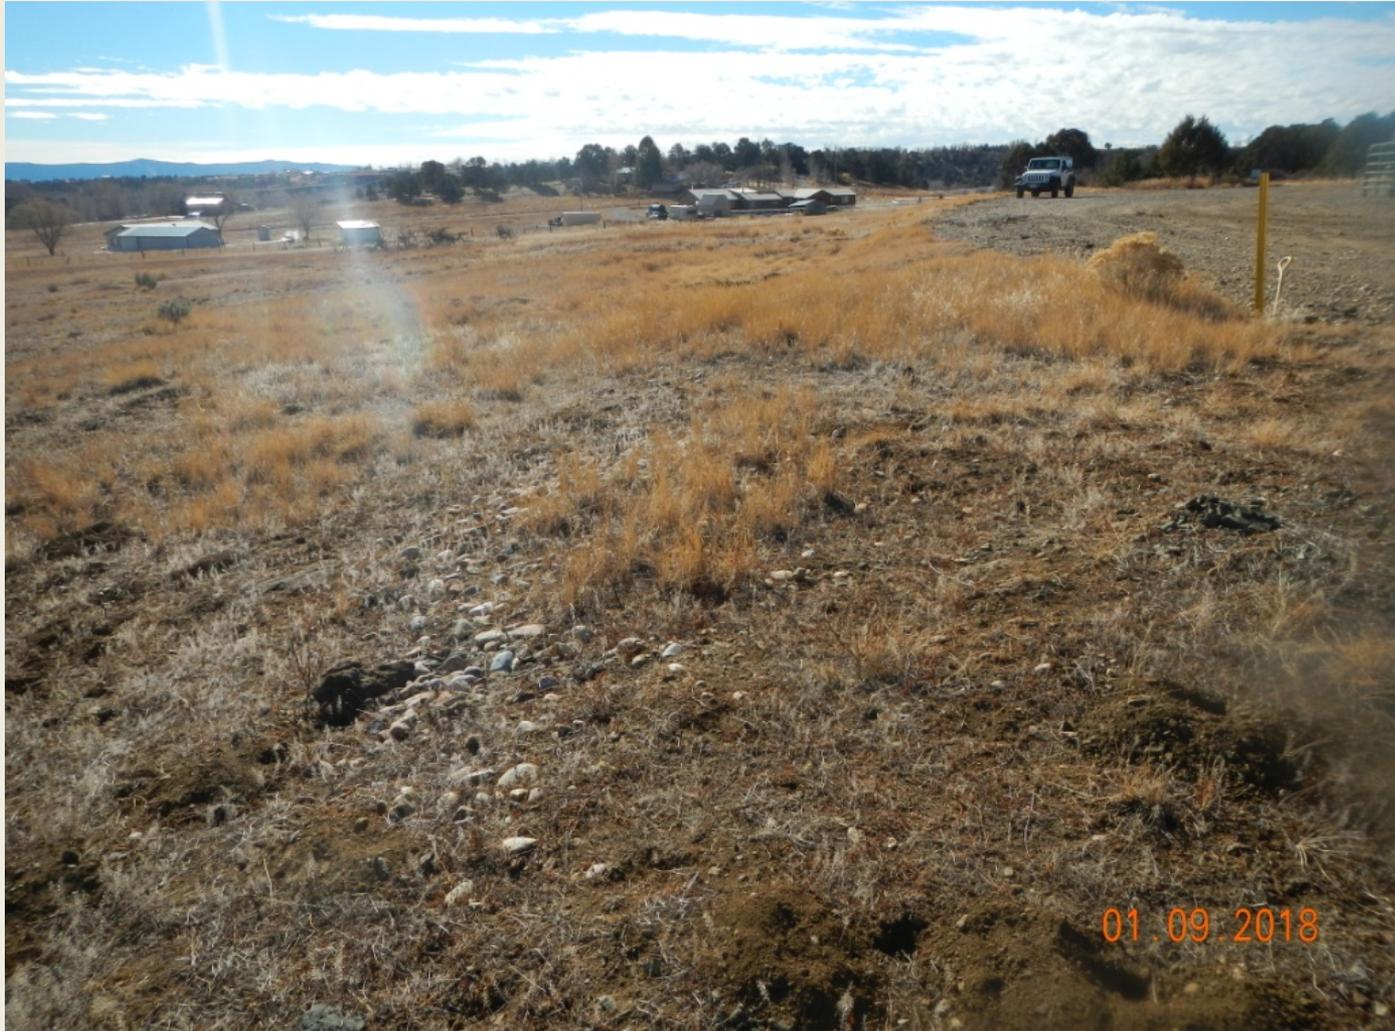
Photo 3. View of the southern portion of the project area from the eastern corner facing southwestward. Revegetation is sparse in areas but progressing with grasses such as western wheatgrass (*Pascopyrum smithii*) and smooth brome (*Bromus inermis*).

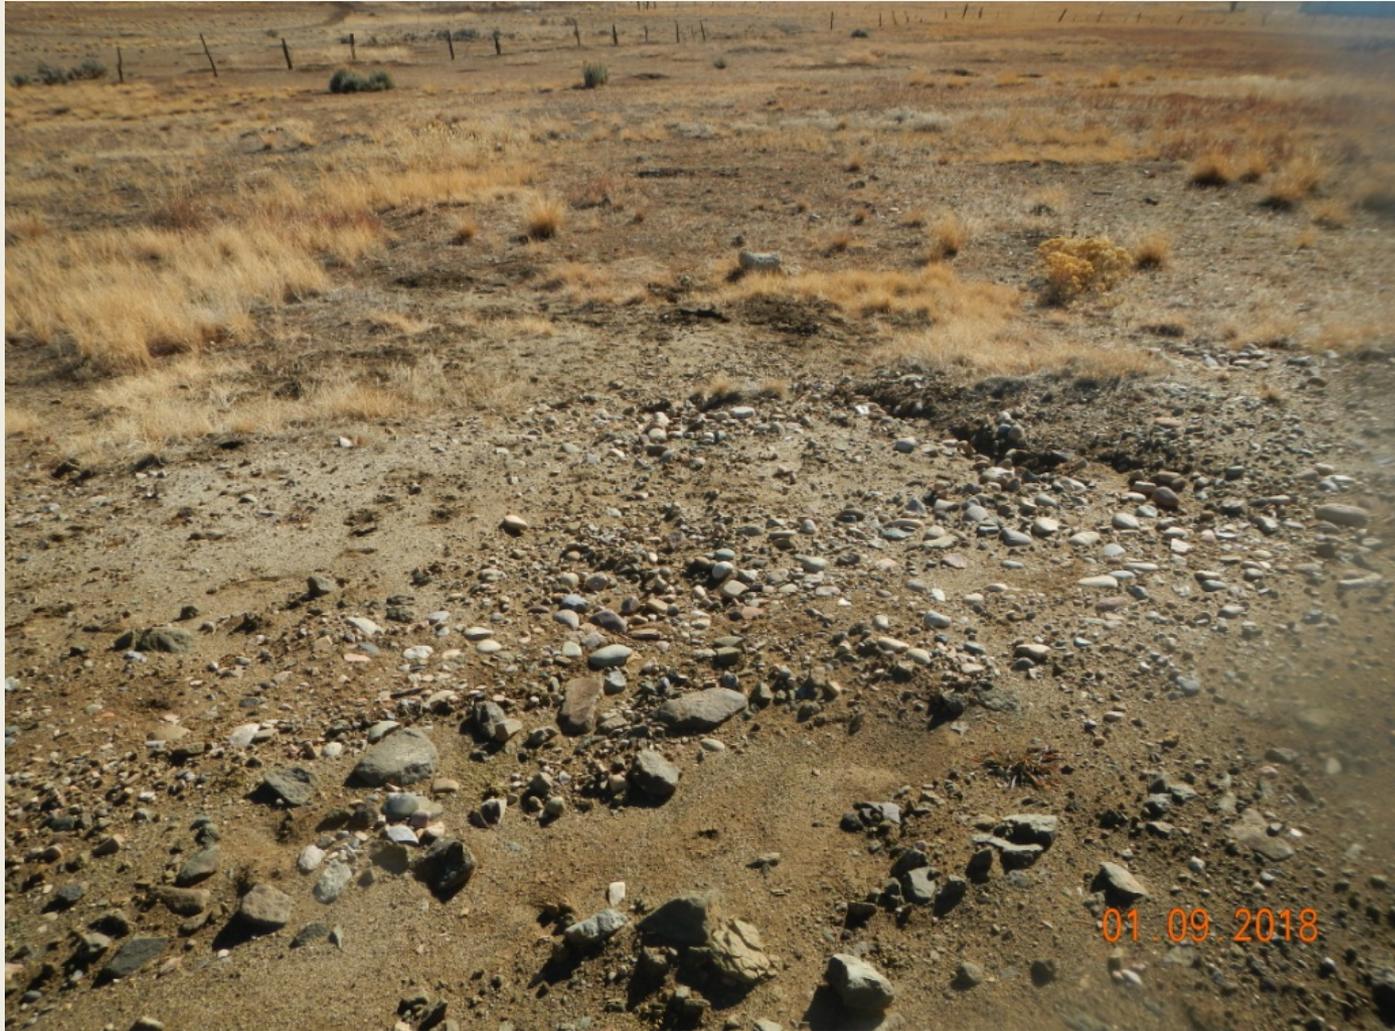
Photo 4. View of scouring and erosion occurring within the southern portion of the project area.

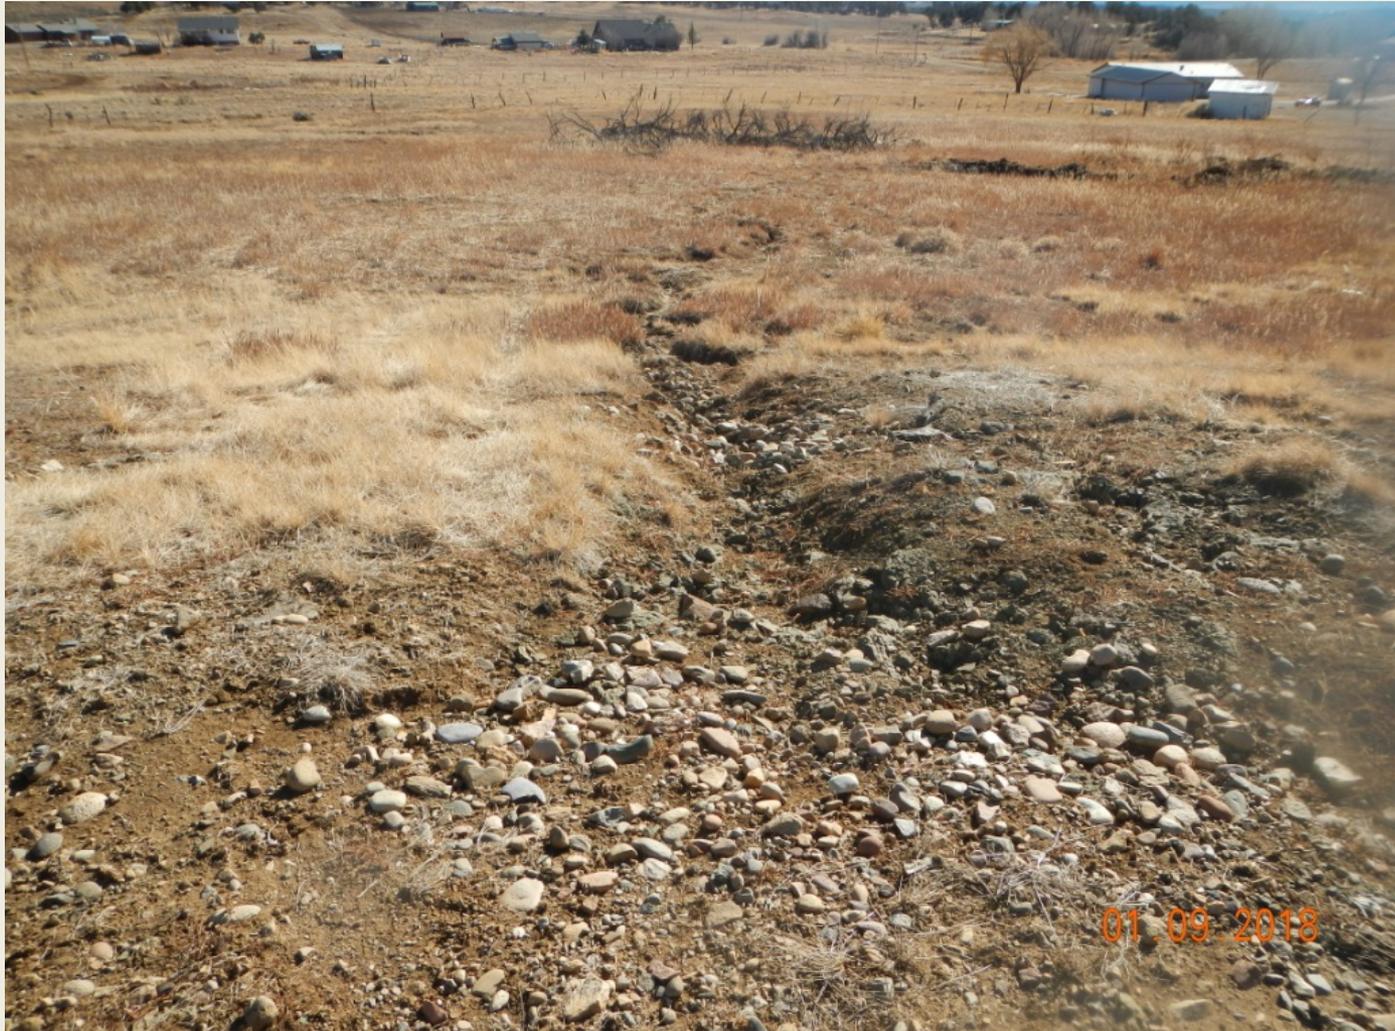
Photo 5. View of erosional channels in the southern portion of the project area.

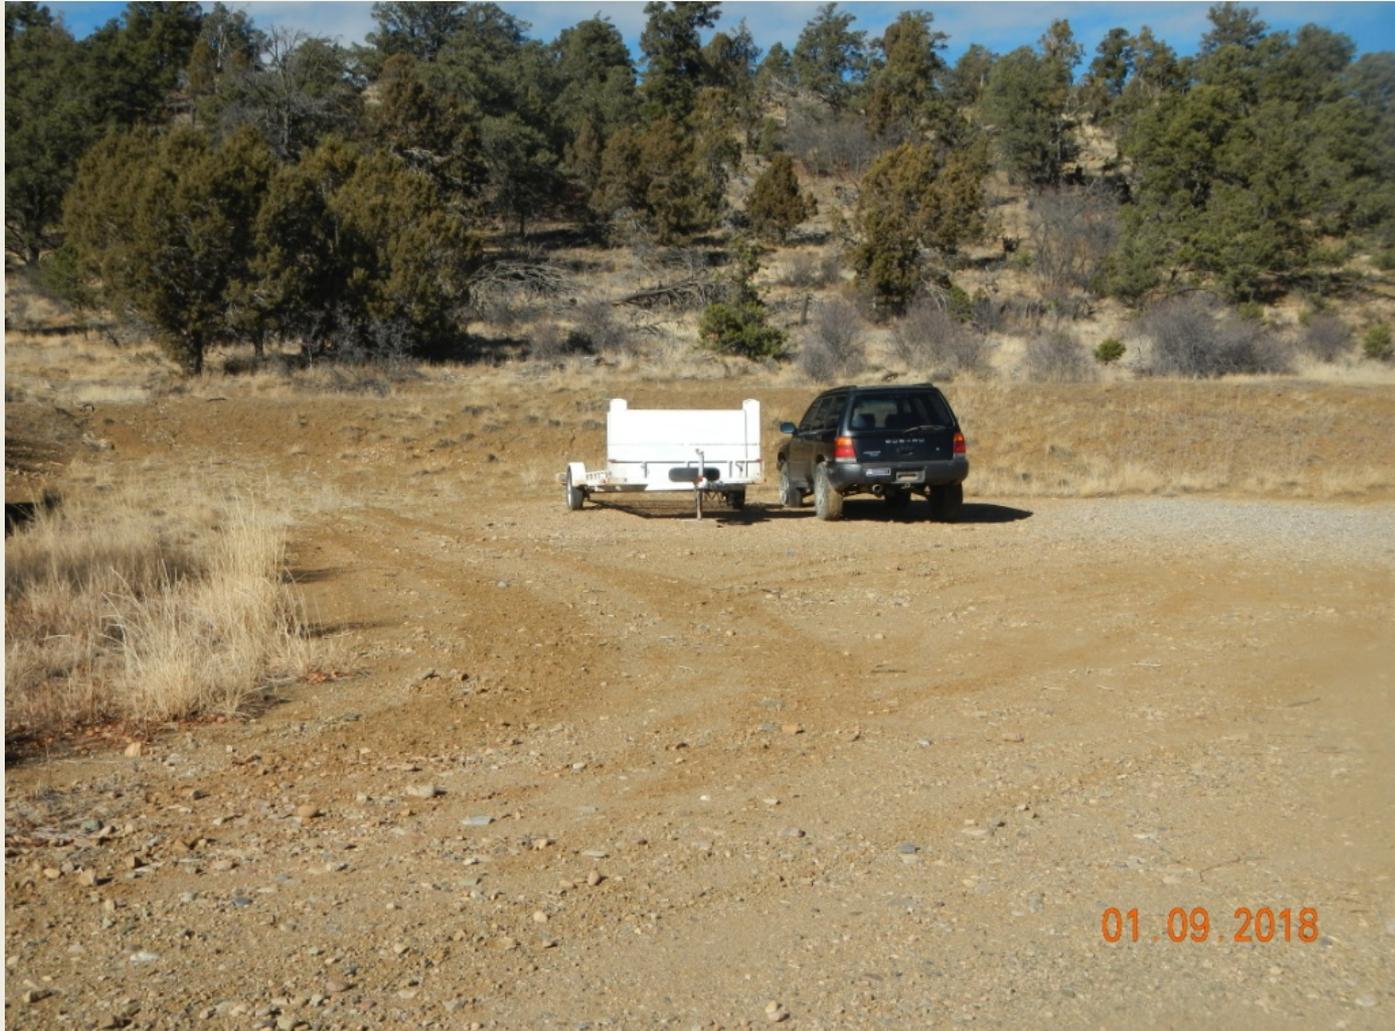
Photo 6. View of what appears to be surface owner vehicle and trailer in the western portion of the project area.
