Interim Reclamation and Stormwater Inspection

January 9, 2018

Operator: NOBLE ENERGY INC- #100322

Location ID: 433936

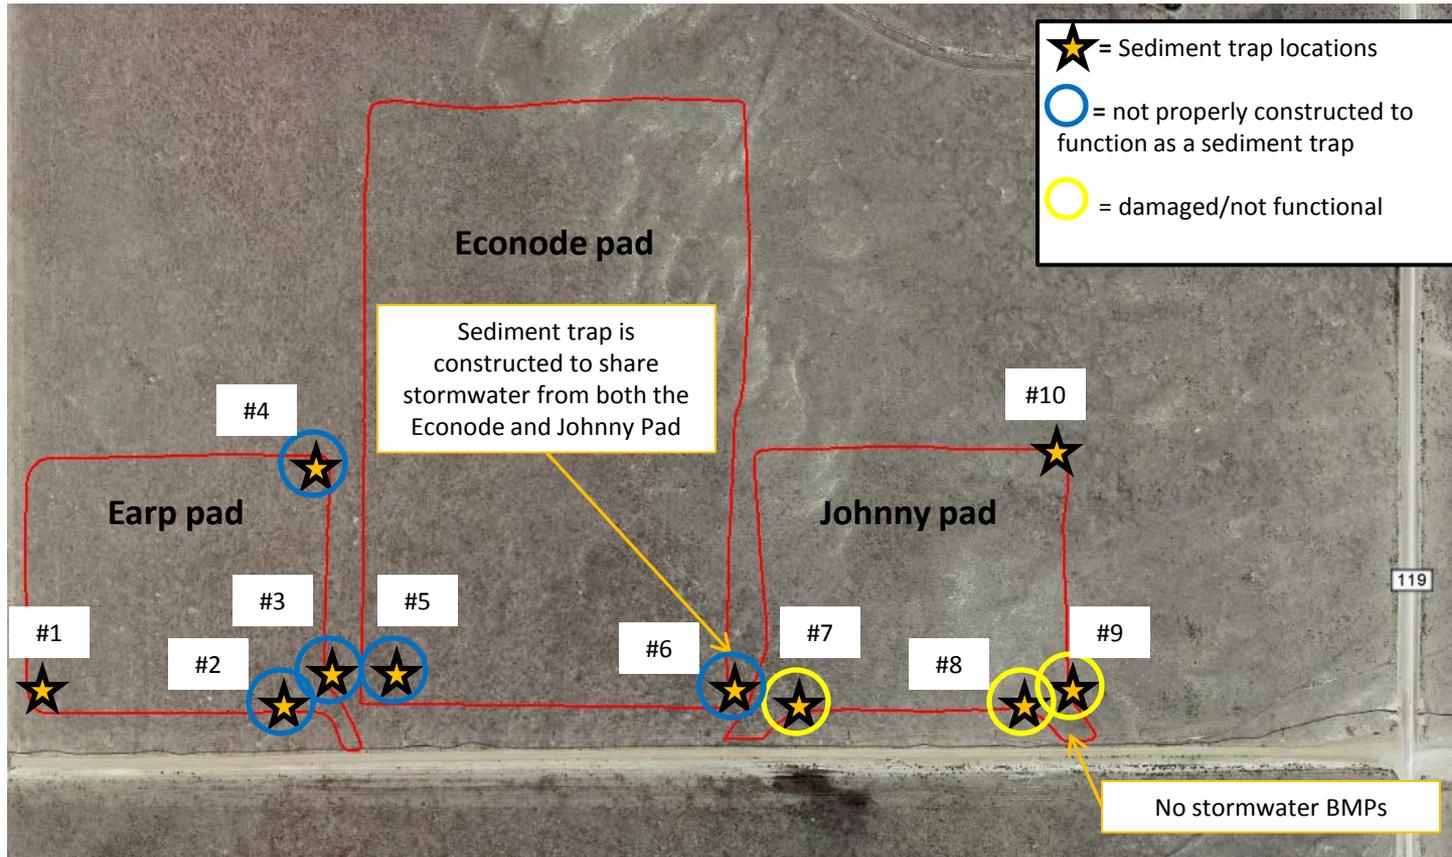
Overview of Location ID 433936 and the associated well pads. In total, 'sediment traps' #2-#6 on the Earp and Econode pad were not properly constructed to function as a sediment trap. Sediment traps #7-#9 on the Johnny pad were damaged and not functional. Sediment traps #1 & #10 did not have a stabilized outlet. Stormwater BMPs were not maintained or in some cases did not exist during interim reclamation activities. Sediment traps were not properly constructed per Noble's own Stormwater BMP Manual or in accordance with good engineering practices.

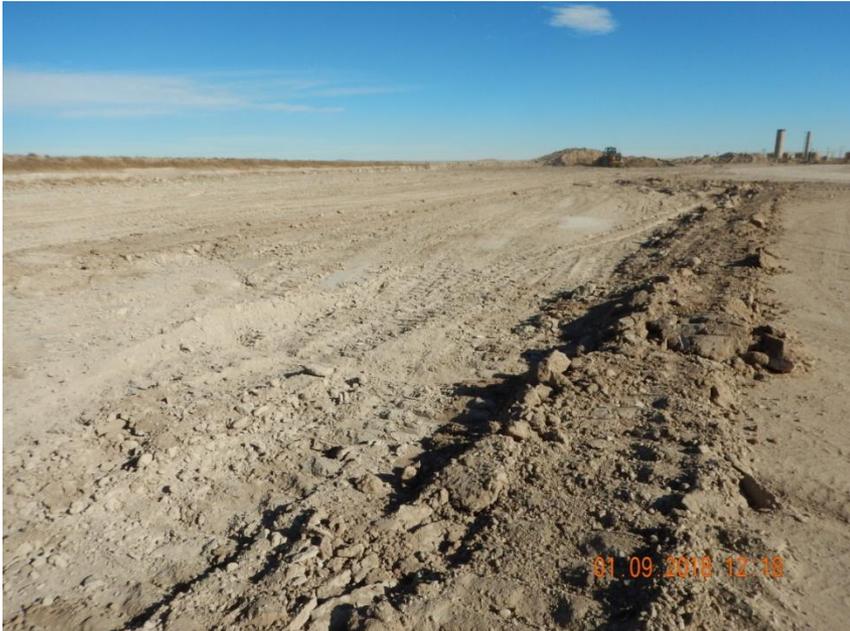
Photo 1. Photo taken from the northwest Earp Pad, facing East. Operator in-process of performing interim reclamation activities. Stormwater BMPs were not maintained or in some cases did not exist during interim reclamation activities.

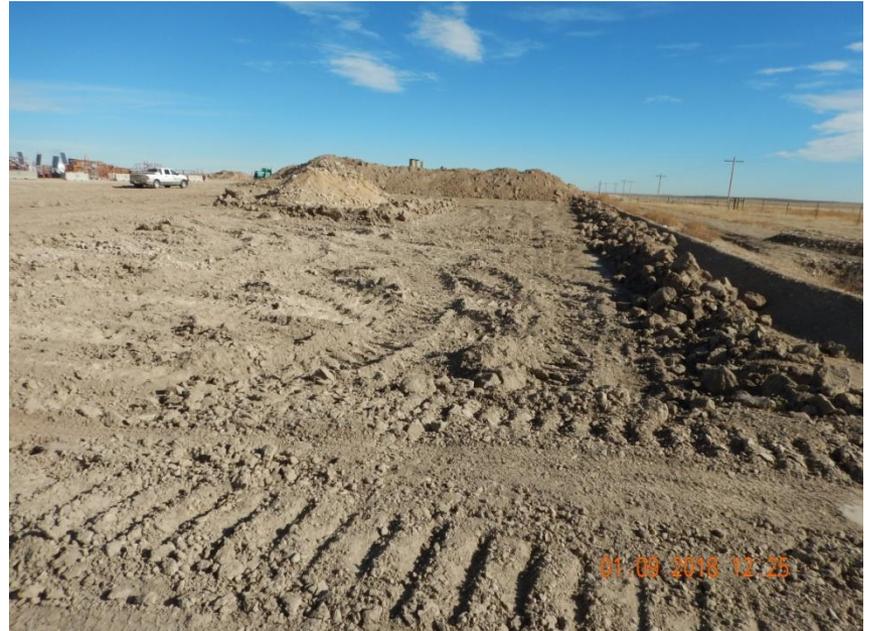
Photo 2. Photo taken from the southwest Earp Pad, facing East. See comments under Photo 1.

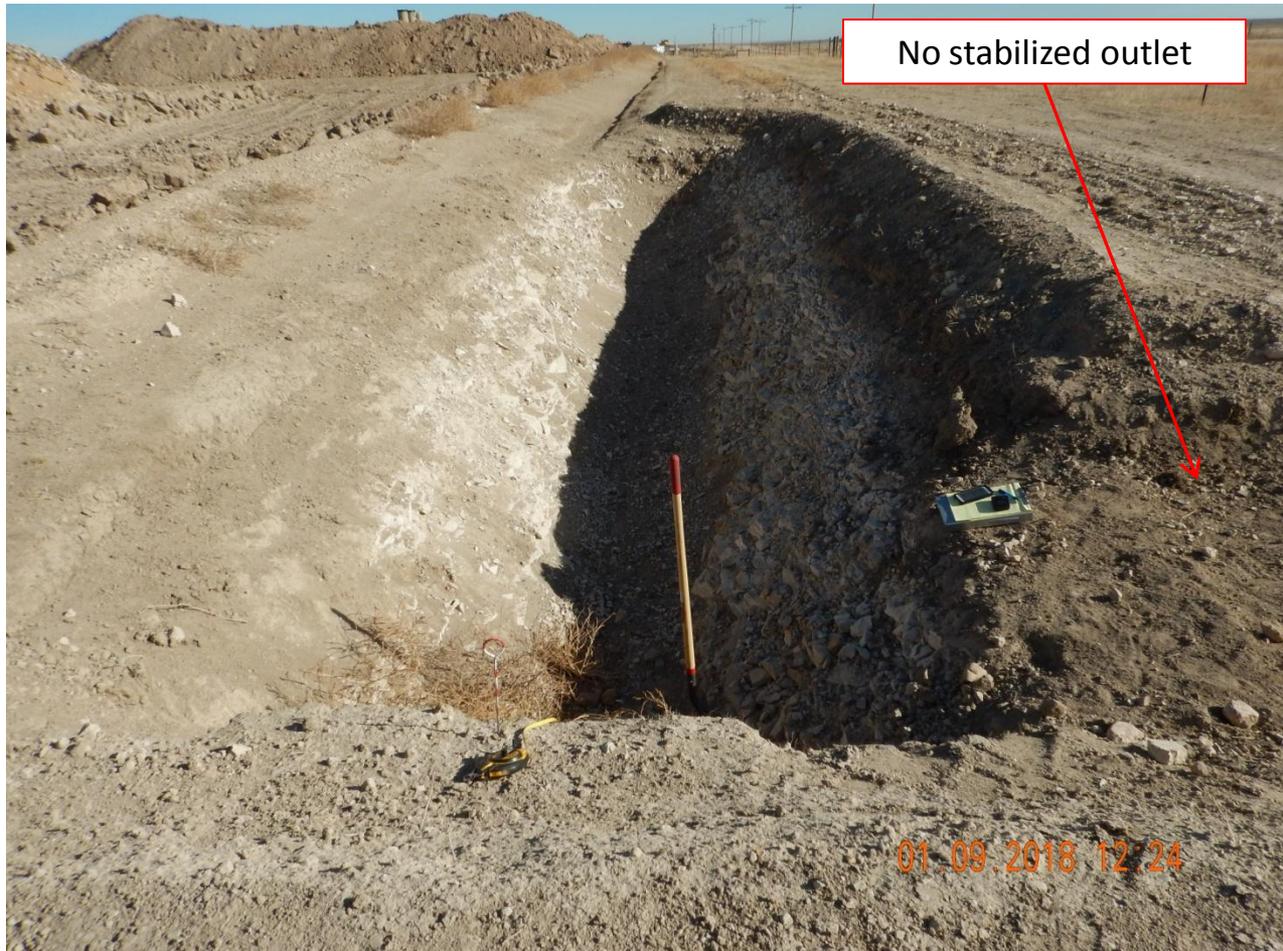
Photo 3. Photo taken from sediment trap #1, facing East. Operator has installed the above sediment trap since the previous inspection. Rock material from the sediment trap has been removed; therefore, the sediment trap has no stabilized outlet. Interim reclamation activities were occurring during the time of the inspection but stormwater BMPs were not maintained. Also, this does not appear to be built to Noble's own Stormwater BMP Manual (i.e., side slopes not 2:1) or in accordance with good engineering practices.

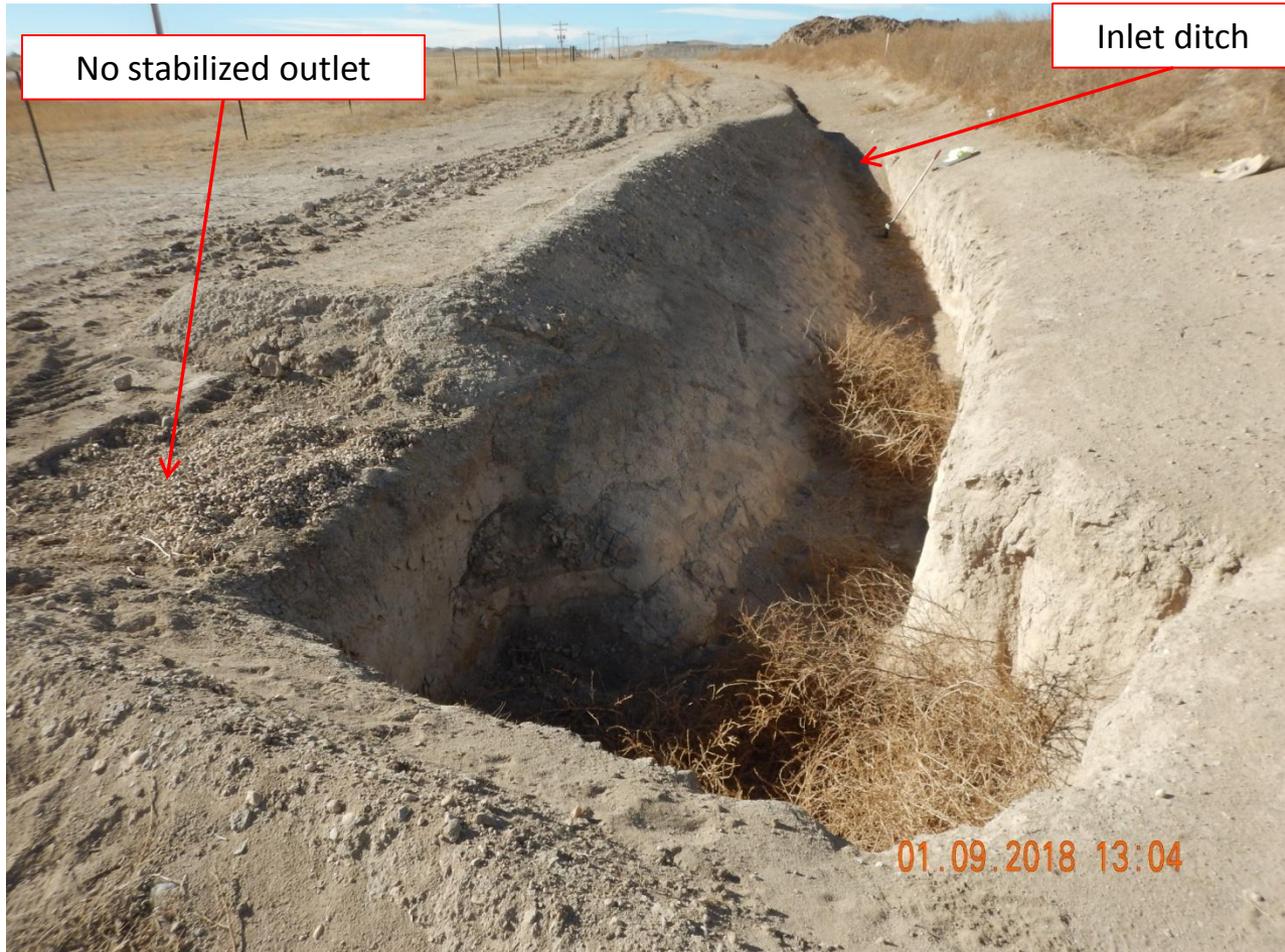
Photo 4. Photo taken from 'sediment trap' #2, facing West. Operator has enlarged the above 'sediment trap' since the previous inspection; however, it is not constructed properly. The outlet area appears to be higher than the inlet ditch and the outlet rock material has been removed. Based on the above description, this would not be considered a constructed sediment trap. This would be considered an enlarged ditch with no stabilized outlet. Photo also indicates unmanaged weed debris on location.

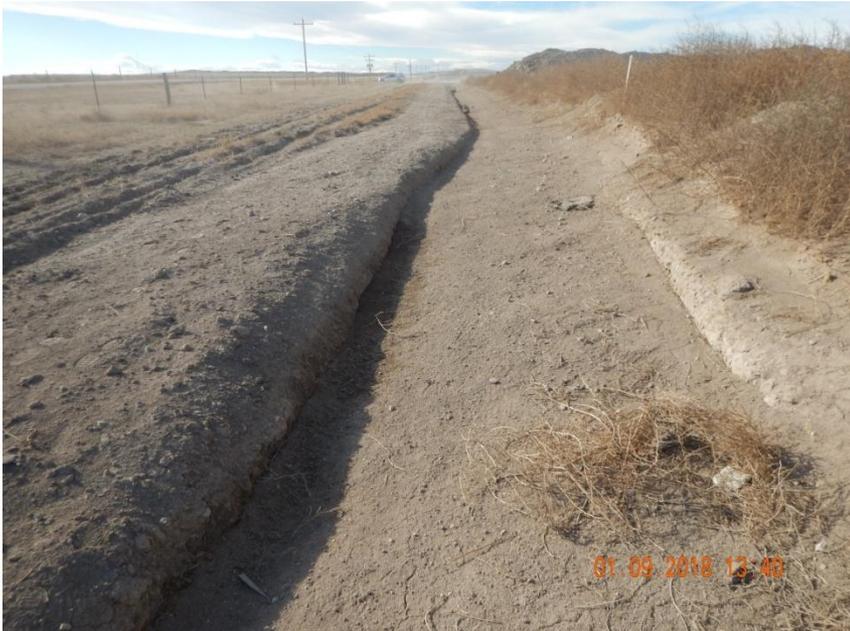
Photo 5. Photo taken from the southeast perimeter of the Earp Pad, facing West. Ditch BMP appears to be filled from wind erosion sediment deposition. Ditch BMP has not been properly installed and does not appear to be installed to Noble's own Stormwater BMP Manual (i.e., not parabolic ditch). Photo also indicates unmanaged weed debris on location.

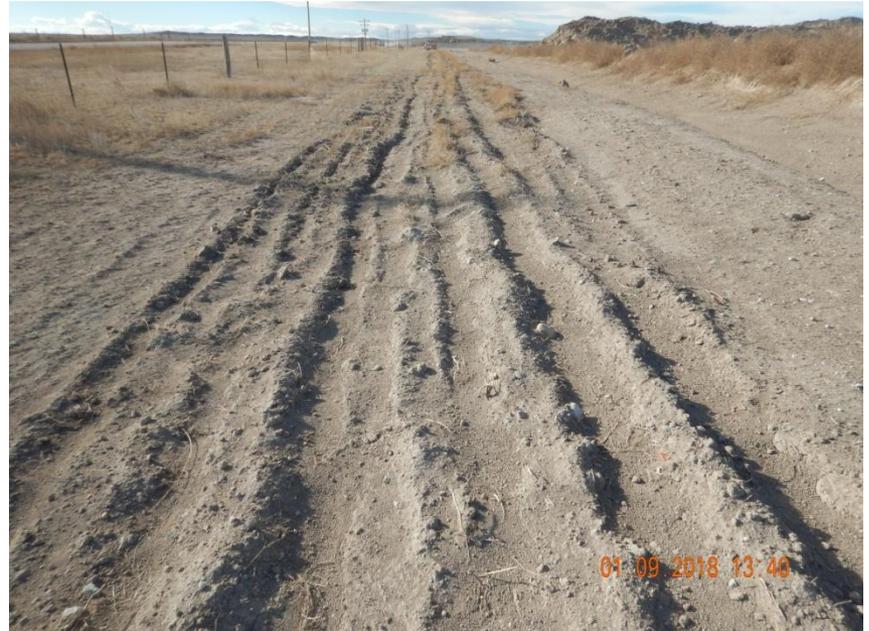
Photo 6. Photo taken from the southeast perimeter of the Earp Pad, facing West. Surface roughening BMP in need of maintenance, as it appears to be filled from wind erosion sediment deposition. Photo also indicates unmanaged weed debris on location.

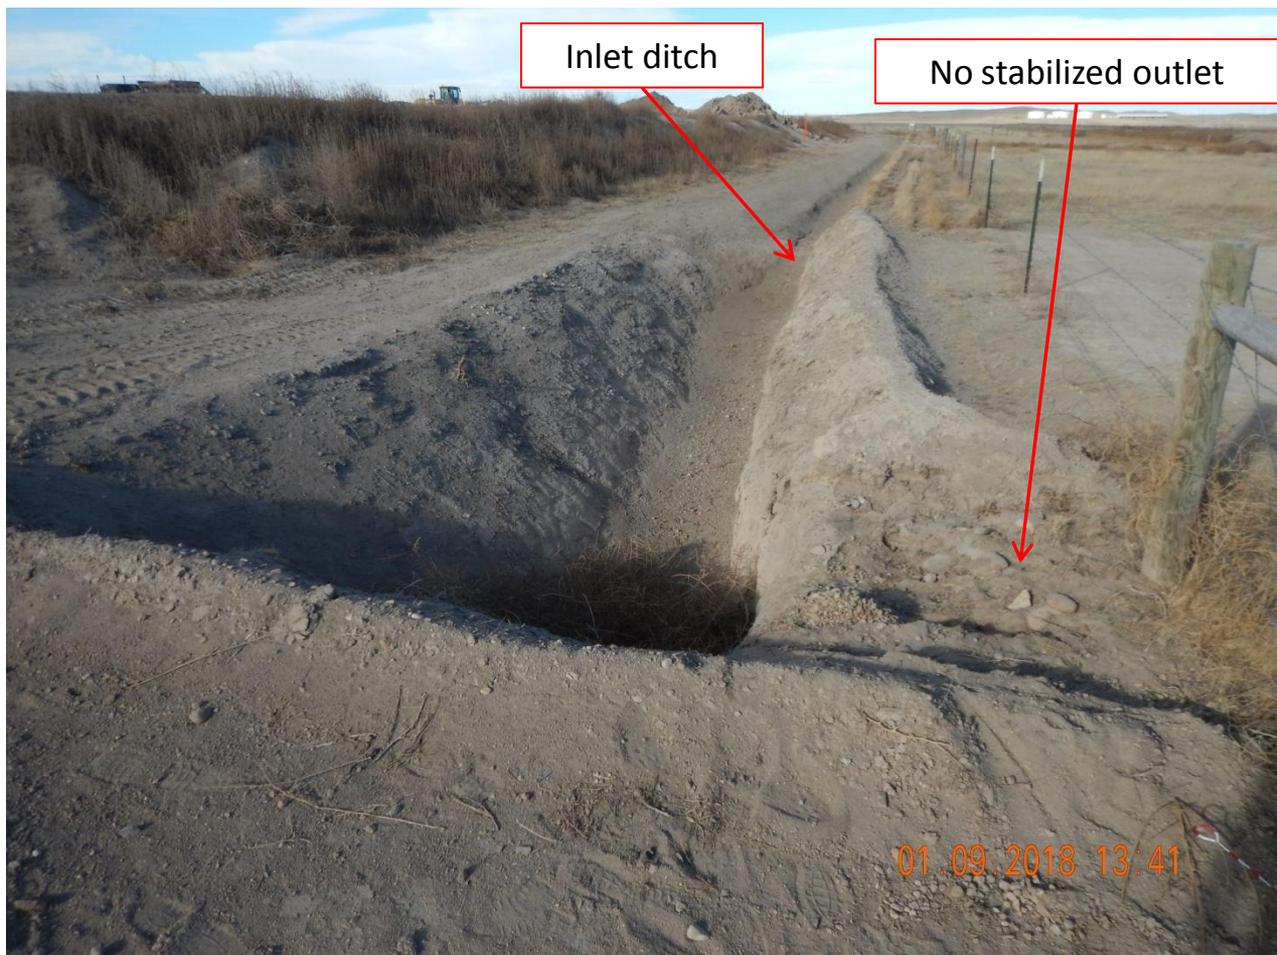
Photo 7. Photo taken from 'sediment trap' #3, facing North. See comments under Photo 4- all comments apply to this 'sediment trap' and weed debris.

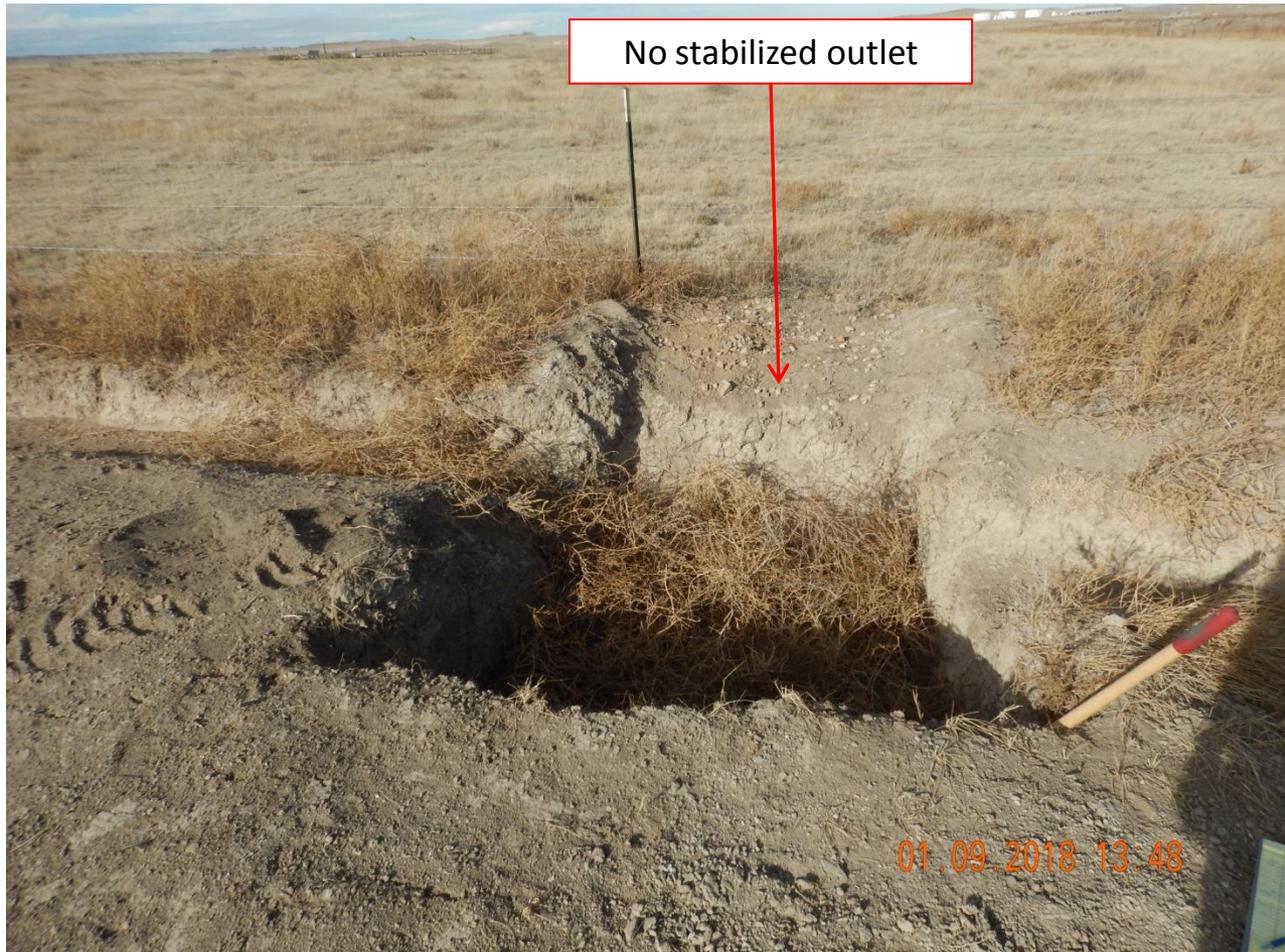
Photo 8. Photo taken from 'sediment trap' #4, facing North. See comments under Photo 4- all comments apply to this 'sediment trap' and weed debris. See photos 9 & 10 to further illustrate how the sediment trap has not been constructed properly.

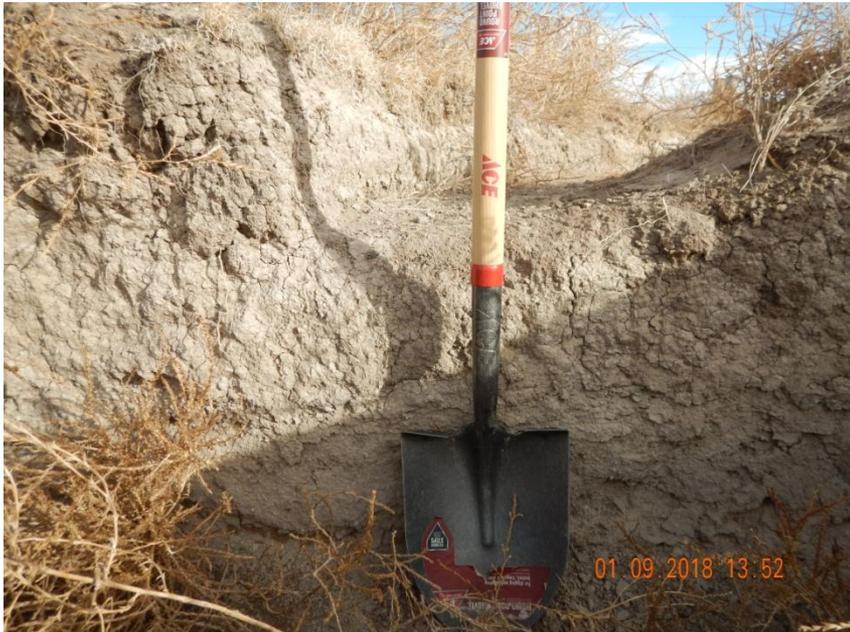
Photo 9. Photo taken from the ditch inlet area of 'sediment trap' #4, facing East. Inlet ditch is approximately 2' in height. Shovel is at the bottom of the 'sediment trap' area which was used to measure the height of the inlet.

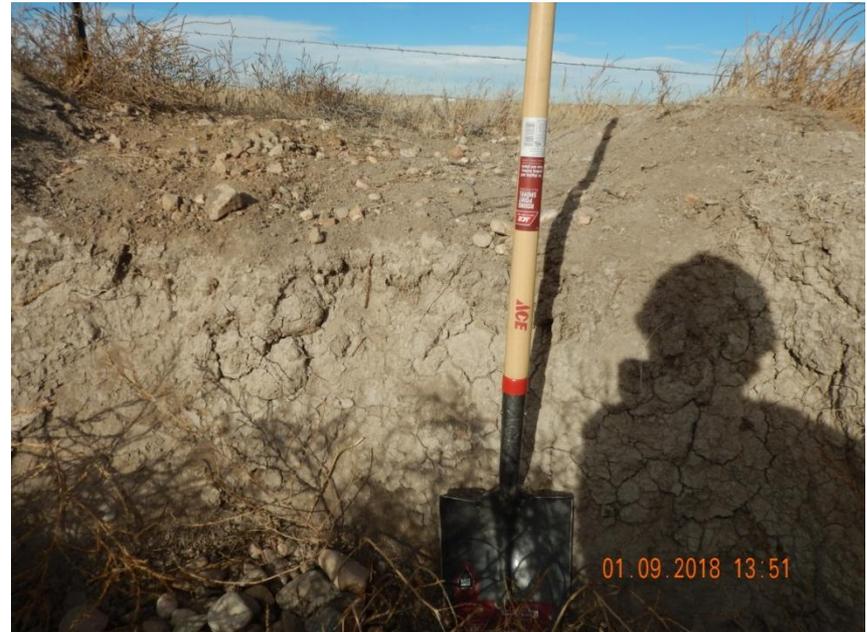
Photo 10. Photo taken from the outlet area of 'sediment trap' #4, facing North. Outlet is approximately 3' in height which is higher than the inlet ditch; therefore, this would not function as a sediment trap. Shovel is at the bottom of the 'sediment trap' area which was used to measure the height of the outlet.

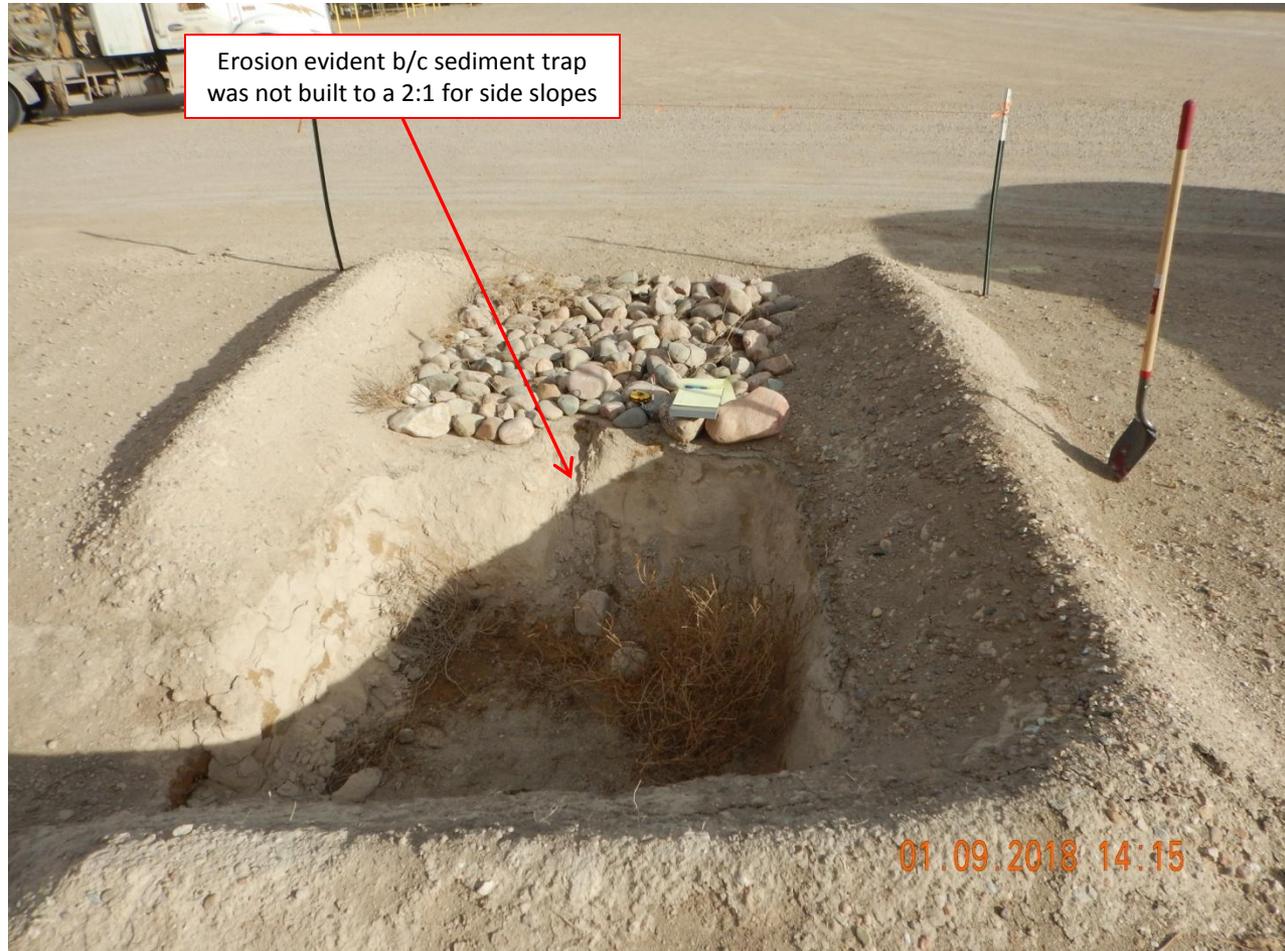
Photo 11. Photo taken from 'sediment trap' #5, facing East. See comments under Photo 4- all comments apply to this 'sediment trap'. Outlet material per good engineering practices should be a combination of coarse aggregate and angular rip rap. The above outlet has not been constructed in accordance with good engineering practices. If it was to discharge from the outlet, it would discharge back onto location which could cause other stormwater issues, for example ponding and vehicle tracking. See photos 12 & 13 to further illustrate how the 'sediment trap' has not been constructed properly.

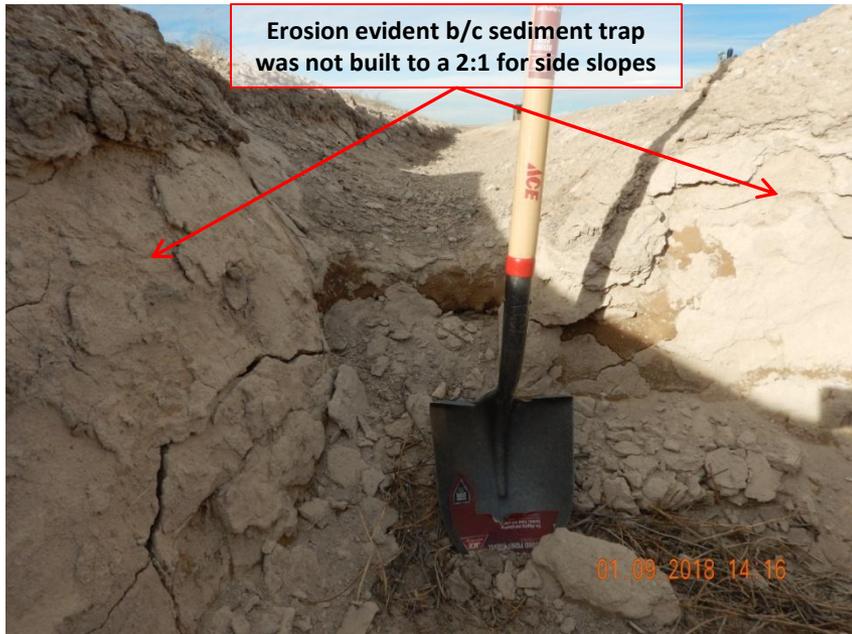
Photo 12. Photo taken from the ditch inlet area of 'sediment trap' #5, facing East. Inlet ditch is approximately 1.5' in height. Shovel is at the bottom of the 'sediment trap' area which was used to measure the height of the inlet.

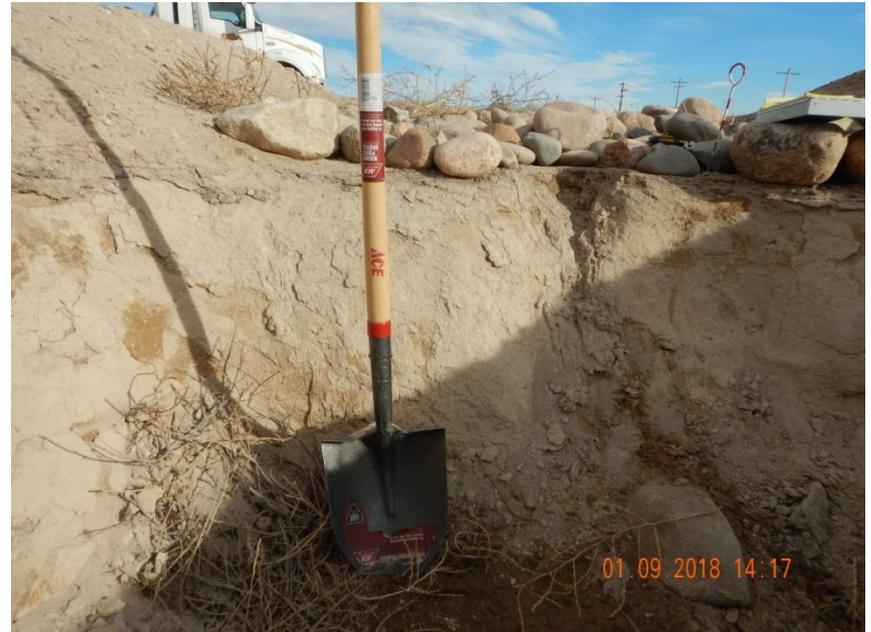
Photo 13. Photo taken from the outlet area of 'sediment trap' #5, facing North. The outlet is approximately 2.5' in height which is higher than the inlet ditch; therefore, this would not properly function as a sediment trap. Shovel is at the bottom of the 'sediment trap' area which was used to measure the height of the outlet.

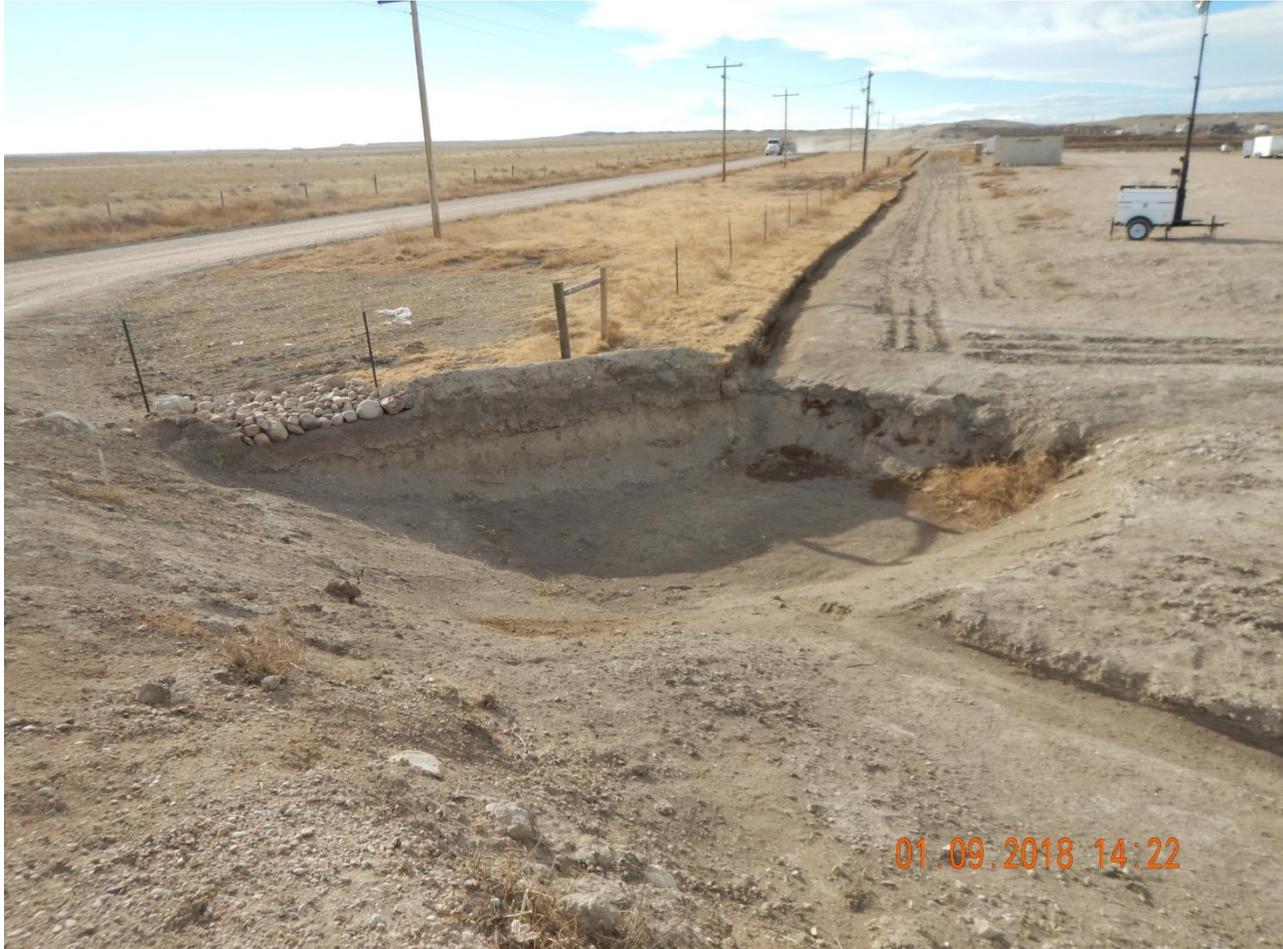
Photo 14. Photo taken from 'sediment trap' #6, facing West. See comments under Photo 4- all comments apply to this 'sediment trap'. See comments under Photo 11 for outlet material. The above outlet has not been constructed using good engineering practices. See photos 15 & 16 to further illustrate how the 'sediment trap' has not been constructed properly.

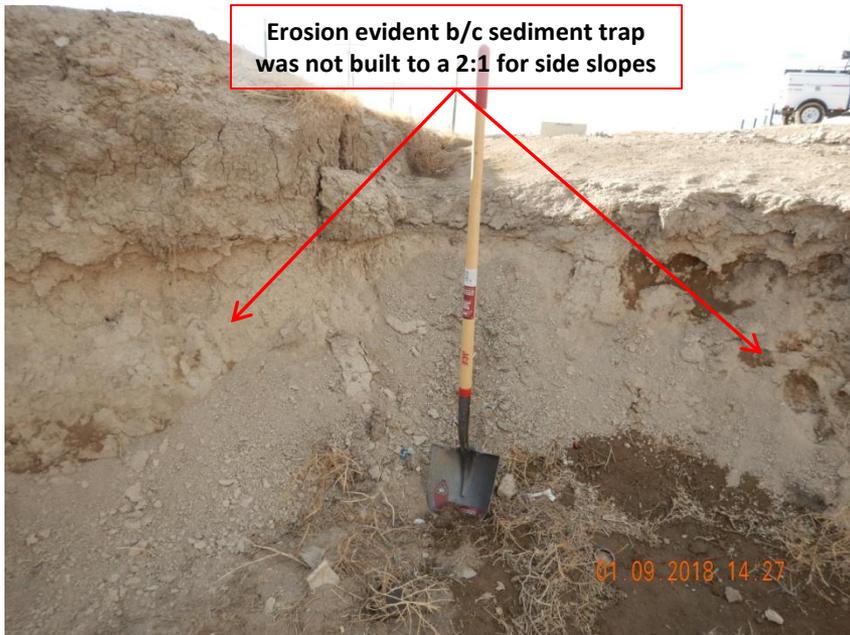
Photo 15. Photo taken from the ditch inlet area of 'sediment trap' #6, facing East. Inlet ditch is approximately 3.5' in height. Shovel is at the bottom of the 'sediment trap' area which was used to measure the height of the inlet.

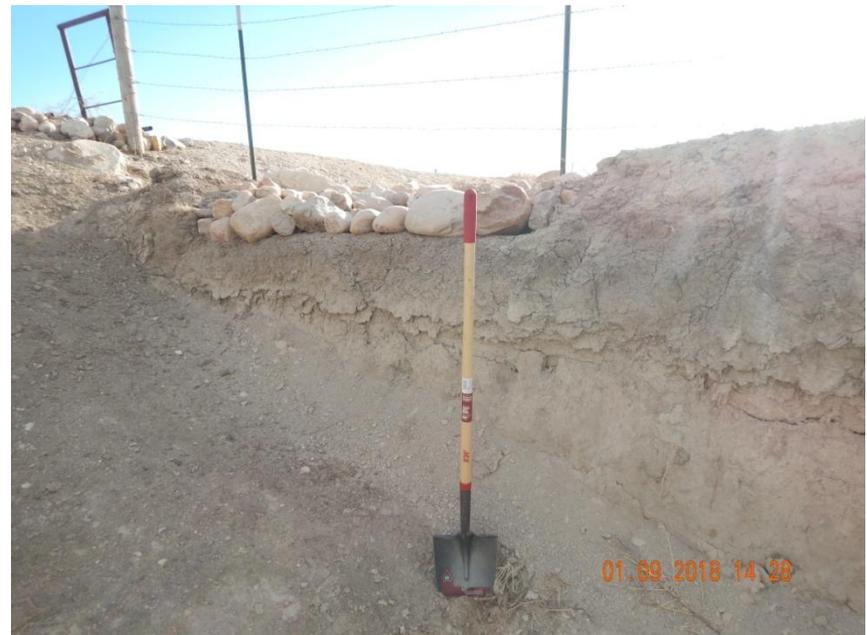
Photo 16. Photo taken from the outlet area of 'sediment trap' #6, facing South. The outlet is approximately 4.5' in height which is higher than the inlet ditch; therefore, this would not properly function as a sediment trap. Shovel is at the bottom of the 'sediment trap' area which was used to measure the height of the outlet.

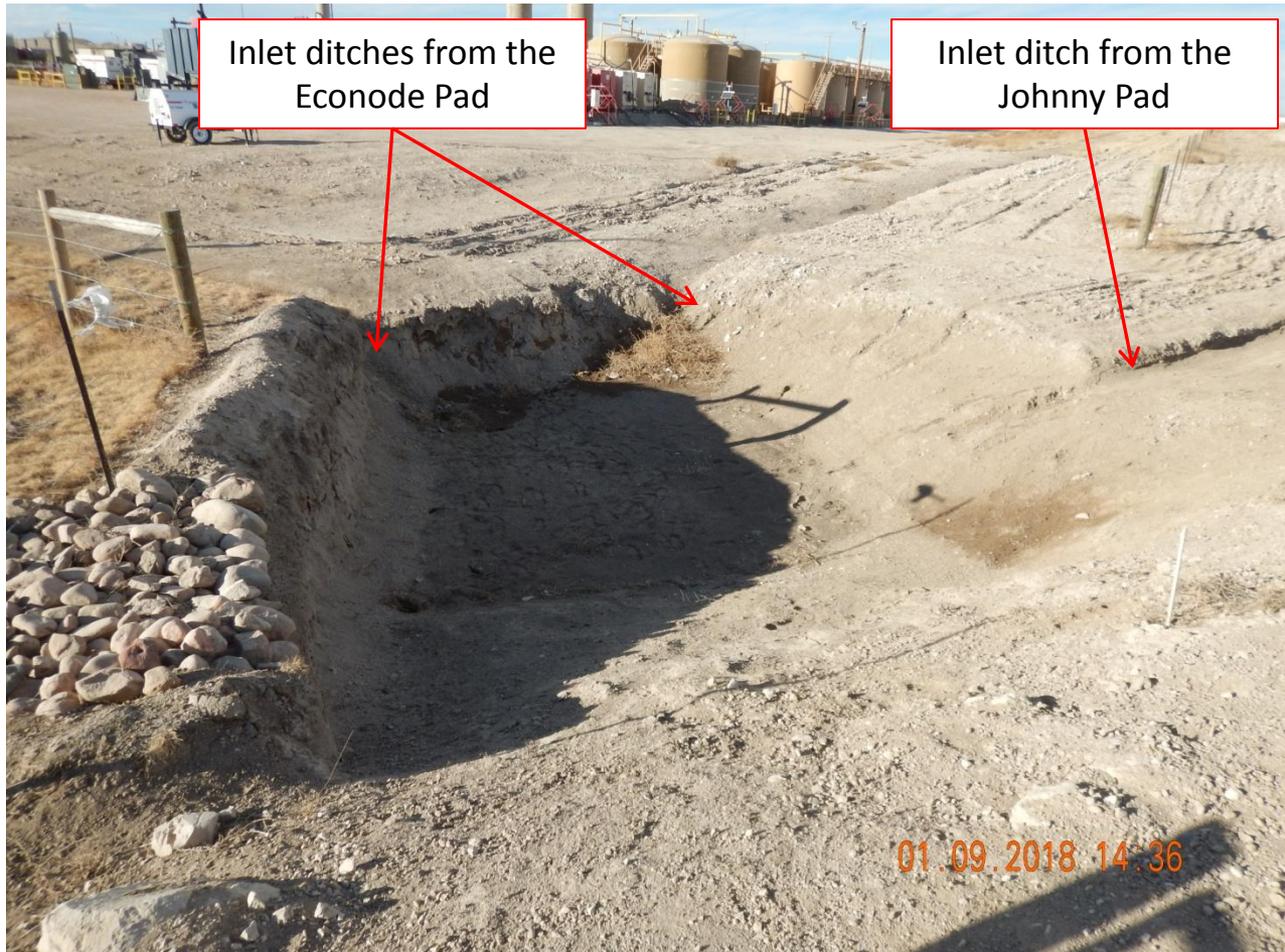
Photo 17. Photo taken from 'sediment trap' #6, facing North. Photo illustrates this 'sediment trap' is being shared with the adjacent Johnny Pad to the east. Ditch BMPs have not been properly installed and does not appear to be installed to Noble's own Stormwater BMP Manual (i.e., not parabolic ditch).

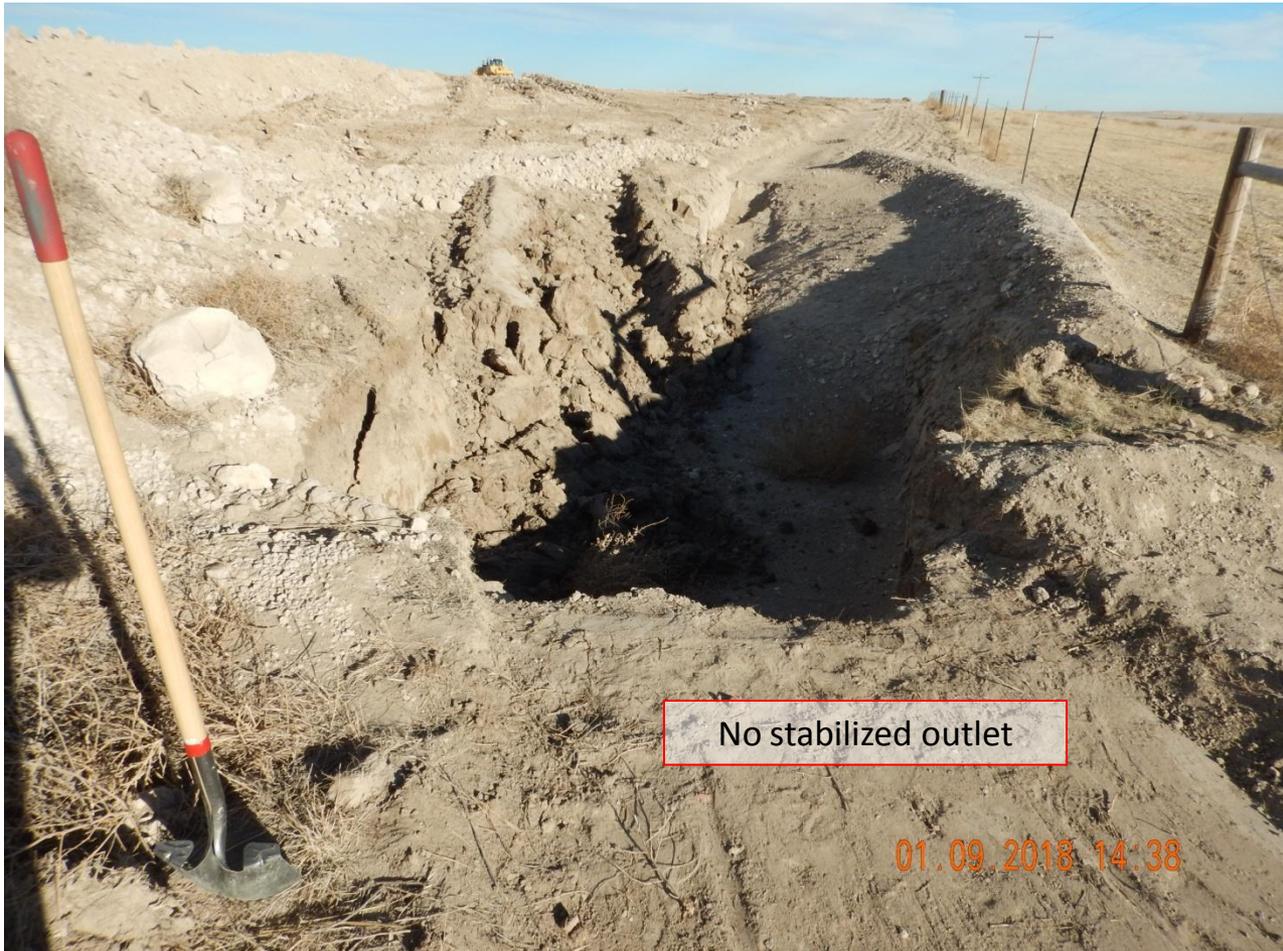
Photo 18. Photo taken from sediment trap #7, facing East. Stormwater BMP has been damaged and not functional. Rock material from the sediment trap has been removed; therefore, the sediment trap has no stabilized outlet. Interim reclamation activities were occurring during the time of the inspection but stormwater BMPs were either removed or not maintained.

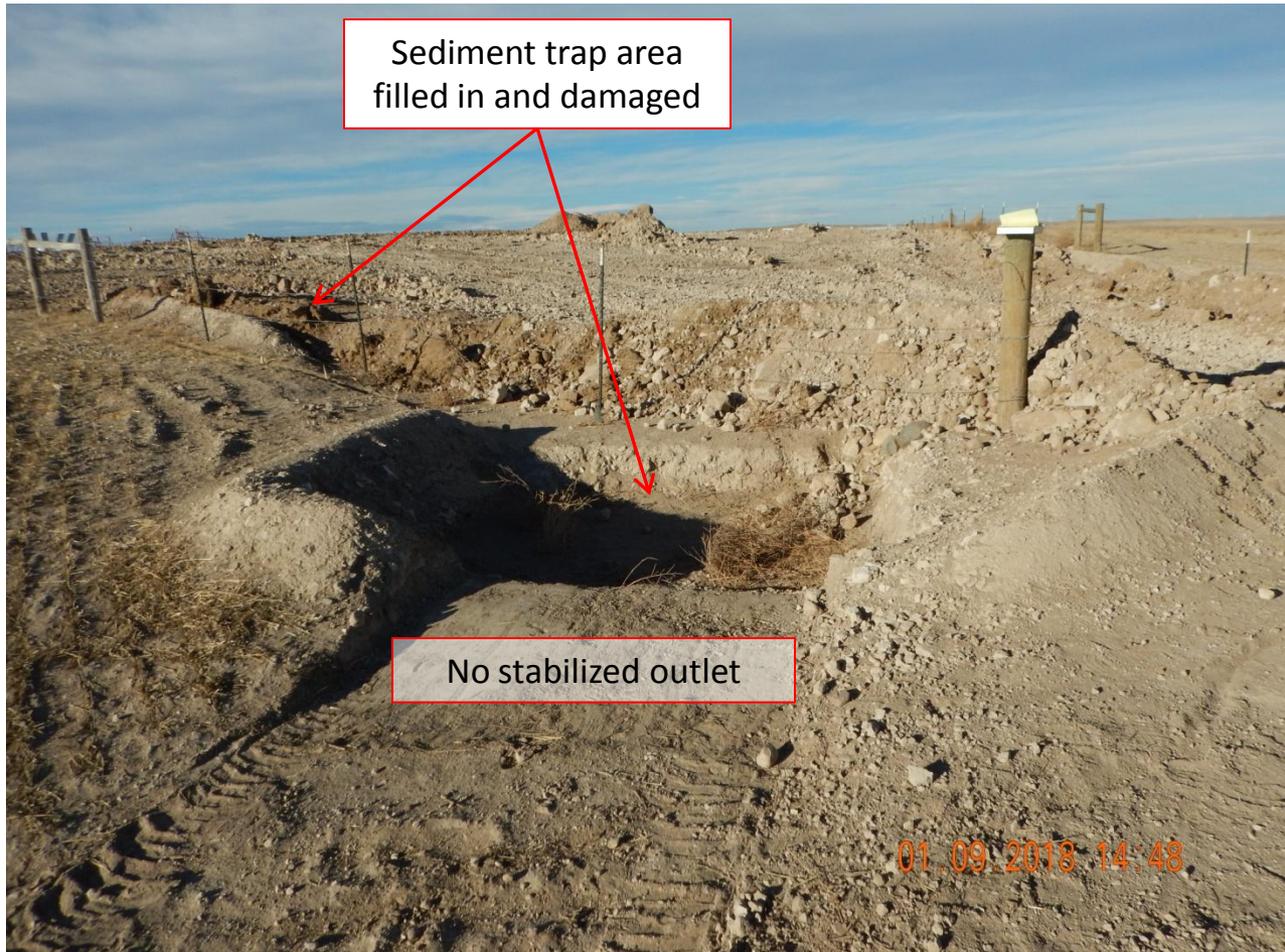
Photo 19. Photo taken from sediment trap #8, facing North. Stormwater controls have been removed- see comments under Photos 18.

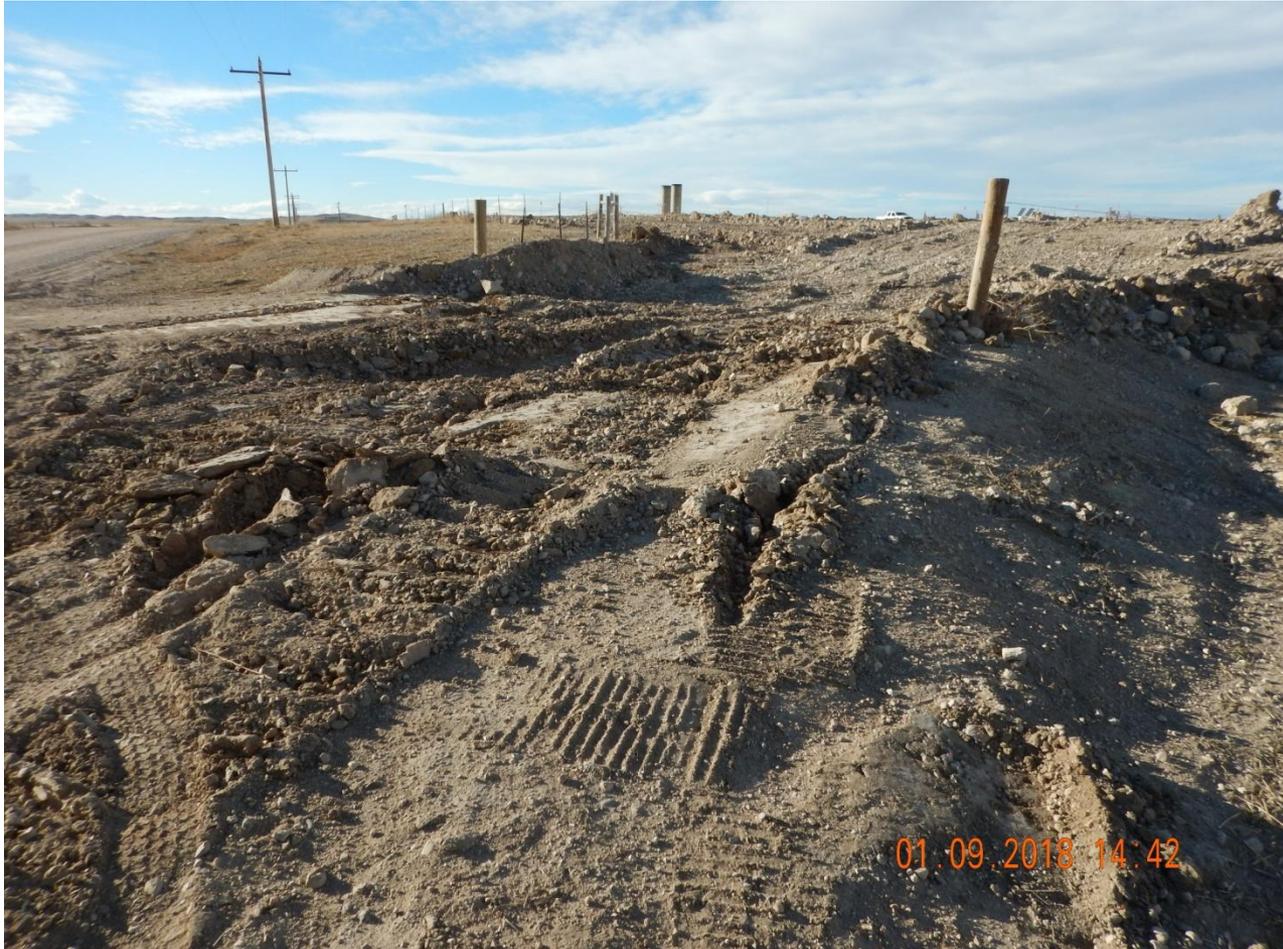
Photo 20. Photo taken from the eastern entrance to the Johnny Pad, facing Northwest. No stormwater BMPs installed around this area during interim reclamation activities.

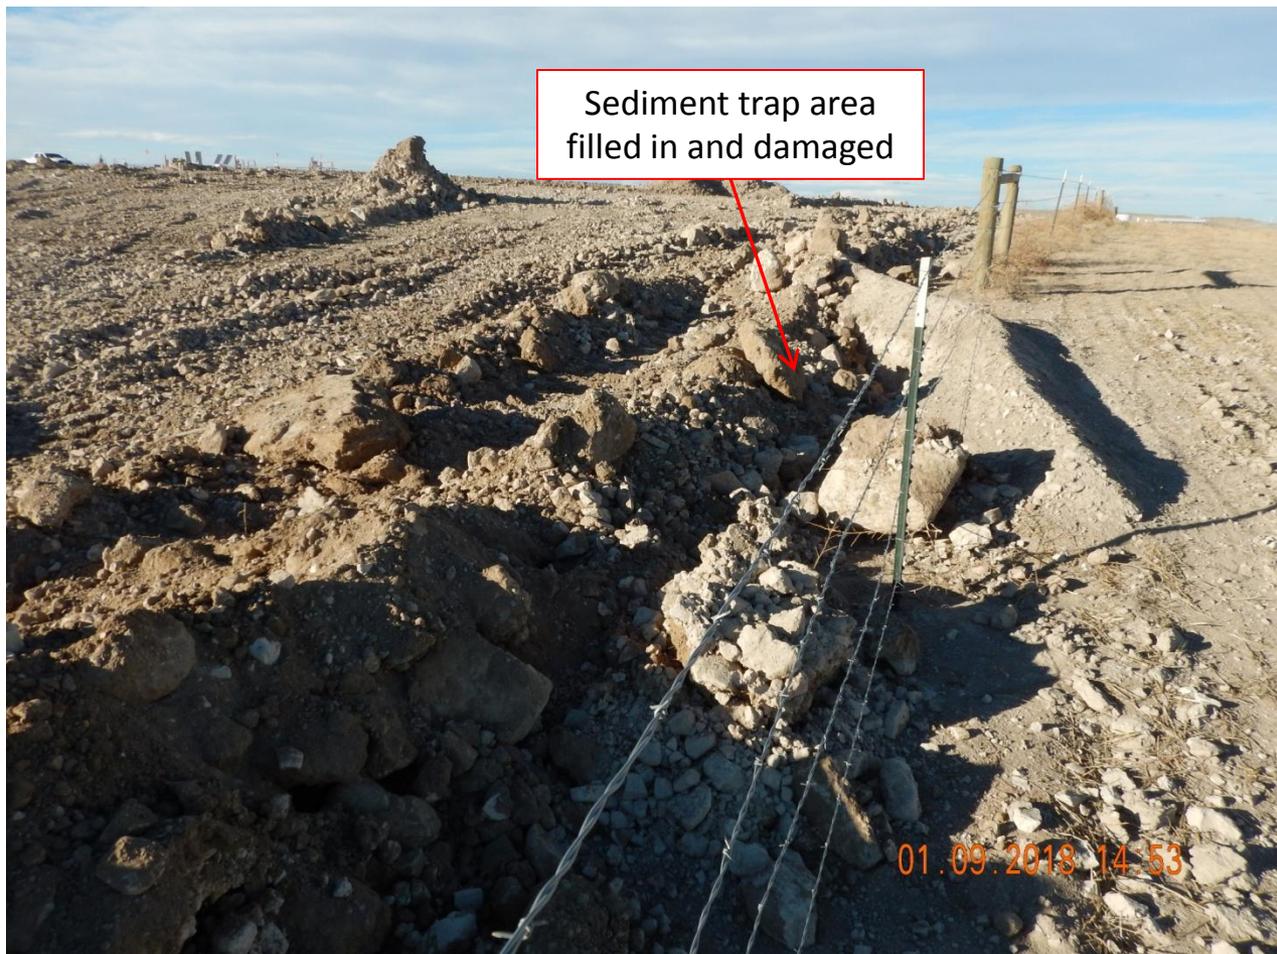
Photo 21. Photo taken from sediment trap #9, facing North. Stormwater controls have been removed- see comments under Photo 18.
