Interim Reclamation and Stormwater Inspection

January 9, 2018

Operator: NOBLE ENERGY INC- #100322

Location ID: 433936

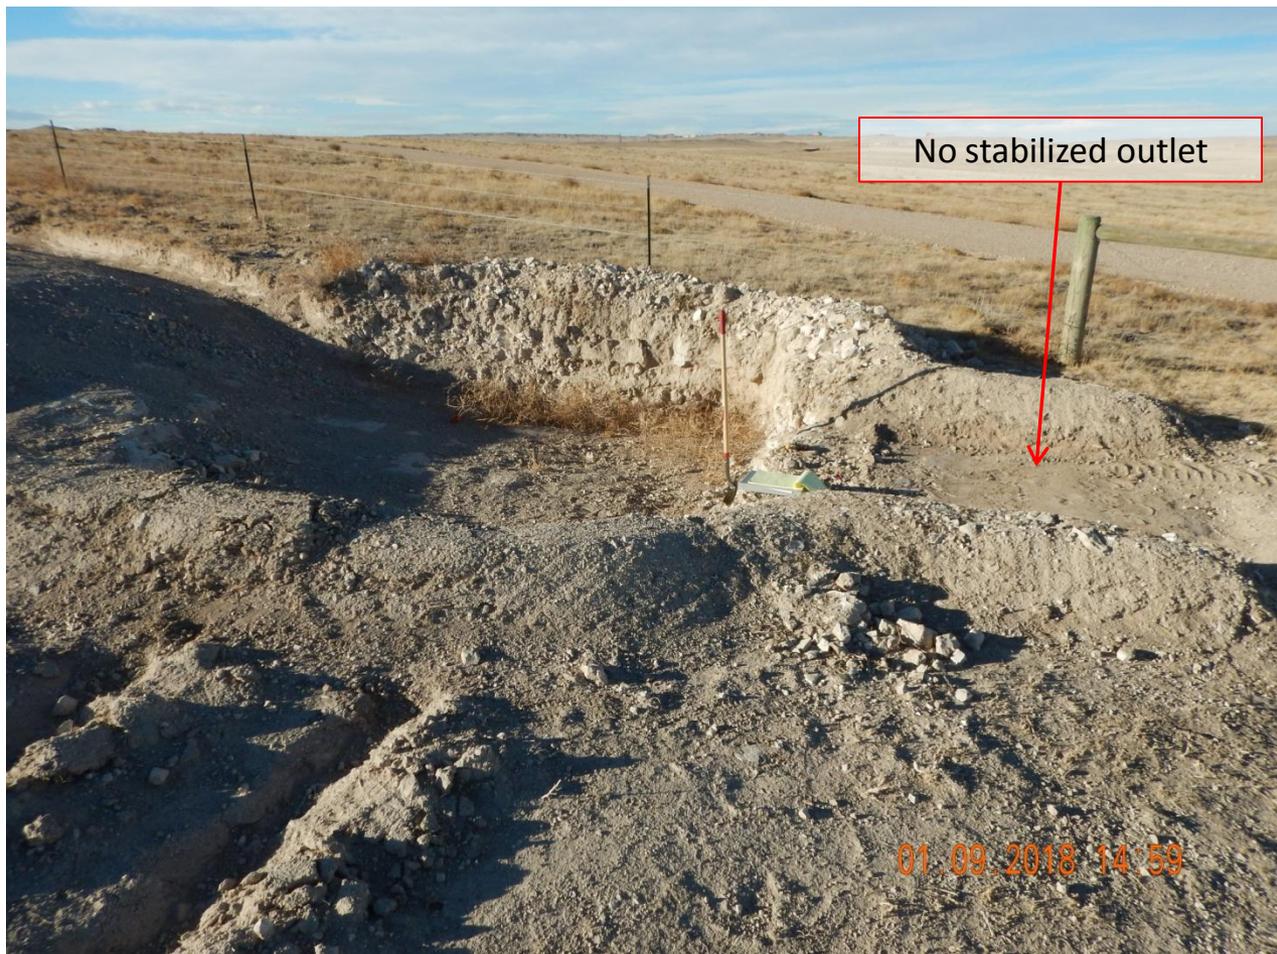
Photo 3. Photo taken from sediment trap #1, facing East. Operator has installed the above sediment trap since the previous inspection. Rock material from the sediment trap has been removed; therefore, the sediment trap has no stabilized outlet. Interim reclamation activities were occurring during the time of the inspection but stormwater BMPs were not maintained. Also, this does not appear to be built to Noble's own Stormwater BMP Manual (i.e., side slopes not 2:1) or in accordance with good engineering practices.

Photo 22. Photo taken from sediment trap #10, facing East. See comments under Photo 3.
